Final Reclamation Inspection

Operator: MAGPIE OPERATING, INC- # 52530

API: 05-069-06159

Inspection Photos
Location Name: PROCTOR-SKAER #1-A
API: 05-069-06159

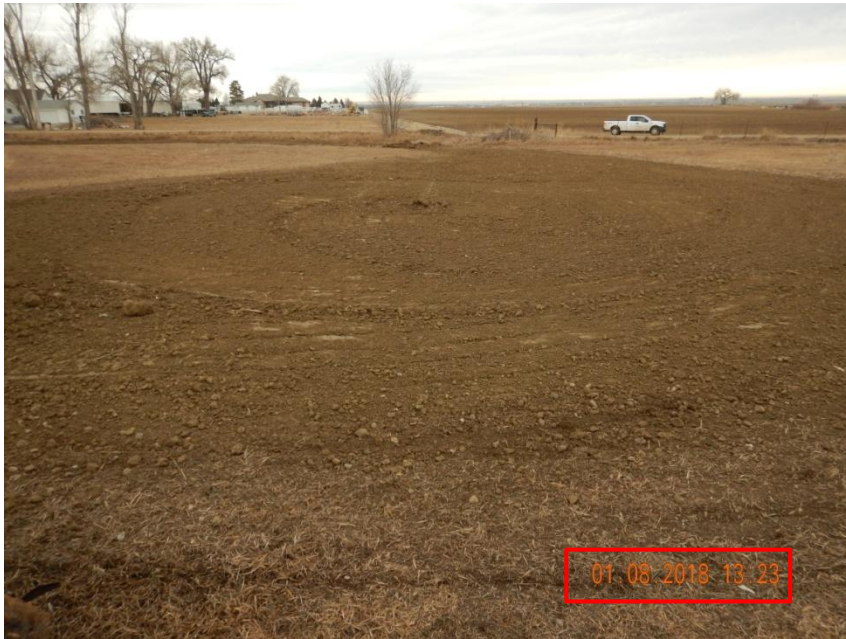
Photo 1. Photo taken on January 8, 2018 from the well location, facing North. Operator is IN-PROCESS of reclamation activities regarding the previous corrective action inspection. A follow-up inspection will occur at a future date to ensure compliance with Rule 1004 standards.

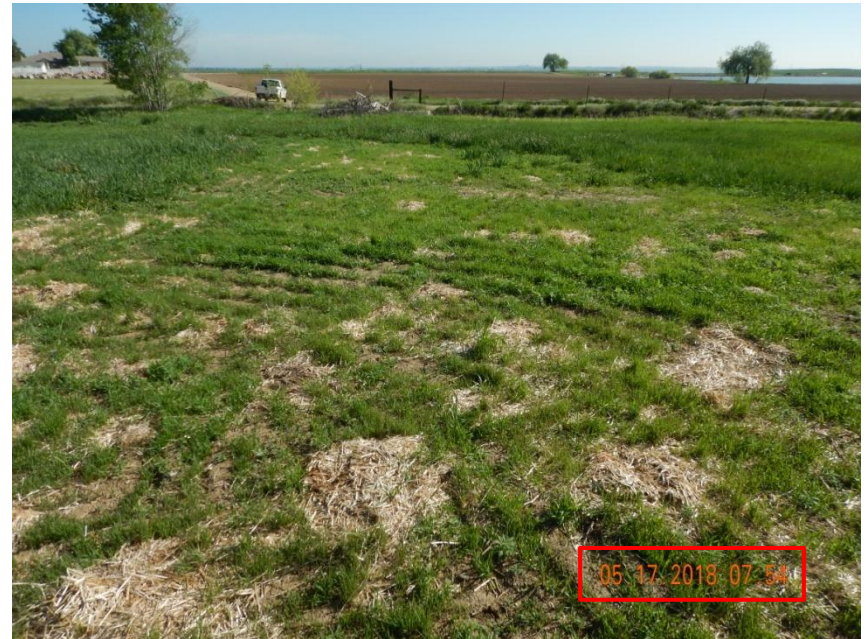
Photo 2. Photo taken on May 17, 2018 from the well location, facing North. Germination evident throughout the entire well location. A follow-up inspection will occur at a future date to ensure compliance with Rule 1004 standards.

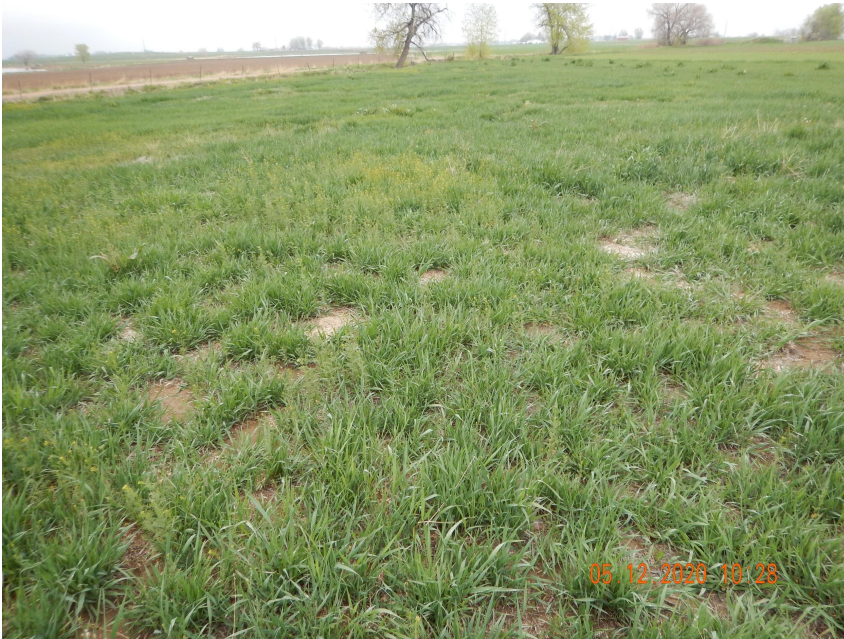
Photo 3. Photo taken on May 12, 2020 from the well location, facing East. Photo illustrates the establishment of desirable species (Smooth brome) which is reflective of reference area vegetative levels.

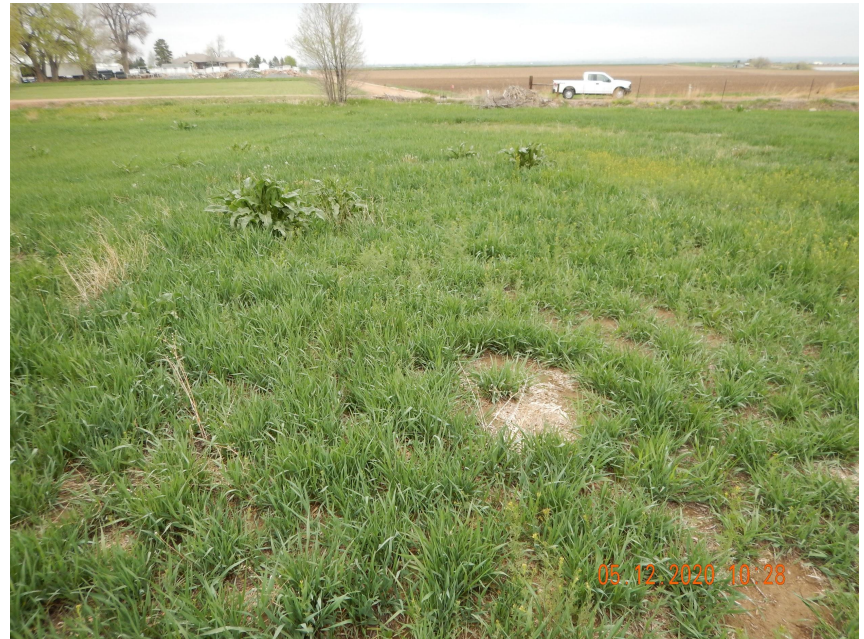
Photo 4. Photo taken on May 12, 2020 from the well location, facing North. See comments under Photo 3. Note: the large robust plants in the photo are *Rumex sp.* which was observed in reference areas and is not a noxious weed.

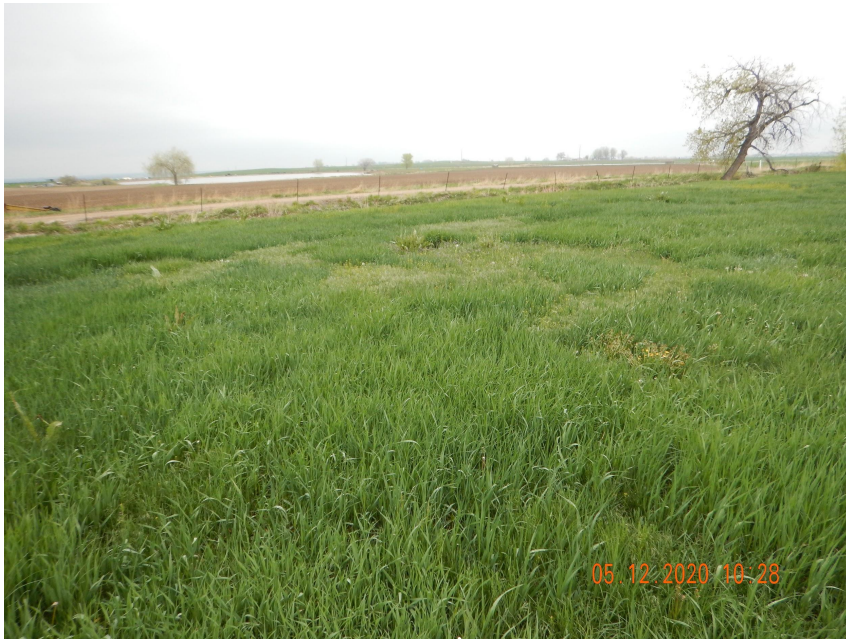
Photo 5. Reference photo taken on May 12, 2020 east of the well location, facing East. Photo illustrates the well location is reflective of reference area vegetative levels.

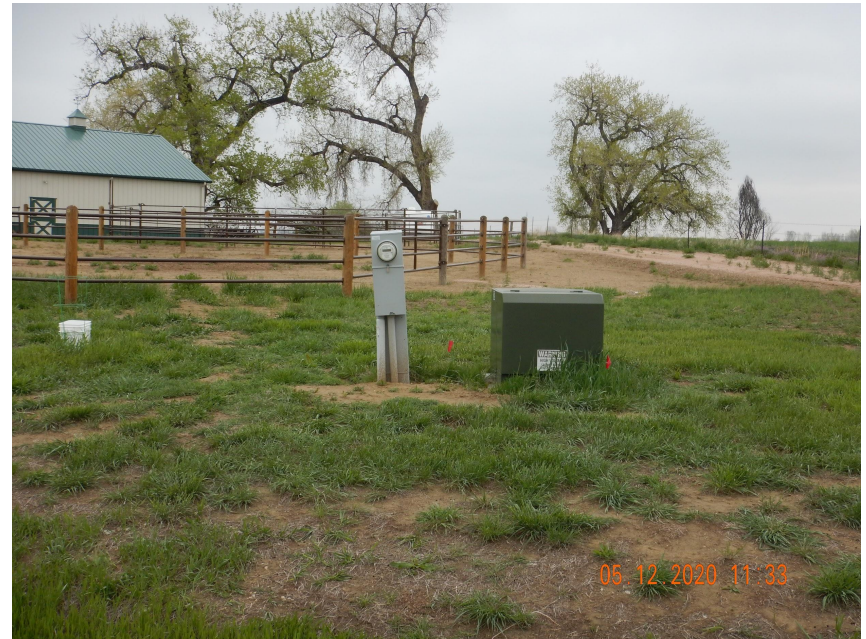
Photo 6. Photo taken on May 12, 2020 from the associated offsite tank battery location, facing East. Photo illustrates a final land use change and the location is now part of a horse arena.
