Inspection Photos

Operator: CHEVRON USA INC - 16700

Location ID: 397120

Rio Blanco County, CO

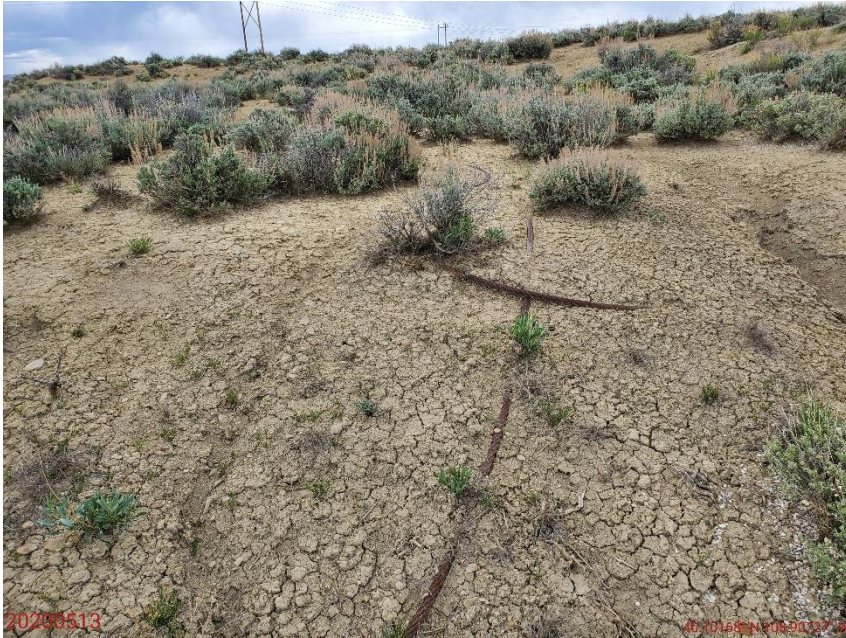
Photo 1: Photo taken from the east end of the Location, facing east. Photo shows cable debris remaining.

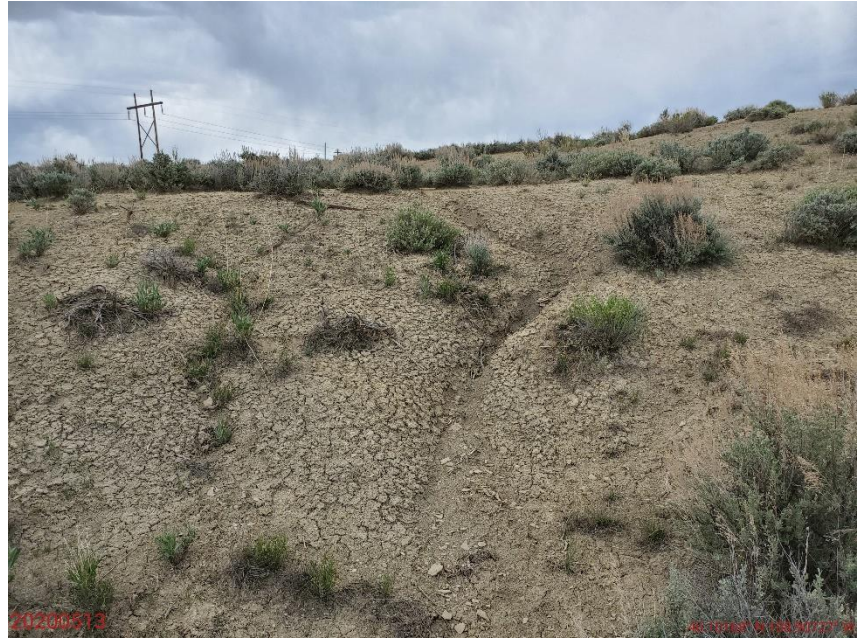
Photo 2: Photo taken from the east end of the Location, facing east. Photo shows erosion degradation due to stormwater runoff evident.

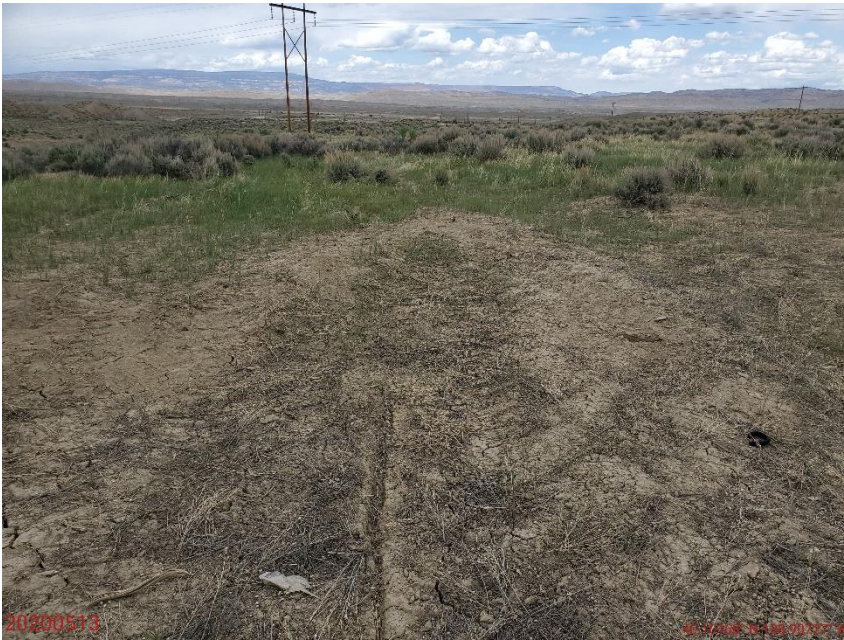
Photo 3: Photo taken from the south end of the Location, facing south. Photo shows riser equipment has been removed.

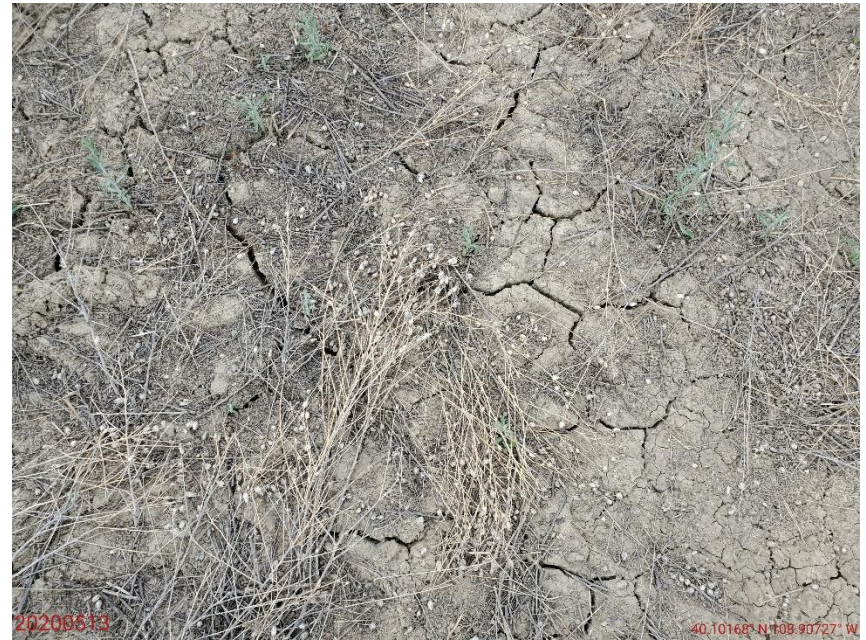
Photo 4: Photo taken from the Location. initial control efforts appear to have been conducted, however an abundant amount of the seed heads appear to have been knocked down onto the soil surface. Knapweed growth currently occurring

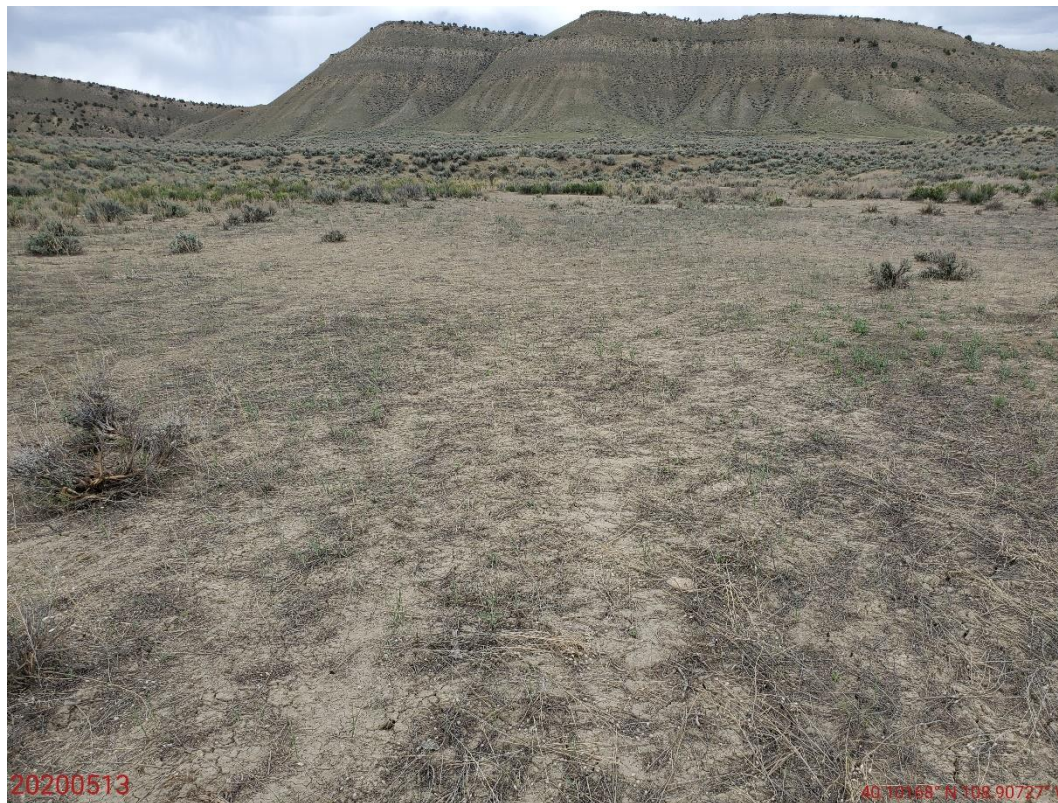
Photo 5: Photo taken from the north end of the Location, facing south. Photo shows Location is predominantly bare; vegetation on Location predominantly undesirable weedy plant species.

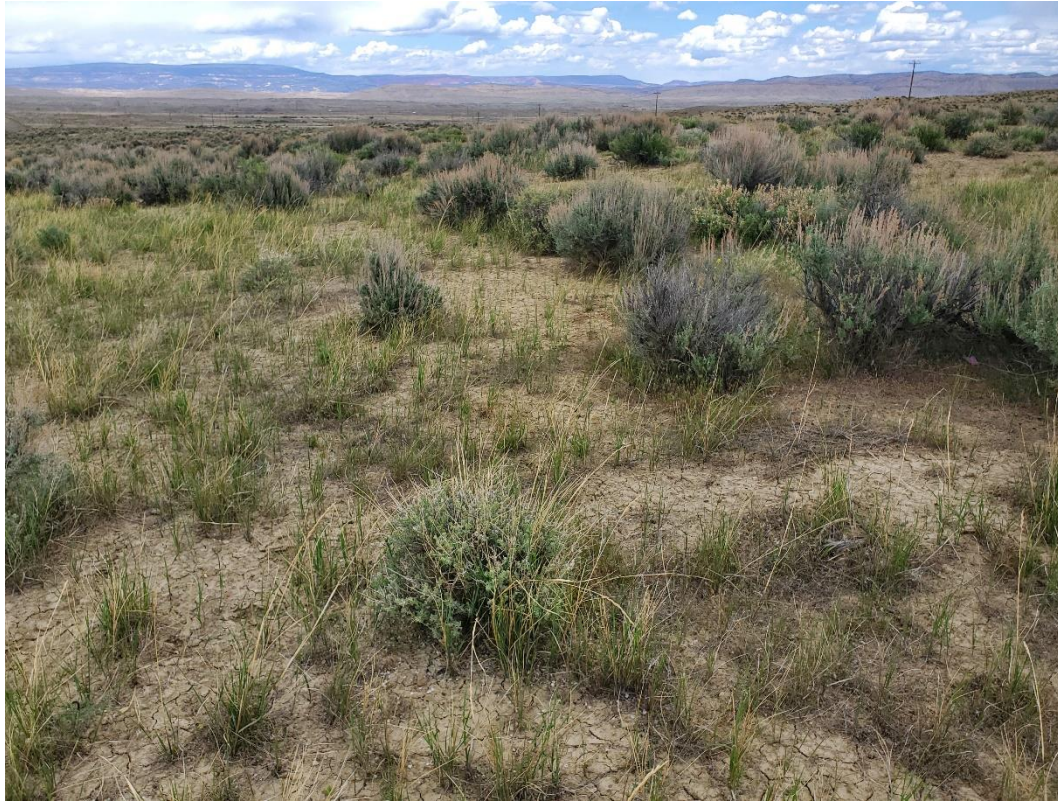
Photo 6: Photo of vegetation over the adjacent reference area; Vegetation on location is not reflective of the reference.
