Inspection Photos
Location Name: BRIANNA 23-16
API#: 05-071-08709
INSP. #: 695102822

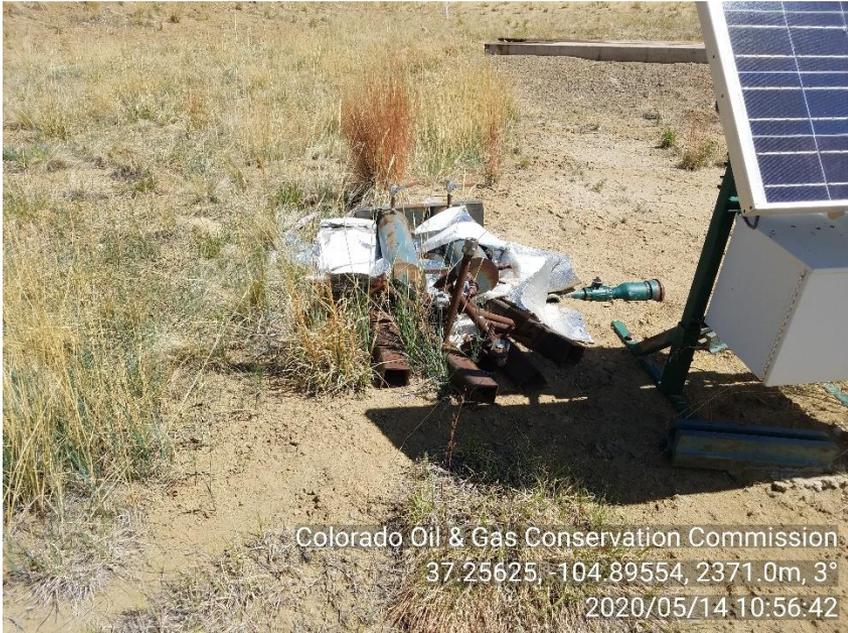
PHOTO 5: UNUSED EQUIPMENT STORED ON LOCATION (MISCELLANEOUS PIECES OF PIPES AND FITTING). REMOVE UNUSED EQUIPMENT COMPLY WITH RULE 603.f. CA DATE 8-14-20.

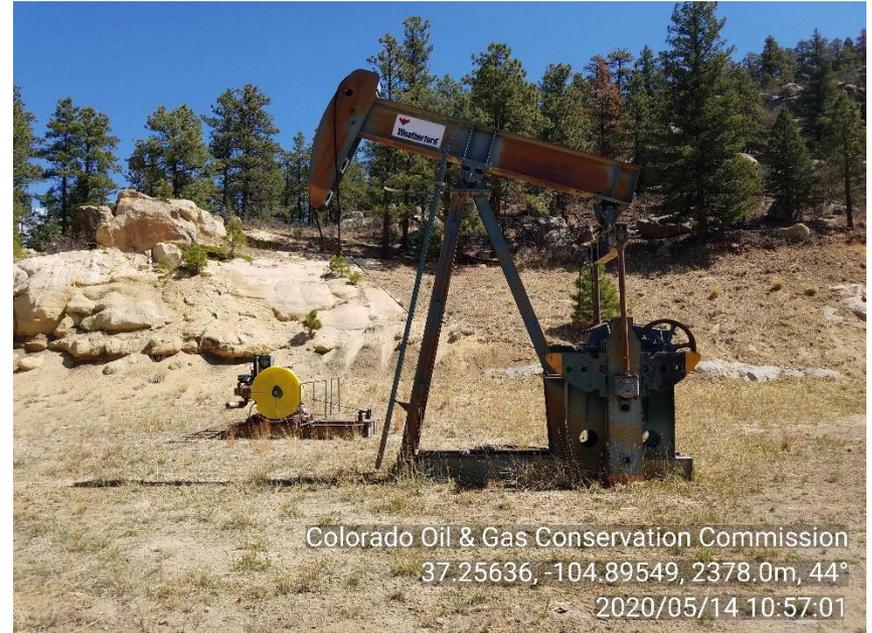
PHOTO 6: UNUSED EQUIPMENT STORED ON LOCATION (PUMPJACK, POWER UNIT FOR PUMPJACK AND LADER). REMOVE UNUSED EQUIPMENT COMPLY WITH RULE 603.f. CA DATE 8-14-20.

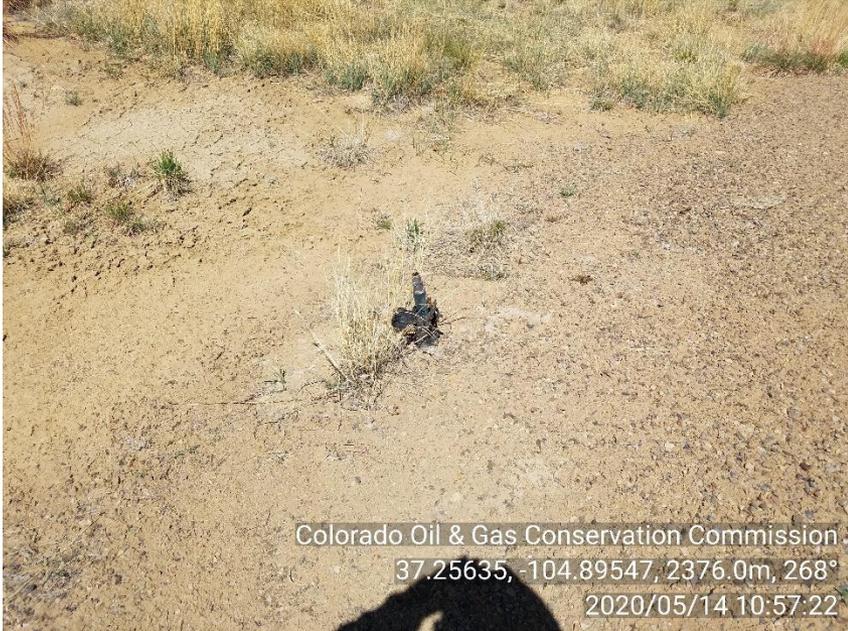
PHOTO 5: UNUSED EQUIPMENT STORED ON LOCATION (1" RISER NEAR PUMPJACK PAD). REMOVE UNUSED EQUIPMENT COMPLY WITH NTO AND RULE 603.f. CA DATE 8-14-20.
