Inspection Photos  
Location Name: MARJO #M2  
API#: 05-071-40017  
INSP. #: 695102870

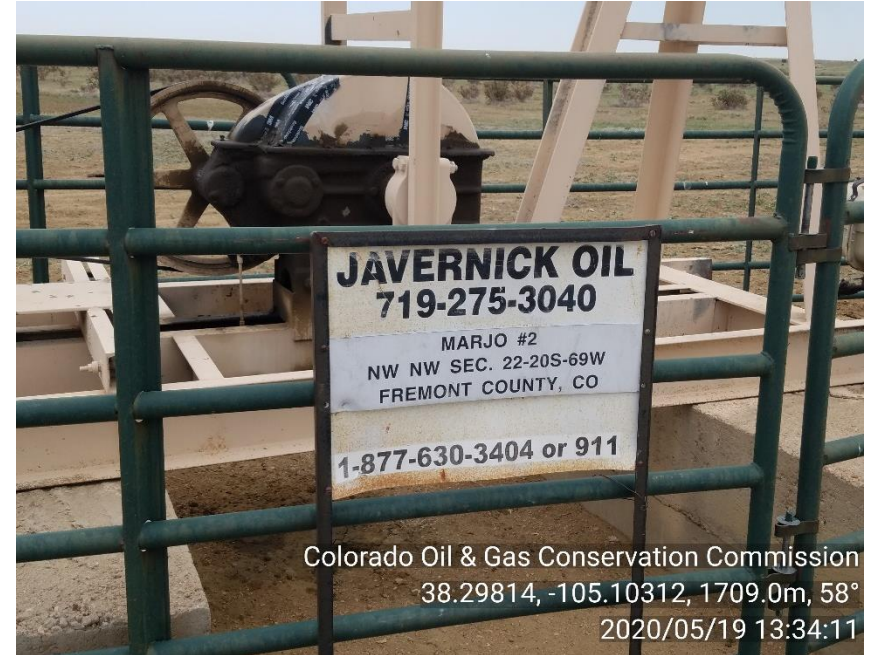
PHOTO 2: WELL SIGN/ ACCORDING TO COGCC RECORD THE WELL NAME IS MARJO #M2. **COMPLY WITH RULE 210.b. CA DATE 8-19-20**

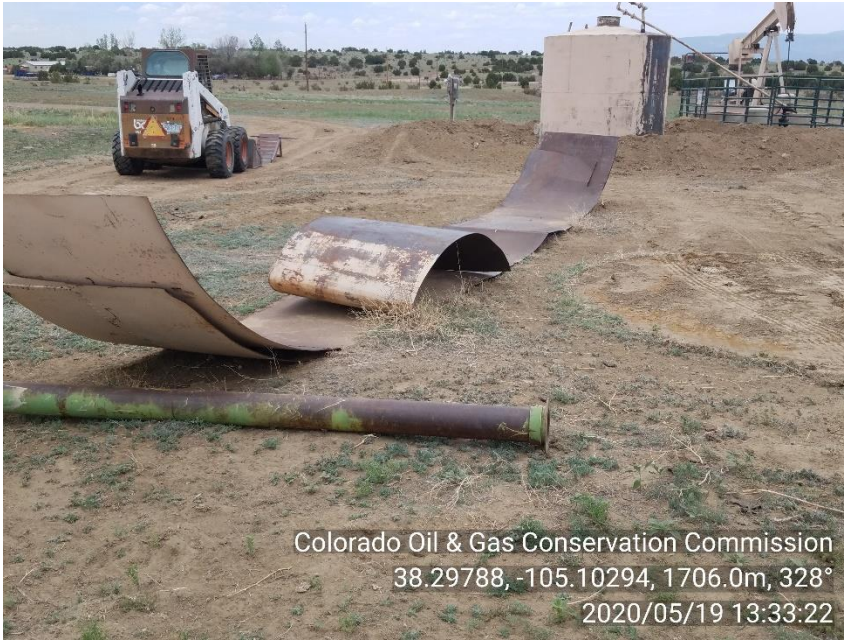
**PHOTO 3: UNUSED EQUIPMENT STORED ON LOCATION  
(PIPE, METAL CONTAINMENT MATERIAL AND SKID STEAR).  
REMOVE OR INSTALL UNUSED EQUIPMENT, COMPLY WITH  
RULE 603.f. THIS IS SECOND NOTICE FOR THIS CA,  
CORRECTIVE ACTION IS THE DATE GIVEN ON ORIGINAL  
INSPECTION DOC#689901527**
