Inspection Photos

API: 071-07705

Operator: EVERGREEN NATURAL RESOURCES

Inspection Date: 5/20/2020

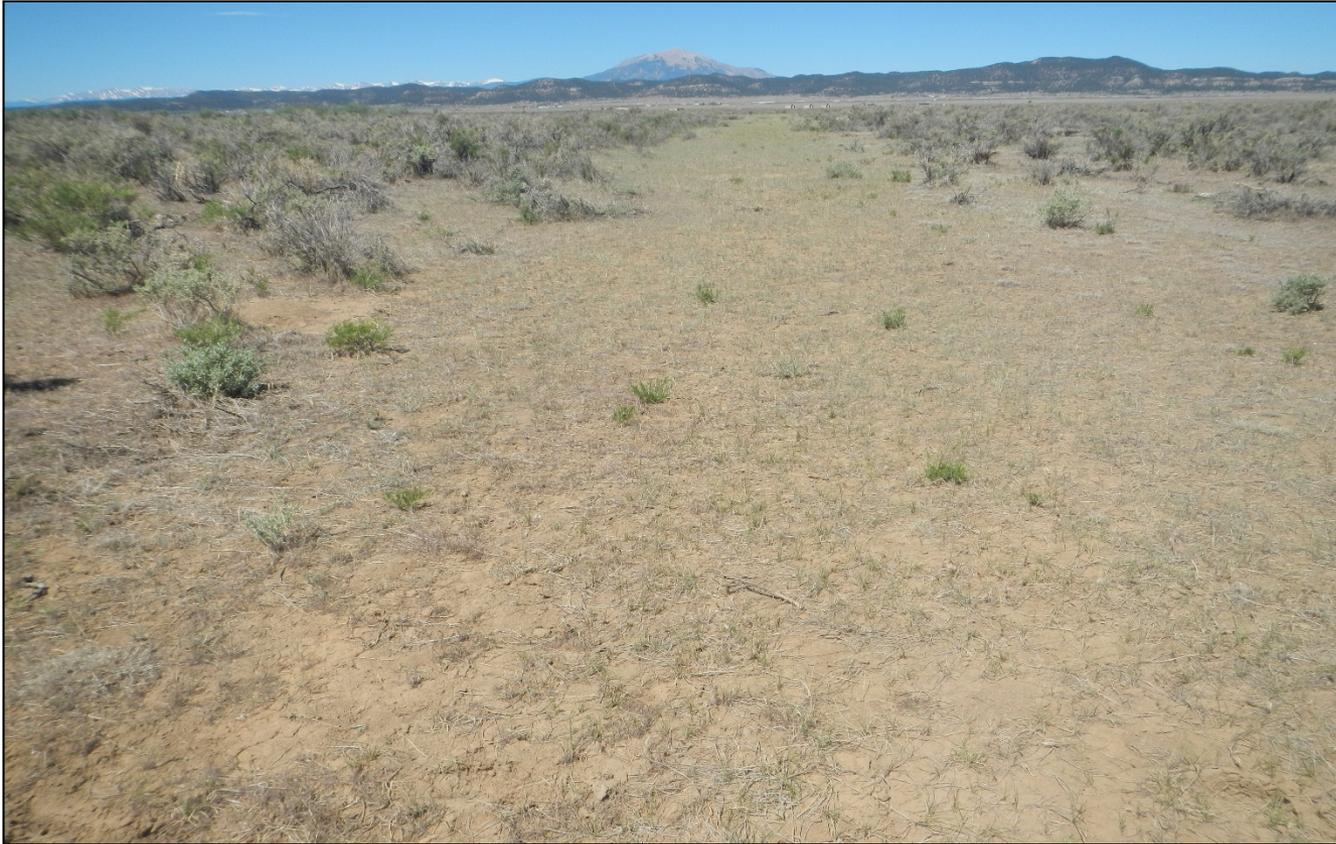
Photo 1. Facing west along the reclaimed access road. The desirable vegetation is uniformly established along the former road.

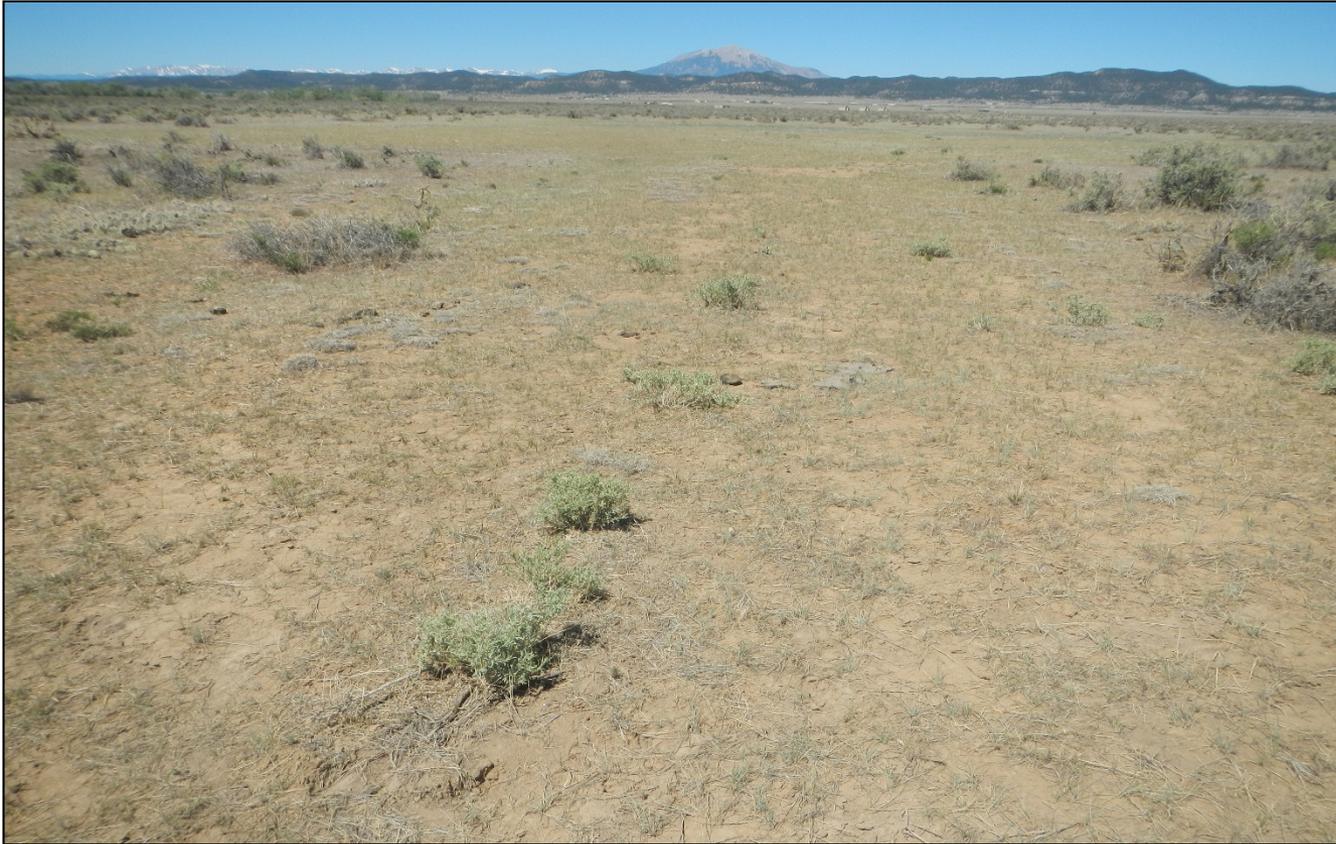
Photo 2. Facing west along the reclaimed road toward the location. The fencing material previously observed in this area has been removed.

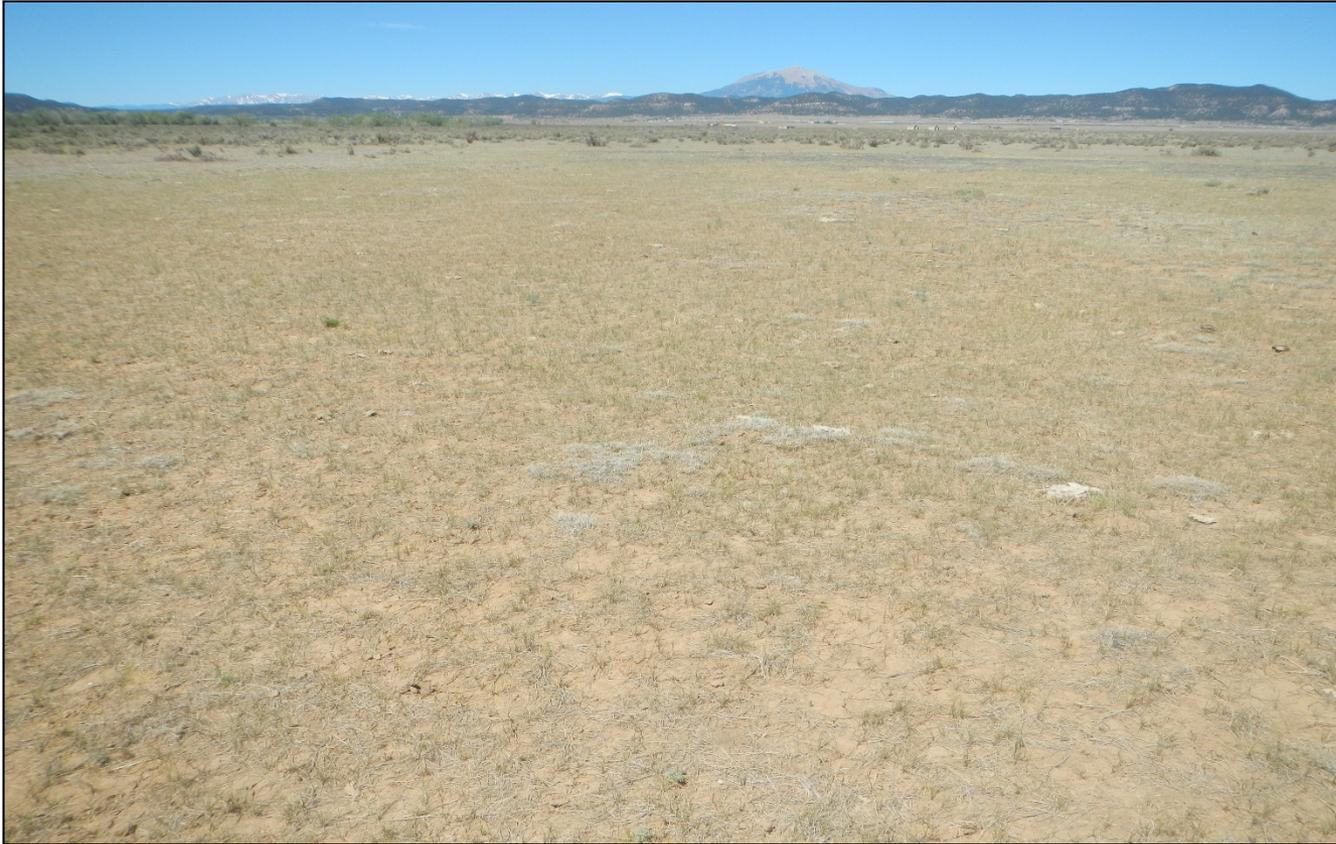
Photo 3. Facing west at the location. The desirable vegetation is uniformly established in this portion of the location.

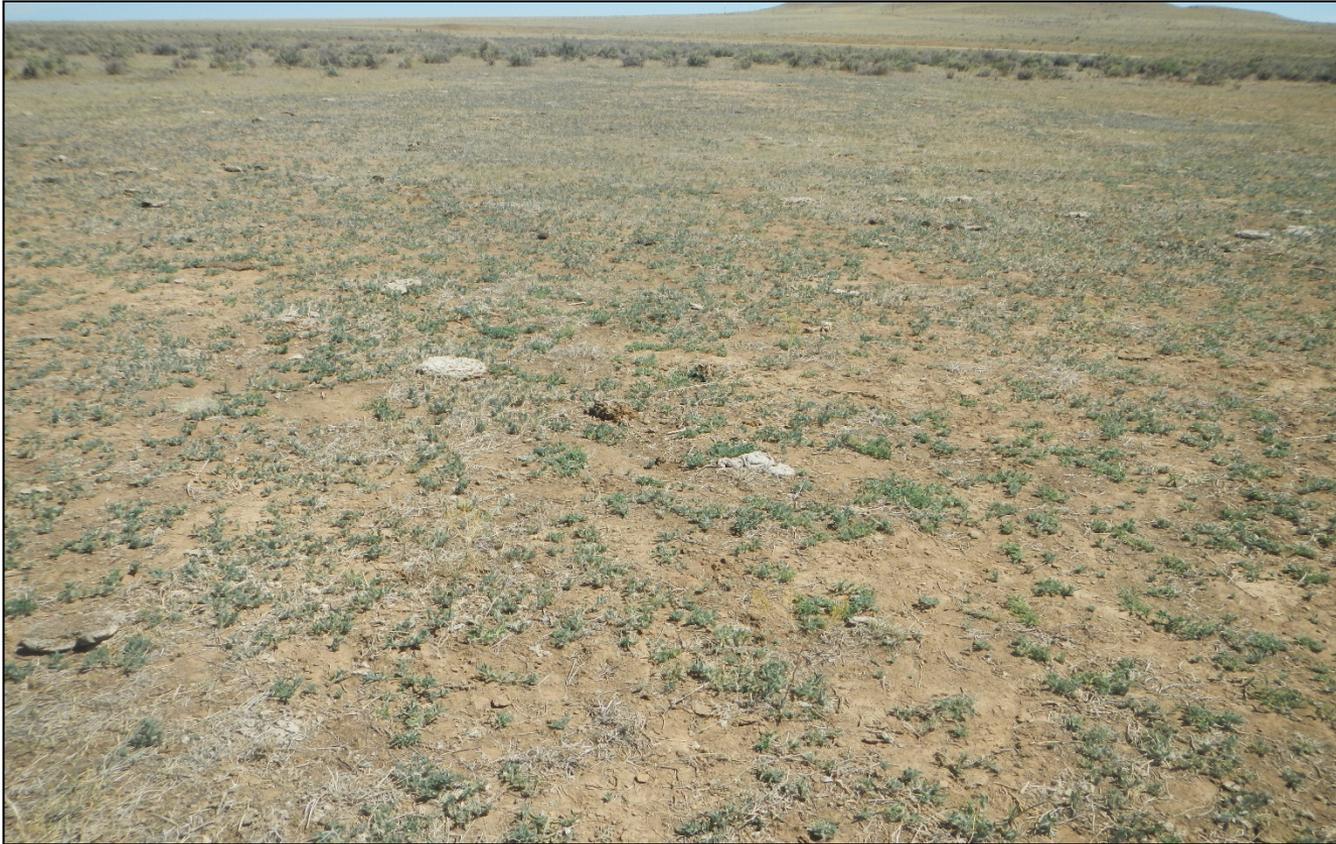
Photo 5. Facing northeast at the west side of the location. This area consists predominately of undesirable weeds (*Kochia* sp.). This appears to be the former area of the pit.

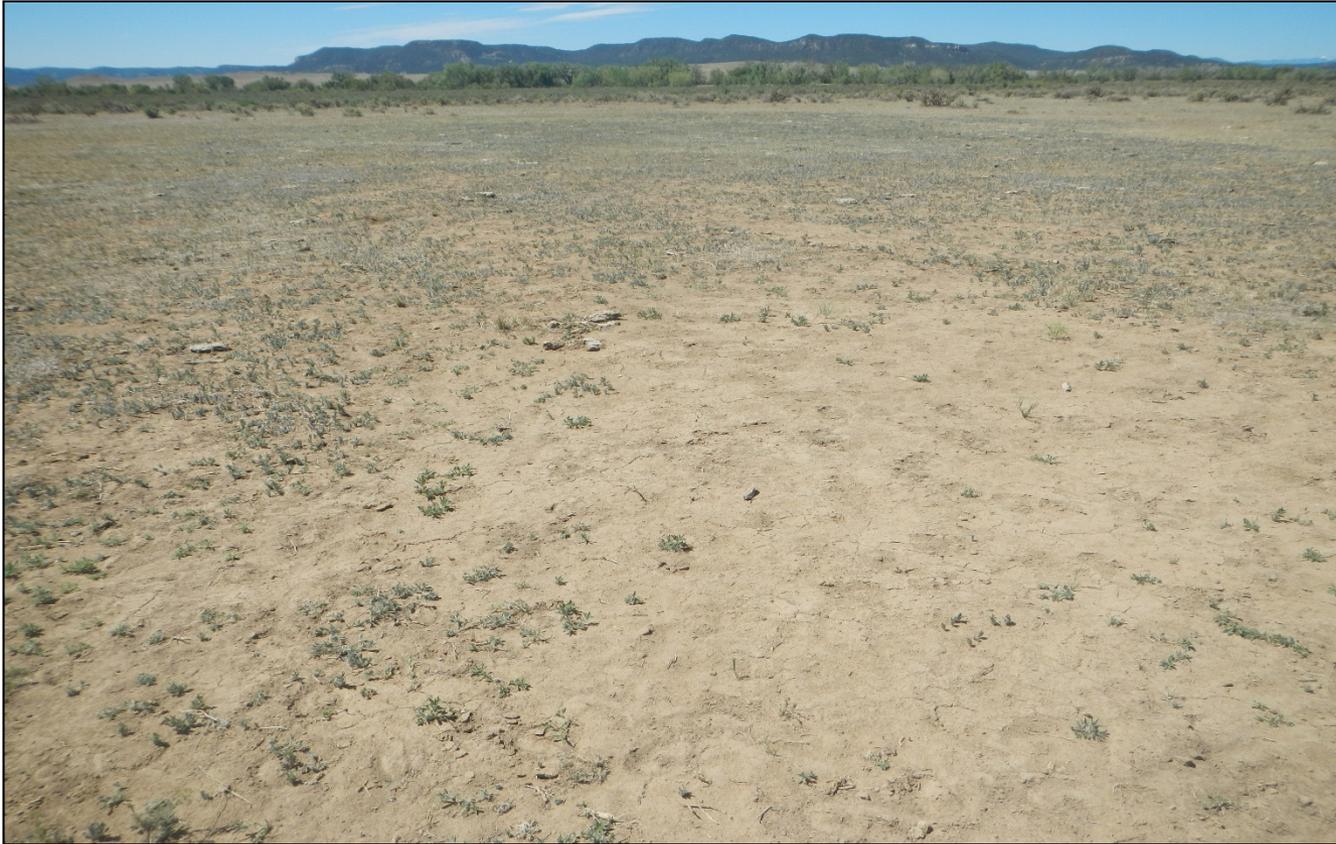
Photo 6. Facing southwest at the west side of the location. This area consists predominately of undesirable weeds (*Kochia* sp.). This appears to be the former area of the pit.
