Inspection Photos

Location Name: MGP A-3 FOLLOW UP

API#: 05-071-06093

INSP. #: 695102875

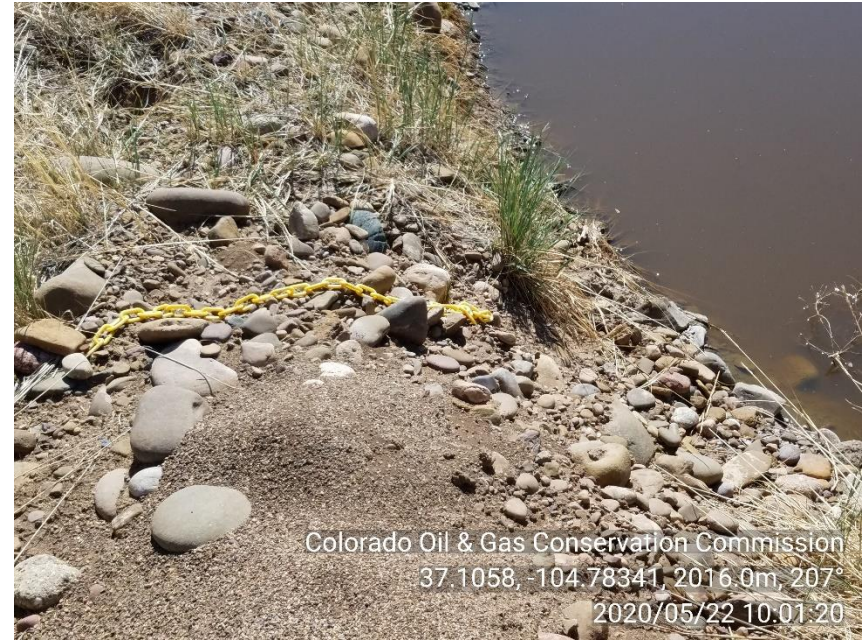
PHOTO 4: FREEBOARD MARKER IS NOT INSTALLED ACCORDING TO THE RULE (THE MARKER HAS TO BE INSTALLED ON THE LOWEST ELEVATION SIDE OF PIT MEASURED FROM ORIGINAL GROUND LEVEL, NOT THE TIP OF THE BERM). **COMPLY WITH RULE 902.b. THIS IS THE SECOND NOTICE FOR THIS CORRECTIVE ACTION, CA DATE IS THE ORIGINAL CA DATE FROM PREVIOUS INSPECTION DOC#695100198.**

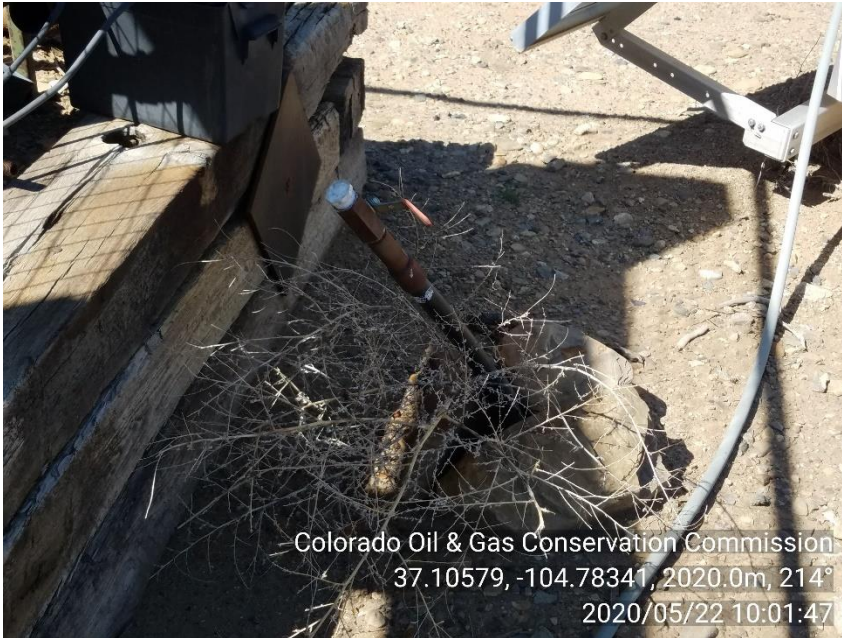
PHOTO 5: UNUSED EQUIPMENT (1" RISER NEAR PUMPJACK).
REMOVE UNUSED EQUIPMENT ACCORDING TO NTO AND
RULE 603.f.. CA DATE 8-22-20.

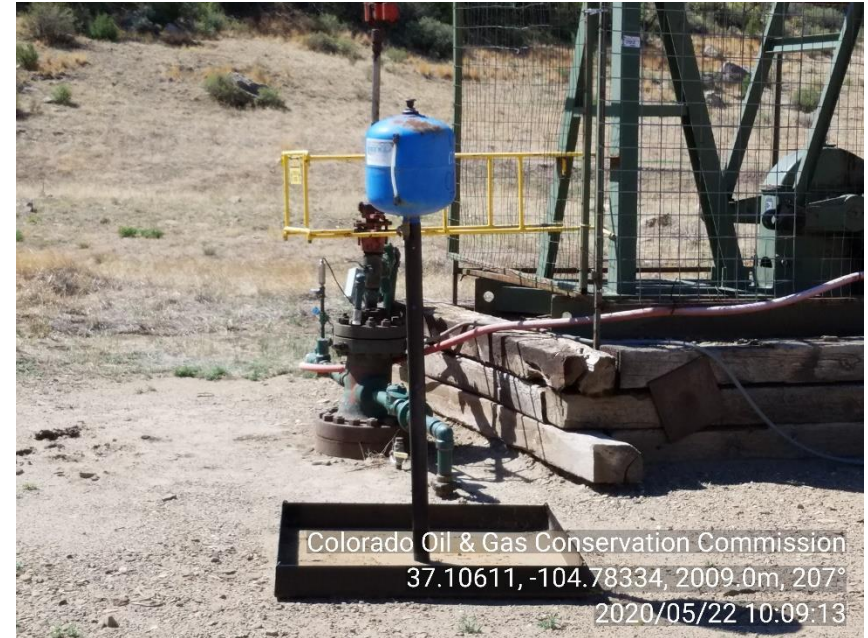
PHOTO 6: UNUSED EQUIPMENT STORED ON LOCATION.
REMOVE OR INSTALL UNUSED EQUIPMENT. COMPLY WITH
RULE 603.f. CA DATE 8-22-20
