Inspection Photos
Operator: BP America
API#: 067-08678
Date: 5/20/2020

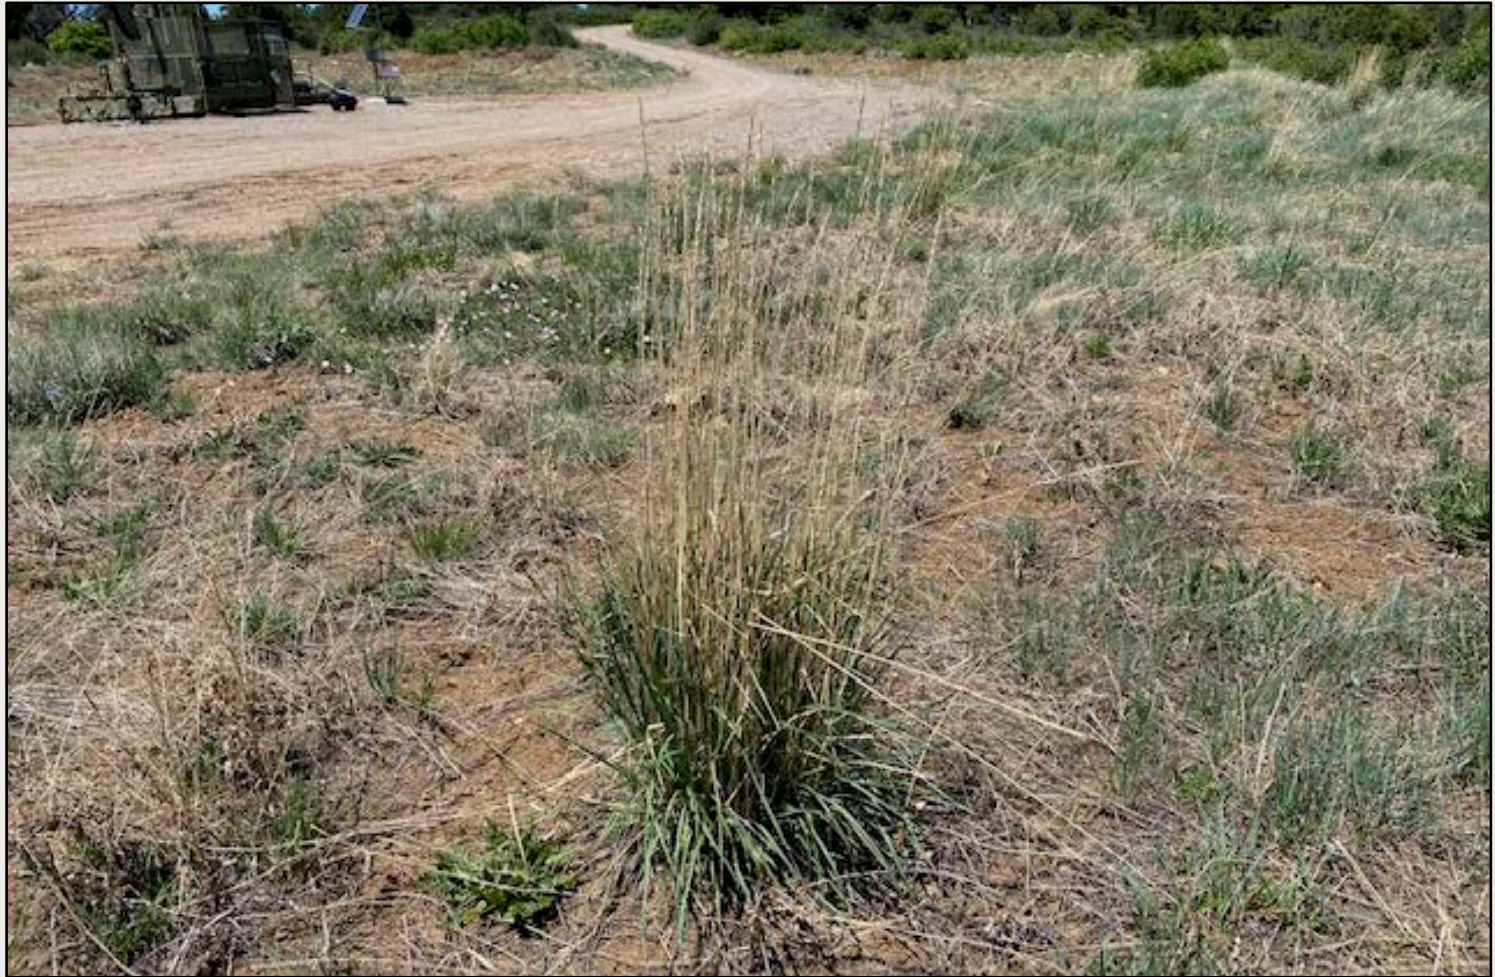
Photo 1. View of the project area from the southeastern corner facing center.

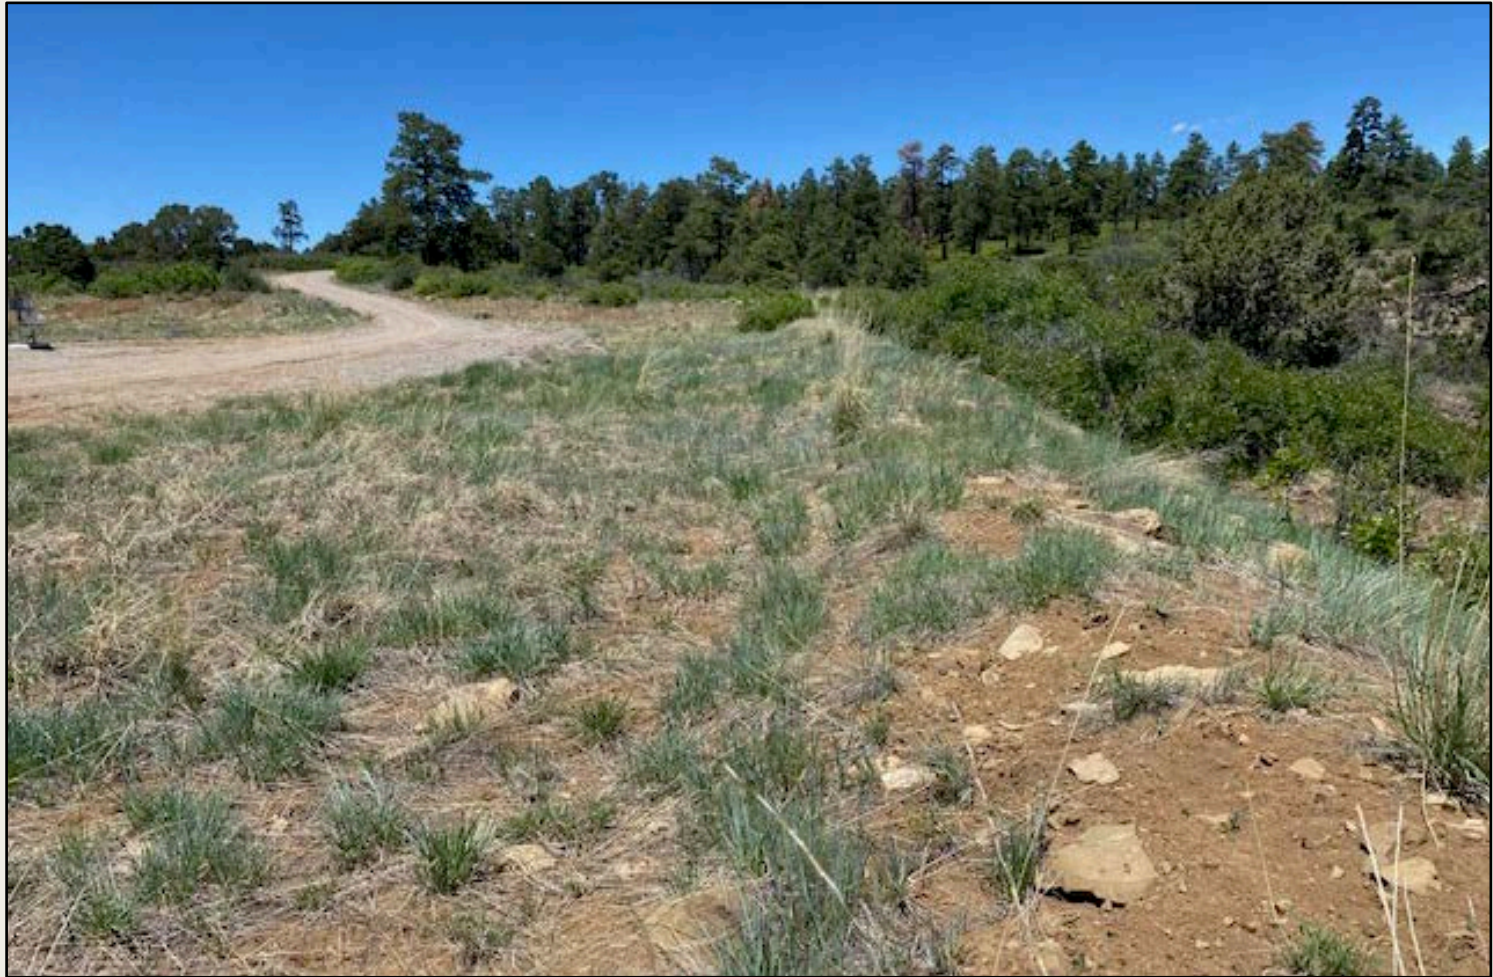
Photo 2. View of the eastern fill slope from the southeastern corner facing northward. Revegetation is progressing on the slope with grasses such as western wheatgrass, James galleta, and intermediate wheatgrass.

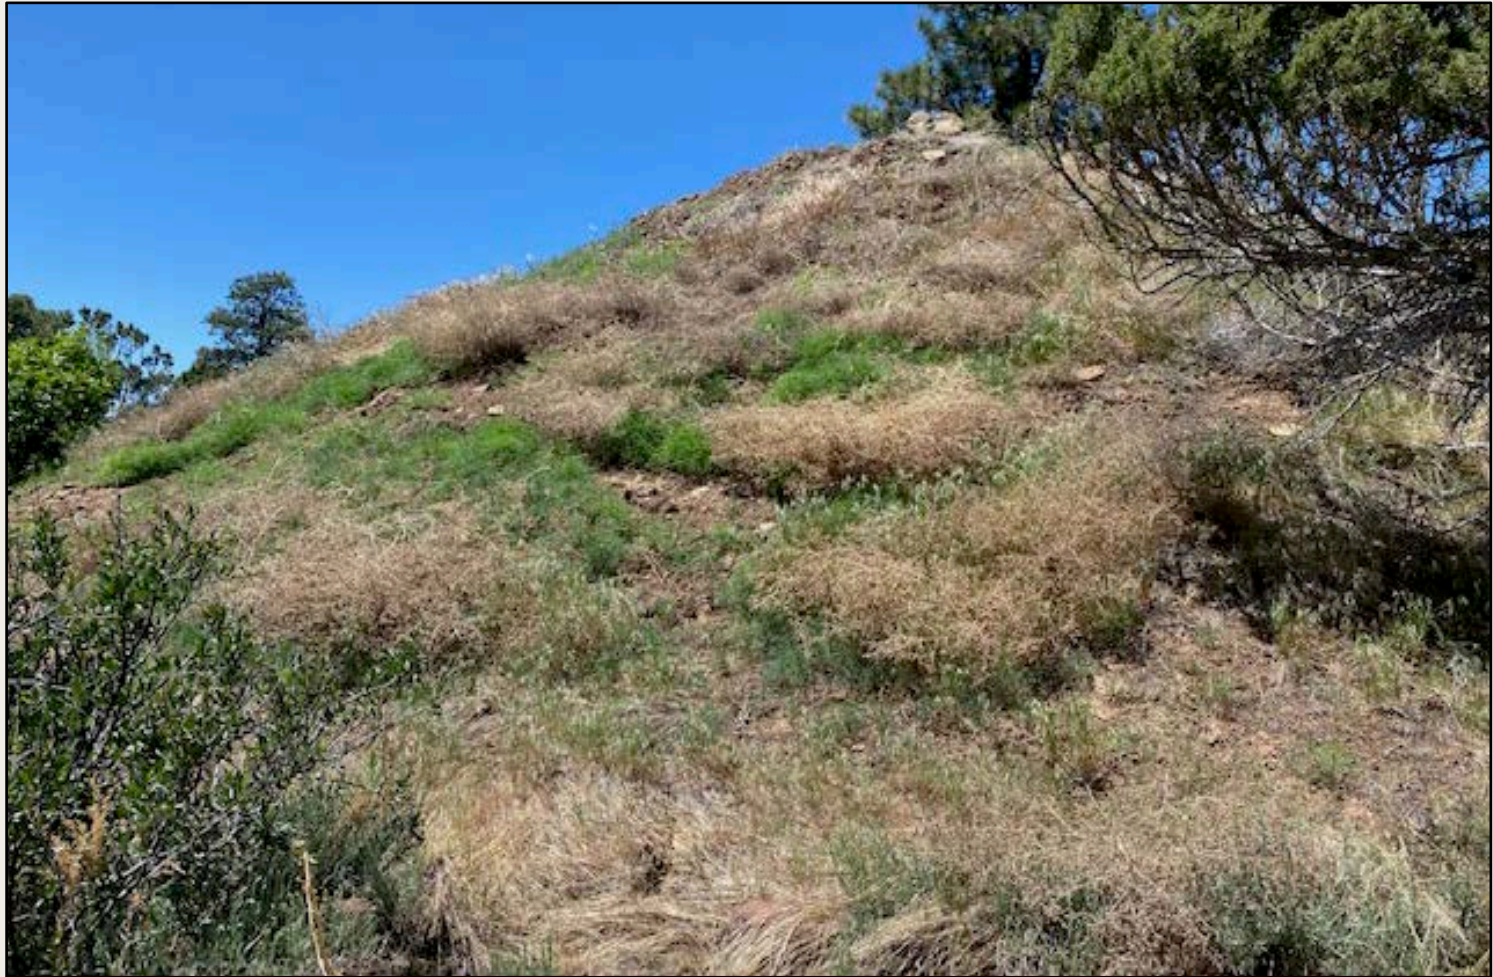
Photo 3. View of what appears to be topsoil stockpile within the southeastern project area. Stockpile is weed infested and is not stabilized.

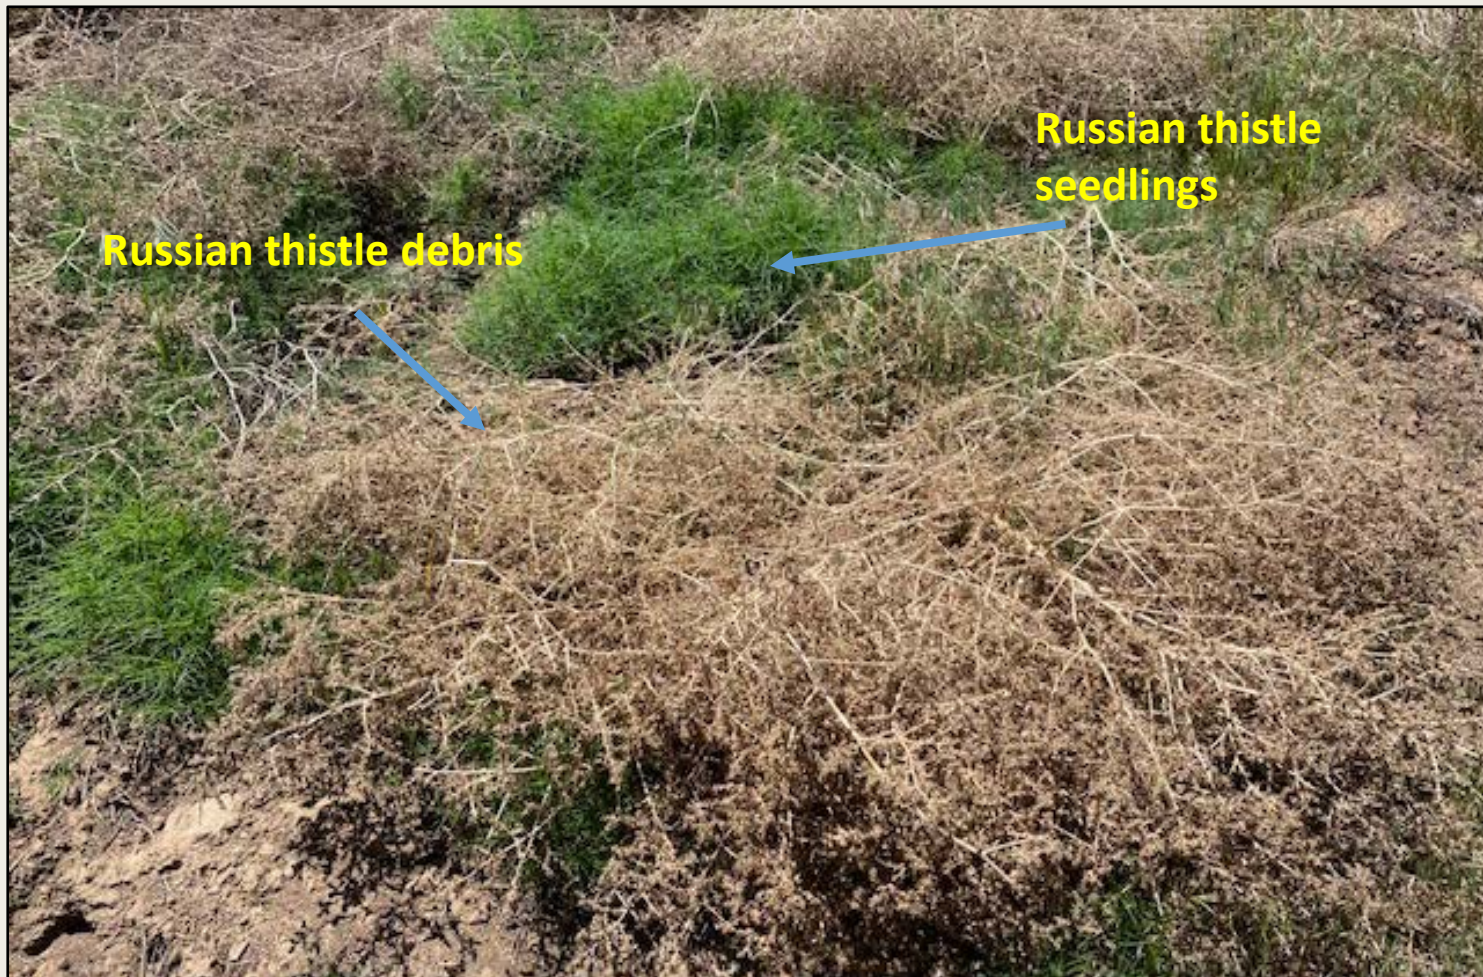
Photo 4. closeup view of dense Russian thistle growing on soil stockpile.

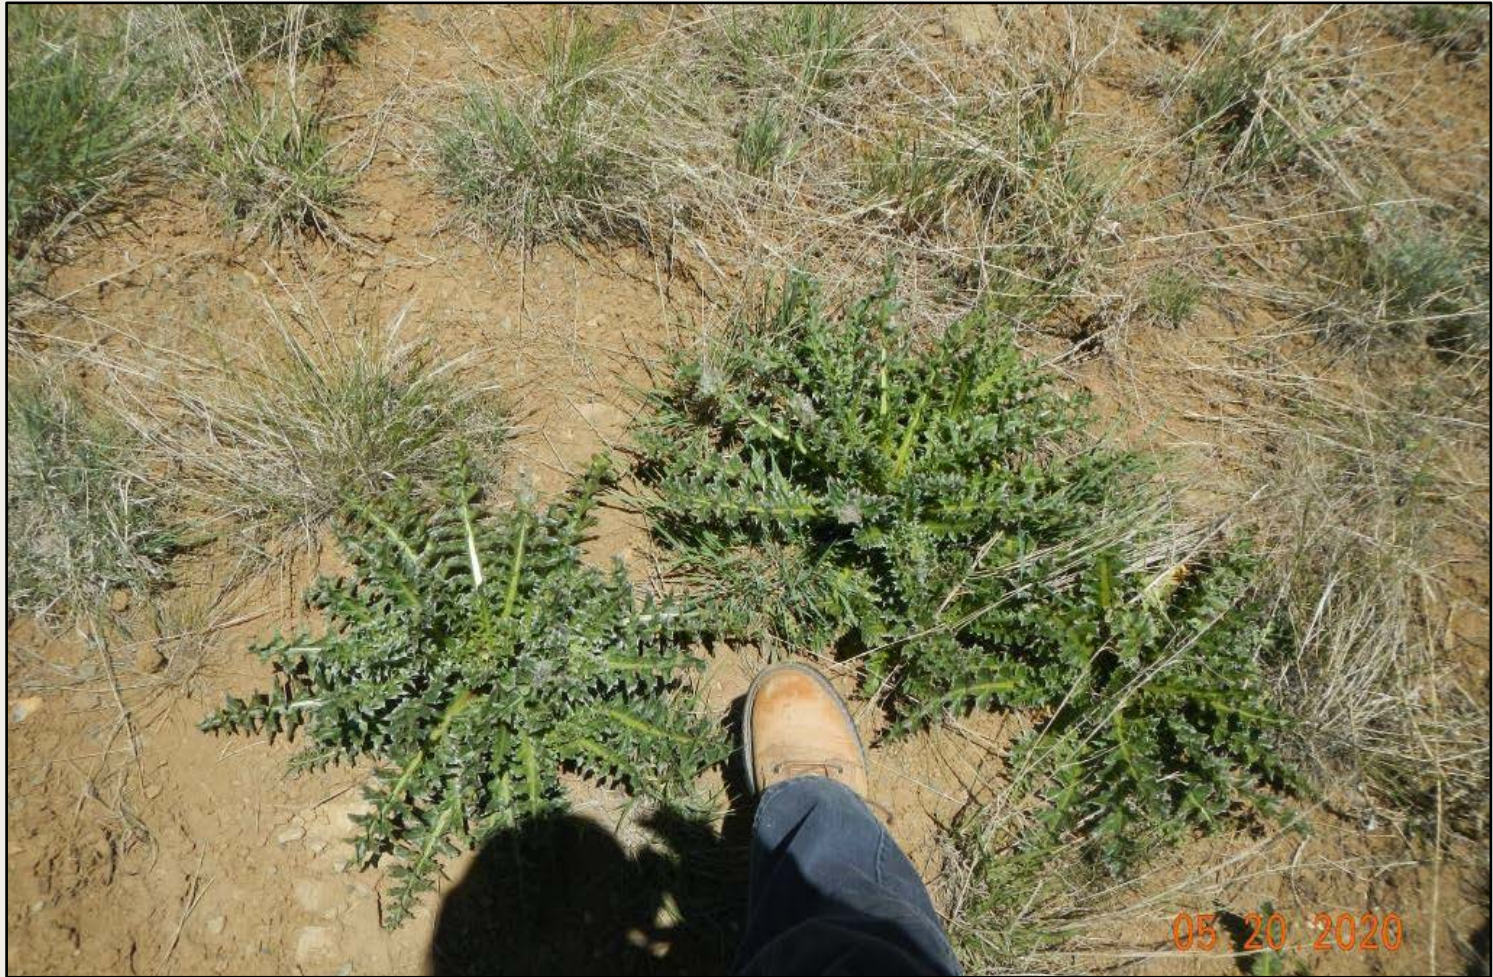
Photo 5. View of musk thistle rosettes within the project area. Approximately 150 individuals observed.

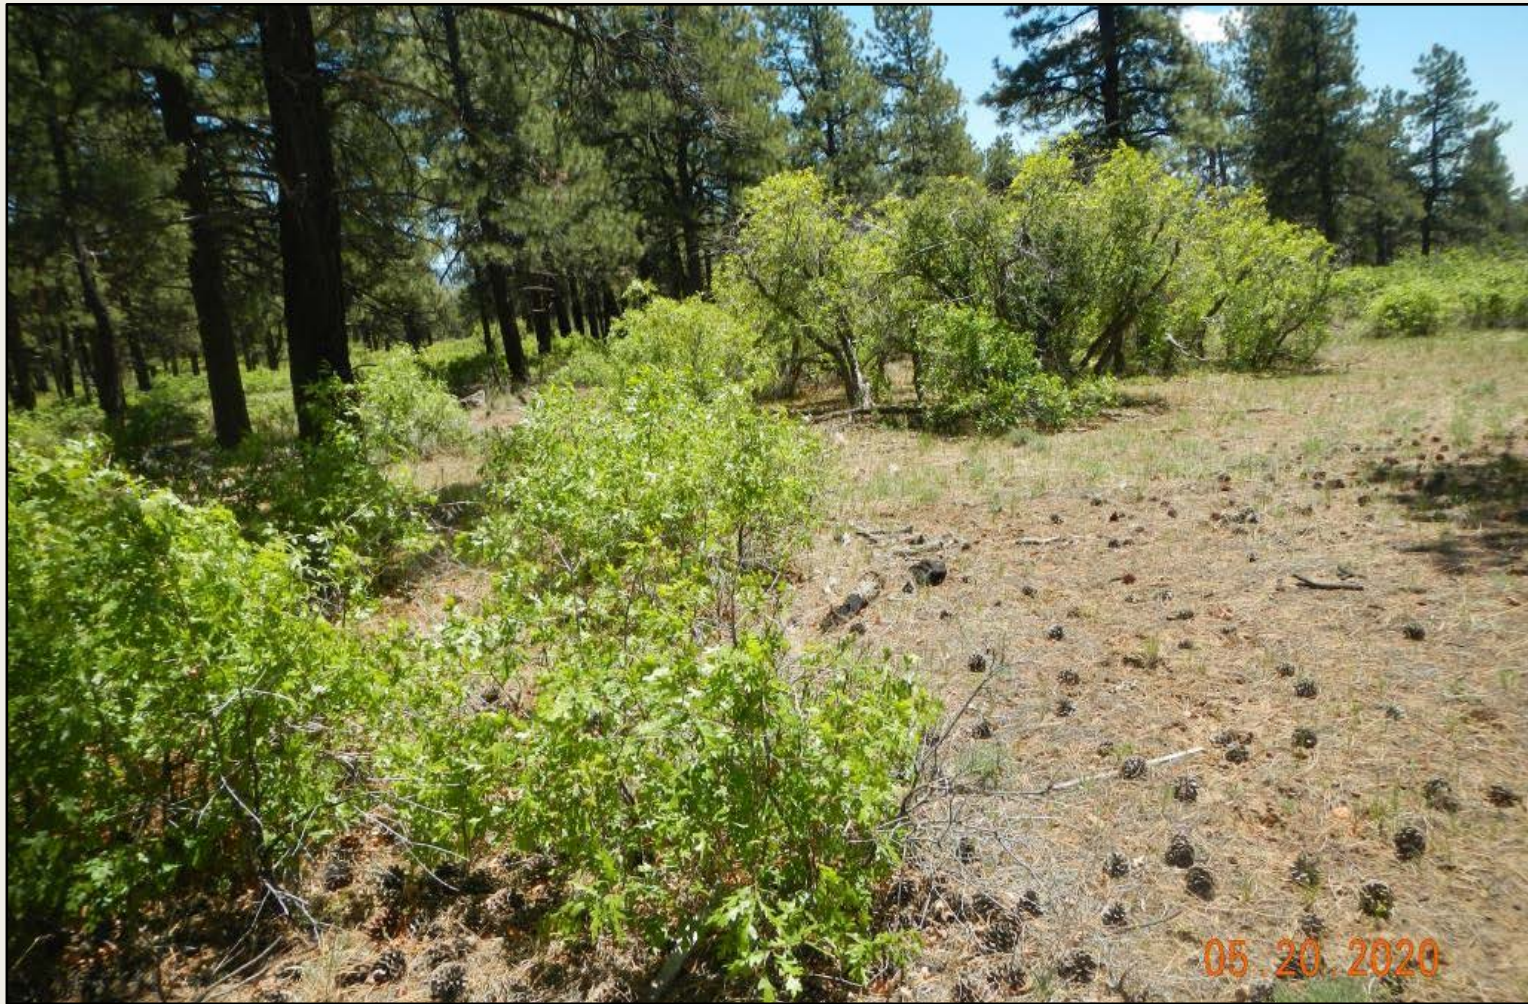
Photo 6. View of reference area vegetation comprised of ponderosa pine woodland with understory of gambel oak, muttongrass, and penstemon.
