# Final Reclamation and Stormwater Inspection

Operator: KERR MCGEE OIL & GAS ONSHORE LP #47120

Location ID: 317847

Inspection Photos  
Location Name: CARL A MILLER UNIT C #1  
Location ID: 317847

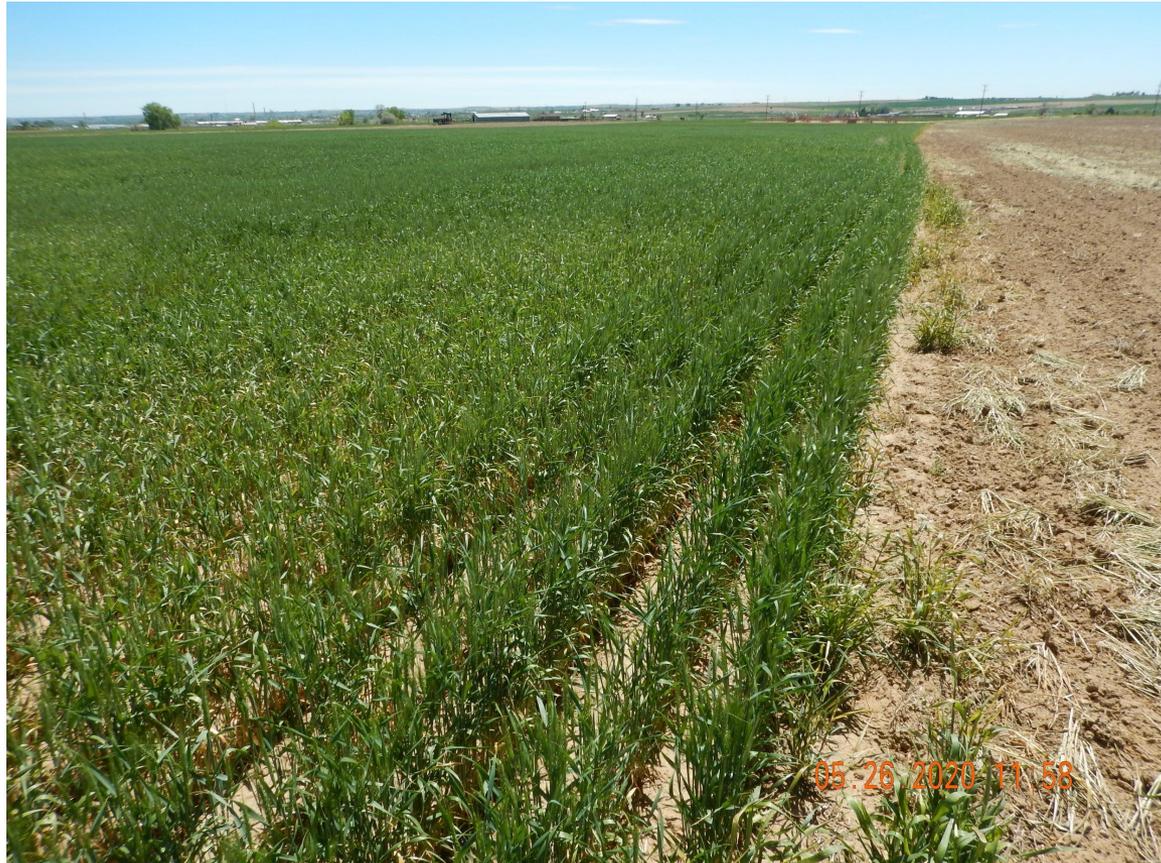
**Photo 1.** Photo taken from the well location, facing South. Photo illustrates the well location is reflective of reference crop areas. The well location was just on the east-side of the crop area which is a sufficient representation of the well location crop growth.

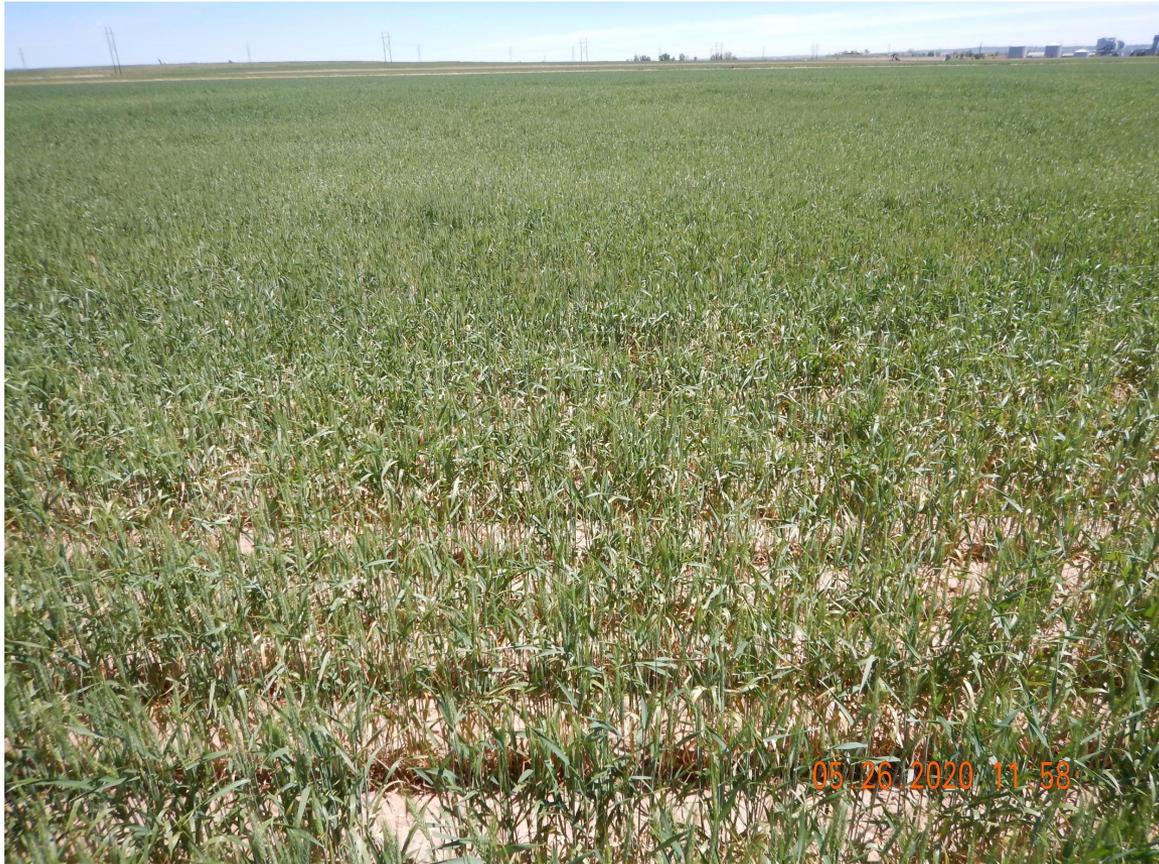
**Photo 2.** Photo taken from the well location, facing East. See comments under Photo 1.

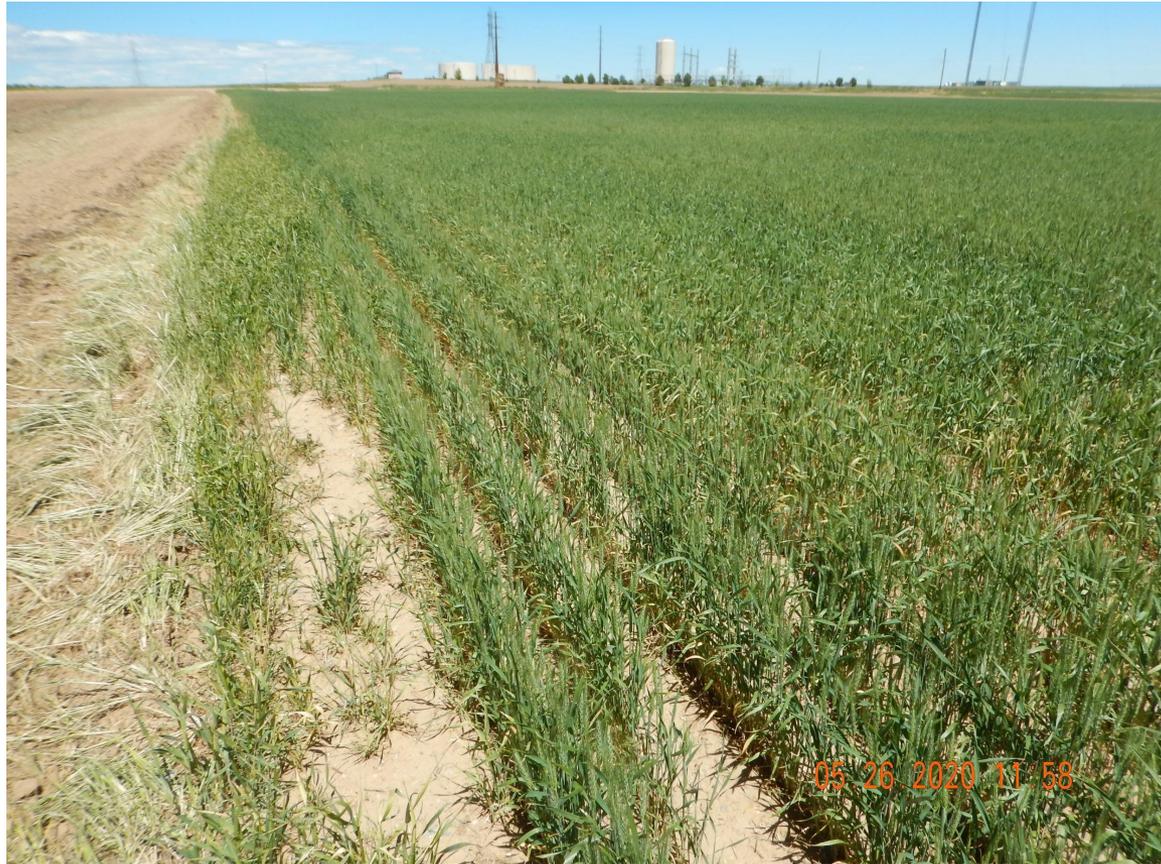
**Photo 3.** Photo taken from the well location, facing North. Photo illustrates the well location access road is reflective of reference crop areas.

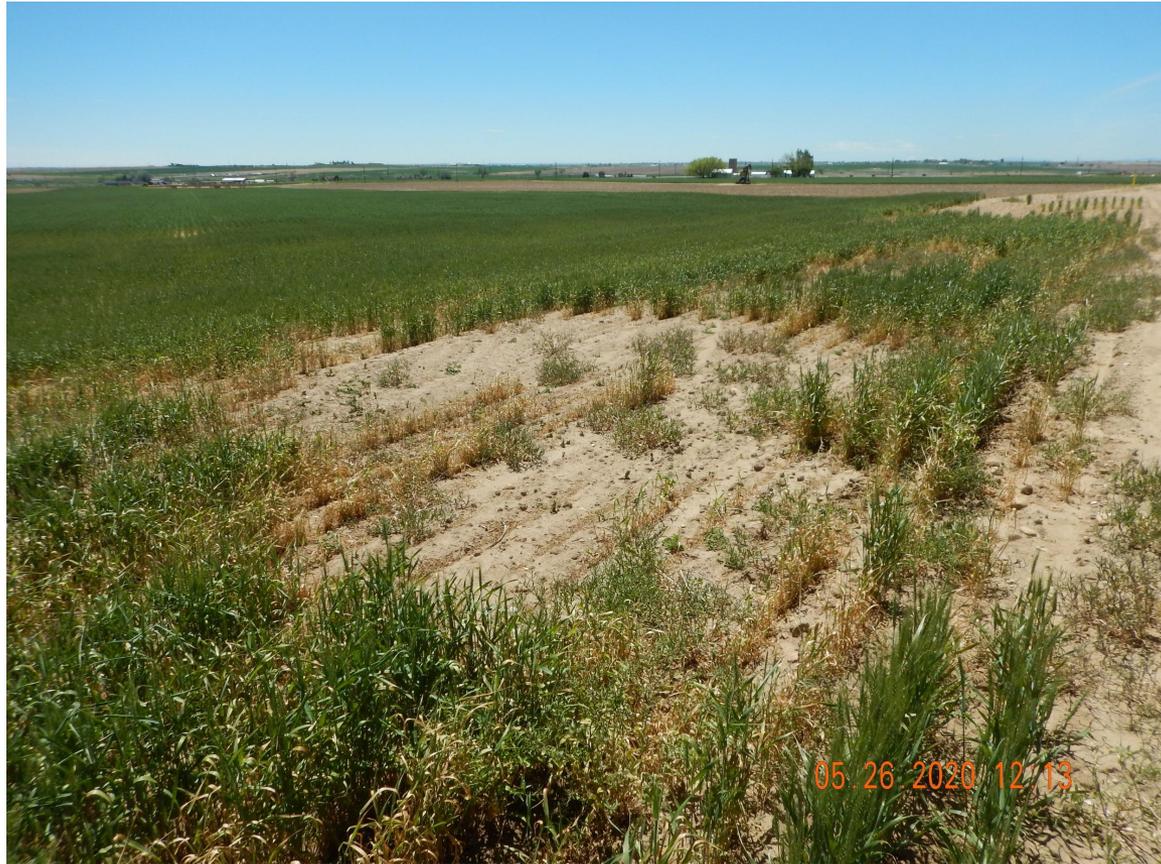
**Photo 4.** Photo taken from the eastern associated offsite tank battery location, facing West. Photo illustrates the tank battery location is bare without crop growth.

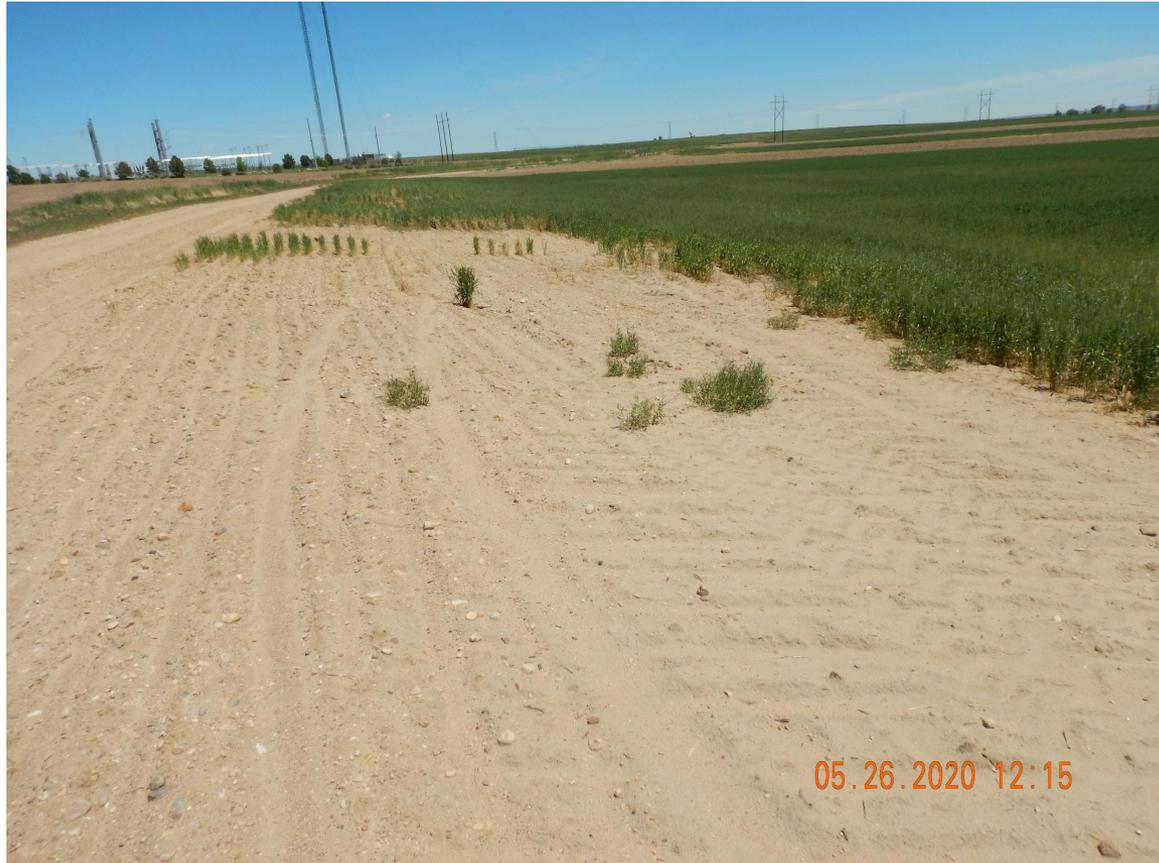
**Photo 5.** Photo taken from the western associated offsite tank battery location, facing East. Photo illustrates the tank battery location is bare without crop growth.
