Final Reclamation Inspection

Operator: EXTRACTION OIL & GAS INC - #10459

Location ID: 318492

Location Name: Rocky Mtn Fuel Co 22-32 battery

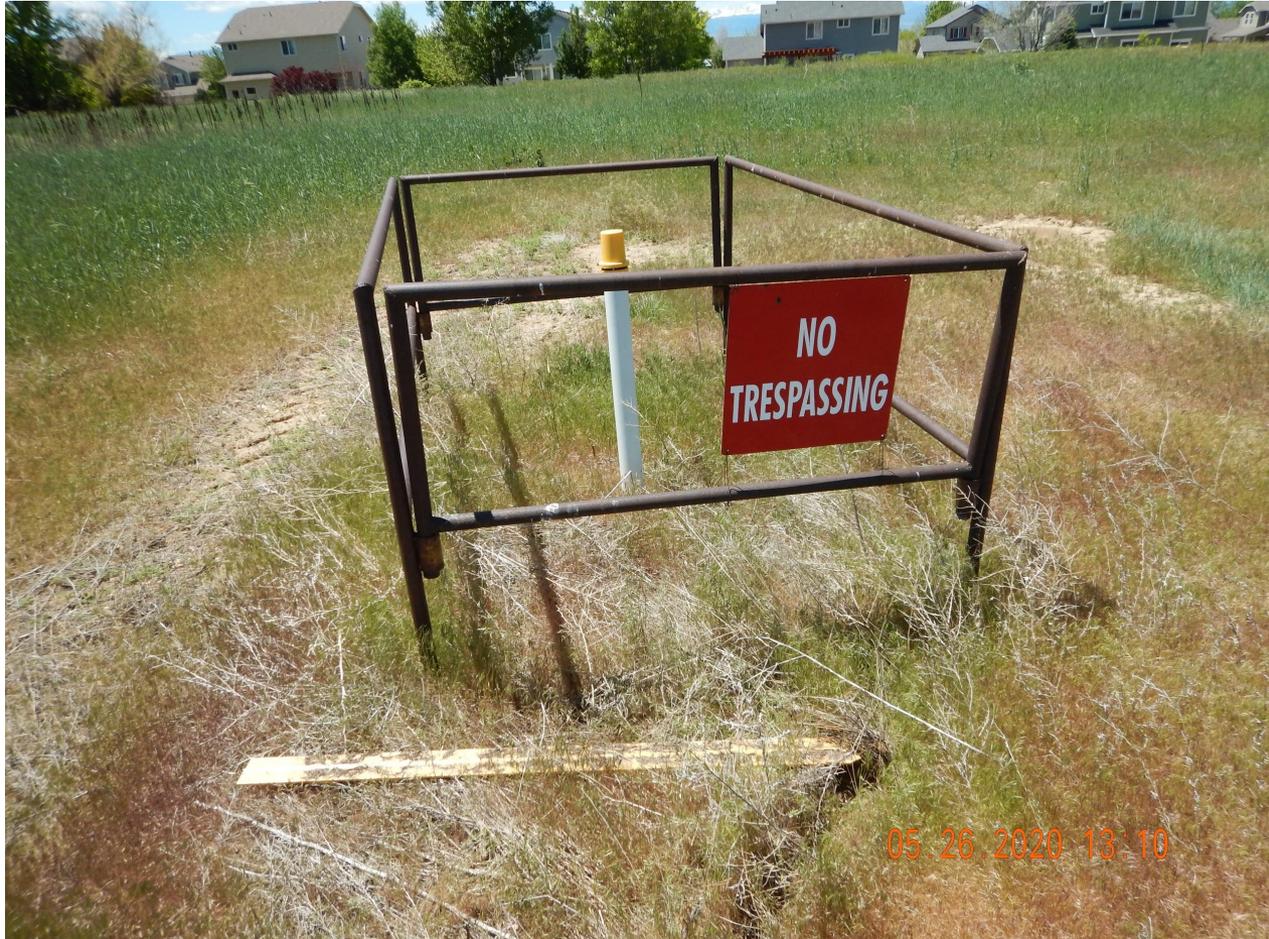
Photo 1. Photo taken from the tank battery location, facing West. Photo illustrates equipment remains at location.

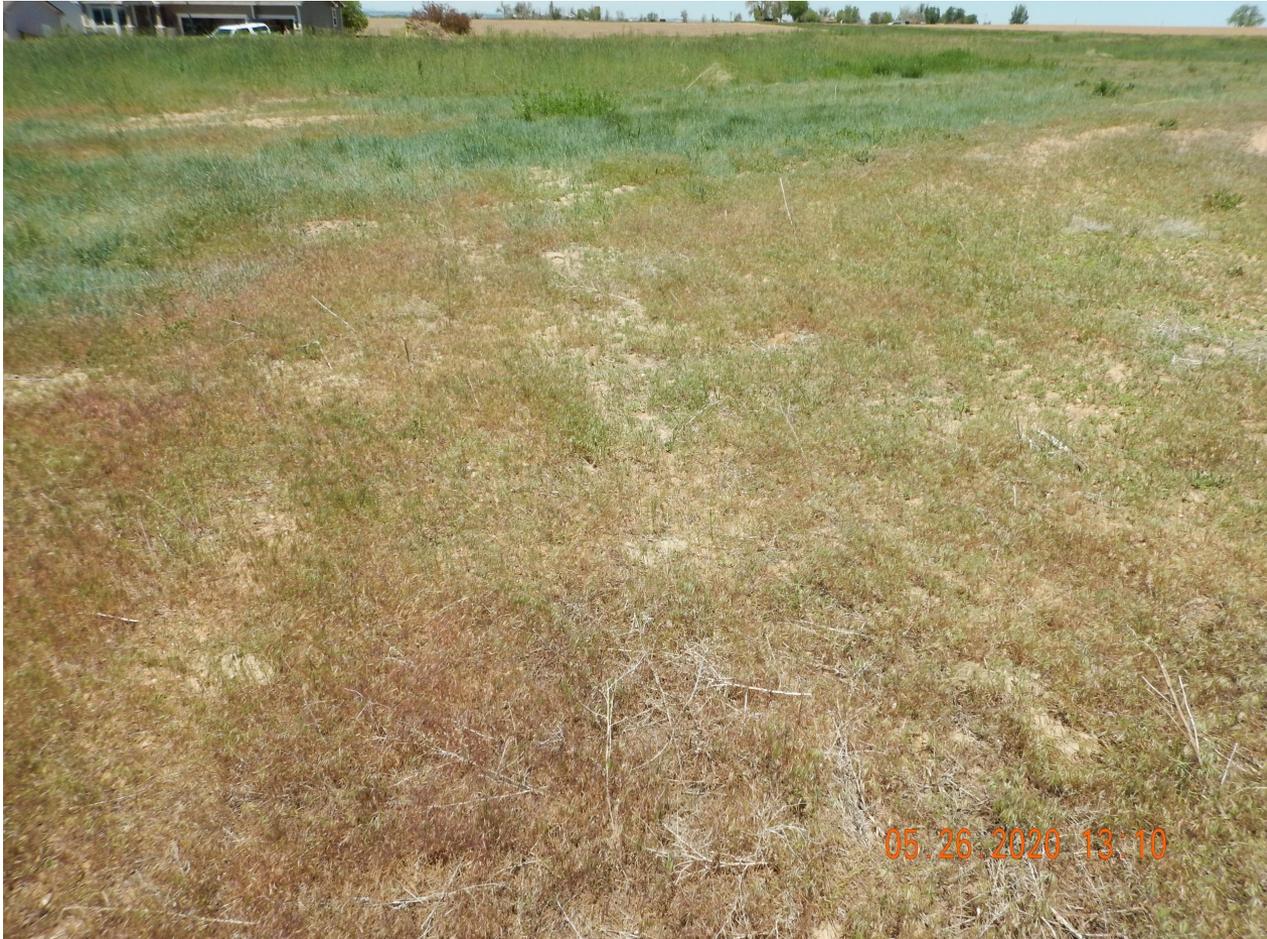
Photo 2. Photo taken from the western tank battery location, facing North. Photo illustrates cheatgrass in the foreground with the establishment of western wheatgrass in the background.

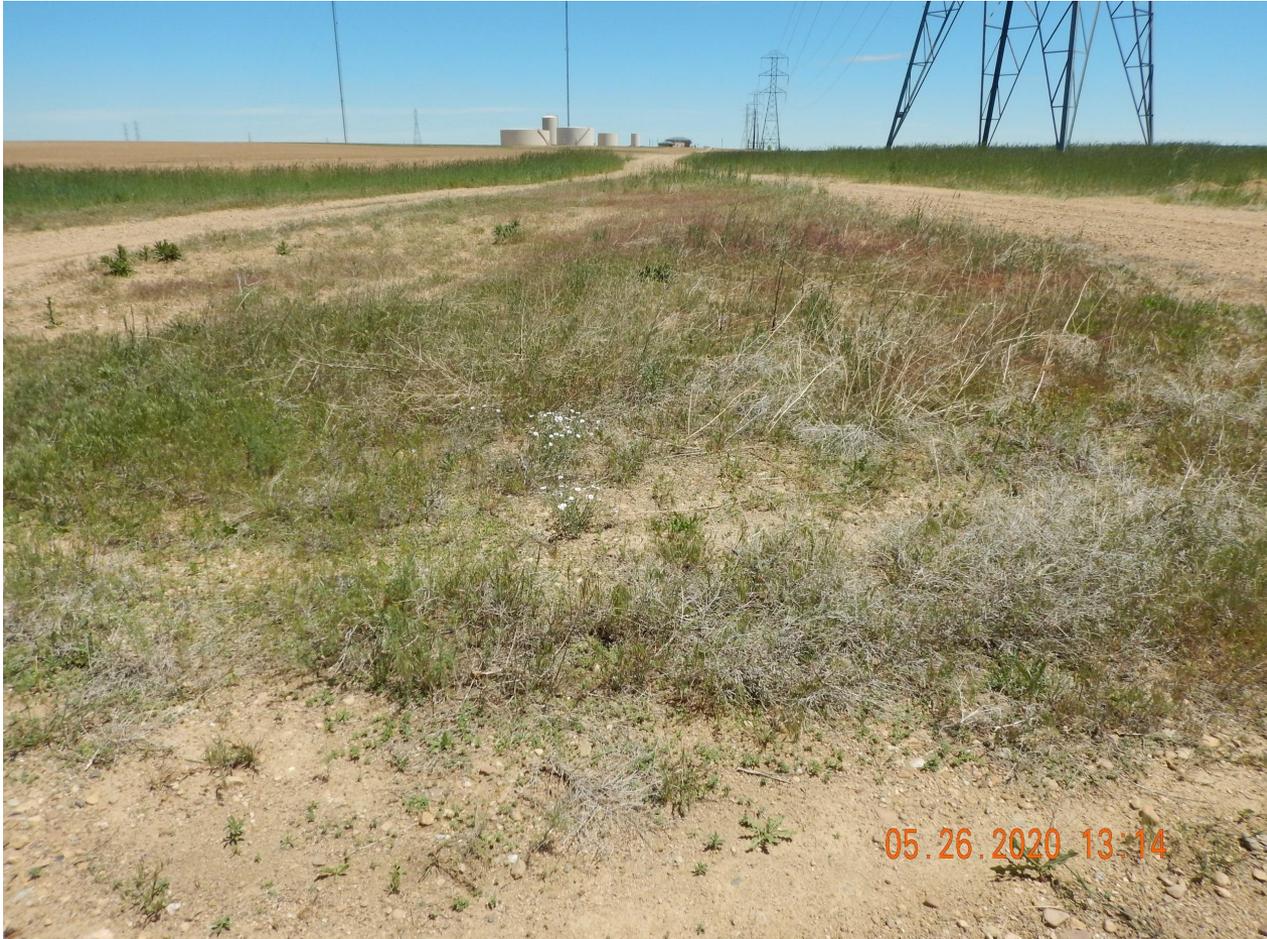
Photo 3. Photo taken from the western tank battery location, facing East. See comments under Photo 2.

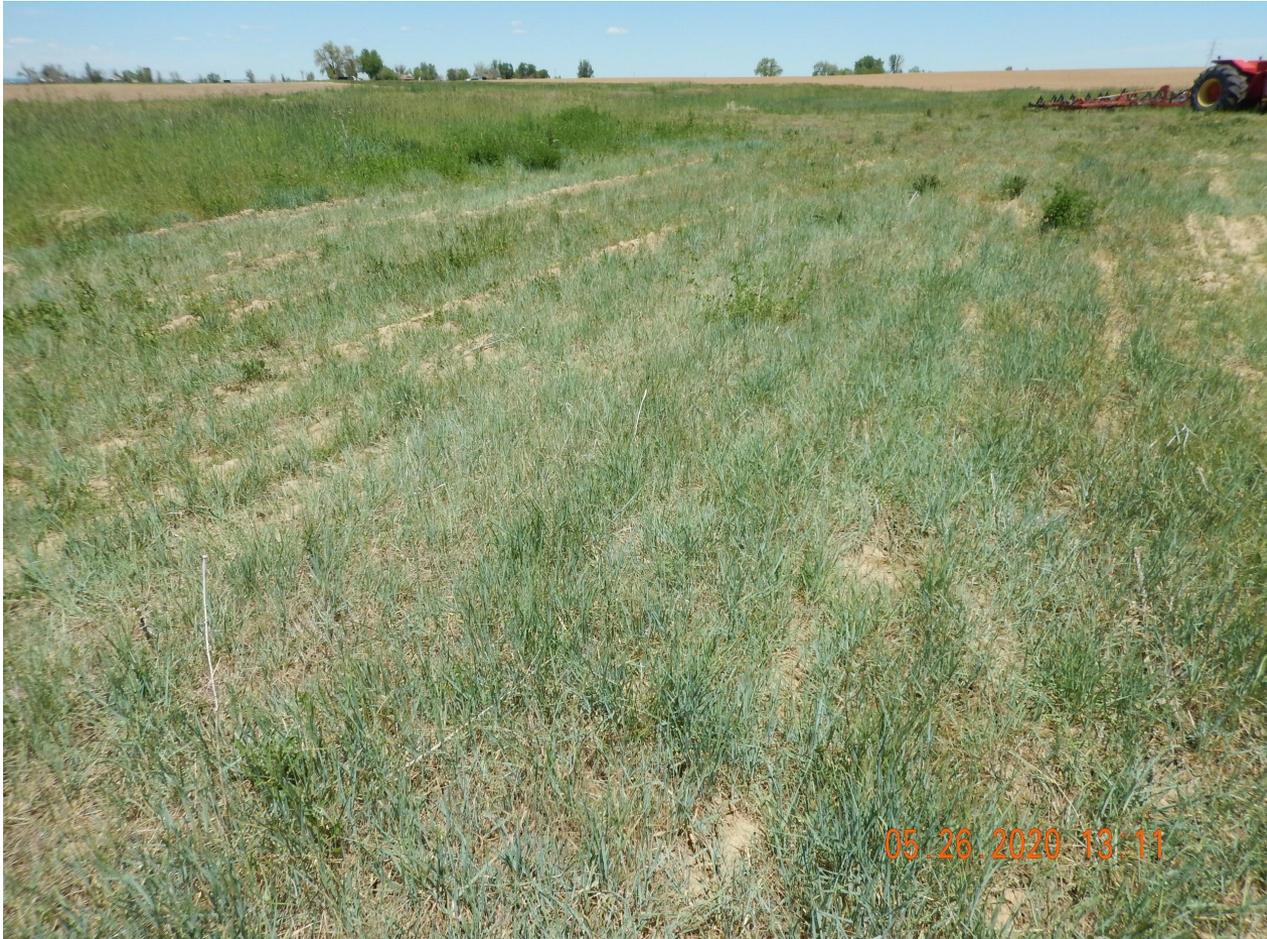
Photo 4. Photo taken from the northwestern tank battery location, facing Northeast. Photo illustrates the establishment of western wheatgrass.

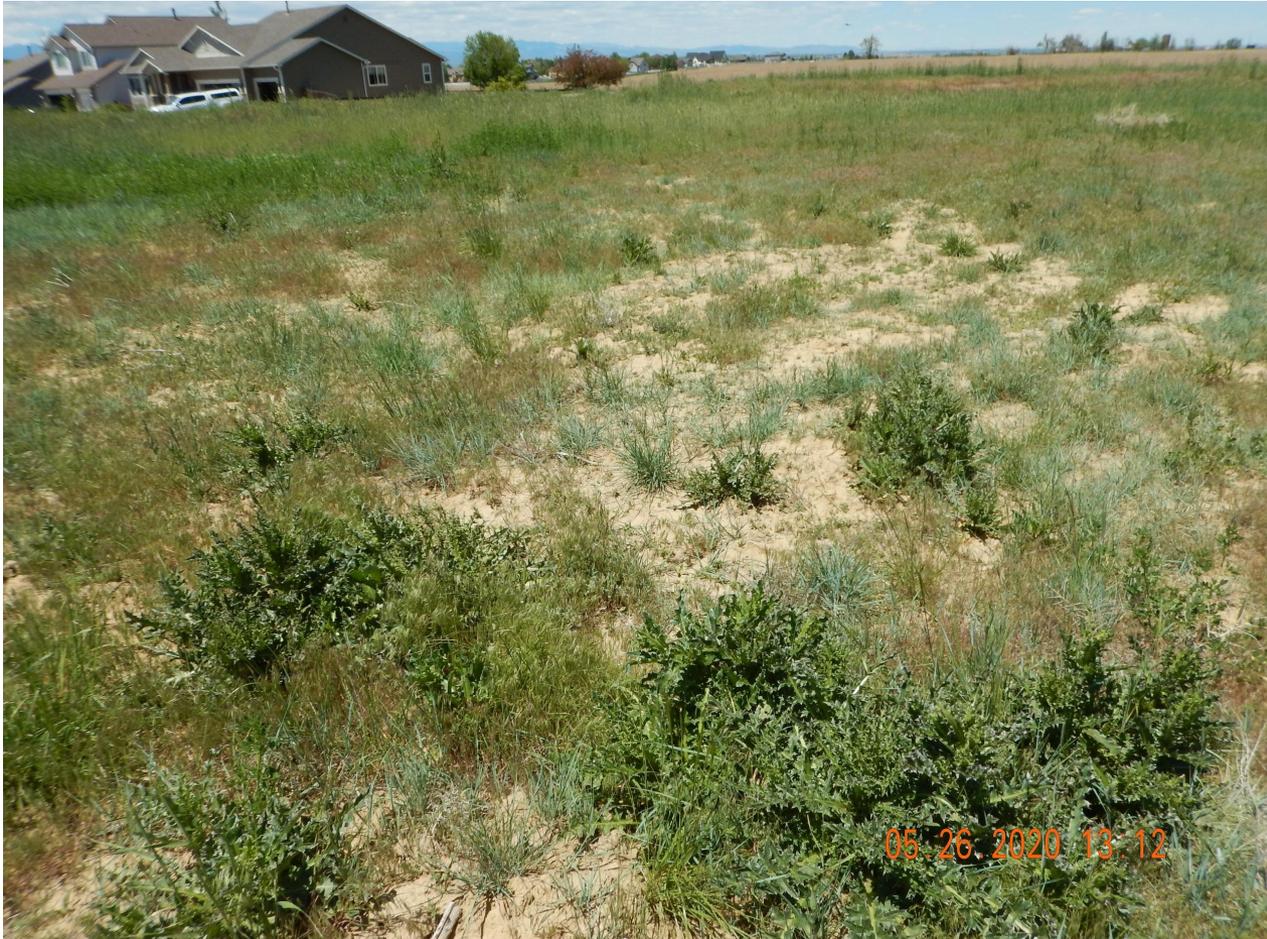
Photo 5. Photo taken from the northern tank battery location, facing Northwest. Photo illustrates a List B Colorado noxious weed, Musk thistle. Musk thistle rosettes were observed; there were no shoots observed.
