# Inspection Photos

ID#: 113490

Operator: PETROGLYPH OPERATING CO

Inspection Date: 5/20/2020

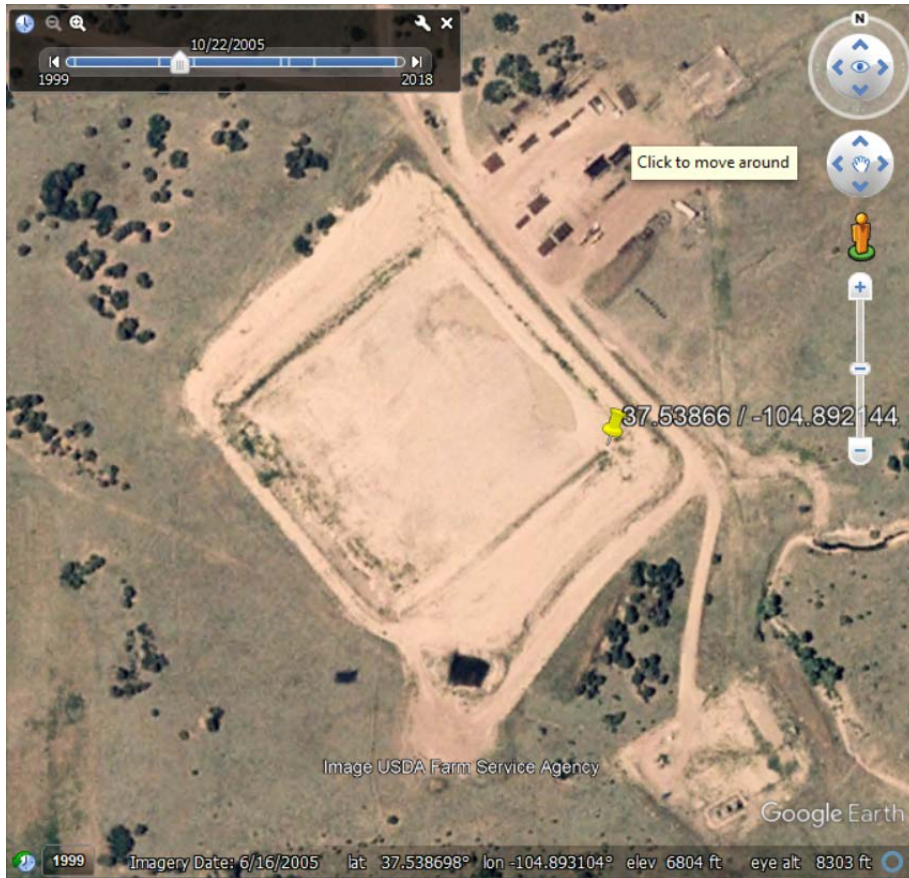
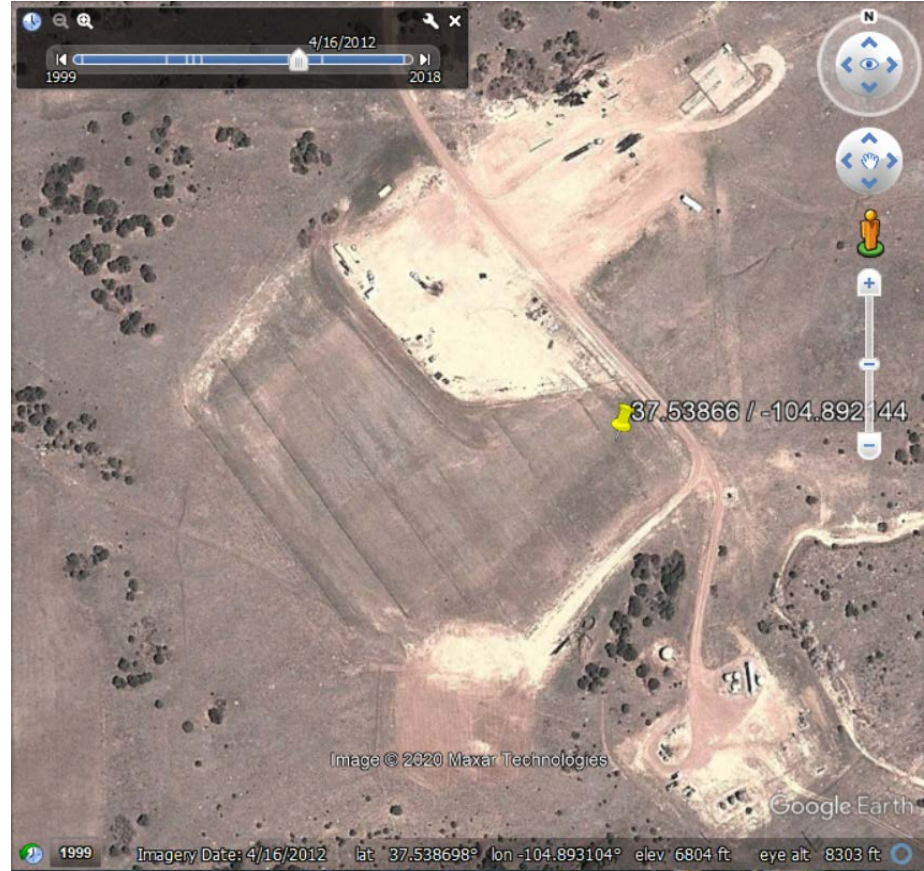
**Photo 1.** The two aerial images above show the disturbance area of the **Rohr 09-10 Big Pit**. The image on the left was taken in 2005 and the image on the right taken in 2012 which shows that most of the Big Pit area was reclaimed during that timeframe.

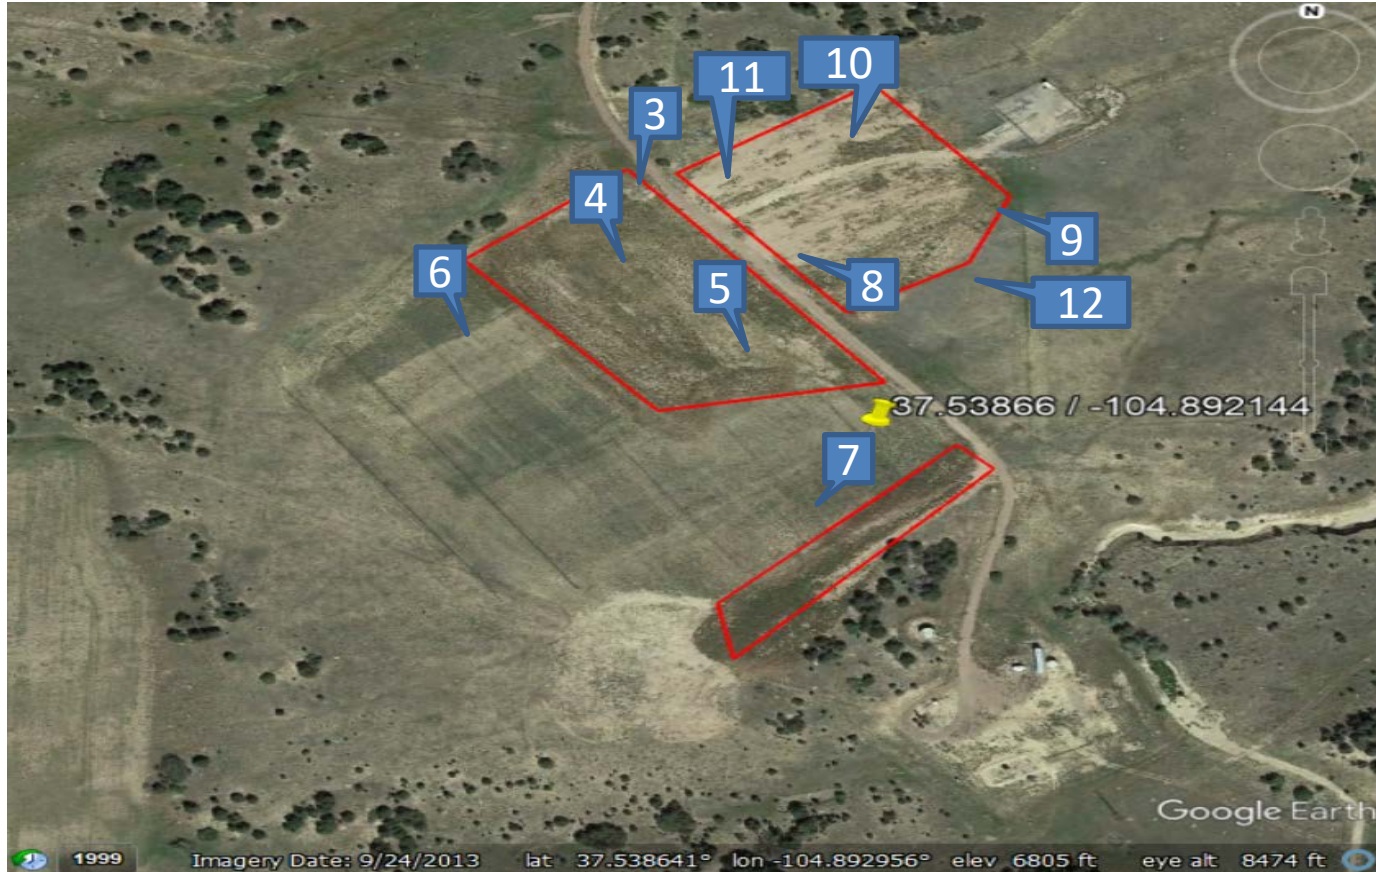
**Photo 2.** The above aerial image taken in 2013 shows the areas highlighted in red were reclaimed however, these areas have not adequately established desirable vegetation as shown in the following photos. The Blue inserted box corresponded to the following photo location.

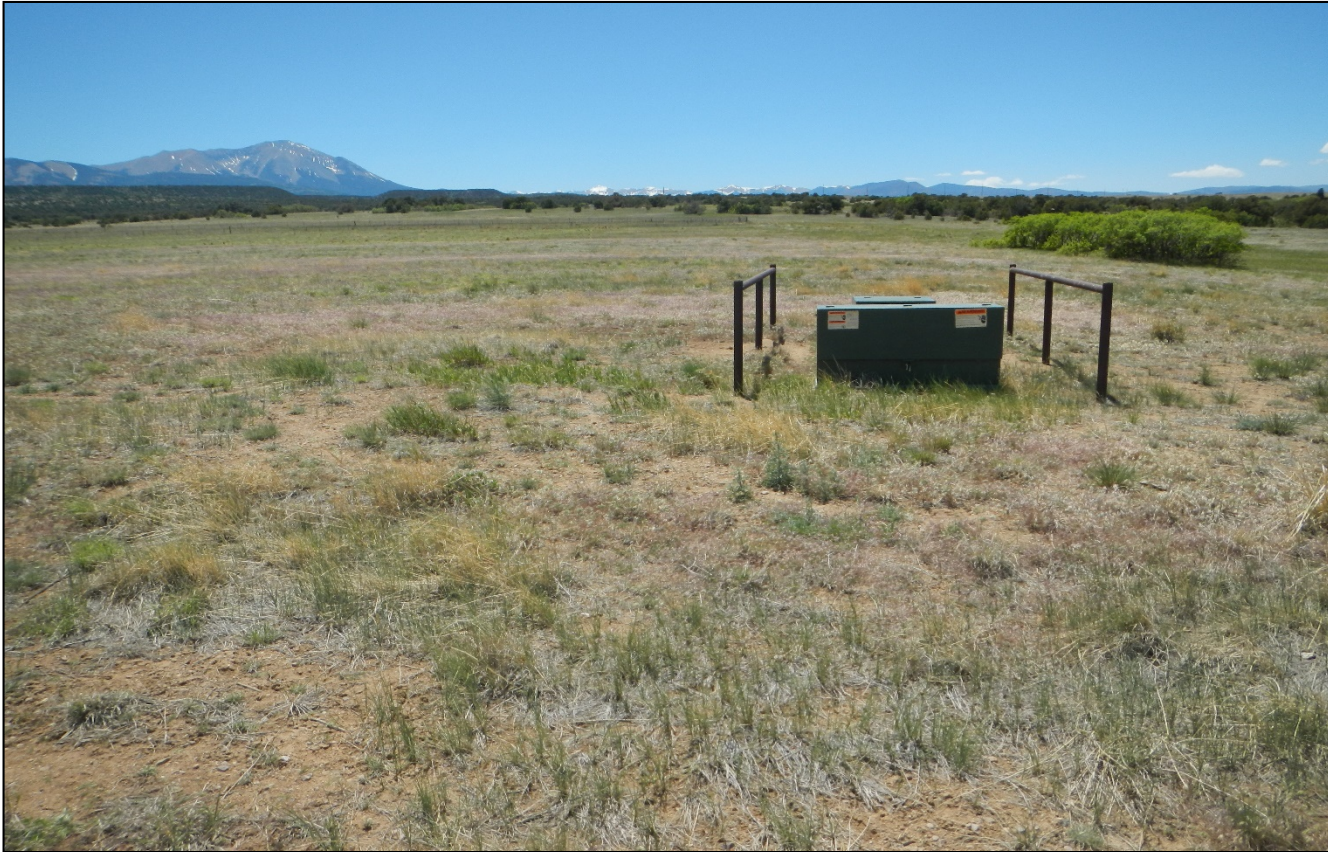
**Photo 3.** Facing southwest to The electric utility remains at this north side of the location.ward the Rohr 09-10 Big Pit reclaimed disturbance area.

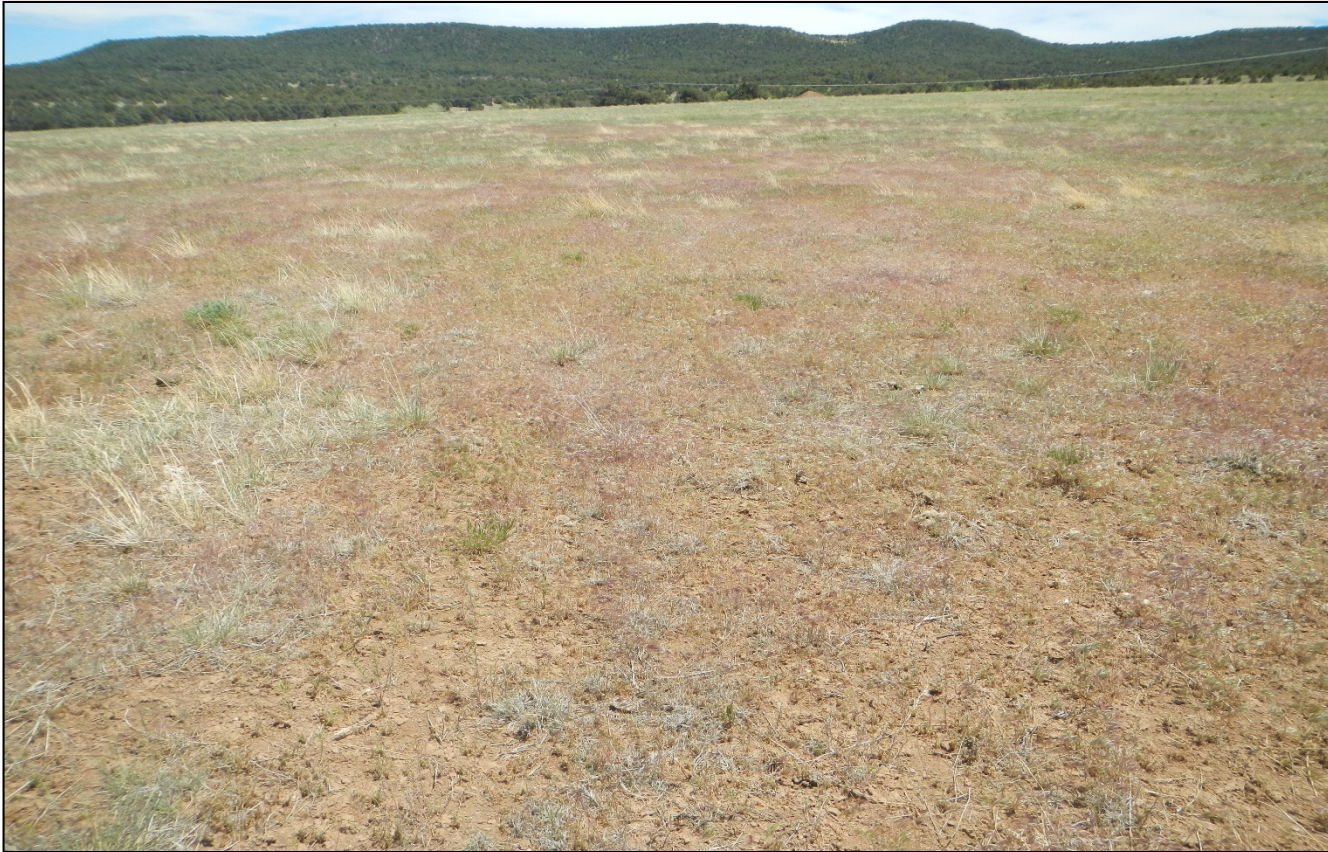
**Photo 4.** Facing southeast at the Big Pit area. This area consists predominately of undesirable weeds (Cheat grass).

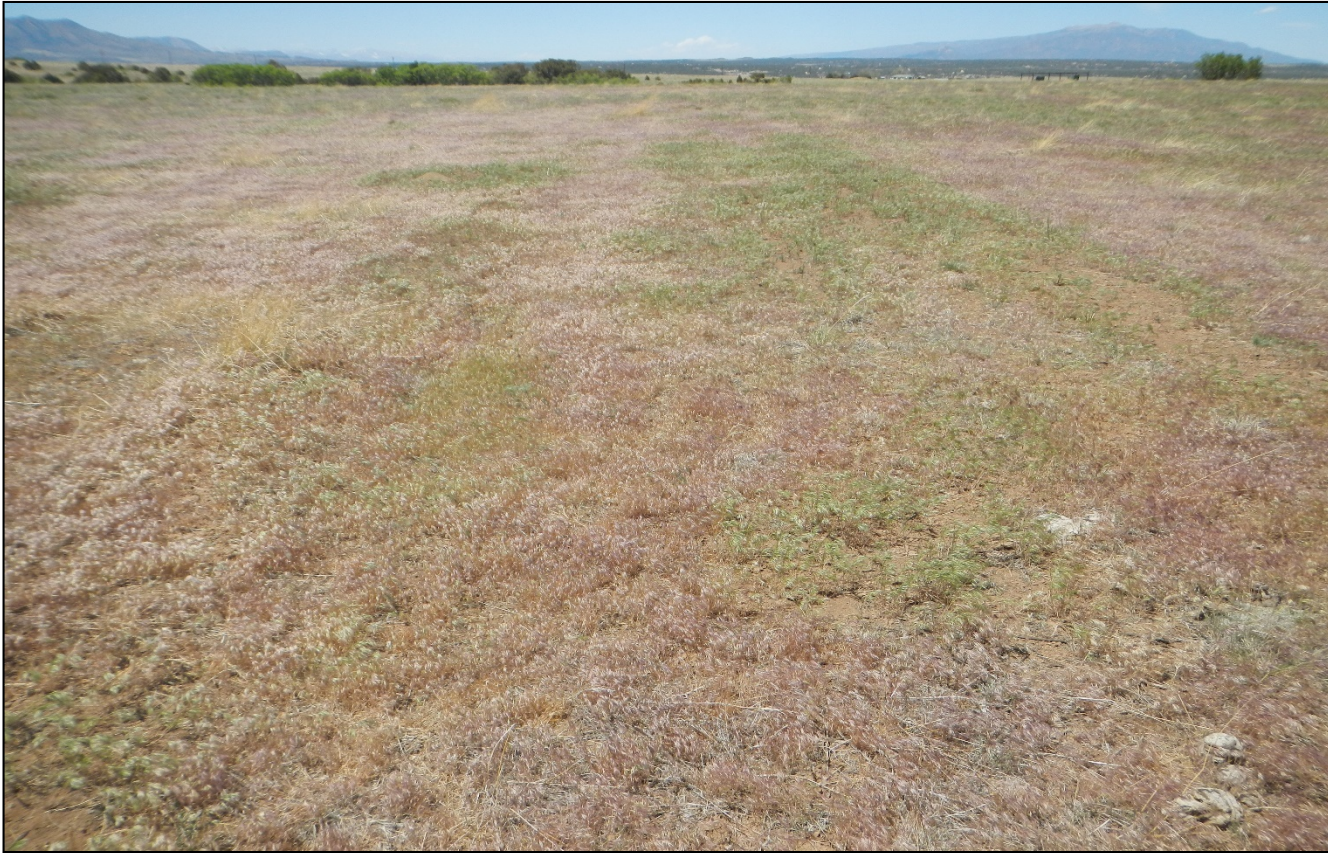
**Photo 5.** Facing northwest at the Big Pit area. This area consists predominately of undesirable weeds (Cheat grass).

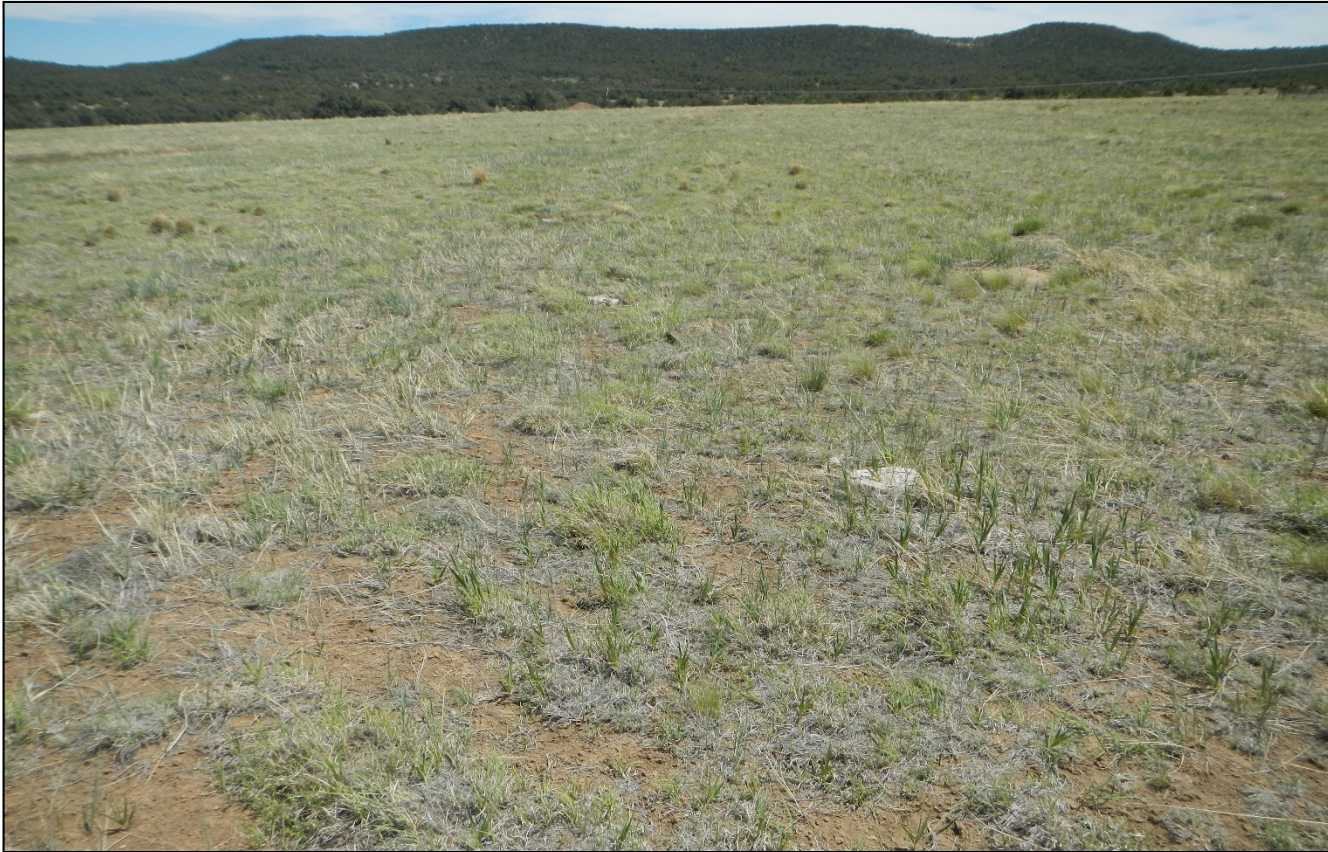
**Photo 6.** Facing southeast at the west side of the Big Pit area. The vegetation in this reclaimed area is well established and consist of desirable species such as western wheat grass, Blue grama, and Sand dropseed.

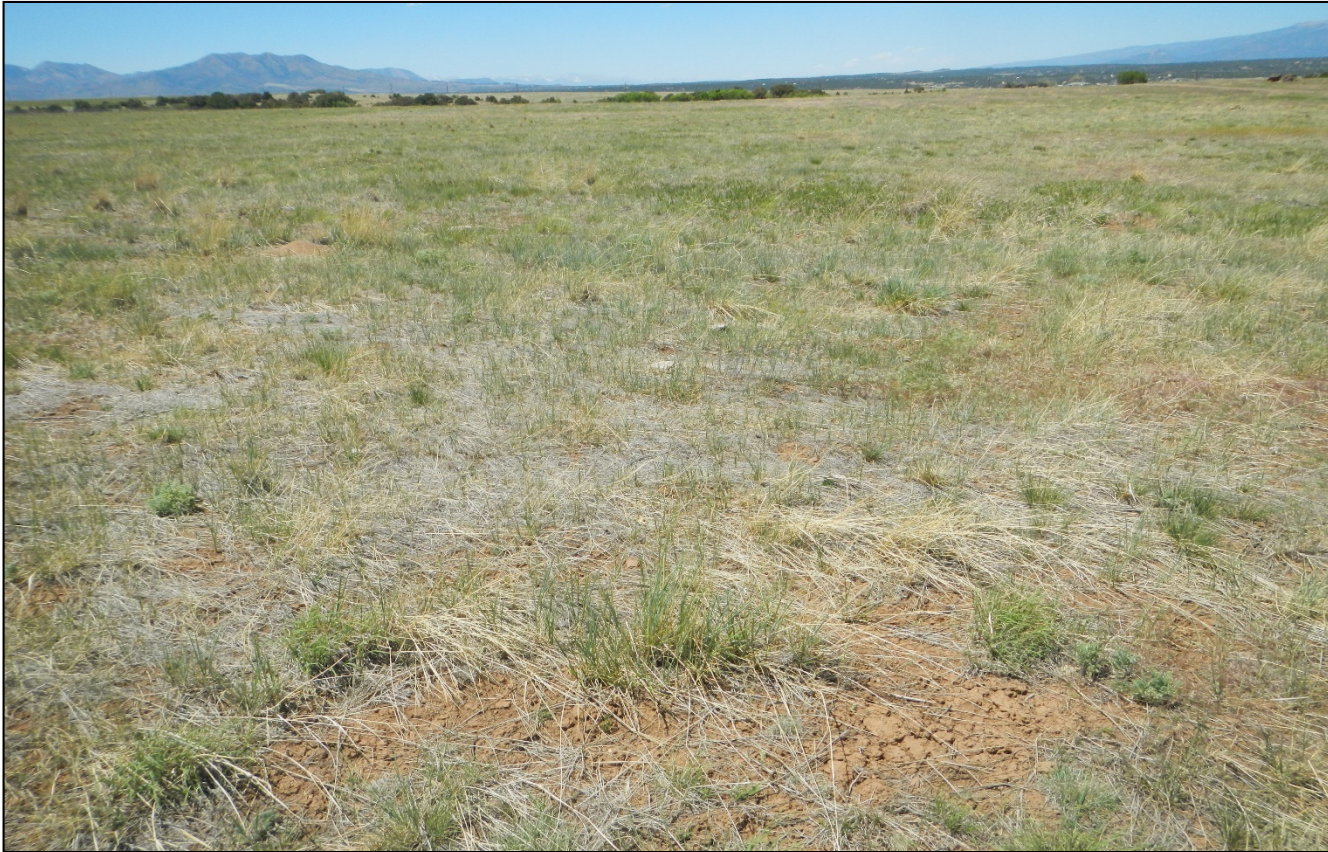
**Photo 7.** Facing northwest at the south side of the Big Pit area. The vegetation in this reclaimed area is well established and consist of desirable species such as western wheat grass, Blue grama, and Sand dropseed.

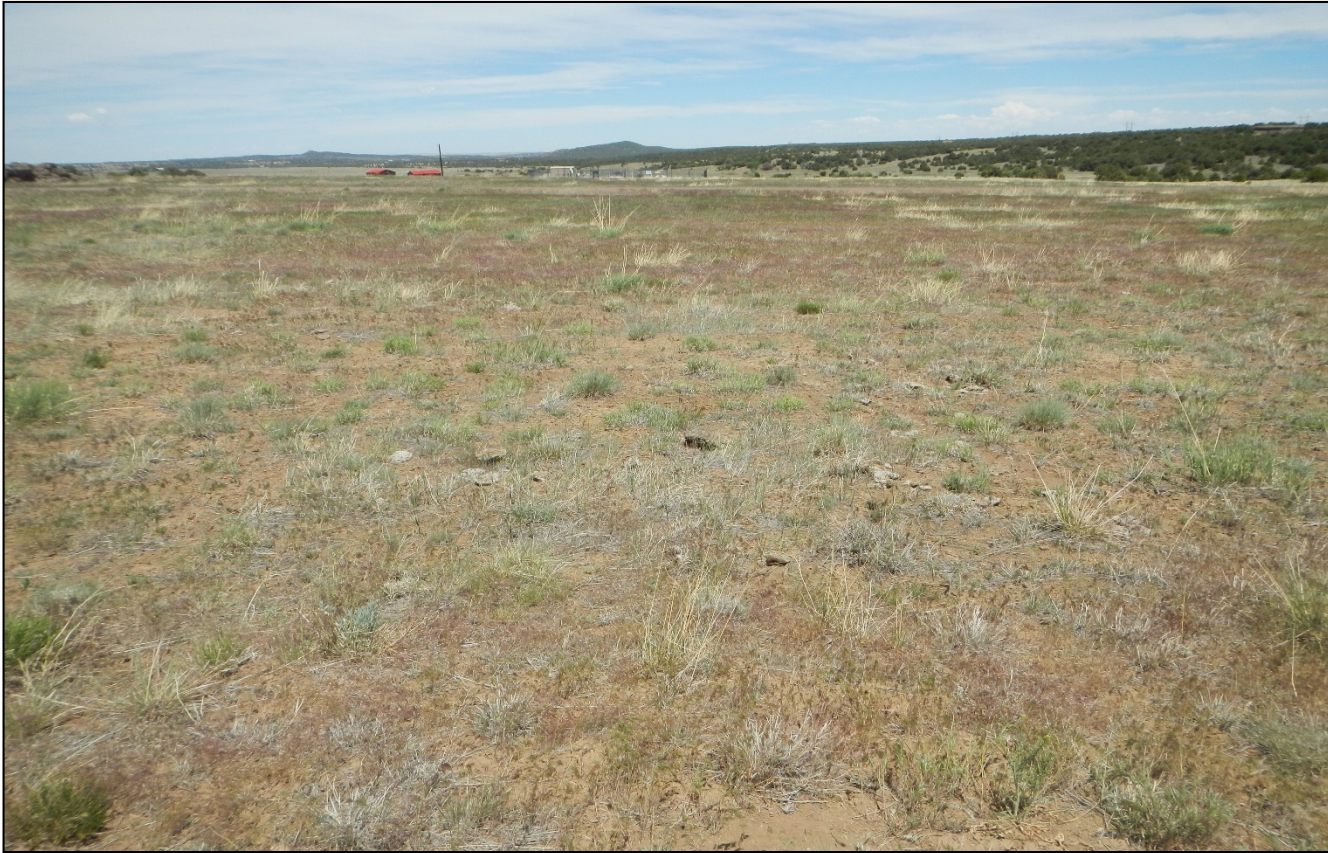
**Photo 8.** Facing northeast toward the disturbance area northeast of the Big Pit area. This area does not have adequate desirable vegetation establishment and consist of undesirable weeds (Cheat grass).

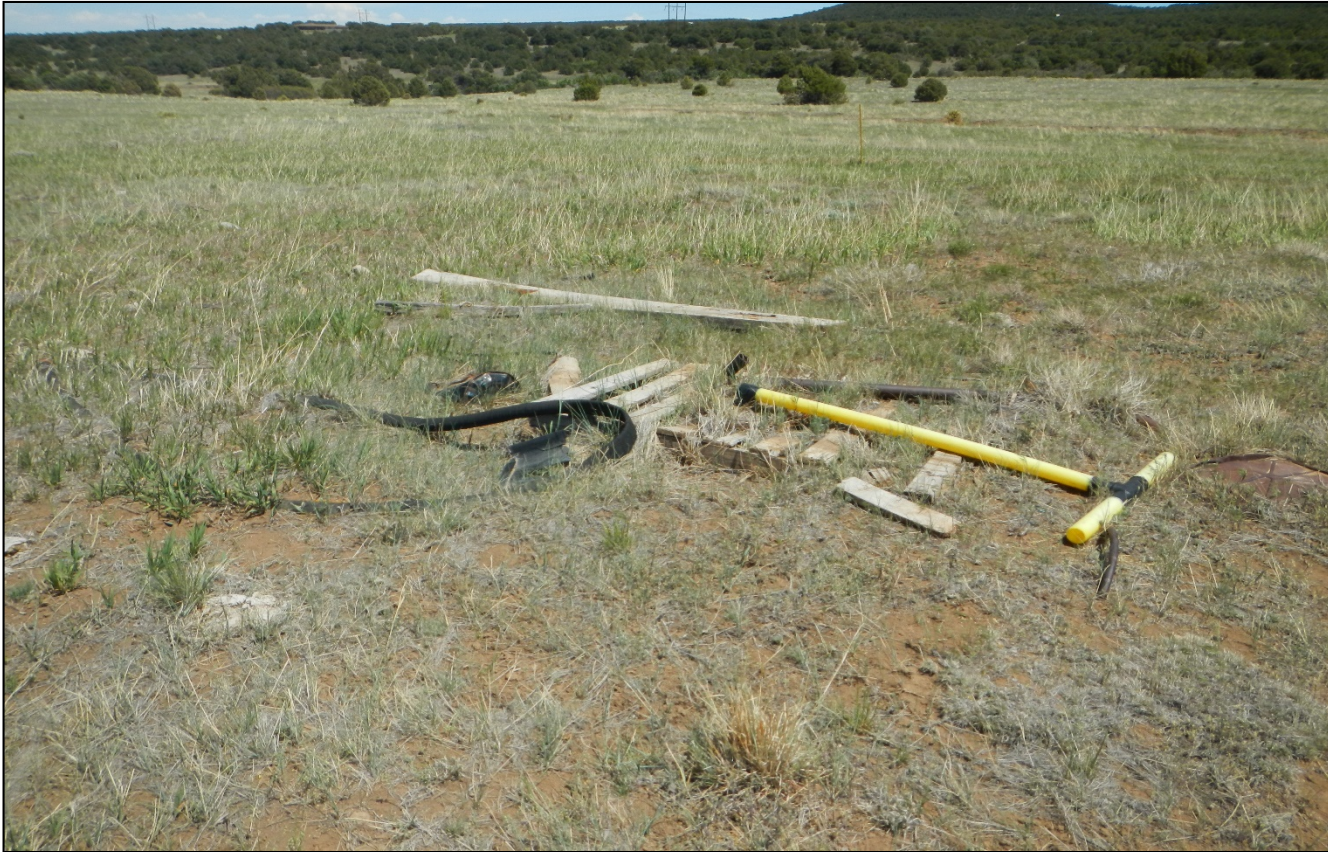
**Photo 9.** There is various debris that remains at the east side of this disturbance area.

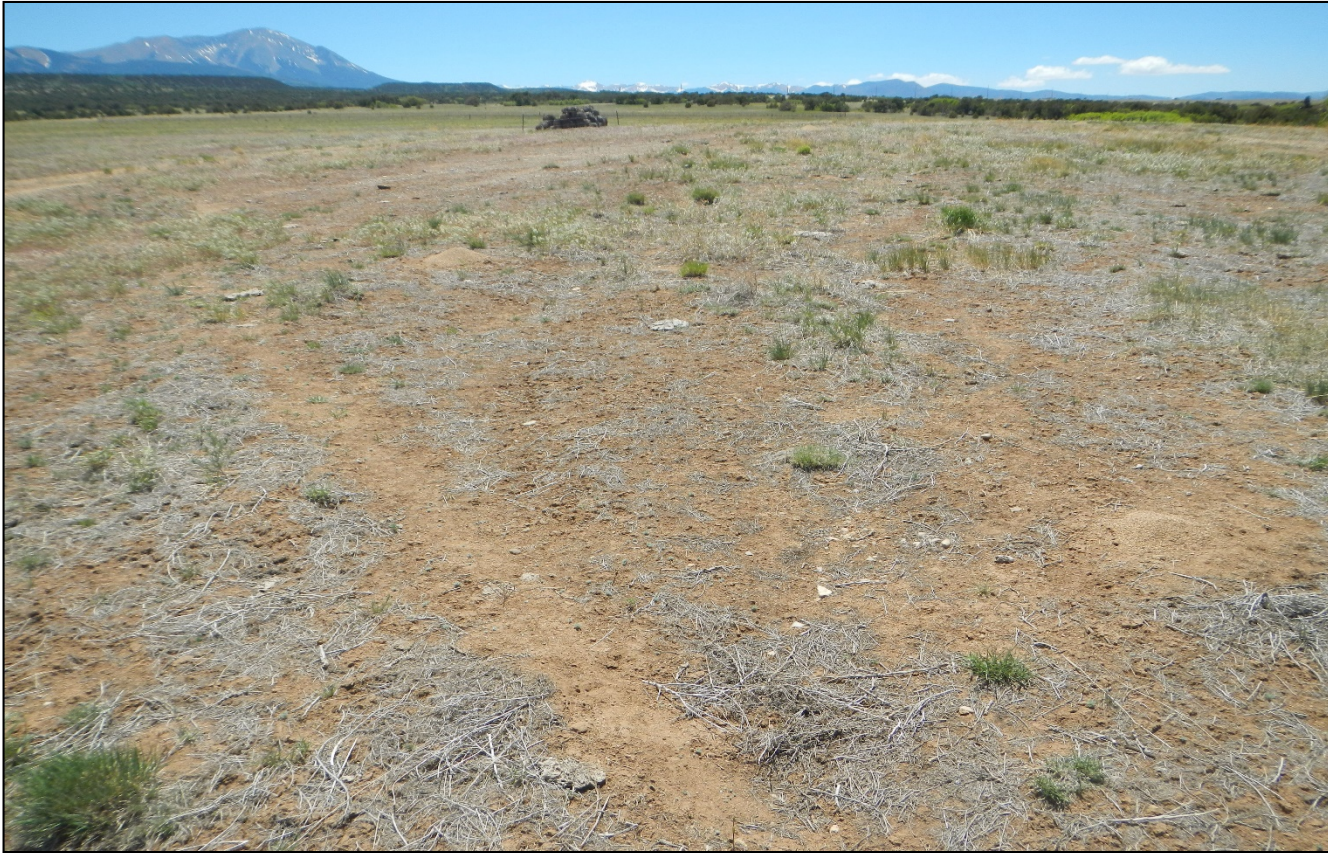
**Photo 10.** Facing southwest toward the disturbance area northeast of the Big Pit area. This area does not have adequate desirable vegetation establishment and consist of undesirable weeds (Cheat grass).

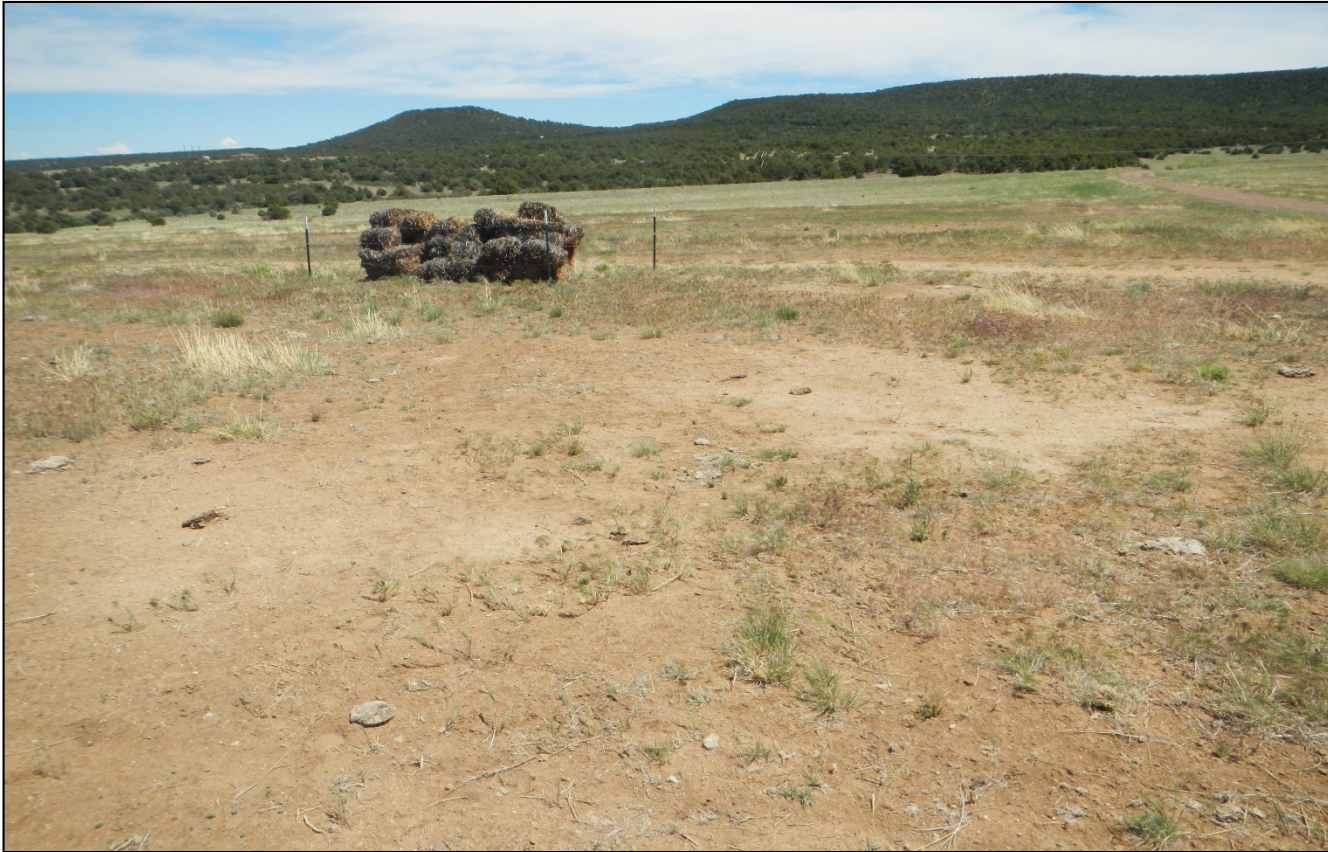
**Photo 11.** Facing southwest at the disturbance northeast of the Big pit area.

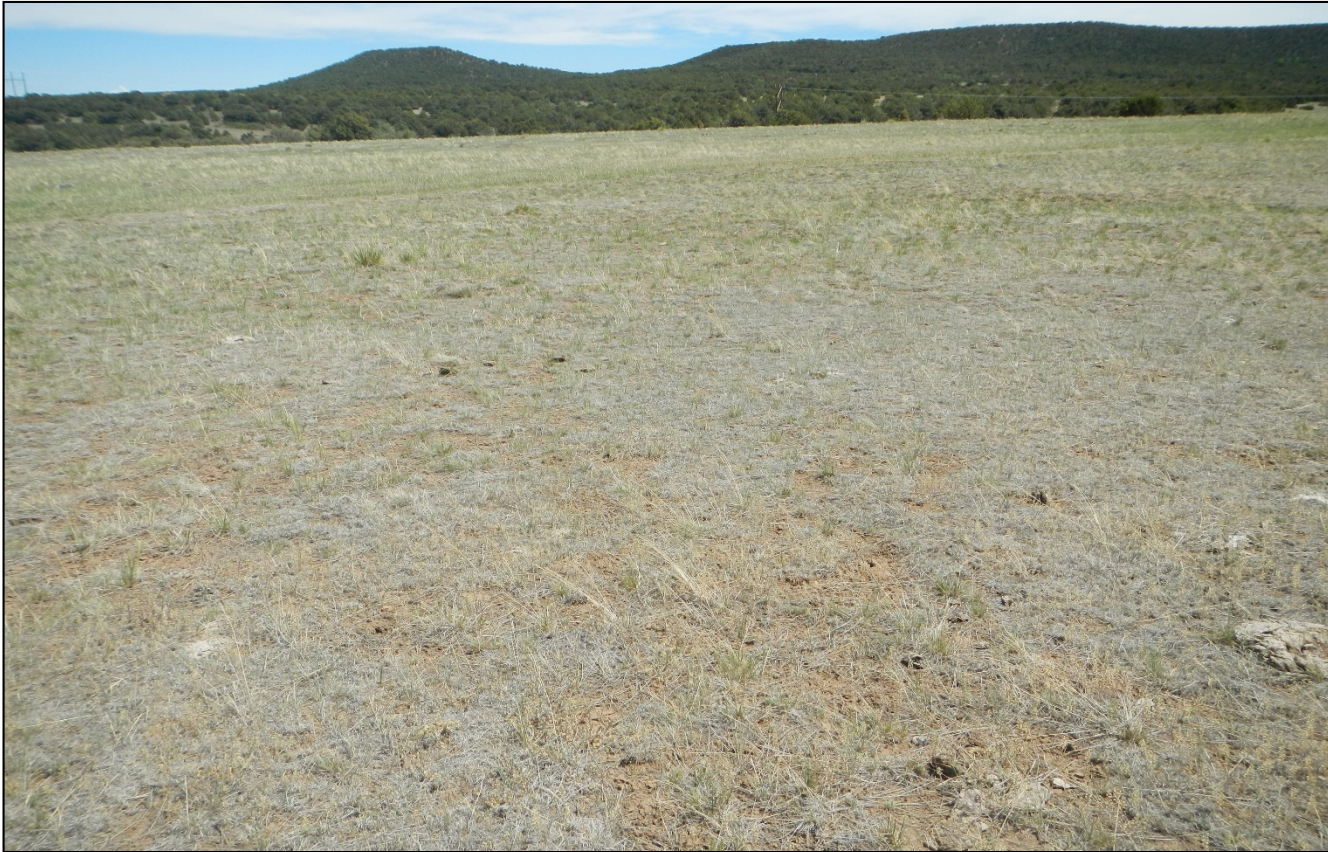
**Photo 12.** Facing southeast toward the undisturbed area. The vegetation consists of Blue grama, Sand dropseed, Prairiejune grass among other species.
