Final Reclamation Inspection

Operator: MACHII-ROSS PETROLEUM CO - 52250

Location ID: 406103

Inspection Photos
Location Name: HALEY #2
Location ID: 406103

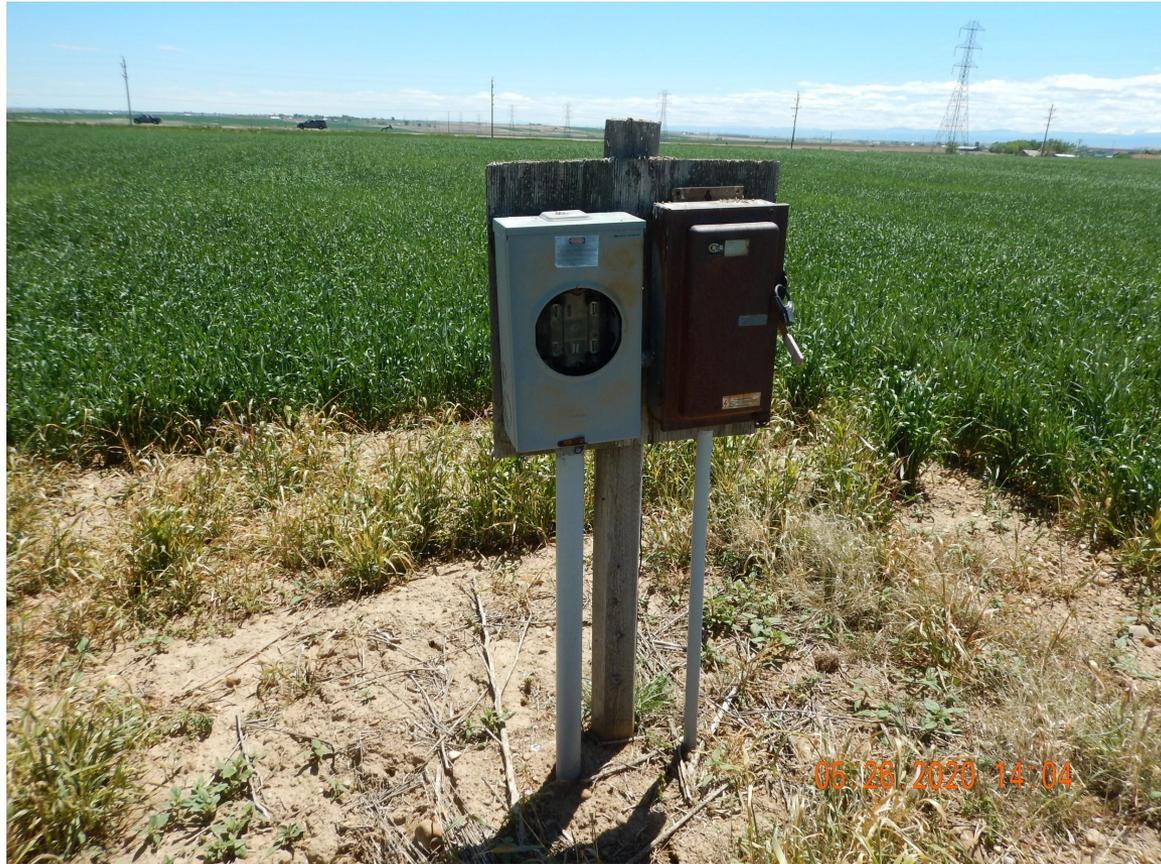
Photo 1. Photo taken from the well location, facing South. Photo illustrates the Operator has failed to remove all equipment.

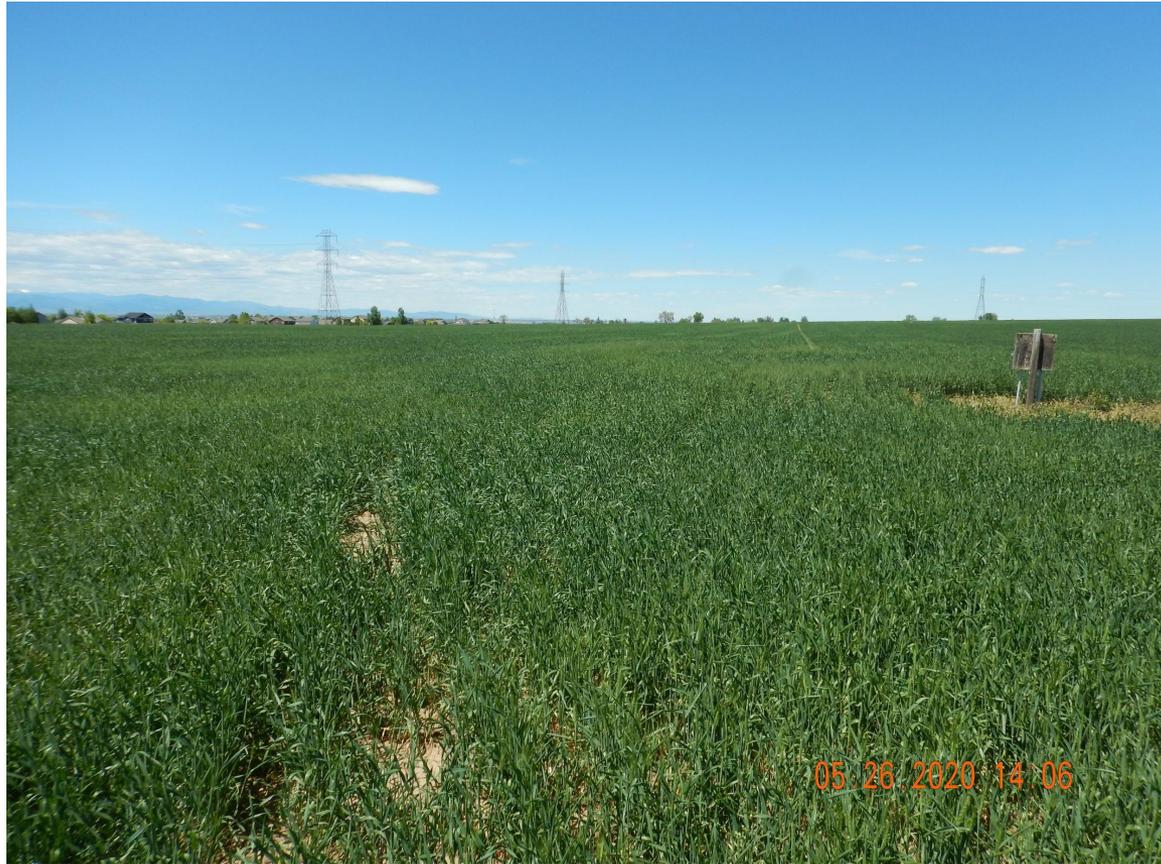
Photo 2. Photo taken from the well location, facing Northwest. Photo illustrates other areas surrounding the well location appear to meet Rule 1004 vegetative standards.

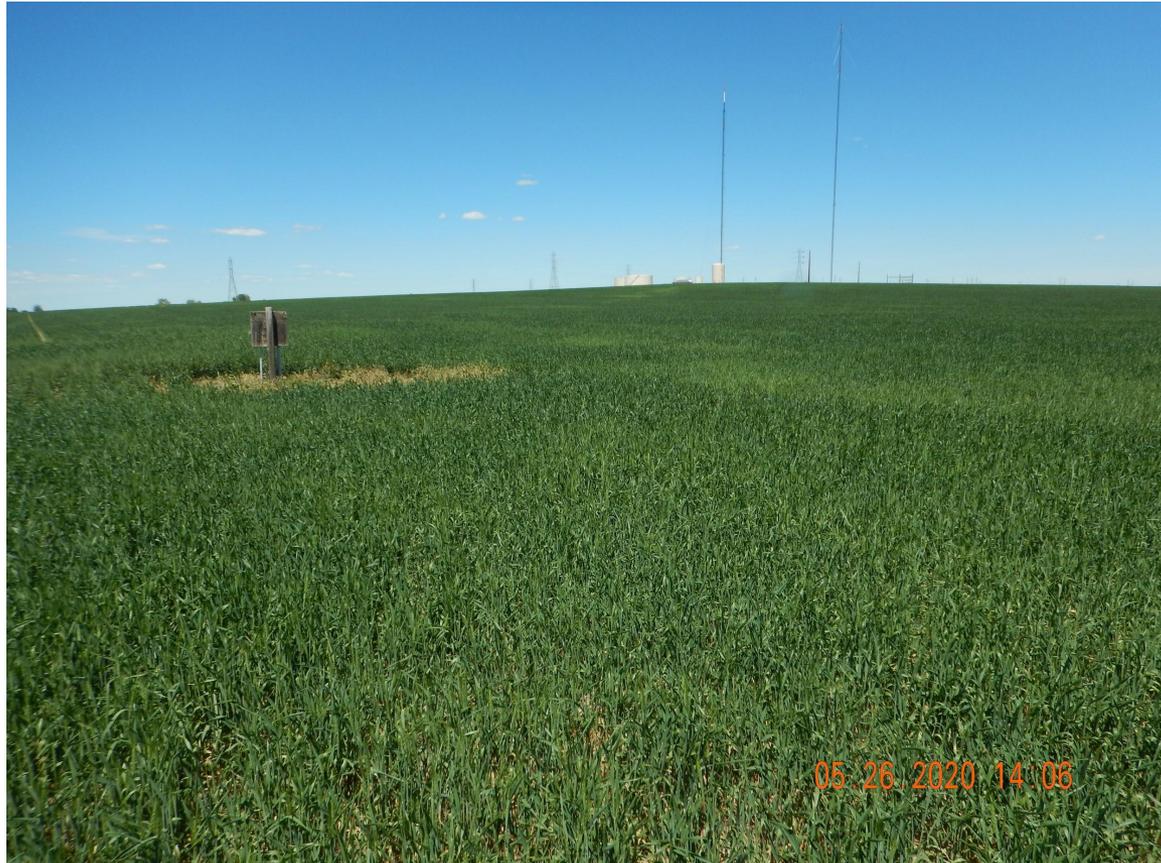
Photo 3. Photo taken from the well location, facing Northeast. See comments under Photo 2.

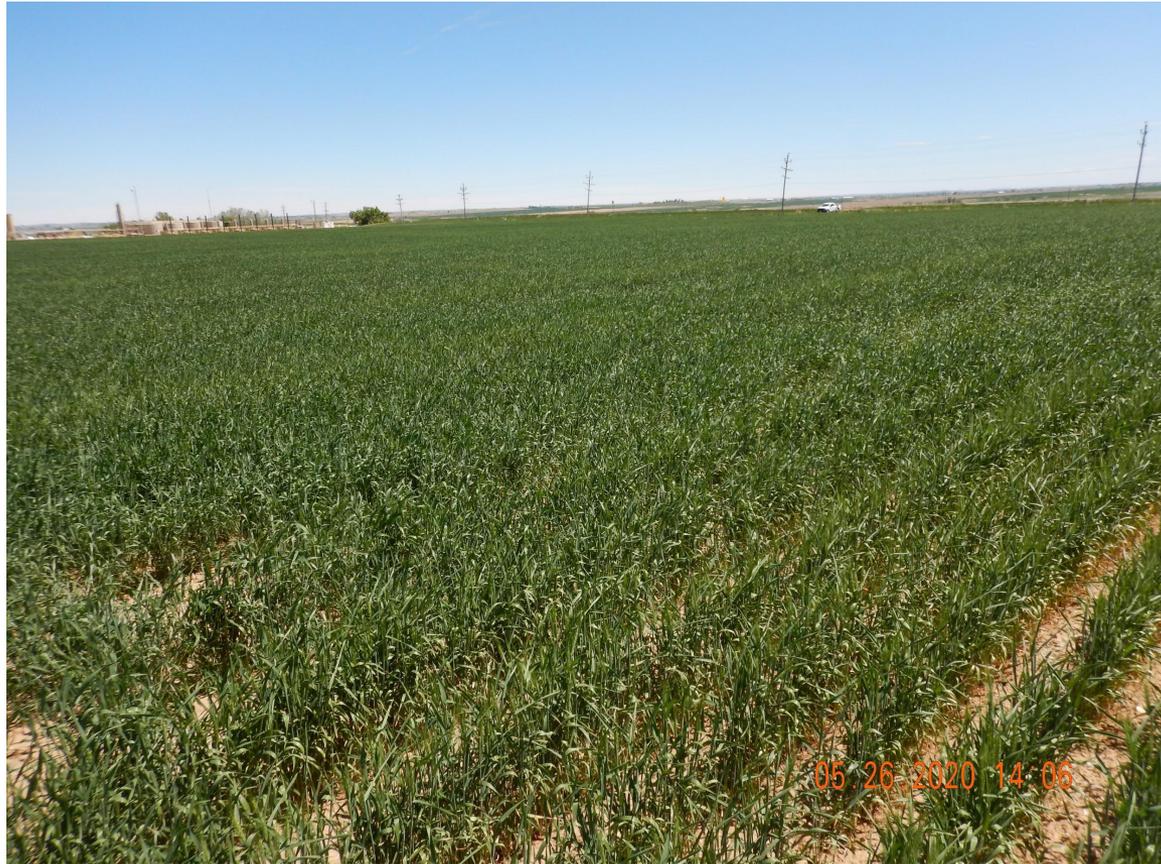
Photo 4. Photo taken from the well location, facing South. Photo illustrates the access road appears reflective of reference crop areas.
