Final Reclamation and Stormwater Inspection

Location ID: 319482

Inspection Document #: 697501570

Inspection Photos
Location Name: ROCKY MOUNTAIN FUEL CO #4-32J
Location ID: 319482

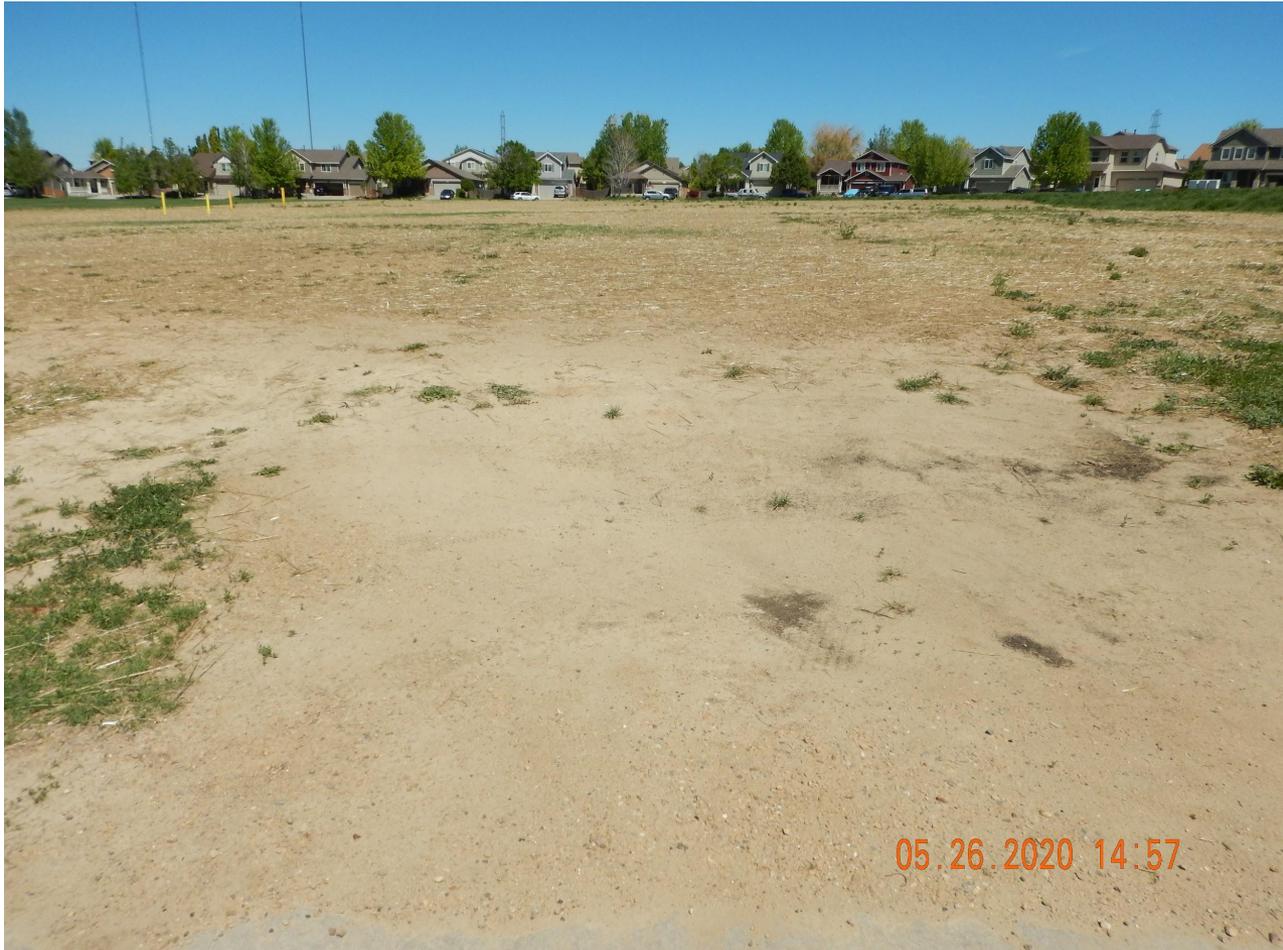
Photo 1. Photo taken from the entrance of location, facing East. Photo illustrates the access point is still be used to access monitoring wells for an active remediation project. Operator will be responsible for reclaiming all disturbance areas.

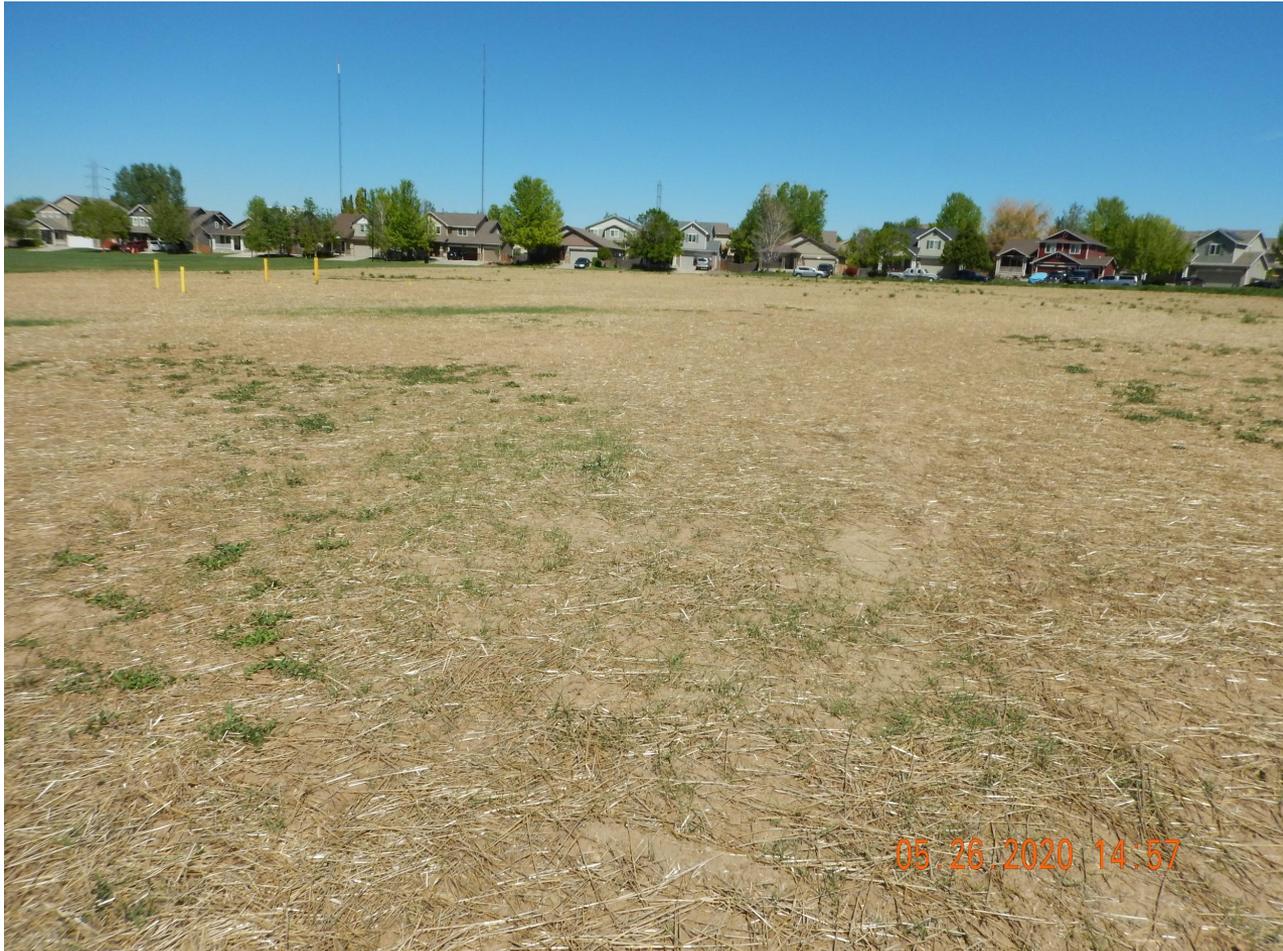
Photo 2. Photo taken from the central location, facing East. Photo illustrates Operator has performed final reclamation activities with the evidence of straw crimped mulch and some germination.

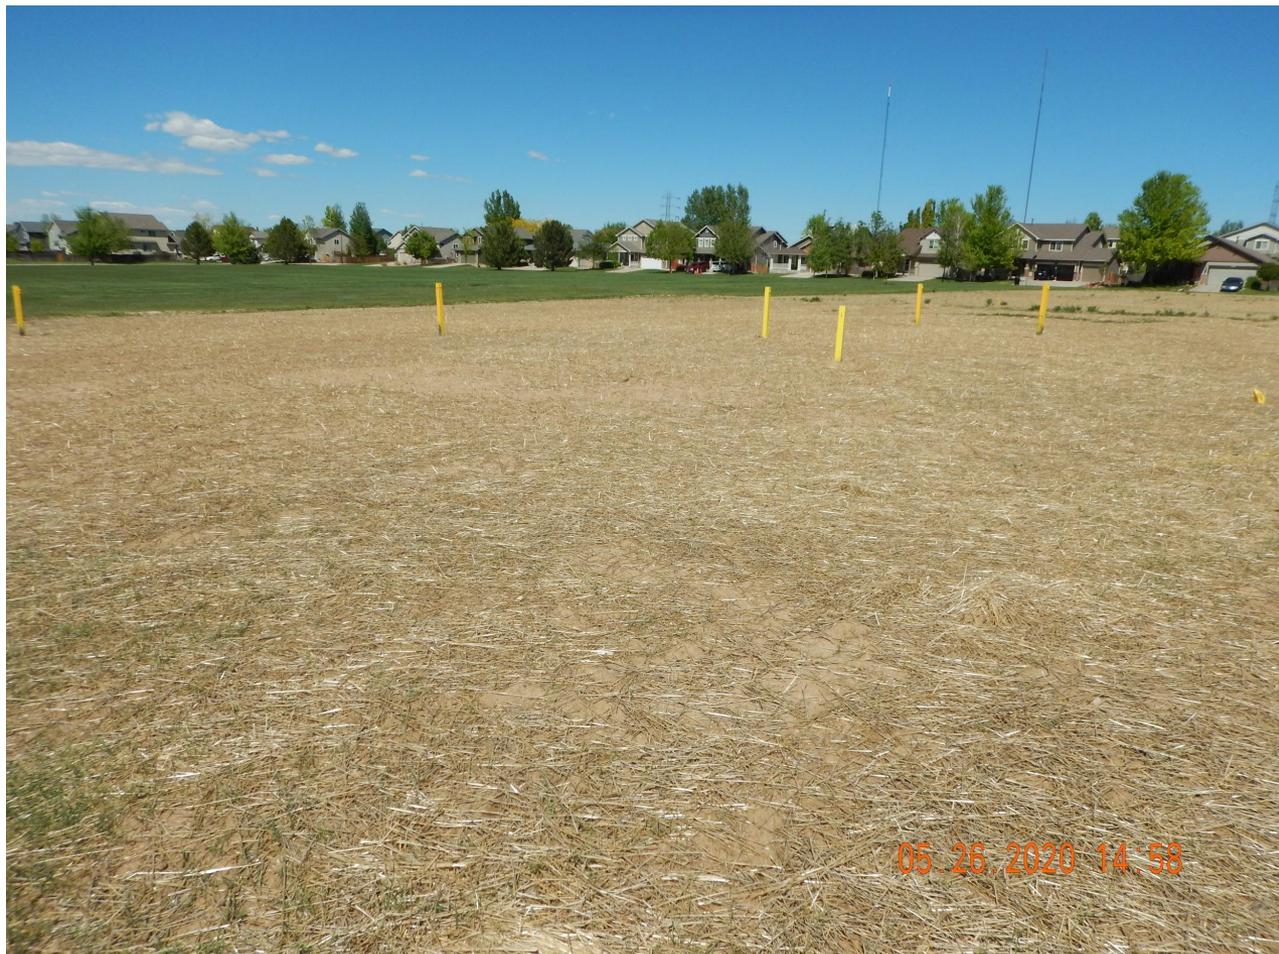
Photo 3. Photo taken from the central location, facing North. Photo illustrates some of the monitoring wells which are located along the northern location.

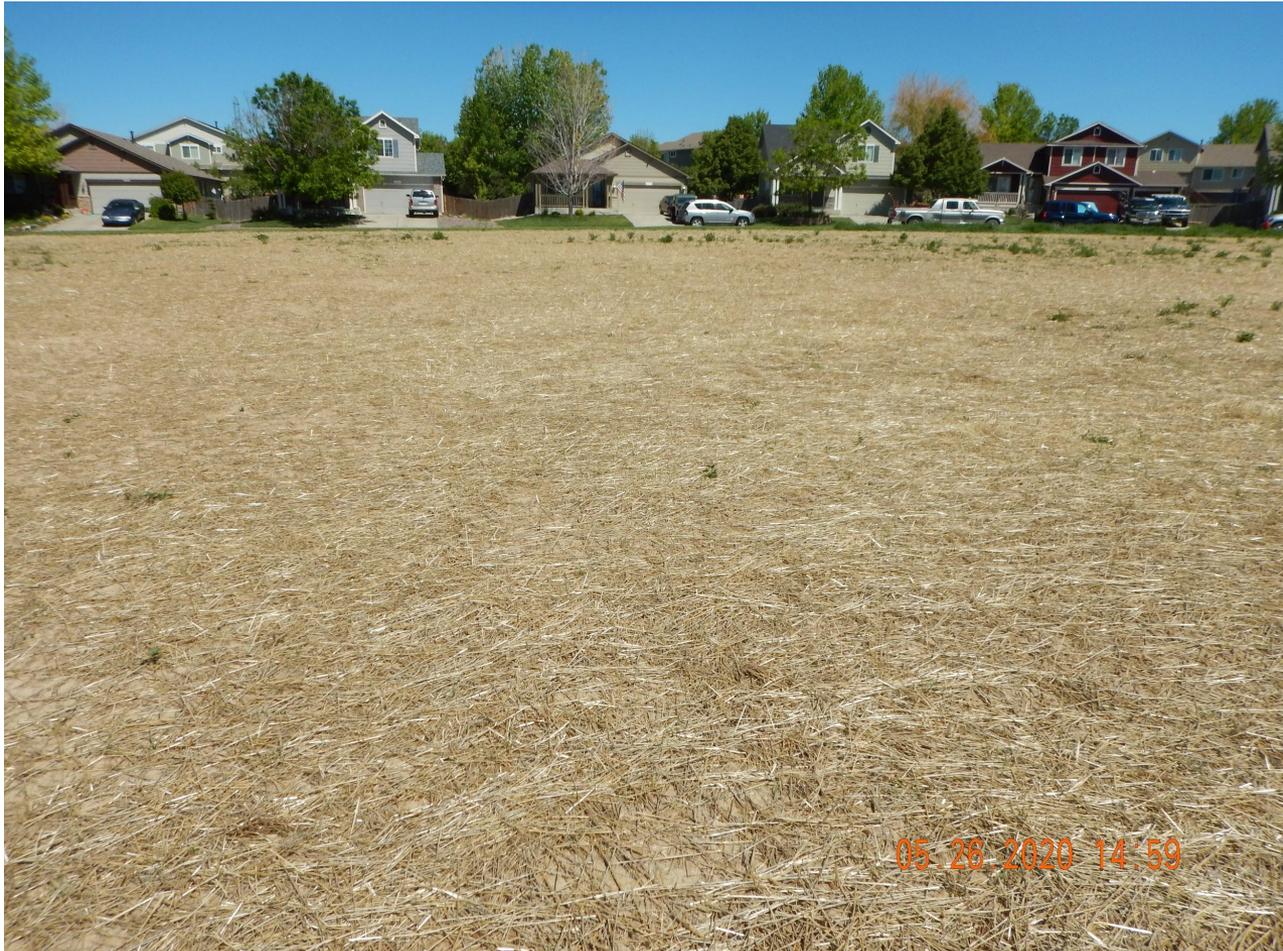
Photo 4. Photo taken from the central location, facing East. Photo illustrates little to no germination throughout large portions of the location. Operator will likely have to perform additional reclamation activities.

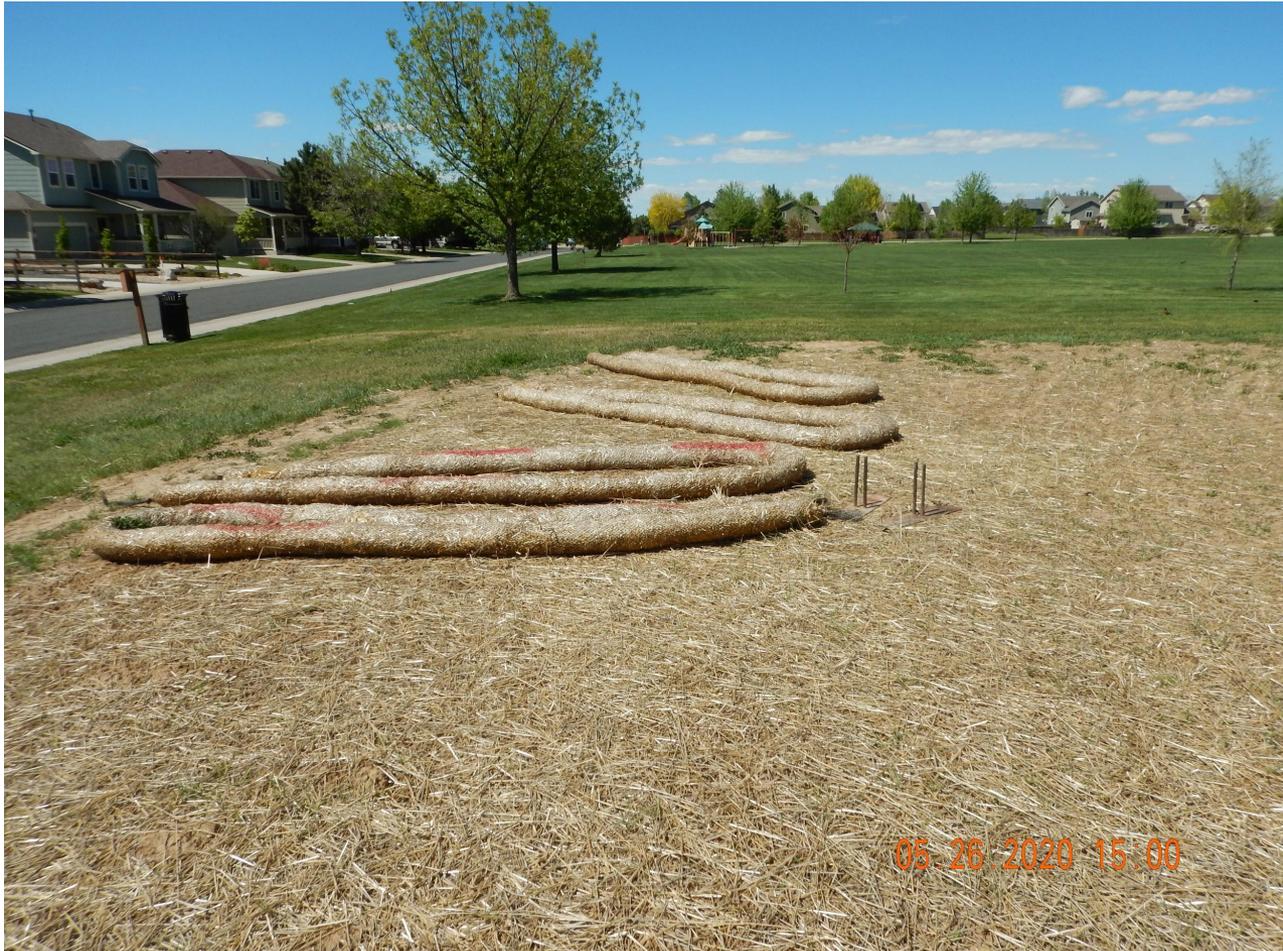
Photo 5. Photo taken from the northwestern location, facing North. Photo illustrates stormwater BMPs that appear to be decommissioned. Operator shall remove all unused materials if no longer needed.
