Inspection Photos
Operator: Highpoint Operating
API#: 033-06158
Date: 5/27/2020

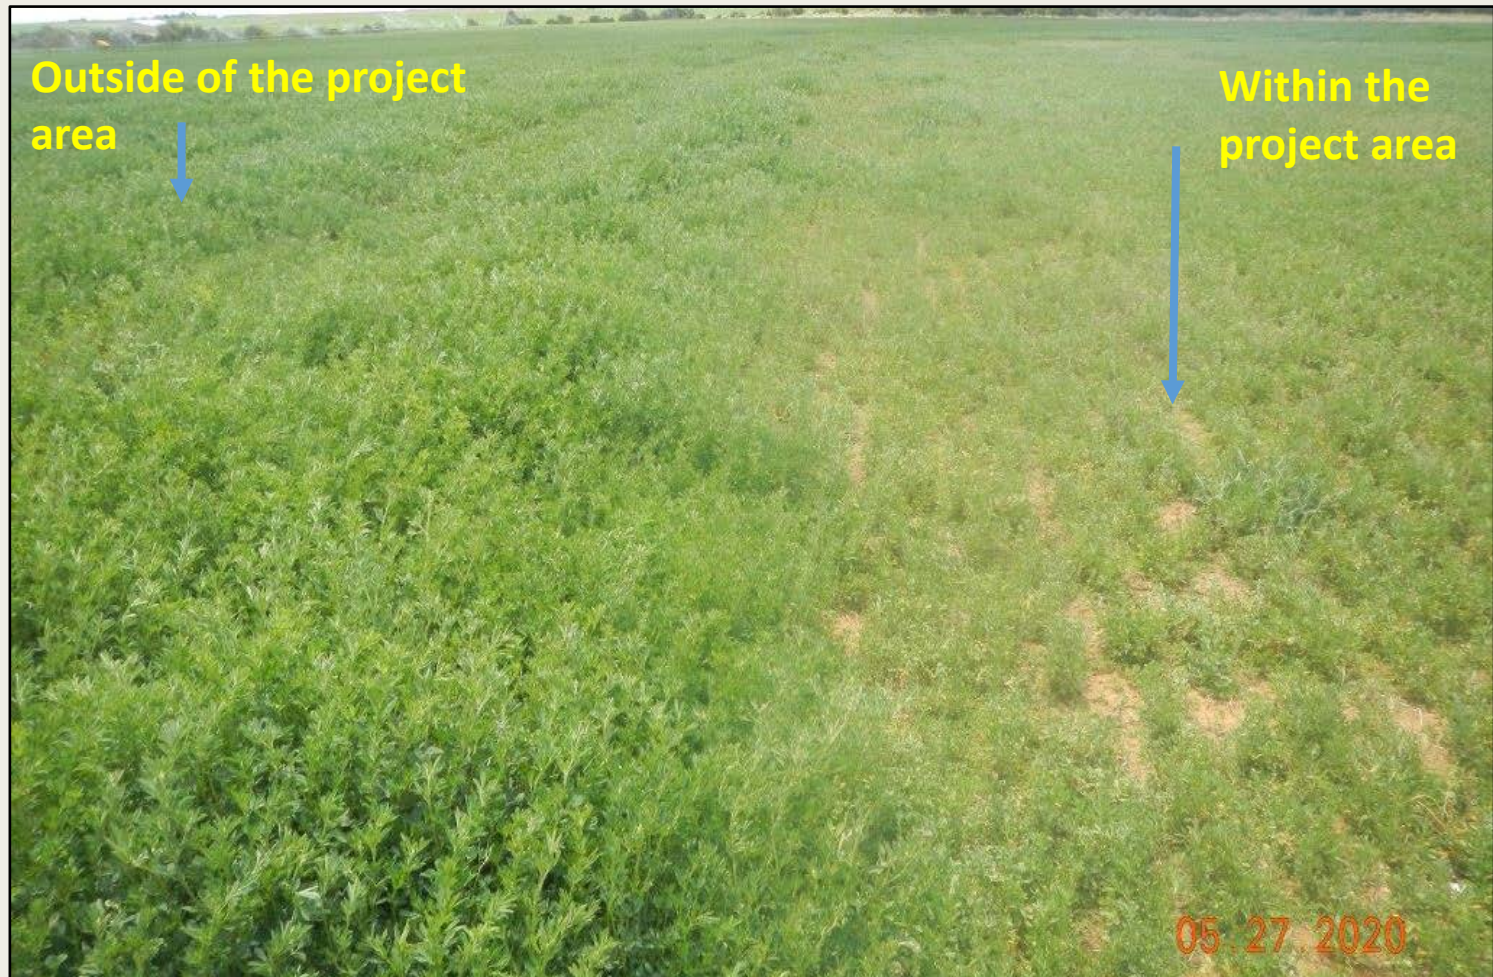
Photo 1. View of the eastern edge of the well pad facing southward. Vegetation (alfalfa) in left portion of the photo is off of the project area, vegetation (alfalfa) in the right of the photo is within the project area. Alfalfa within the project area is significantly more stunted, sparse, and weedy than the alfalfa outside of the project area.

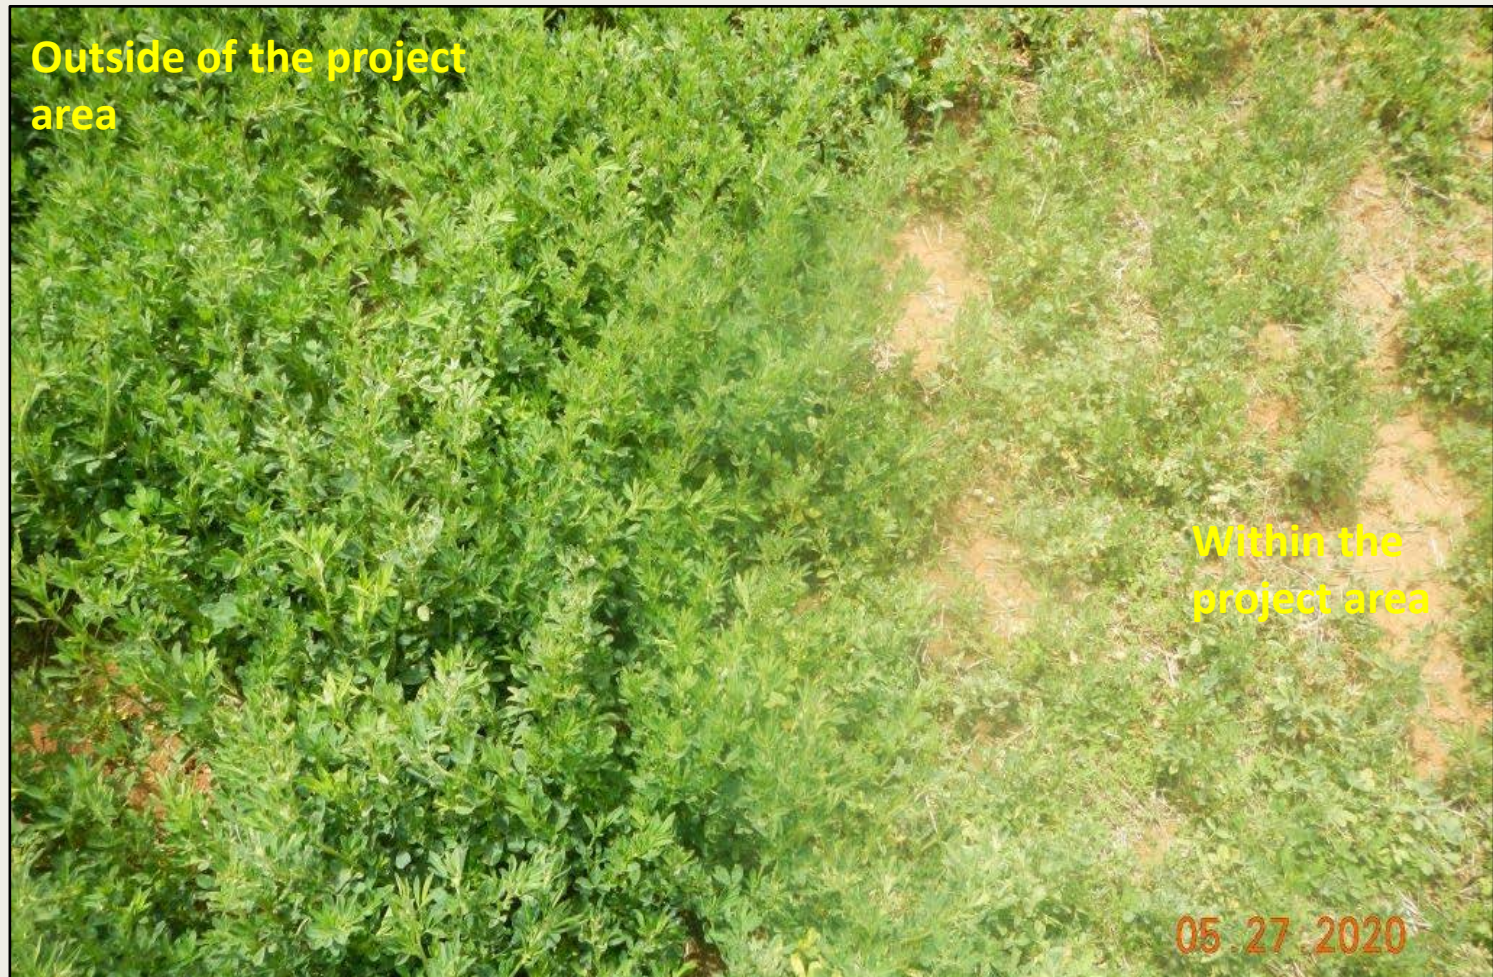
Photo 2. Closeup of vegetation at the edge of the project area showing well-established alfalfa on left and stunted vegetation on the right.

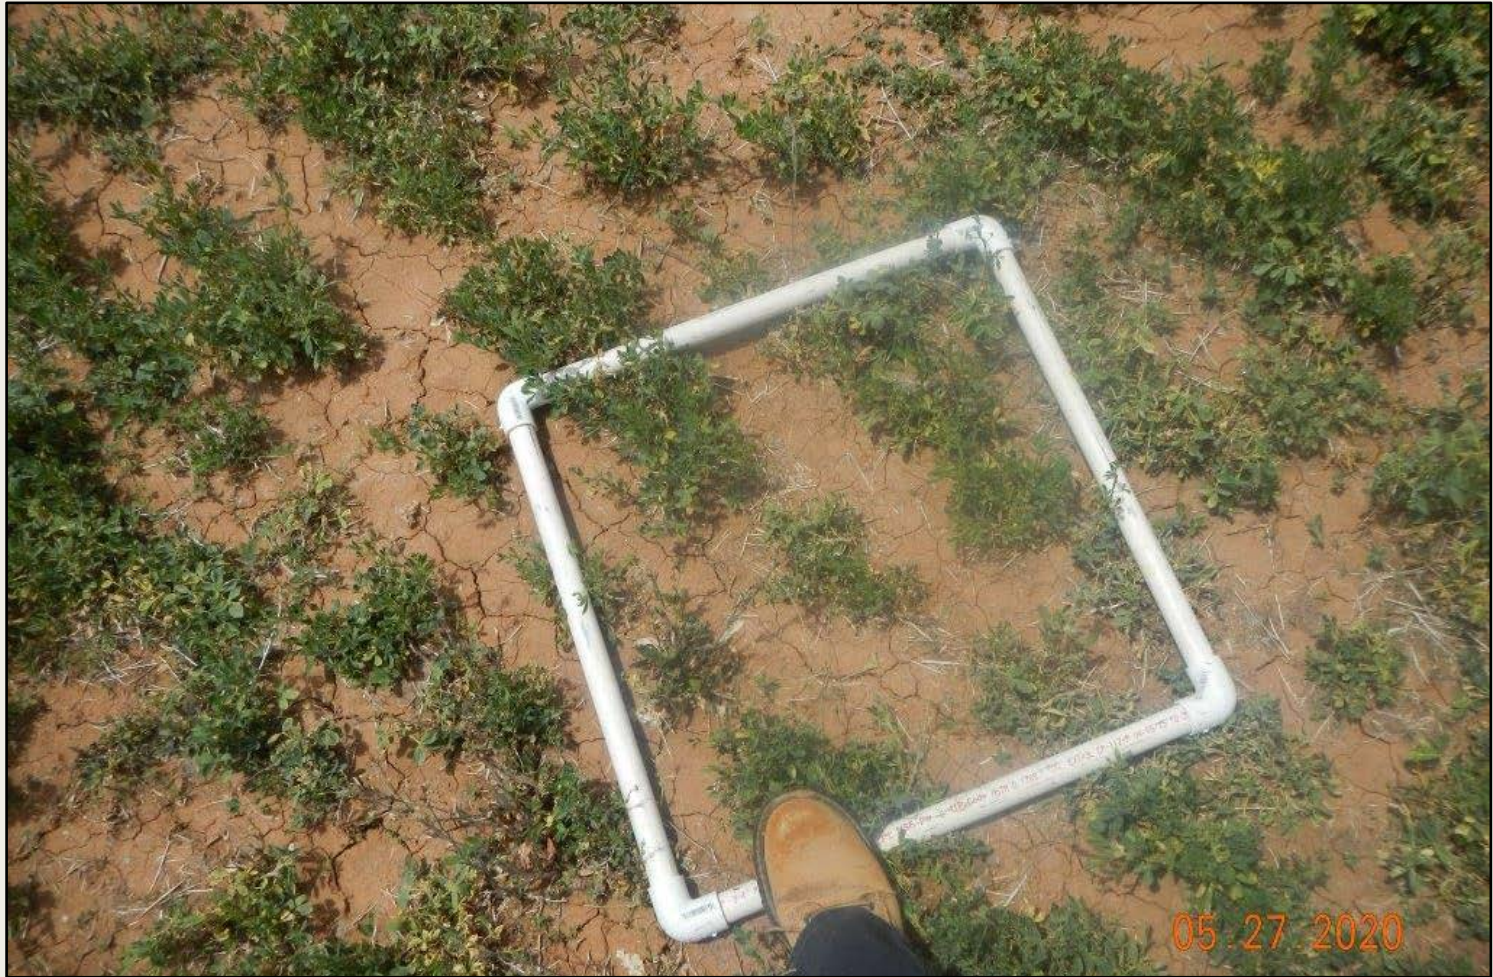
Photo 3. View of representative quadrat vegetation within the project area. Alfalfa is approximately 4 inches tall and sparse.

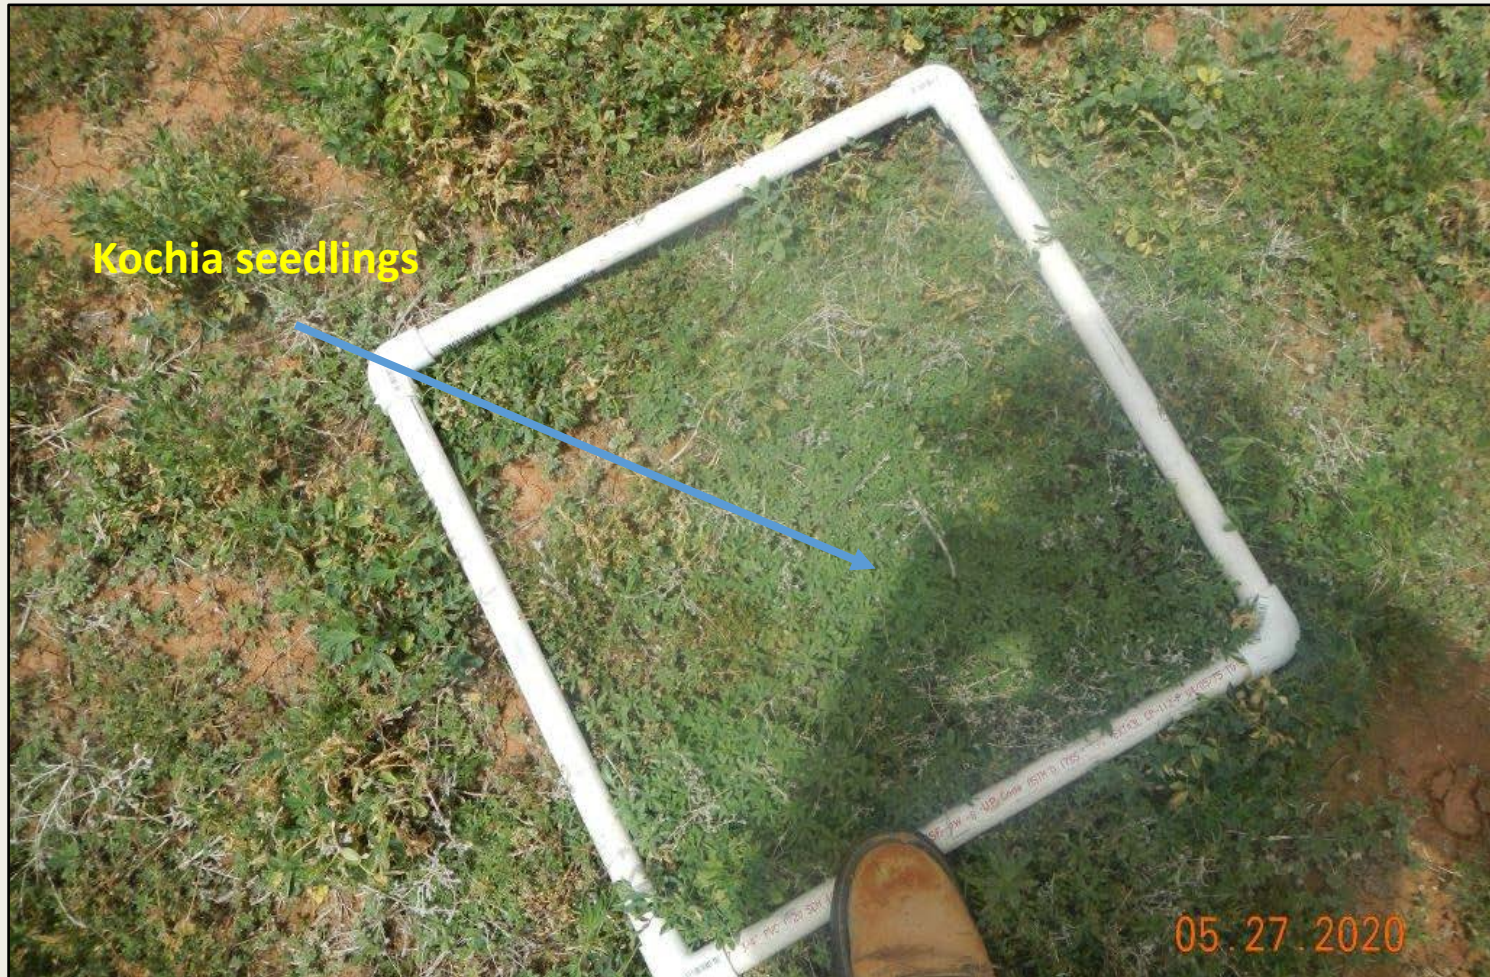
Photo 4. View of another representative quadrat within the project area. Dense kochia seedlings present.

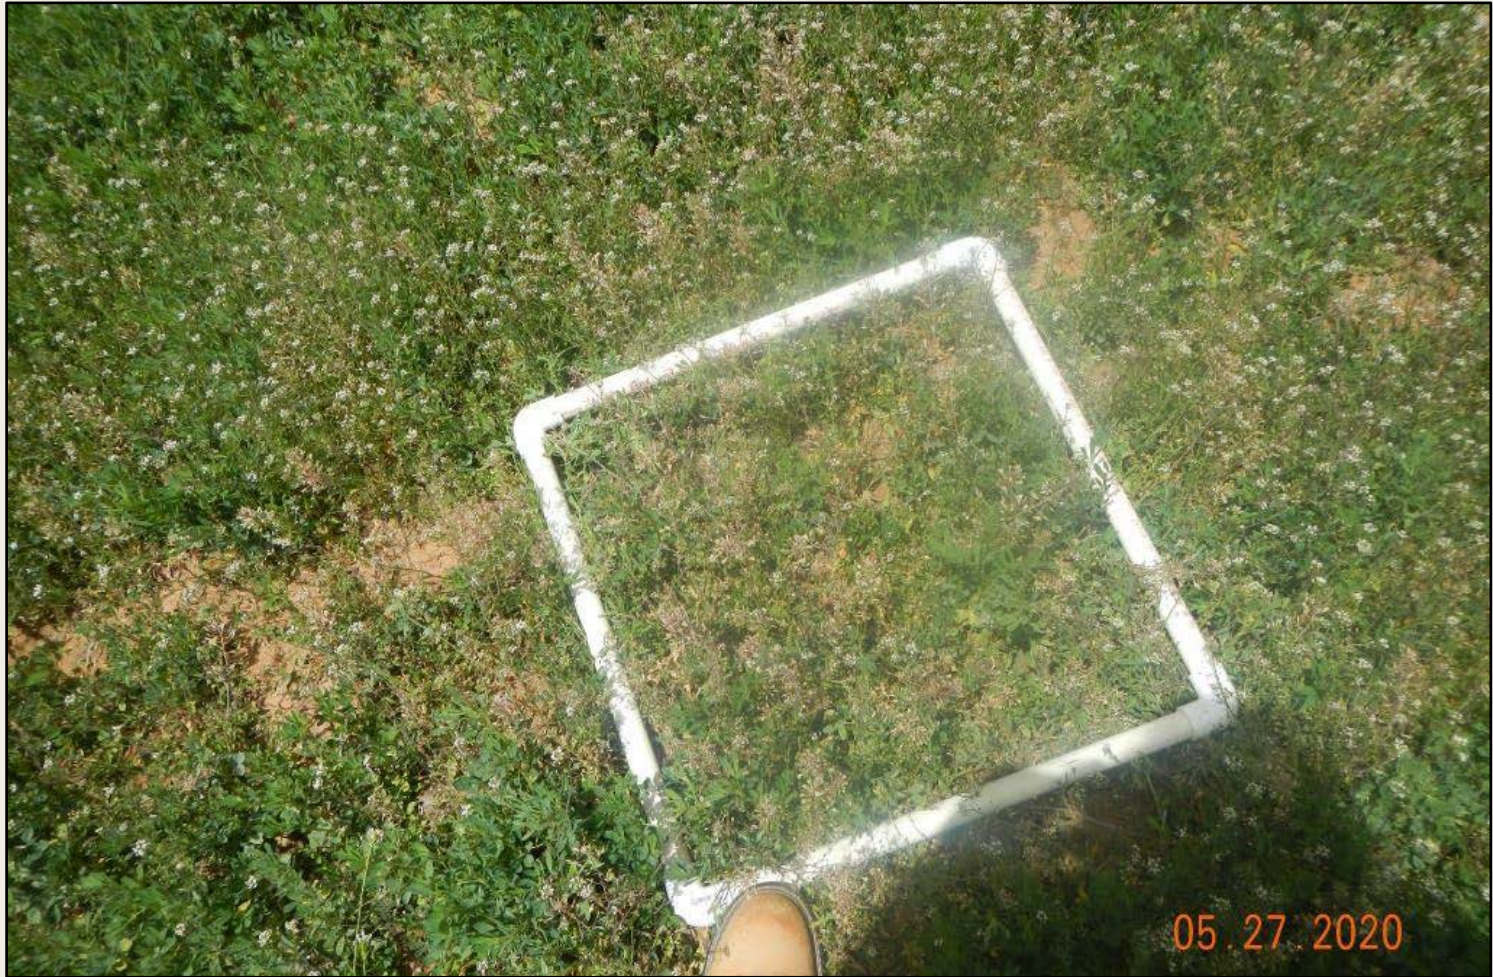
Photo 5. View of another vegetation quadrat within the project area. Vegetation is mixed with alfalfa and weedy shepherd's purse. Alfalfa is also stunted here compared to reference area.

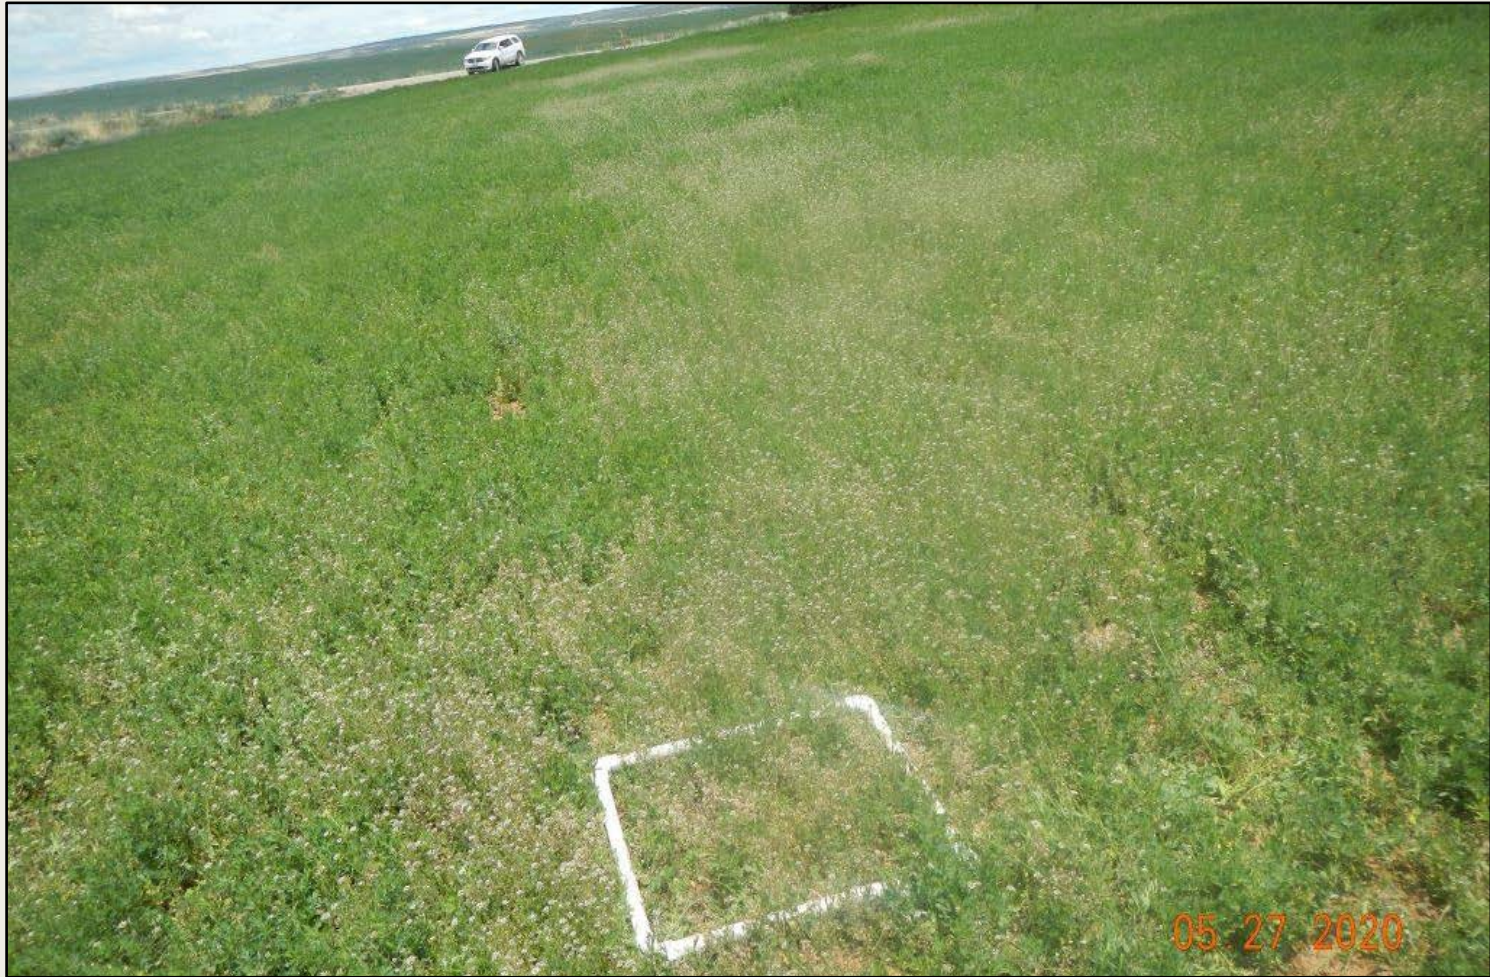
Photo 6. View of crop vegetation along the former access road facing northward. Vegetation is significantly shorter and weedier than reference area (see photos 7 & 8).

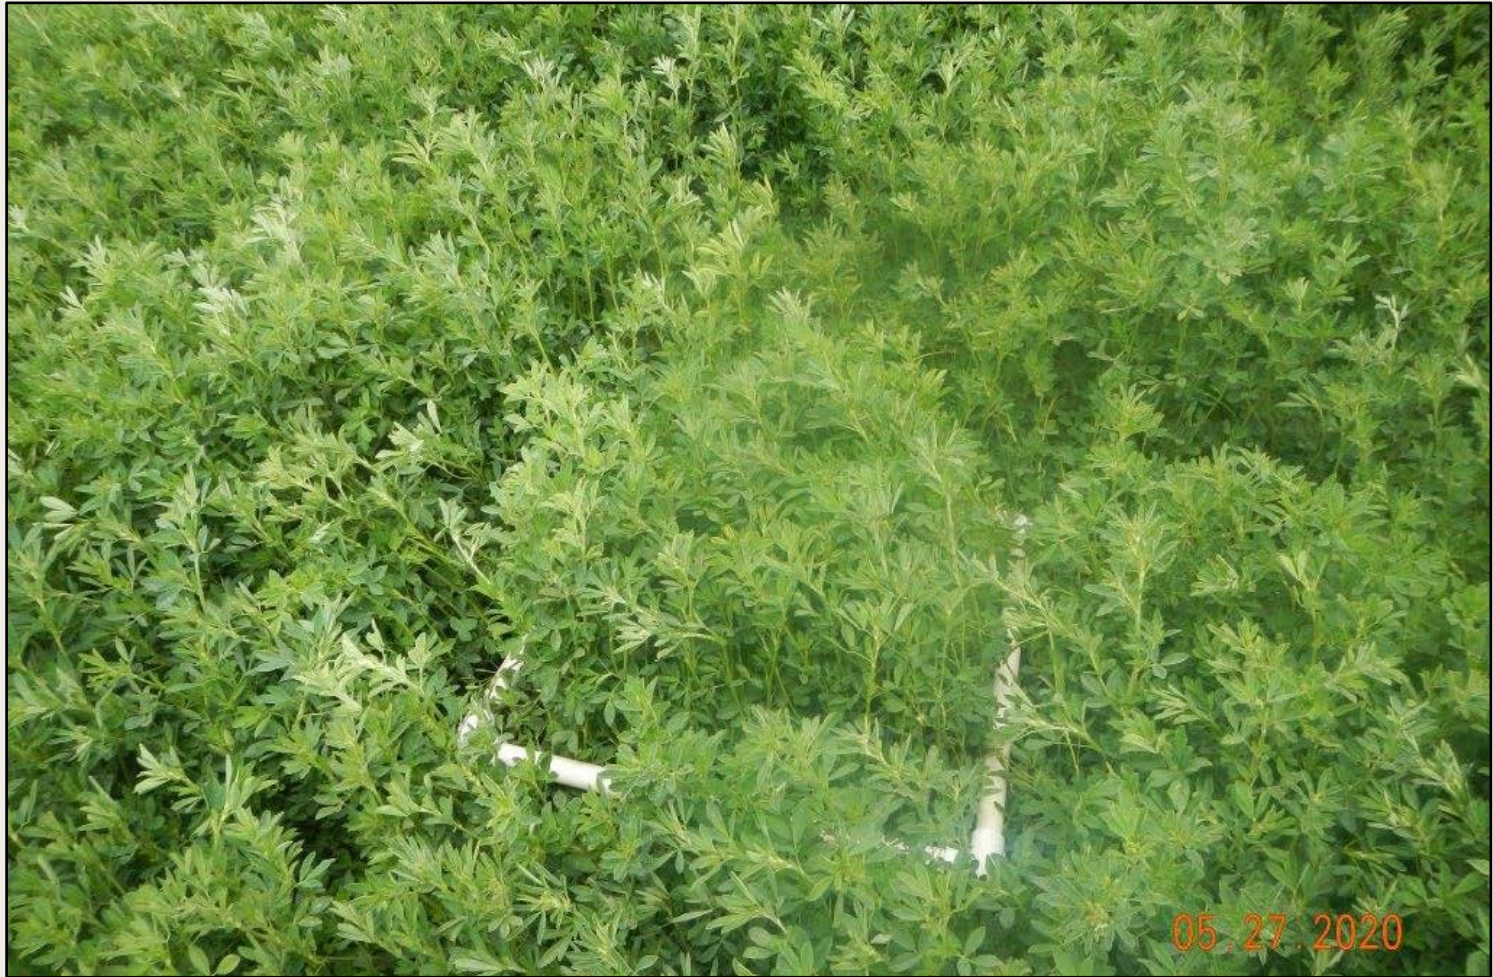
Photo 7. View of reference area quadrat within the cropfield, and outside of the project area. Alfalfa plants are approximately 24-30 inches tall with approximately 100 percent vegetative cover within the quadrat.

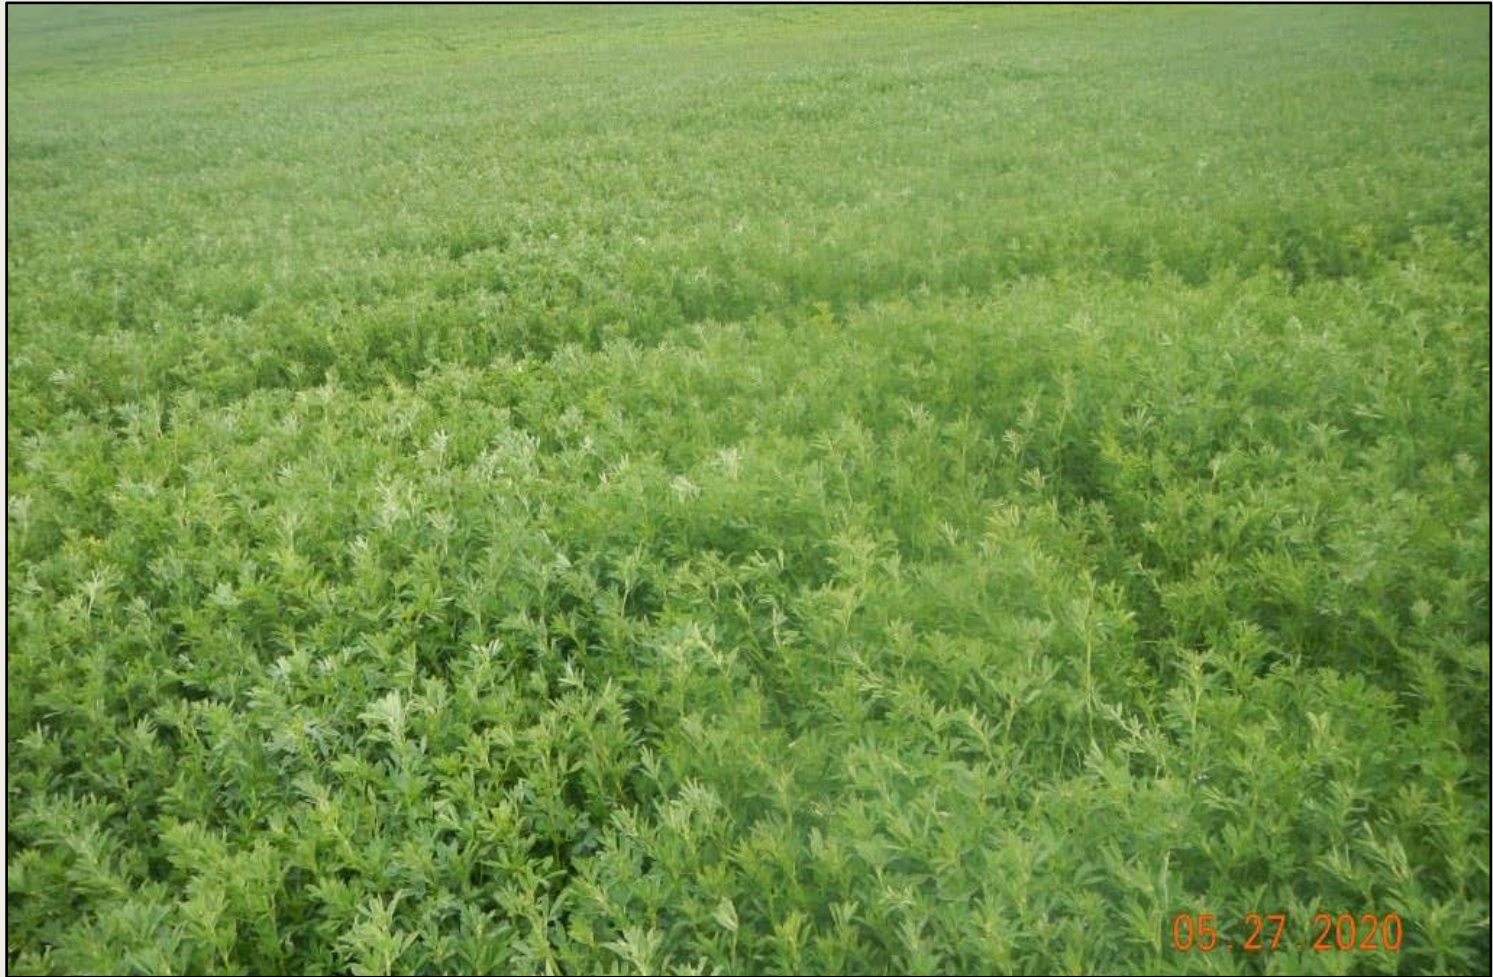
Photo 8. View of reference area vegetation facing westward, outside and west of the project area.
