Inspection Photos  
Operator: Highpoint Operating  
API#: 033-06146  
Date: 5/27/2020

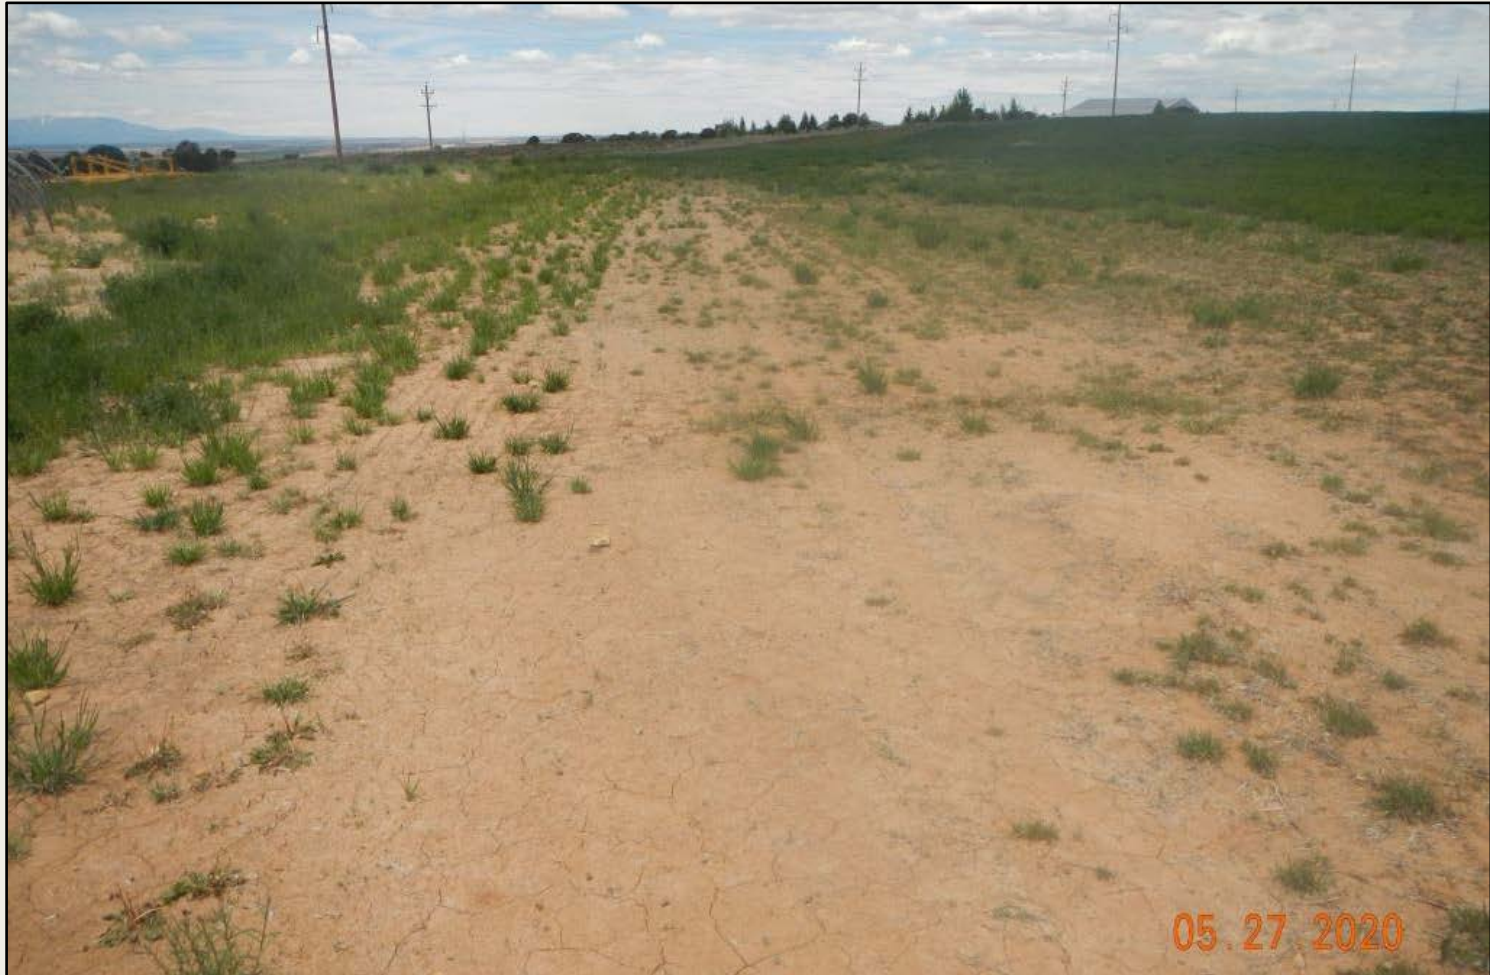
Photo 1. View of sparse revegetation within the northeastern project area. Revegetation is comprised of mixed grasses such as crested wheatgrass and western wheatgrass.

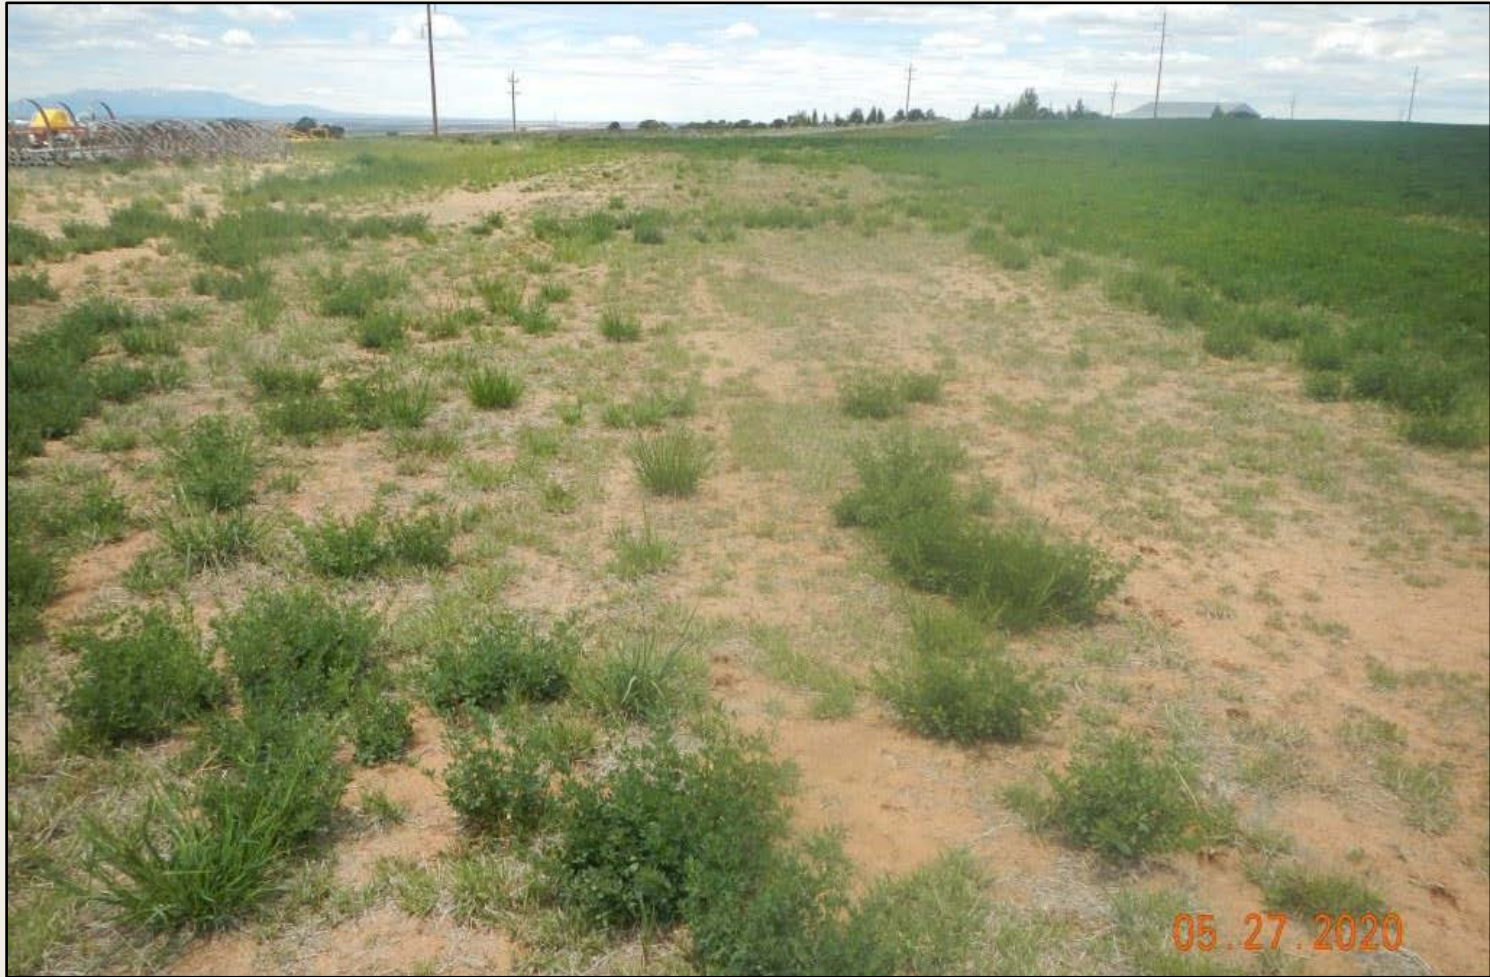
Photo 2. View of sparse revegetation within the southeastern project area. Scattered alfalfa are significantly more sparse and smaller than surrounding cropfield.

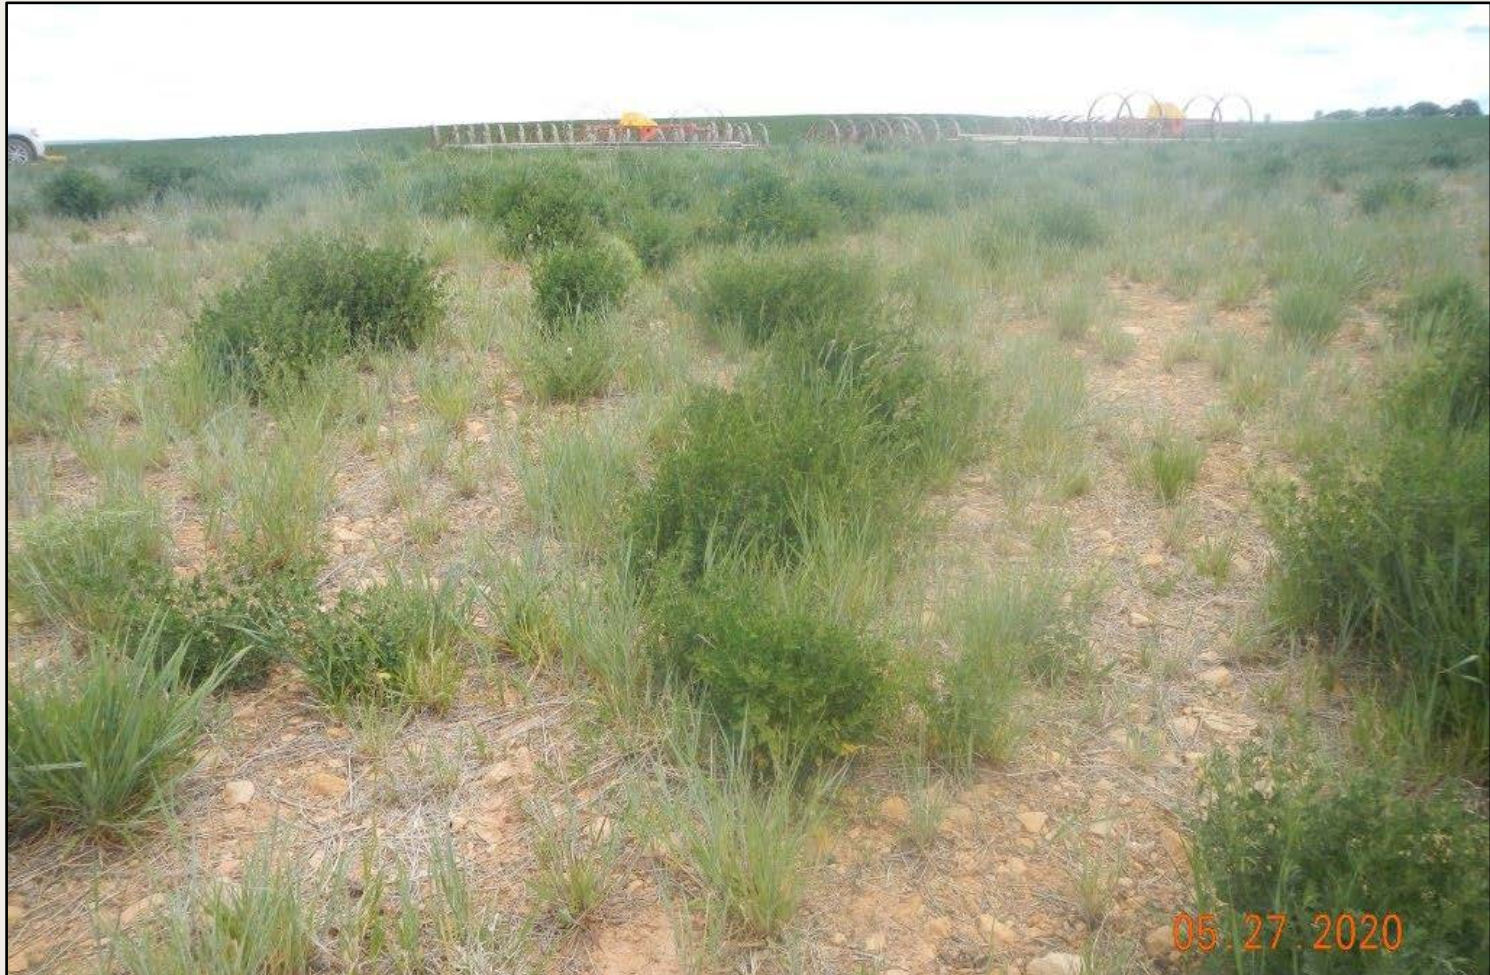
Photo 3. View of the central well pad from the southwestern corner facing center. Revegetation is progressing here.

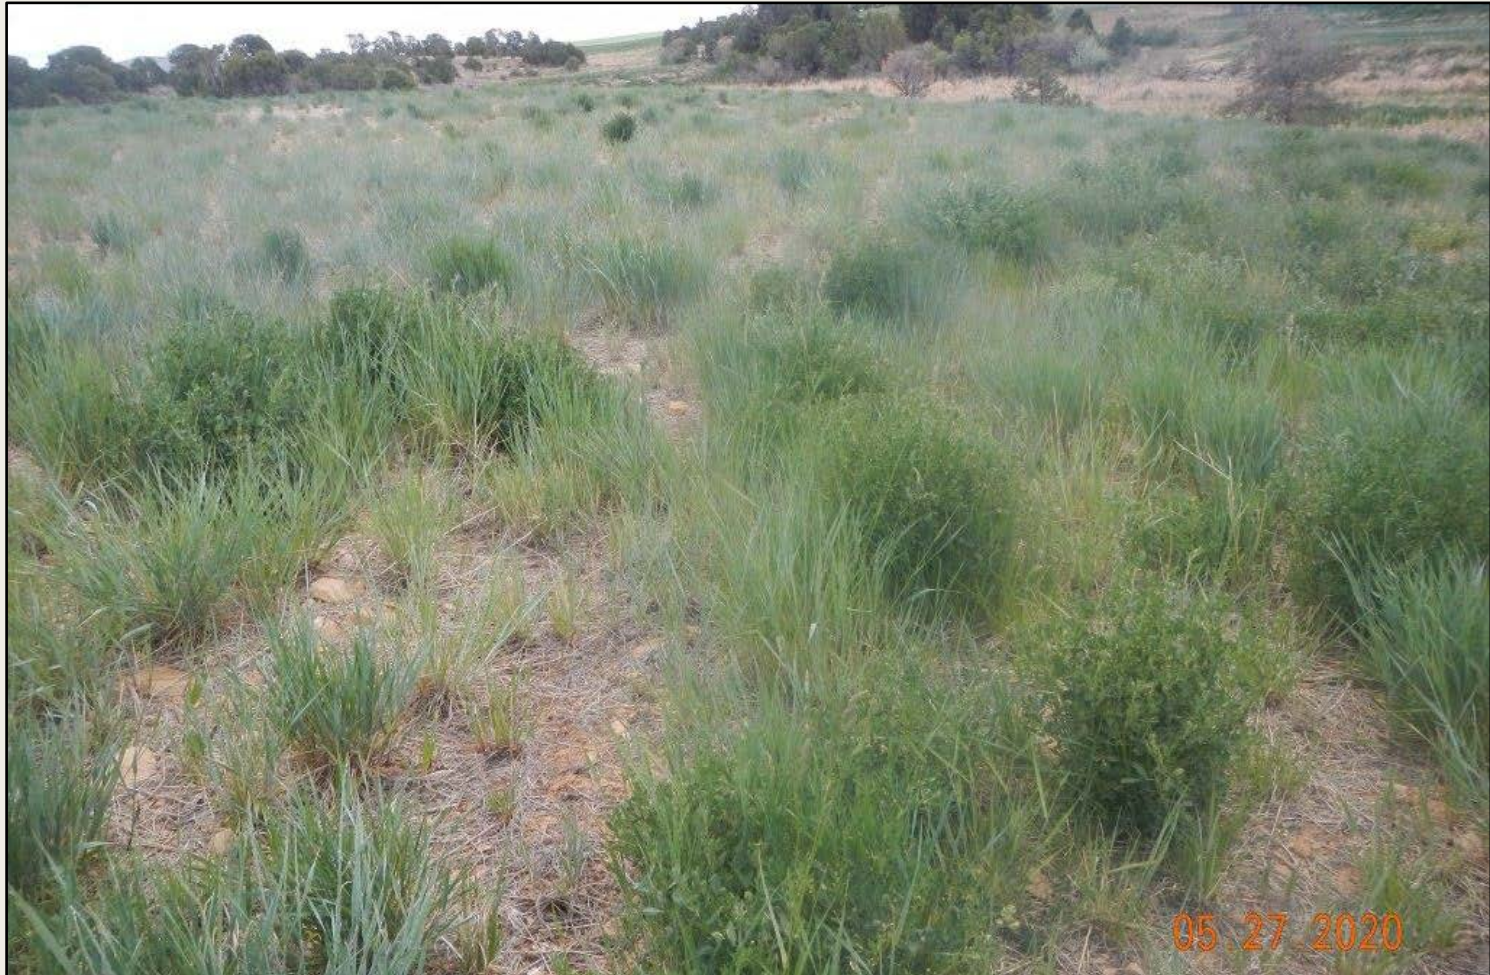
Photo 4. View of the southwestern fill slope facing southeastward. Revegetation is progressing on the fill slope.

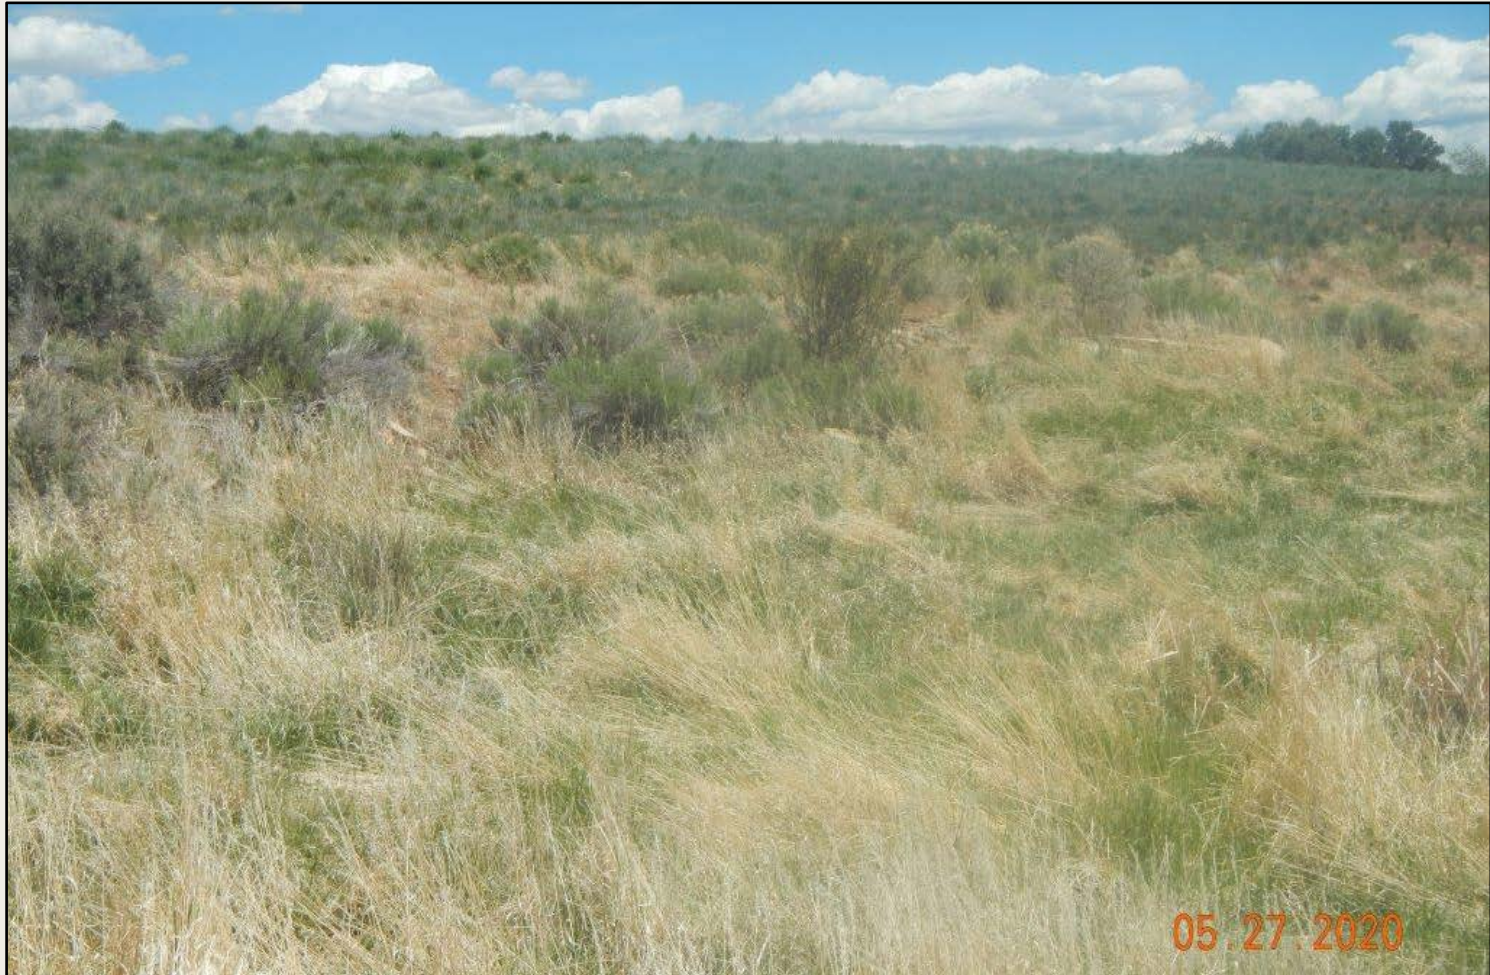
Photo 5. View of reference area vegetation comprised of rabbitbrush and sagebrush shrublands with understory of seeded grasses such as smooth brome and crested wheatgrass.
