Inspection Photos

Operator: SG INTERESTS I LTD - 77330

Location ID: 422990

Gunnison County, CO

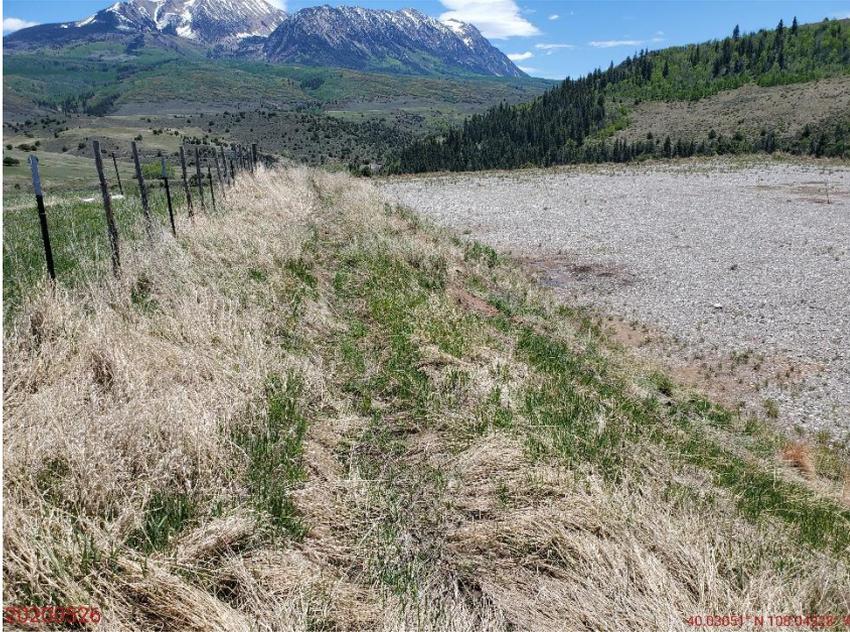
Photo 1: Photo taken from the northern corner of the Location, facing southeast. Photos 1-2 provide an overview of the Location from southeast to southwest.

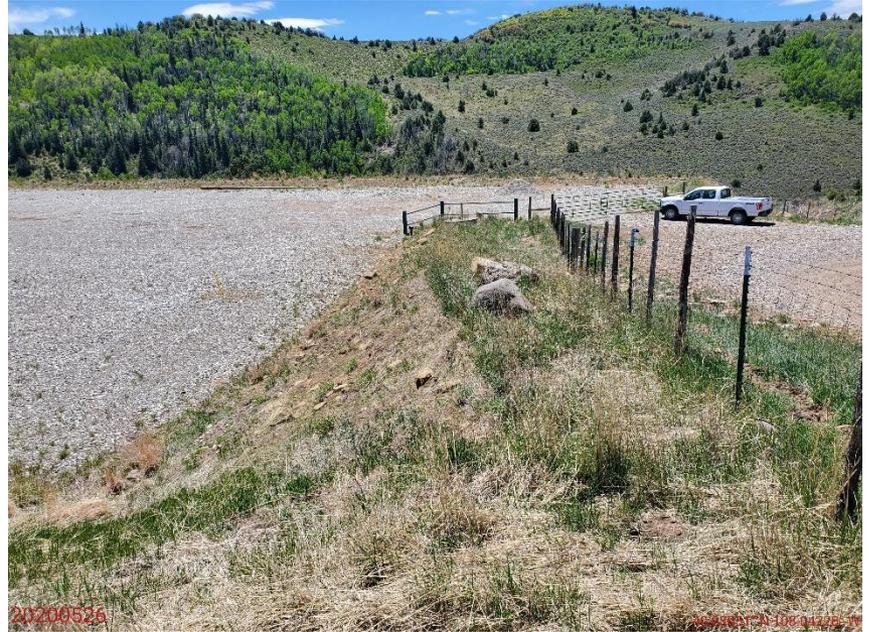
Photo 2: See comments under photo 1.

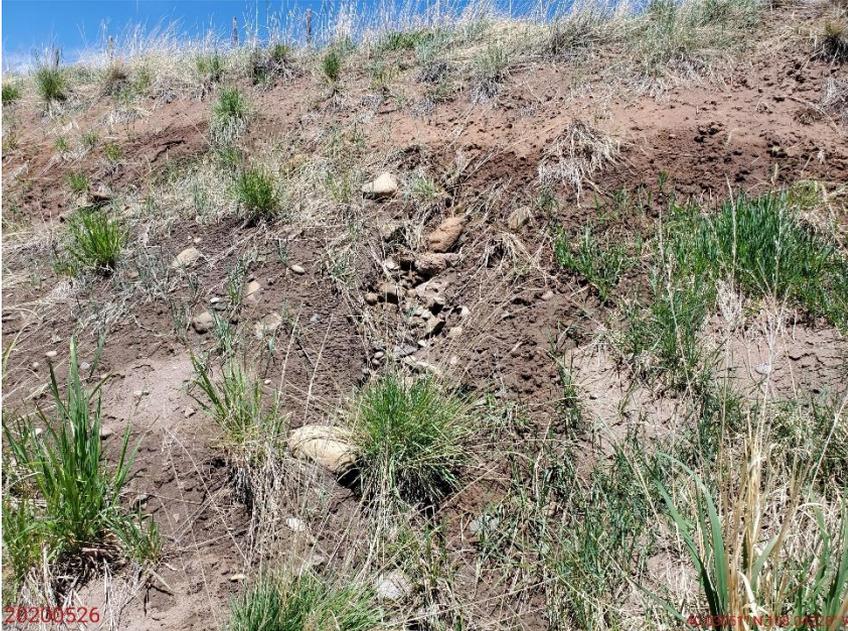
Photo 3: Photo taken from the cut slopes on the northern end of the Location. Photo shows a seep appears to have developed in the cut slope resulting in water discharging and erosion degradation.

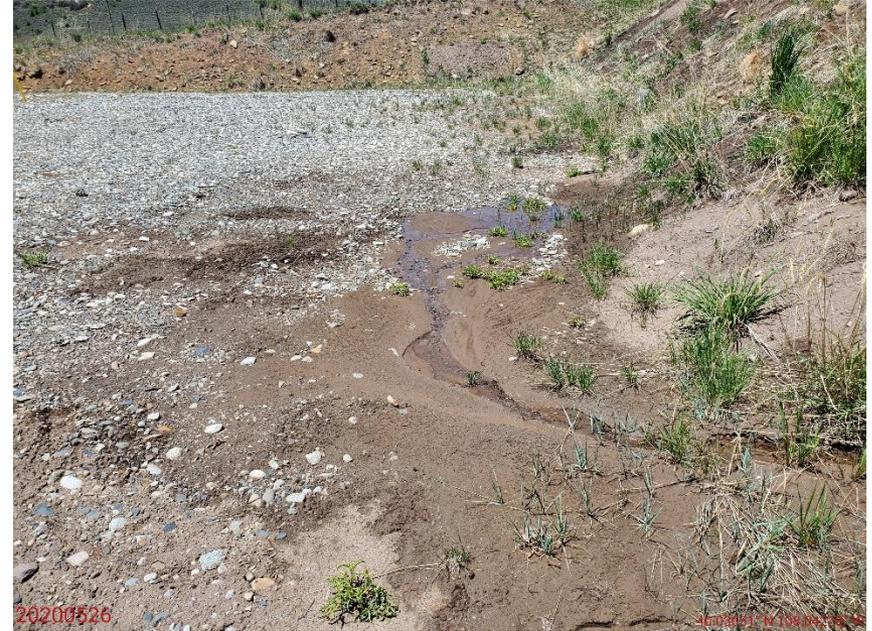
Photo 4: Continued from photo 3. Photo shows erosion degradation/sediment deposition on the pad from the cut slope

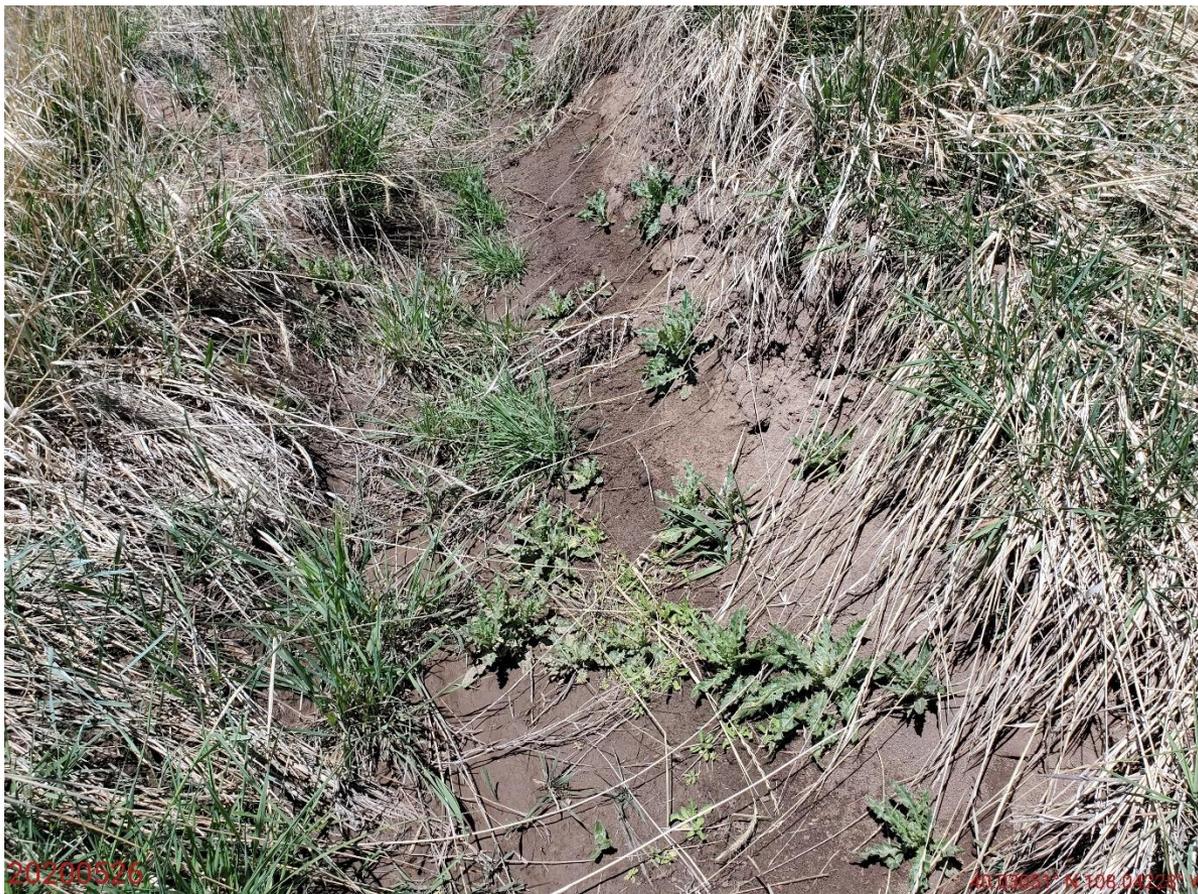
Photo 5: Photo taken from the perimeter stormwater diversion ditch on the north end of the Location. Photo shows Canada thistle rosettes; This is a Colorado State listed noxious weed and requires management.
