# Inspection Photos

Operator: SG INTERESTS I LTD - 77330

Location ID: 414132

Gunnison County, CO

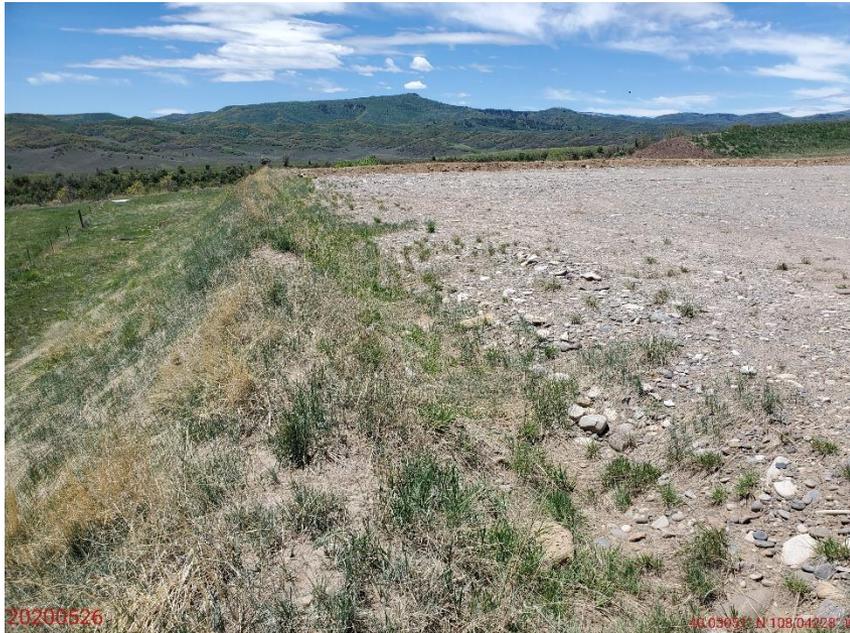
**Photo 1:** Photo taken from the south end of the Location, facing west. Photos 1-3 provide an overview of the Location from west, north to east. Photo shows interim reclamation appears to have been conducted, however areas remain on the current pad that do not appear to be needed for production.

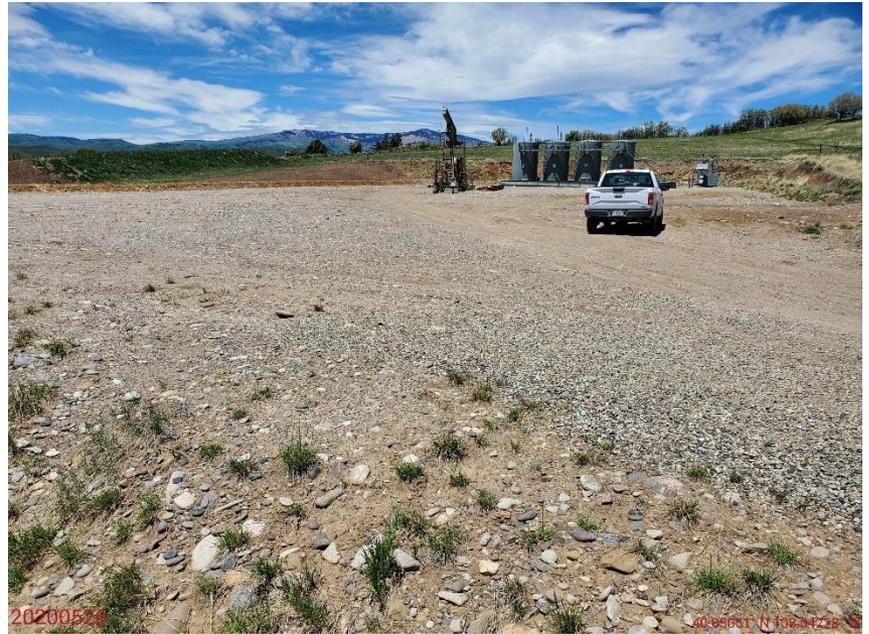
**Photo 2:** See comments under photo 1.

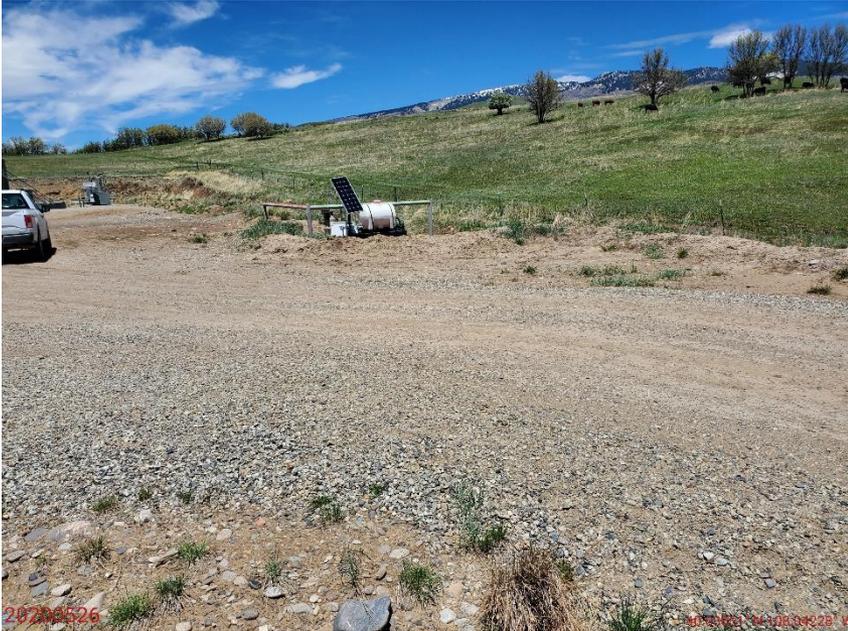
**Photo 3:** See comments under photo 1.

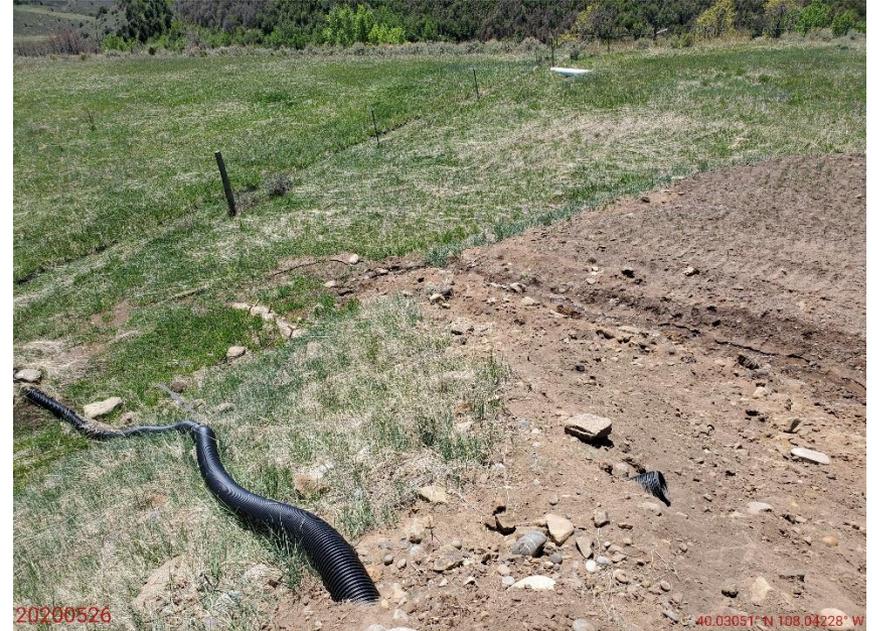
**Photo 4:** Photo taken from the southwest end of the Location, facing southwest. Photo shows area where perimeter stormwater diversion ditch discharges from the Location; BMP has not been constructed in accordance with good engineering practices, or with a sufficient stabilized outlet to prevent degradation, and allow for sediment laden-free stormwater discharge from the Location; Erosion degradation evident with off-site sediment transport and deposition occurring

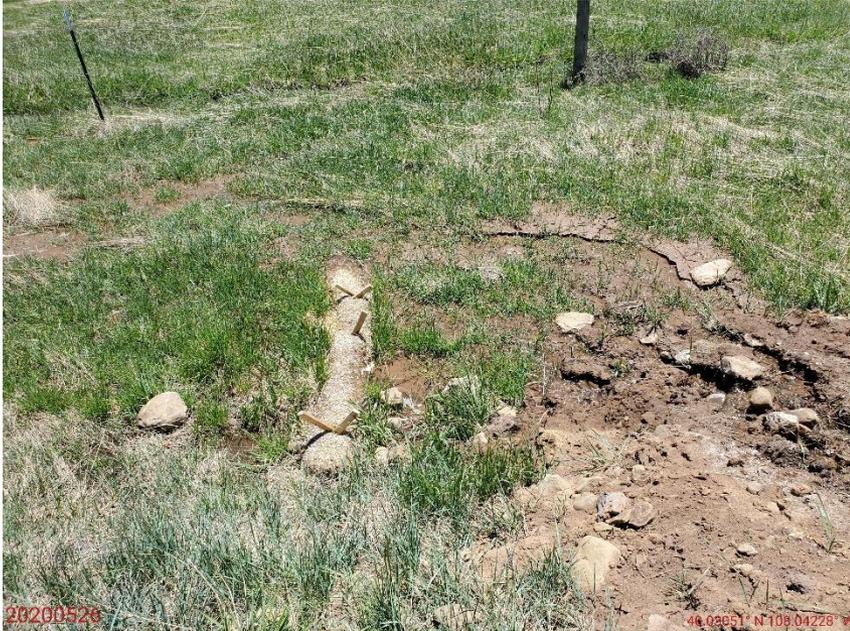
**Photo 5:** Photo taken from the southwest end of the Location, facing south. Photo shows stormwater erosion and off-site sediment transport and deposition occurring

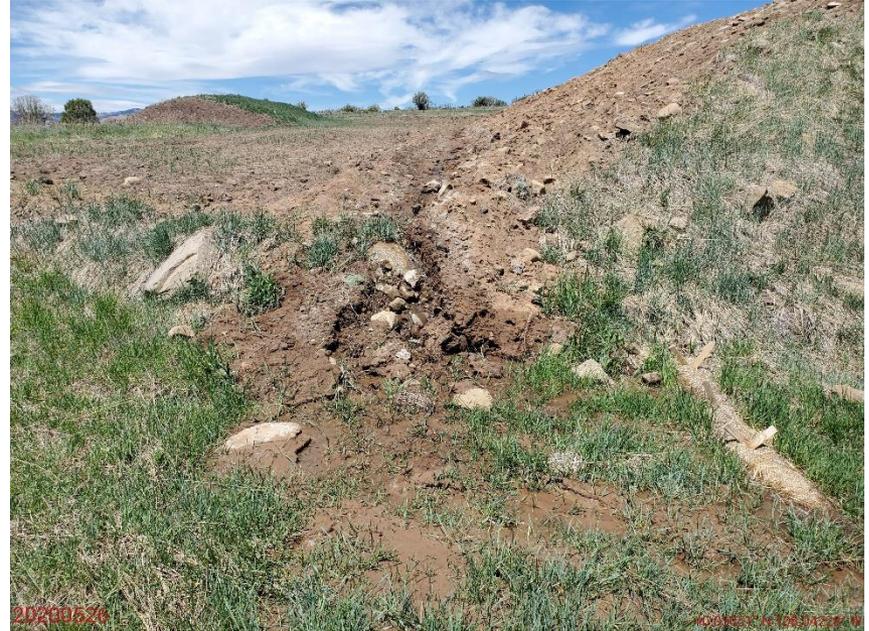
**Photo 6:** Photo taken from the southwest end of the Location, facing north. Photo shows area where perimeter stormwater diversion ditch discharges from the Location; BMP has not been constructed in accordance with good engineering practices, or with a sufficient stabilized outlet to prevent degradation, and allow for sediment laden-free stormwater discharge from the Location; Erosion degradation evident with off-site sediment transport and deposition occurring
