# Final Reclamation Inspection

Operator: TOP OPERATING COMPANY - 39560

API: 05-123-07899

Inspection Photos  
Location Name: KNOX #1-23  
API: 05-123-07899

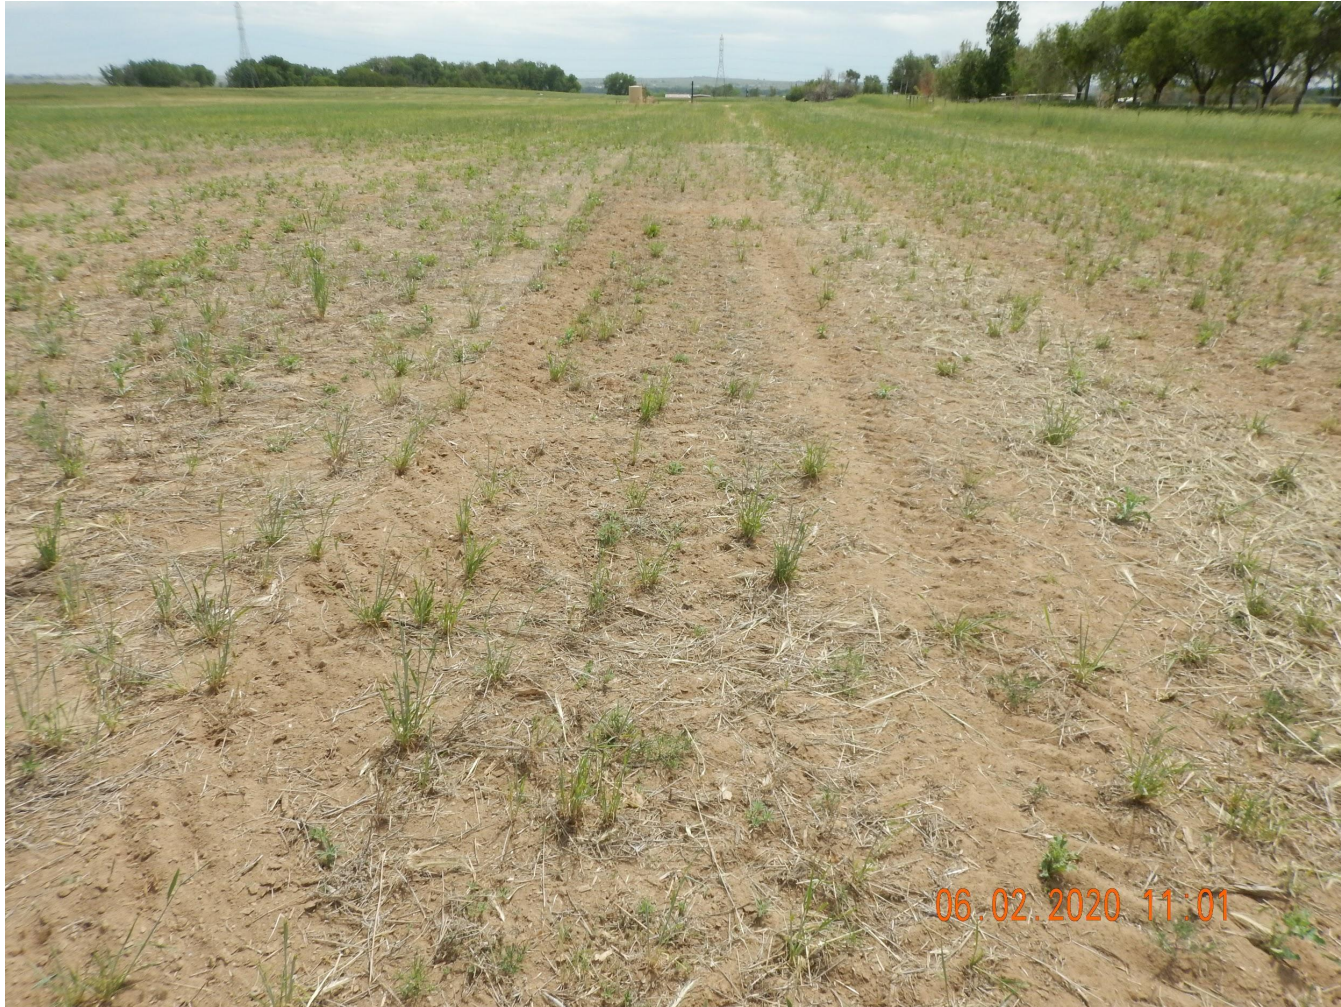
**Photo 1.** Photo taken from the western location, facing East. Operator has performed final reclamation activities with the evidence of reference area grass species (Cereal rye). The establishment of Cereal rye does not appear to be reflective of reference areas; therefore, this location will remain in-process.

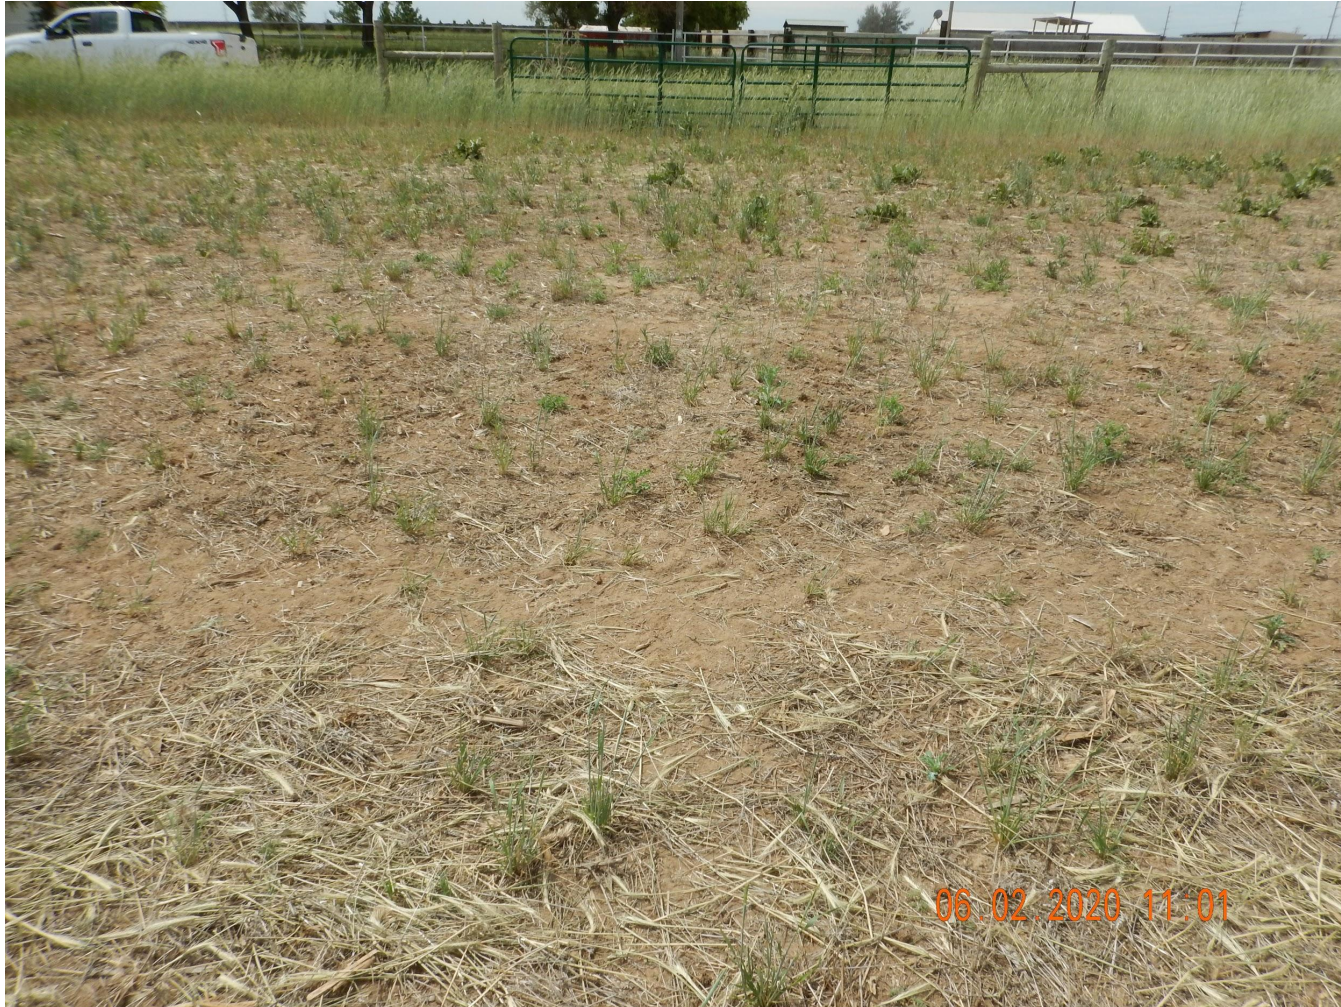
**Photo 2.** Photo taken from the western location, facing South. See comments under Photo 1.

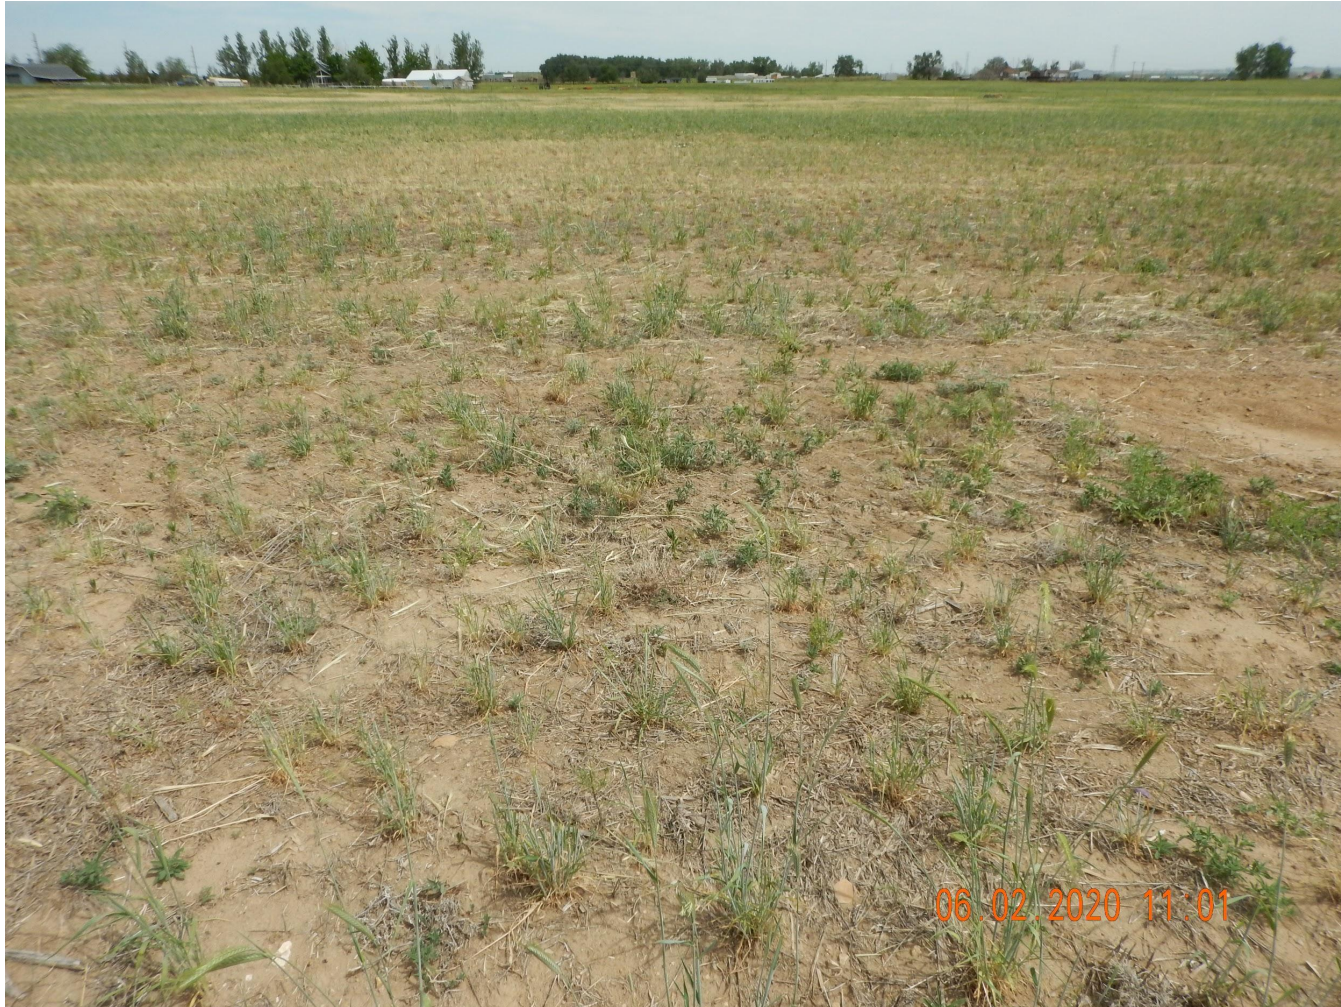
**Photo 3.** Photo taken from the western location, facing North. See comments under Photo 1.

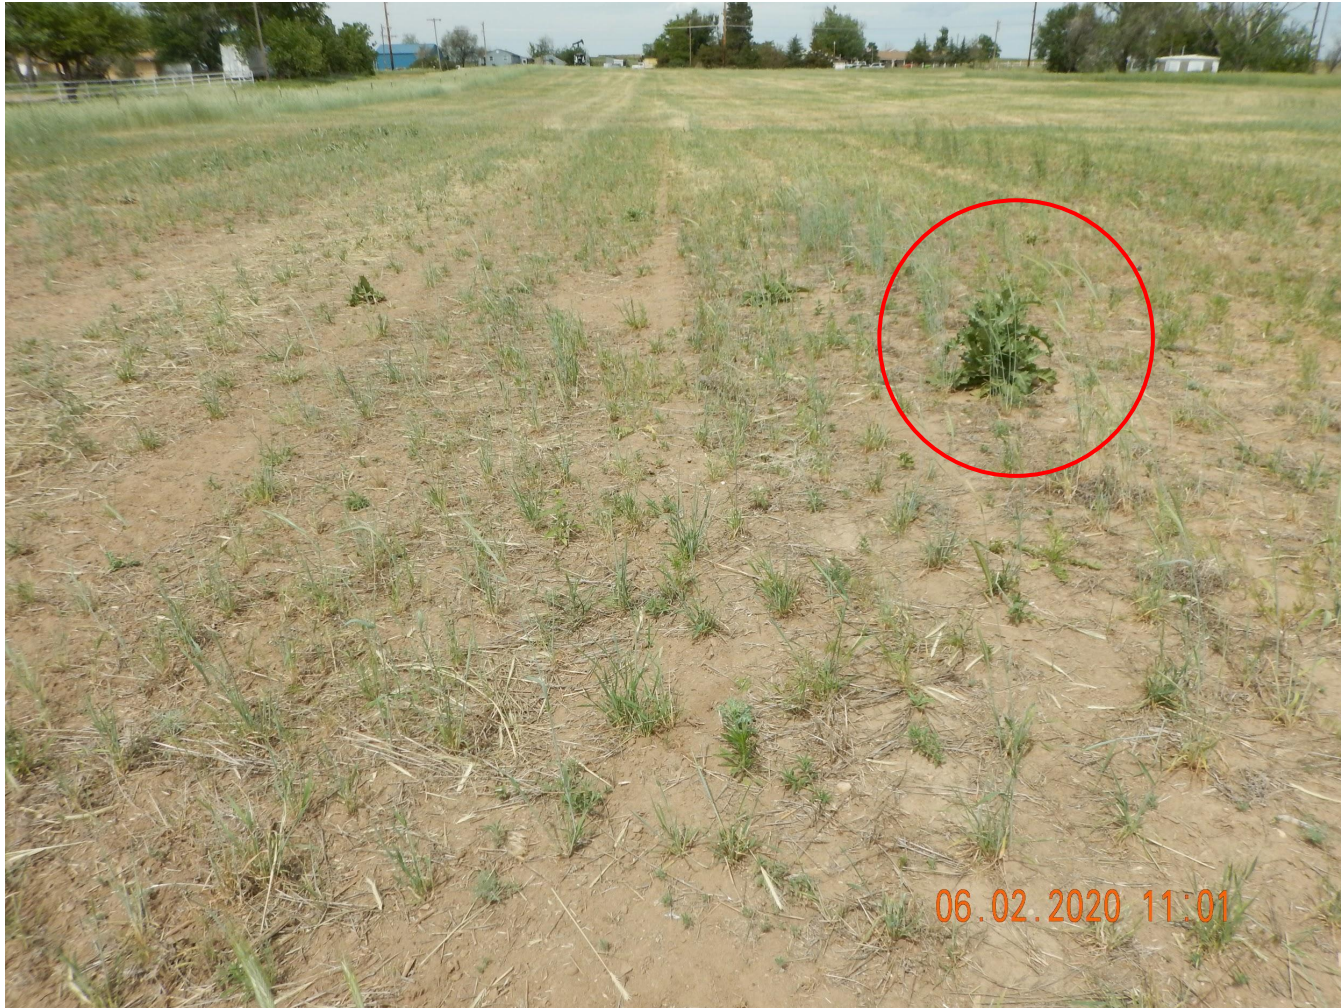
**Photo 4.** Photo taken from the western location, facing West. See comments under Photo 1. Photo also illustrates a List B Colorado noxious weed, Scotch thistle (red circle).

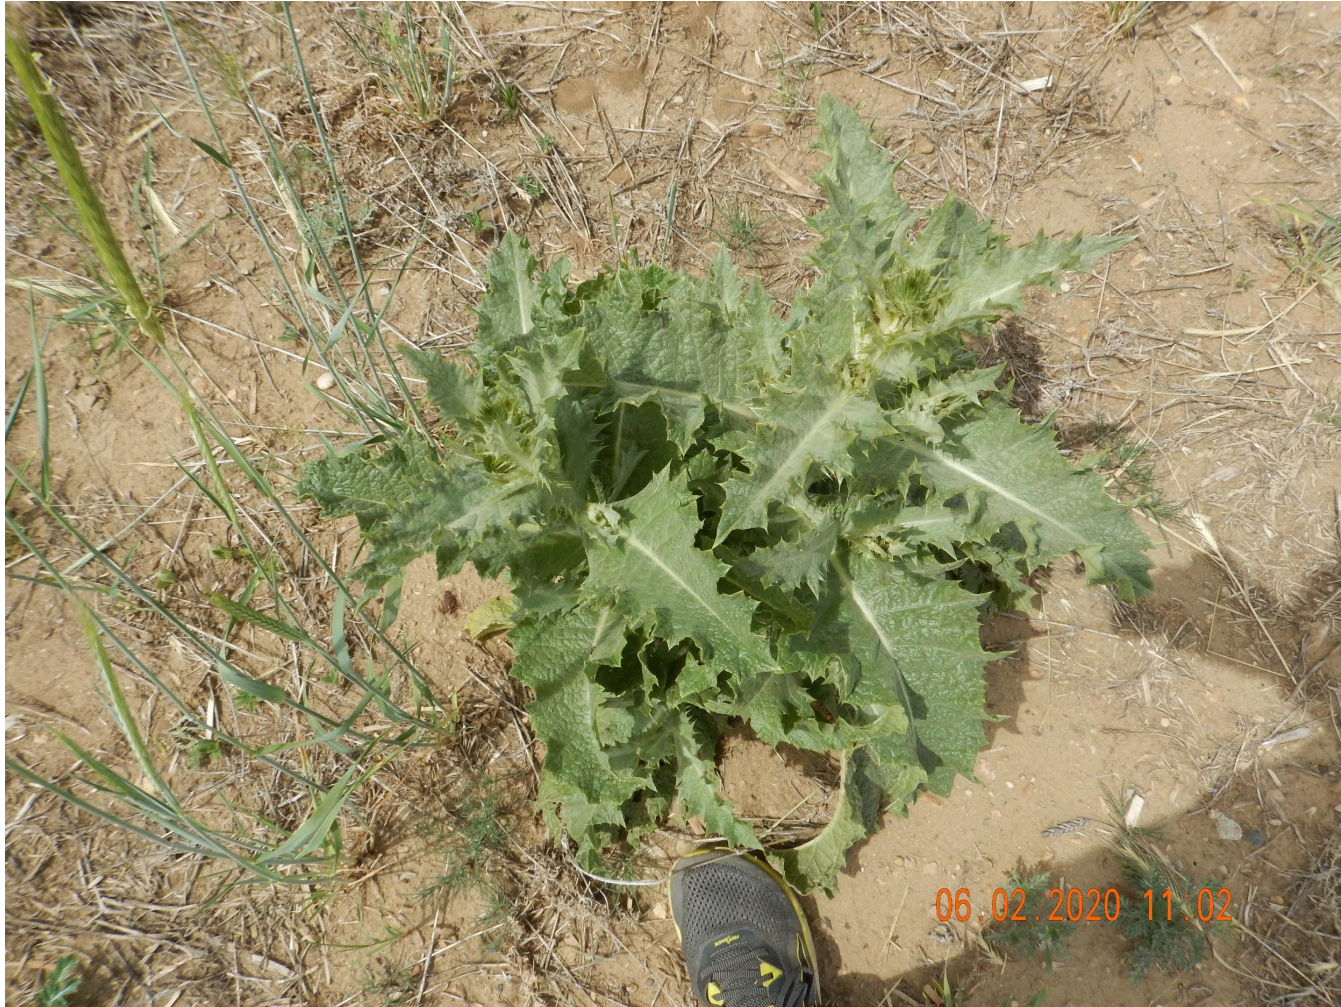
**Photo 5.** Close up photo taken of a List B Colorado noxious weed, Scotch thistle.

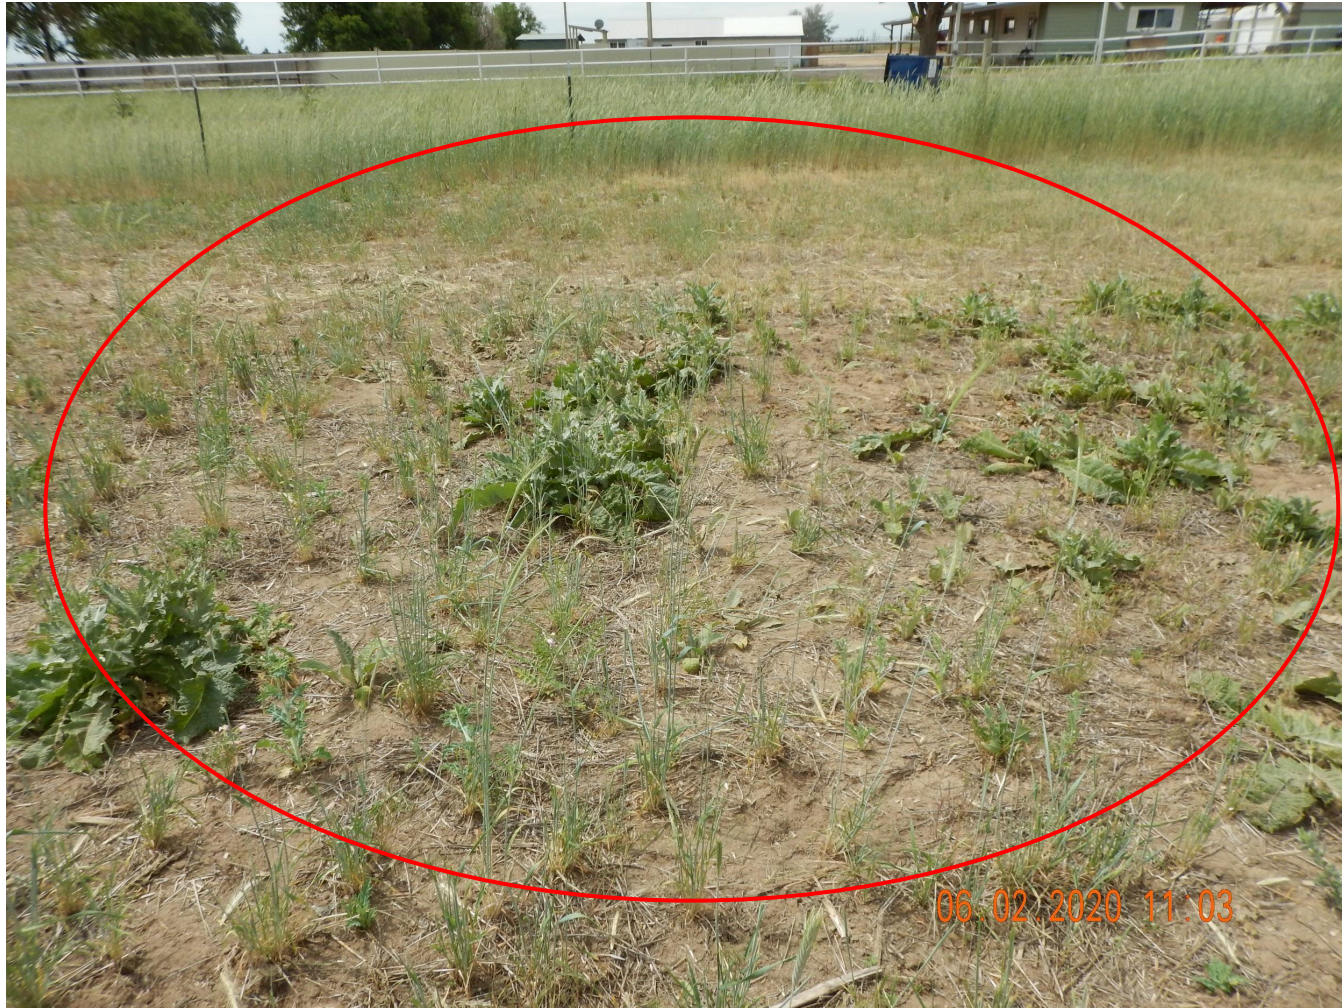
**Photo 6.** Photo taken from the southwestern location, facing South. Photo also illustrates a patch of List B Colorado noxious weeds, Scotch thistle (red circle).

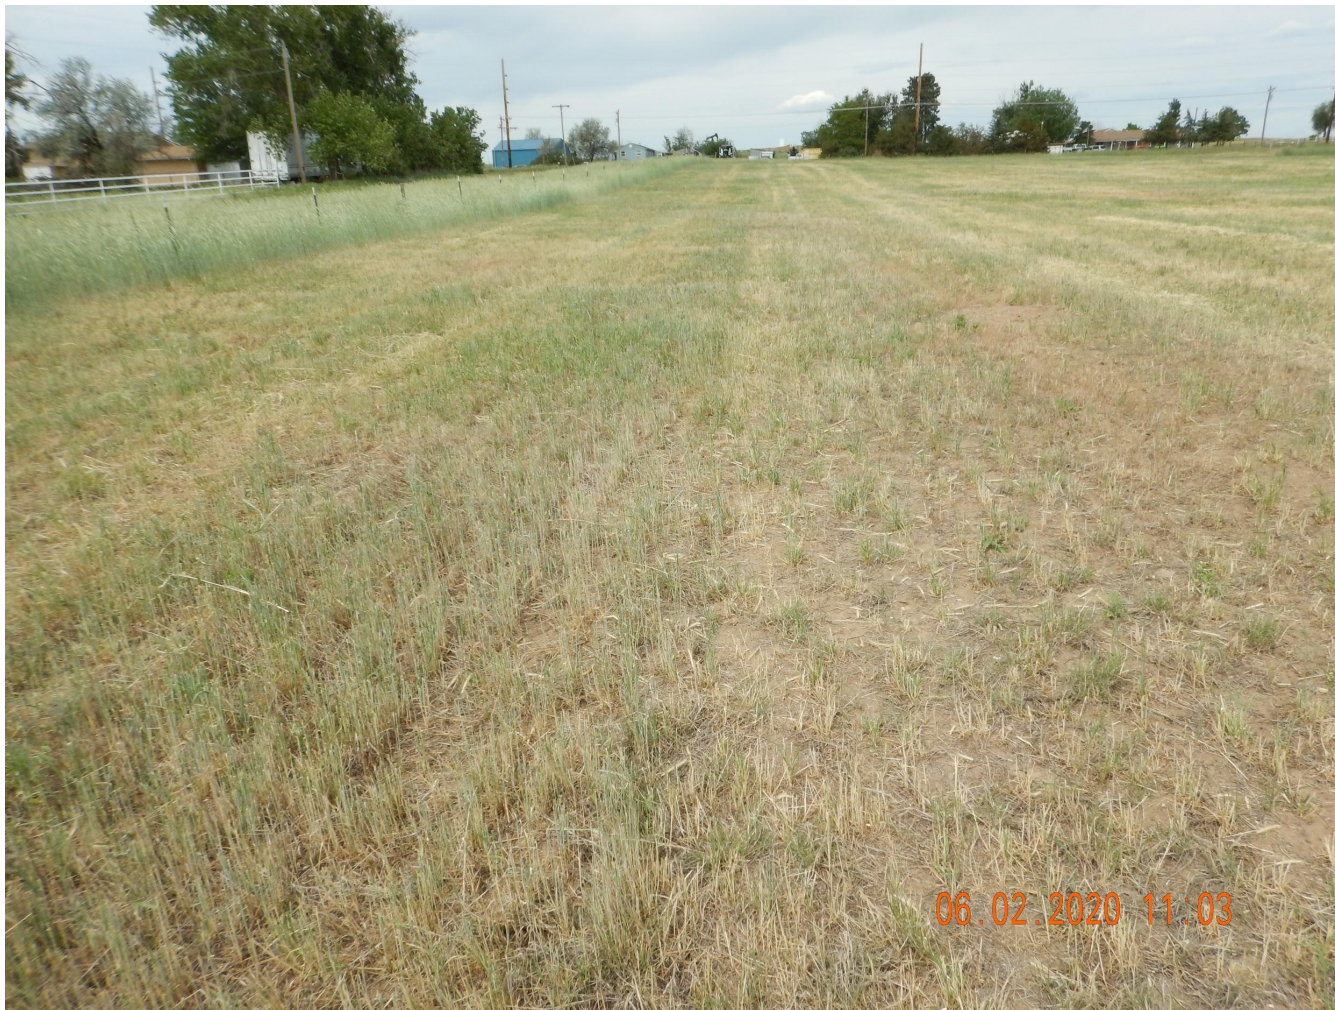
**Photo 7.** Reference photo taken west of the location, facing West. Photo illustrates the location is not reflective of reference area vegetative levels; therefore, will remain in-process.
