Inspection Photos

6/03/2020

Operator: RIO MESA RESOURCES INC - 74740

Location ID: 398846

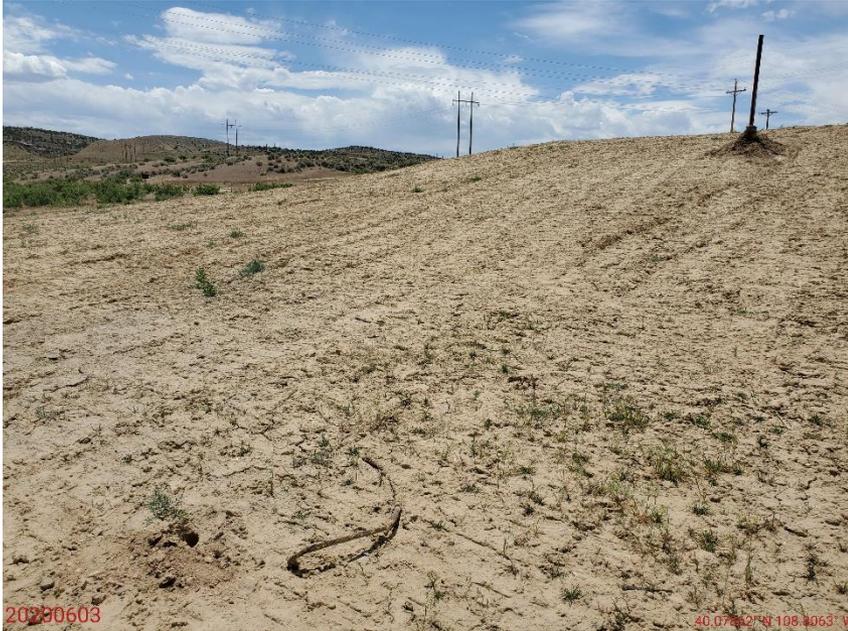
Photo 1: Photo taken from the east end of the Location, facing southwest. Photo provides an overview of the Location. Photo shows Operator has not installed additional BMPs to be used in conjunction with tracking; Tracking is a temporary control and will not be sufficient for long term stabilization until vegetation has established; Tracking should be used in conjunction with other BMPs per good engineering practices.

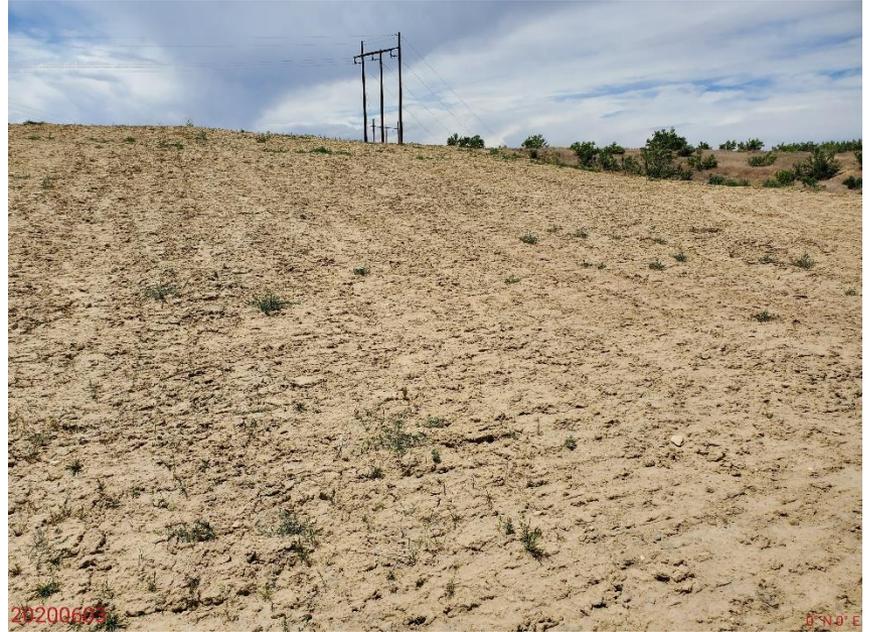
Photo 2: Photo taken from the east end of the Location, facing northwest. See comments under photo 1.

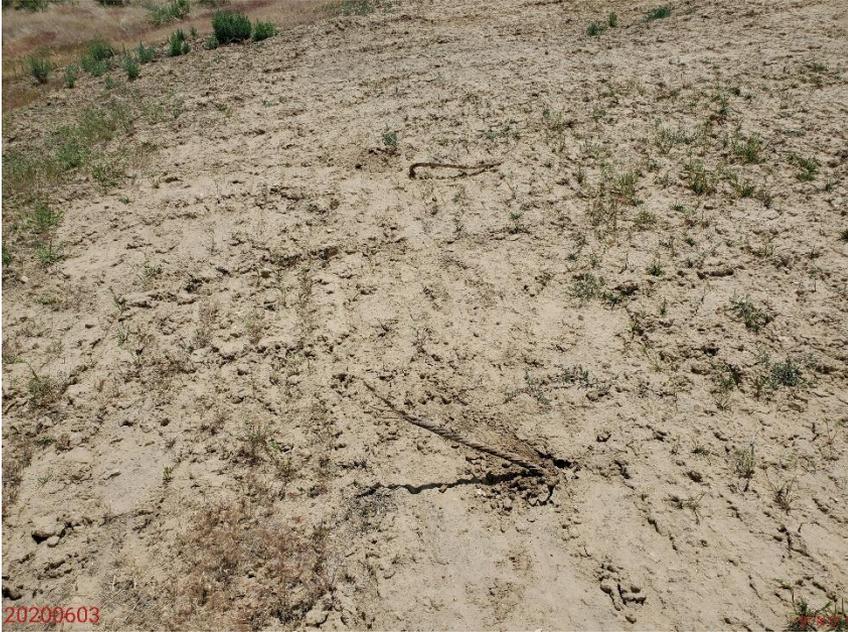
Photo 3: Photo taken from the east end of the Location. Photo shows cable debris remaining on the Location.

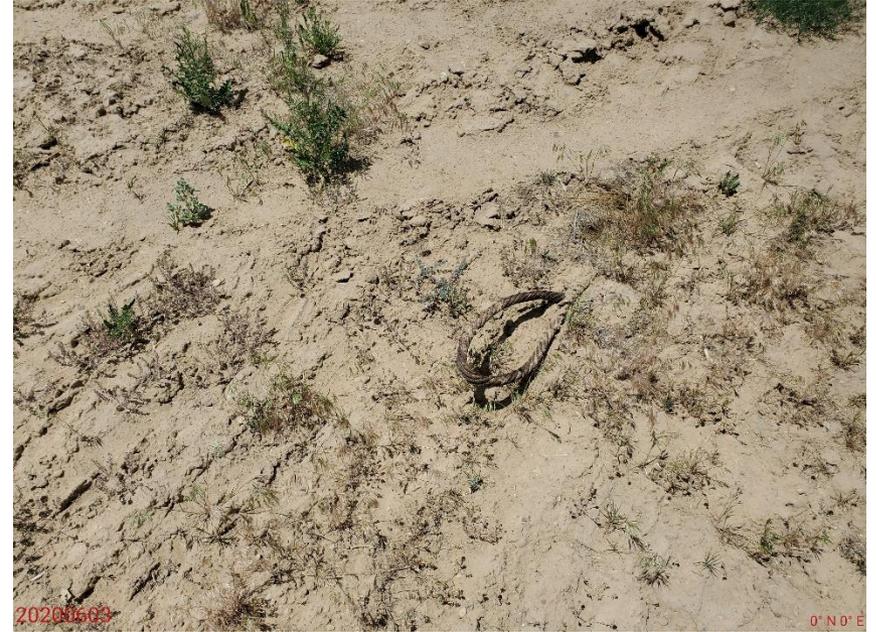
Photo 4: Photo taken from the east end of the Location. Photo shows what appears to be a cable anchor remaining on the Location.

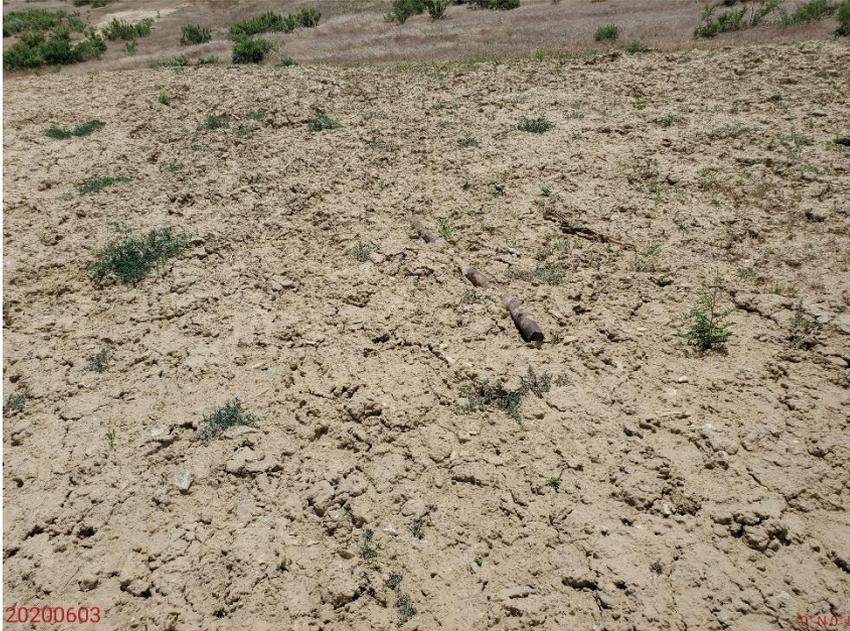
Photo 5: Photo taken from the southwestern area of the Location. Photo shows pipe debris has not been removed from the Location.

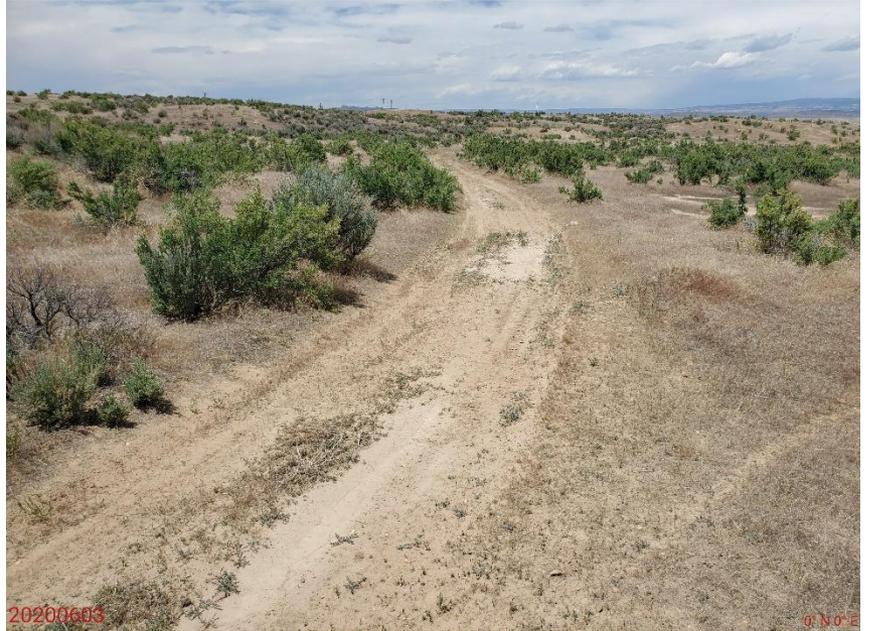
Photo 6: Photo taken from the access road. Photo shows access road has not been reclaimed in accordance with COGCC 1004 rules.
