Interim Reclamation and Stormwater Inspection

Operator: GREAT WESTERN OPERATING COMPANY LLC- #10110

Location ID: 446251

Inspection Photos
Location Name: Rael /34-4-2HC
Location ID: 446251

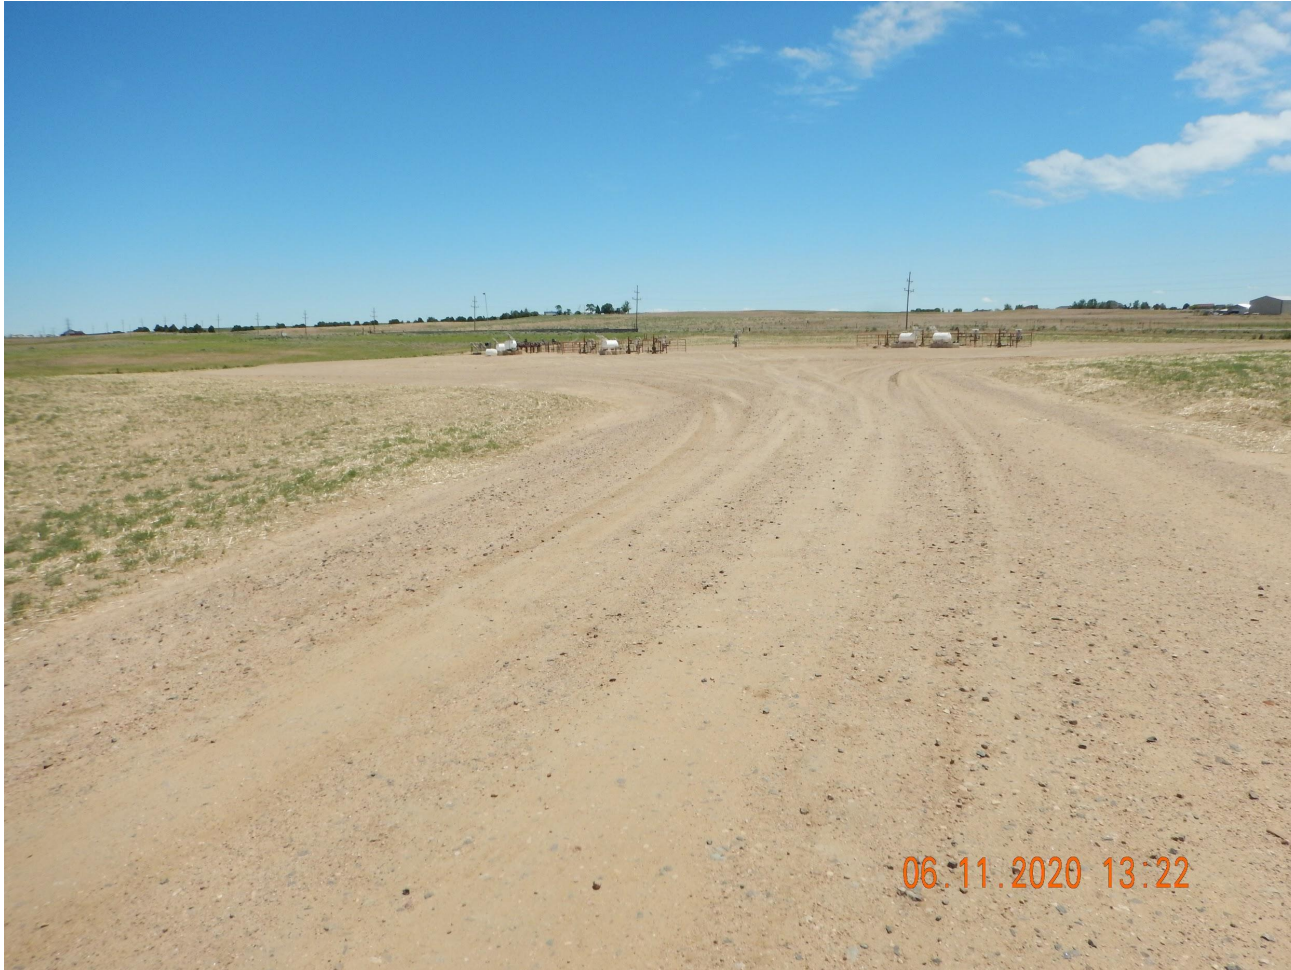
Photo 1. Photo taken from the northwestern well location, facing Southeast. Photo illustrates Operator has performed interim reclamation activities.

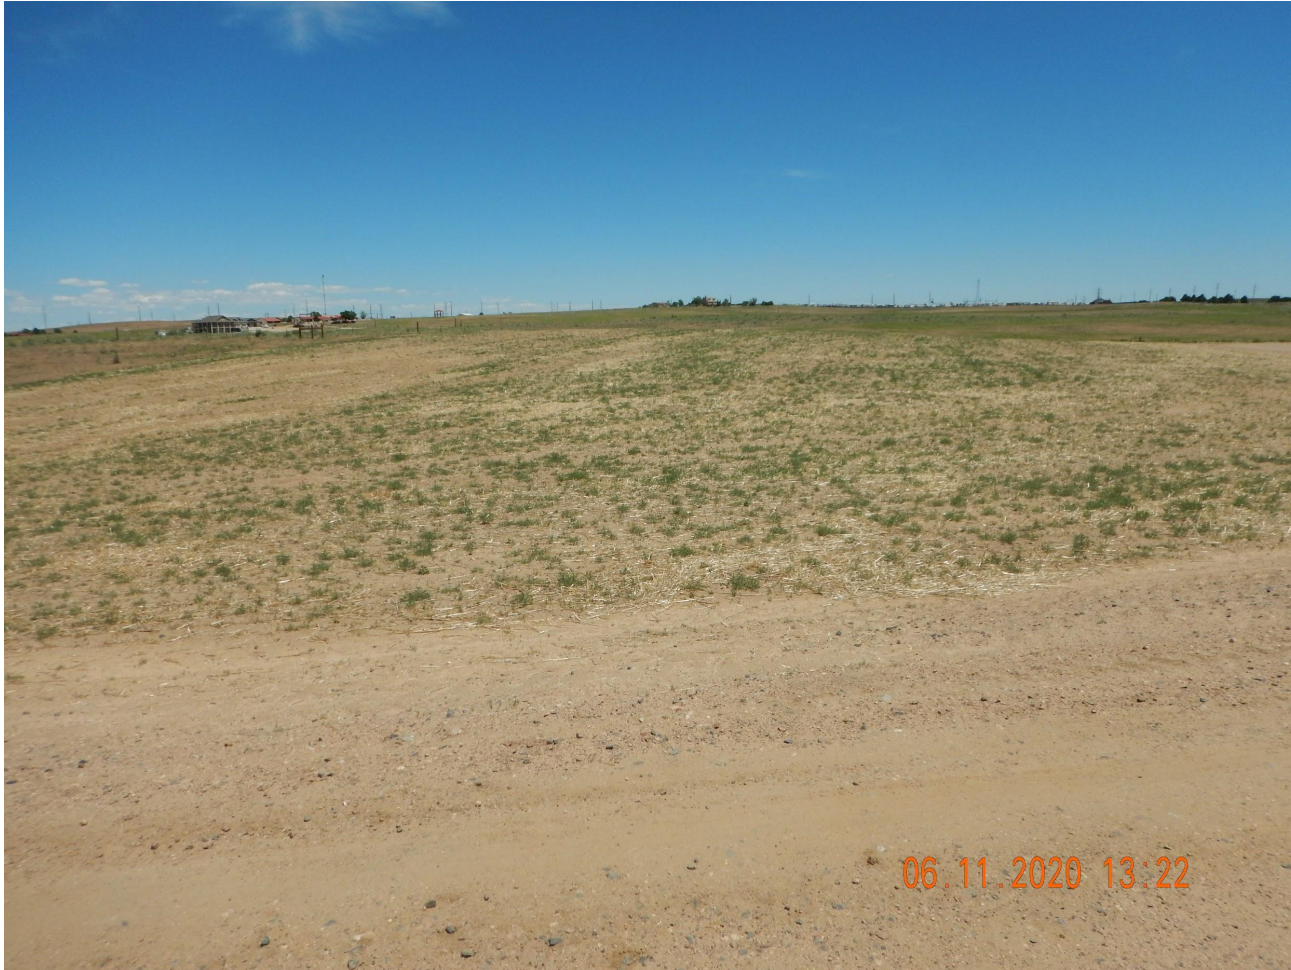
Photo 2. Photo taken from the northwestern well location, facing East. See comments under Photo 1.

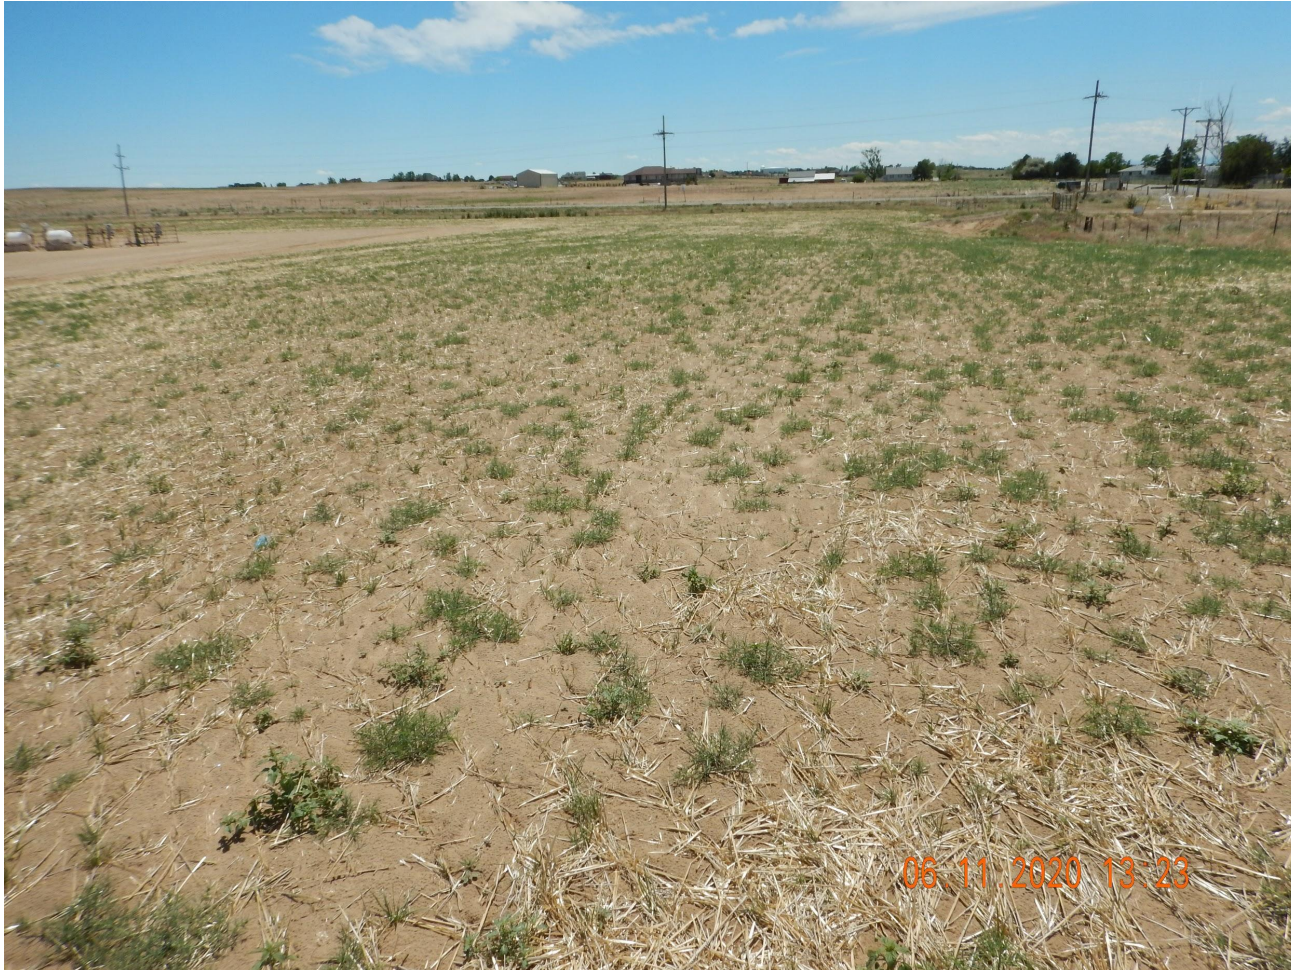
Photo 3. Photo taken from the northwestern well location, facing South. See comments under Photo 1.

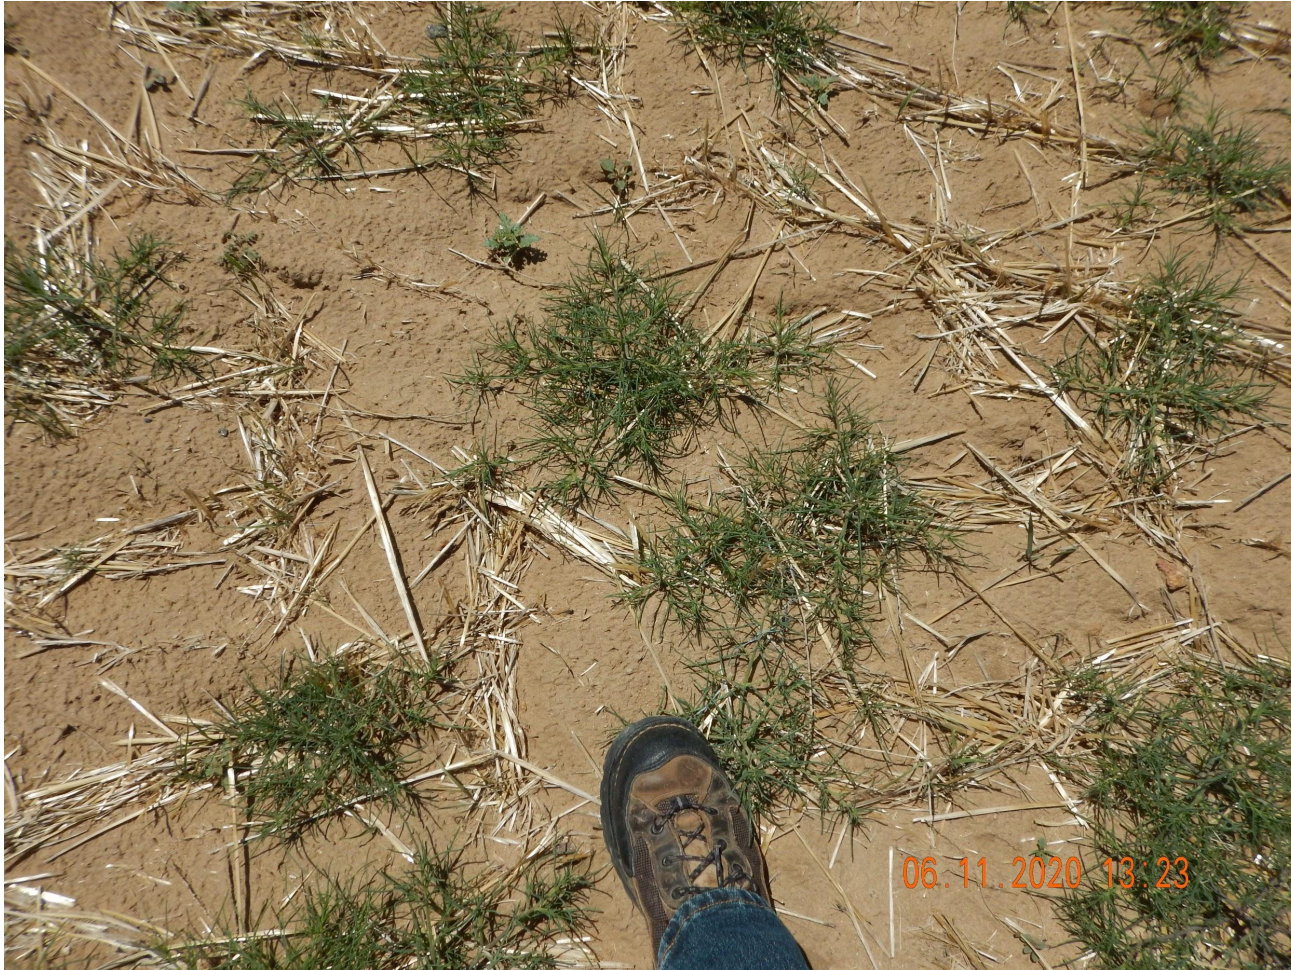
Photo 4. Close up photo taken from the northwestern interim reclamation area. Photo illustrates the establishment of Russian thistle, which will have to be controlled and managed.

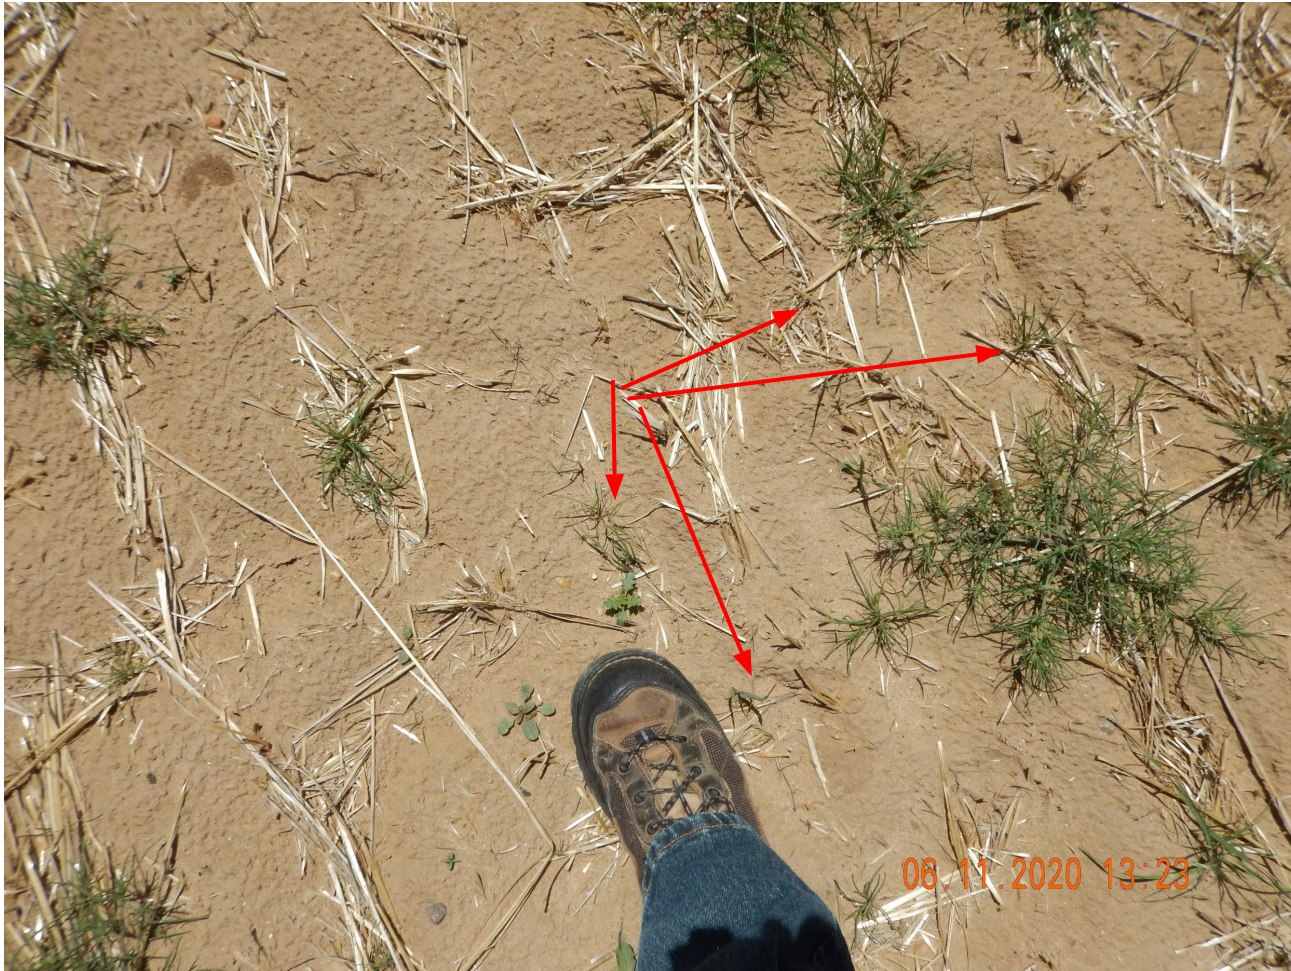
Photo 5. Close up photo taken from the western interim reclamation area. Photo illustrates the establishment of desirable species. However, Operator may need to perform additional reclamation activities as germination did not appear uniform.

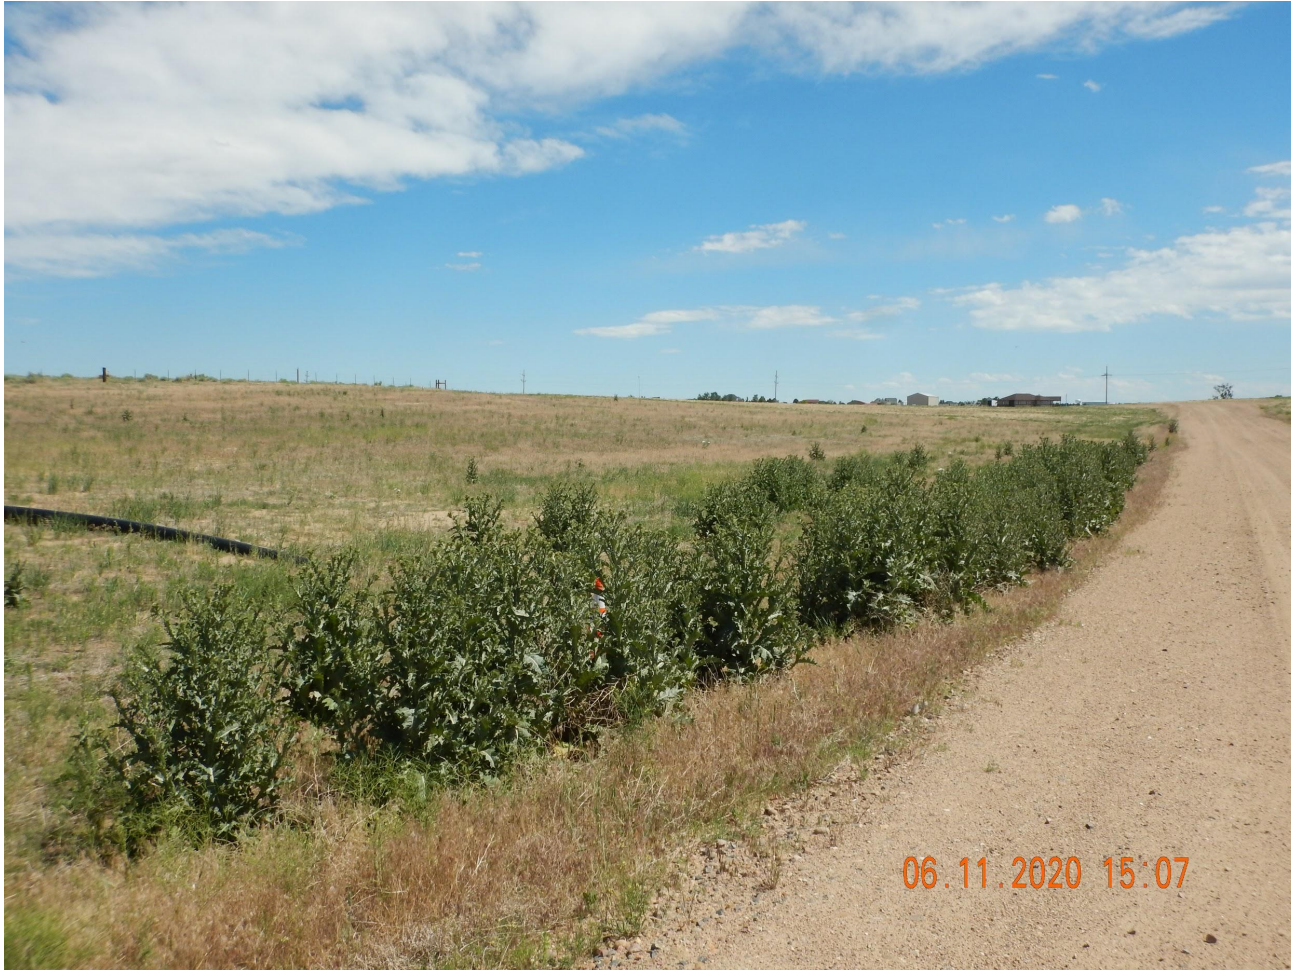
Photo 6. Photo taken between the well location and facility location, facing South. Photo illustrates a List B Colorado noxious weed, Scotch thistle, alongside the access road and a portion of the flowline area.

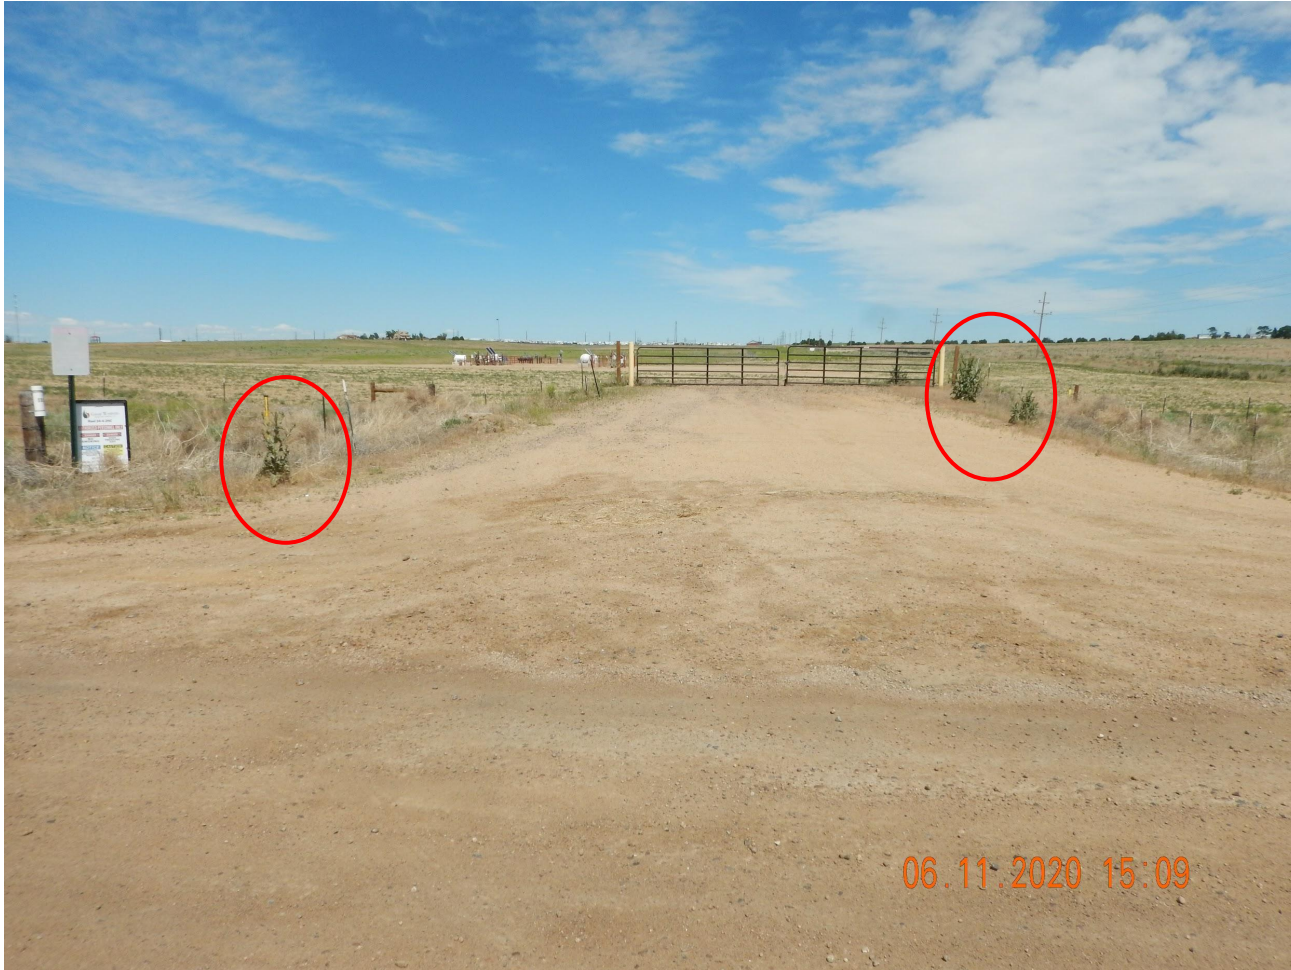
Photo 7. Photo taken from the southern well location entrance, facing East. Photo illustrates a List B Colorado noxious weed, Scotch thistle.

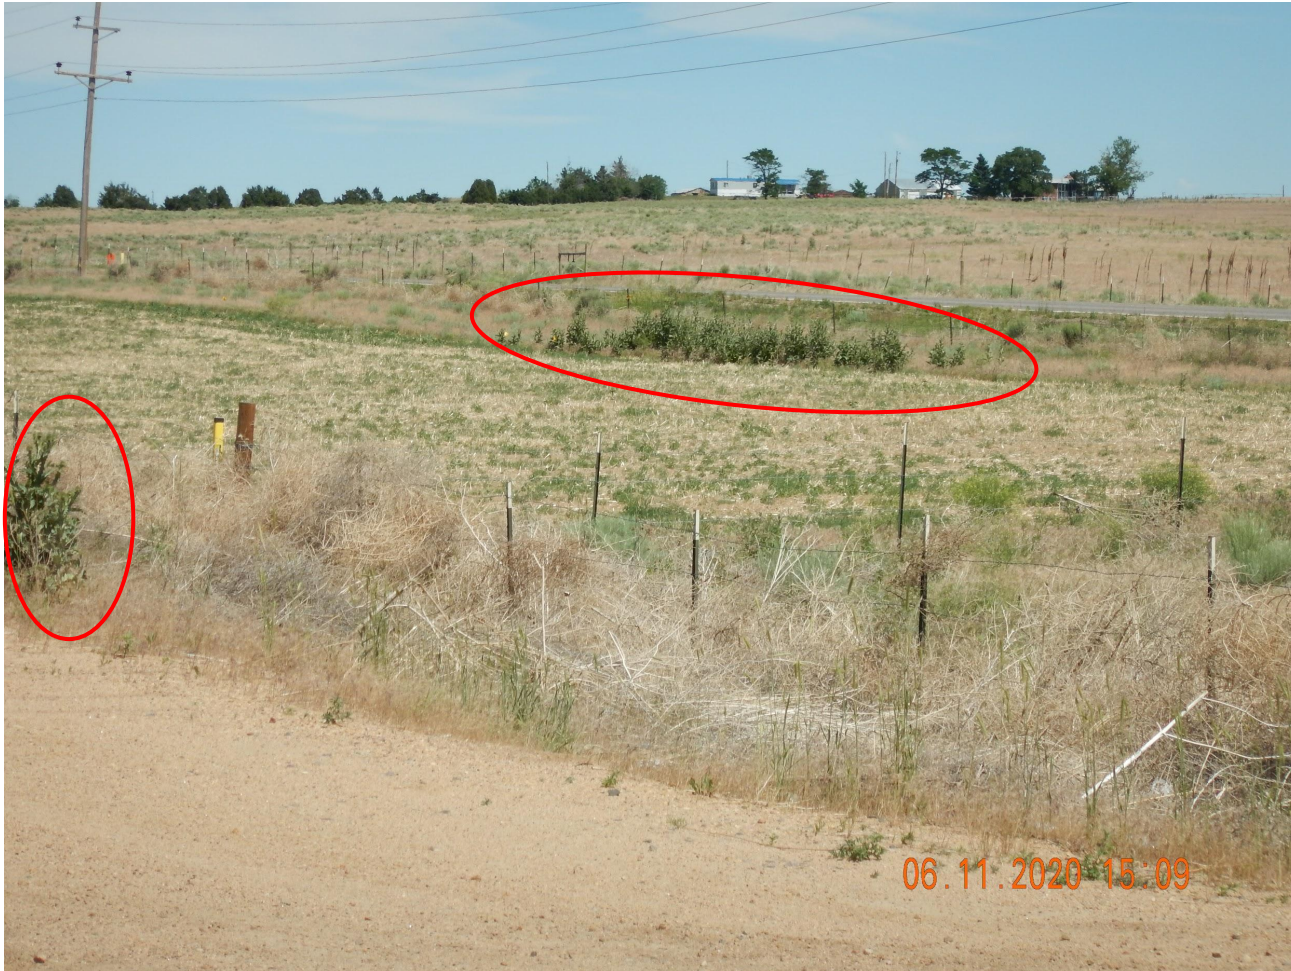
Photo 8. Photo taken from the southern well location entrance, facing Southeast. Photo illustrates a List B Colorado noxious weed, Scotch thistle, along the southwestern location.
