Construction and Stormwater Inspection

Operator: GREAT WESTERN OPERATING COMPANY LLC- #10110

Location ID: 459907

Inspection Photos
Location Name: TOWER LD PAD
Location ID: 459907

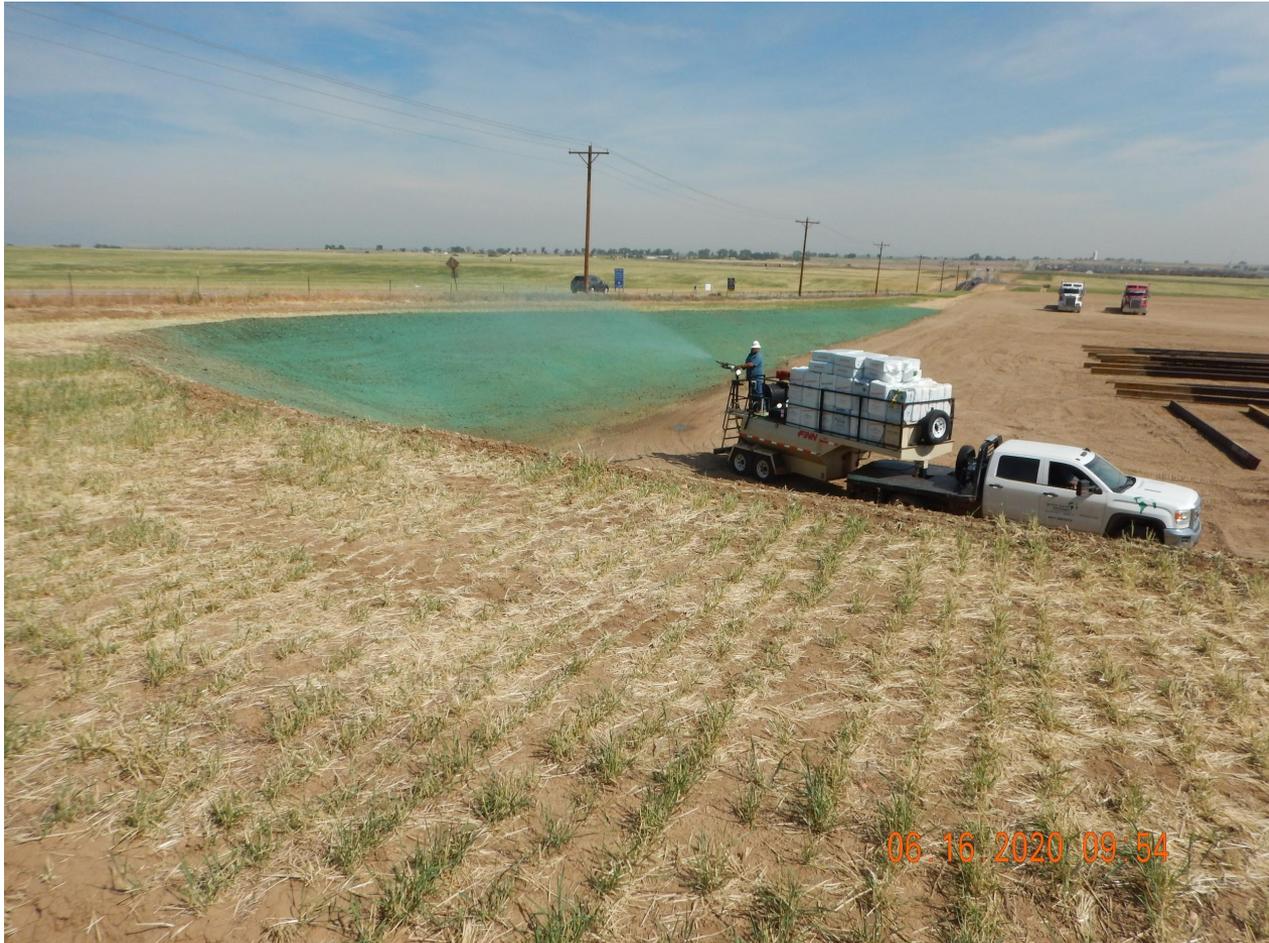
Photo 1. Photo taken from the southwestern location, facing North. Photo illustrates Operator is implementing temporary stabilization (i.e., hydromulch) along portions of the well pad cut slope .

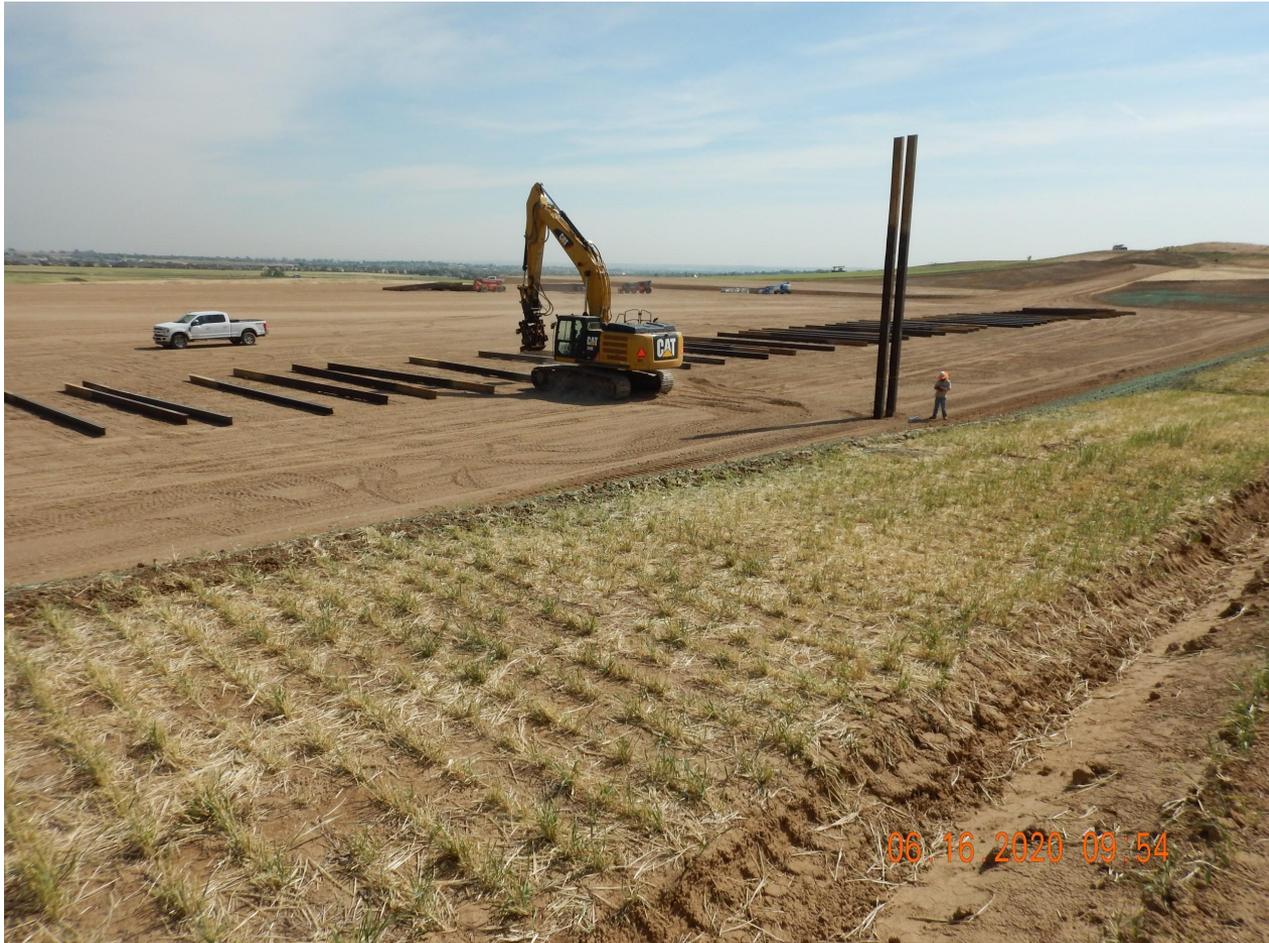
Photo 2. Photo taken from the southwestern location, facing Northeast. Photo illustrates Operator is in process of installing the sound wall along the southern well pad.

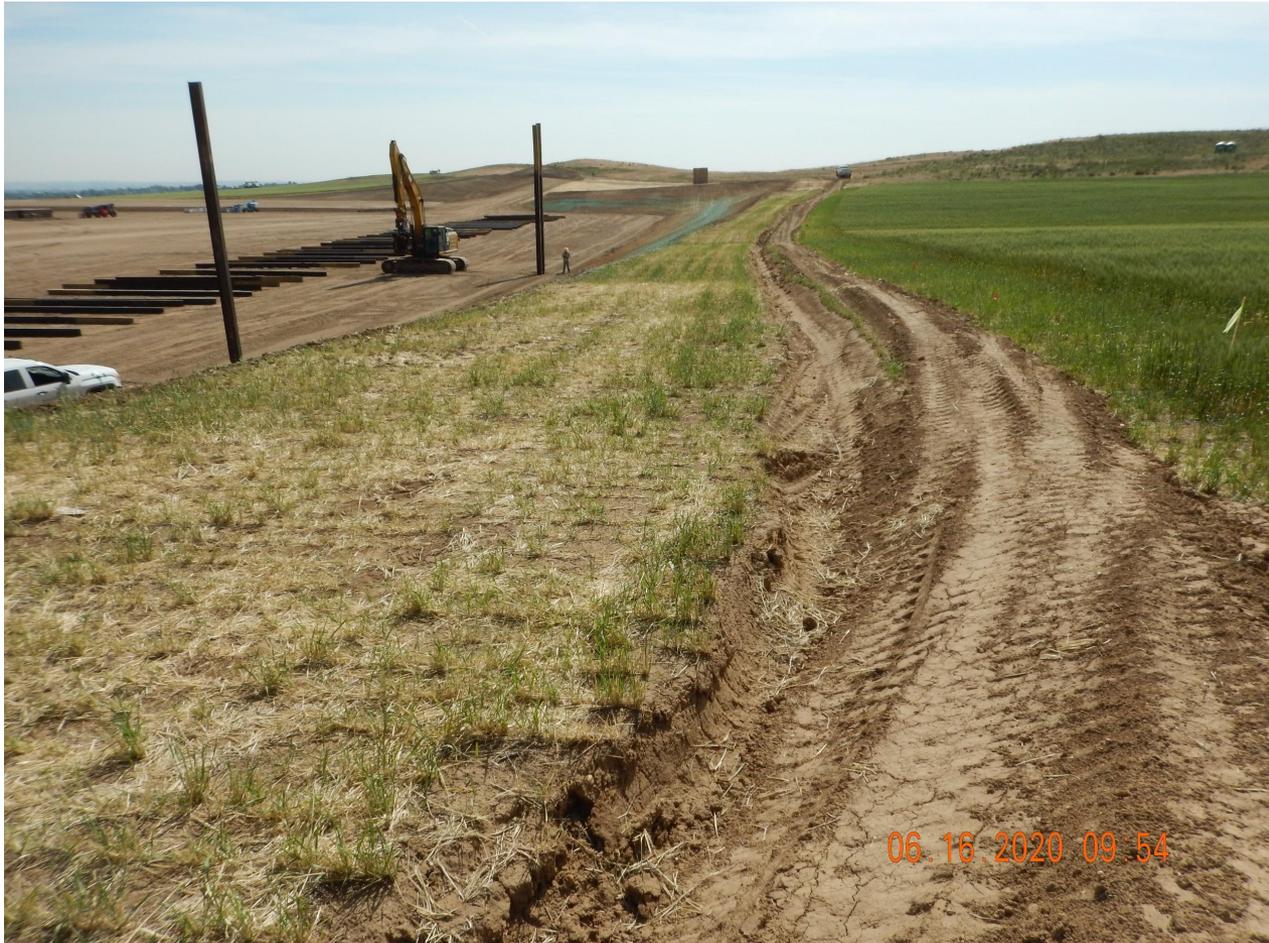
Photo 3. Photo taken from the southwestern location, facing East. See comments under Photo 2. Photo also illustrates the ditch and berm BMP that has been installed around the entire perimeter of location.

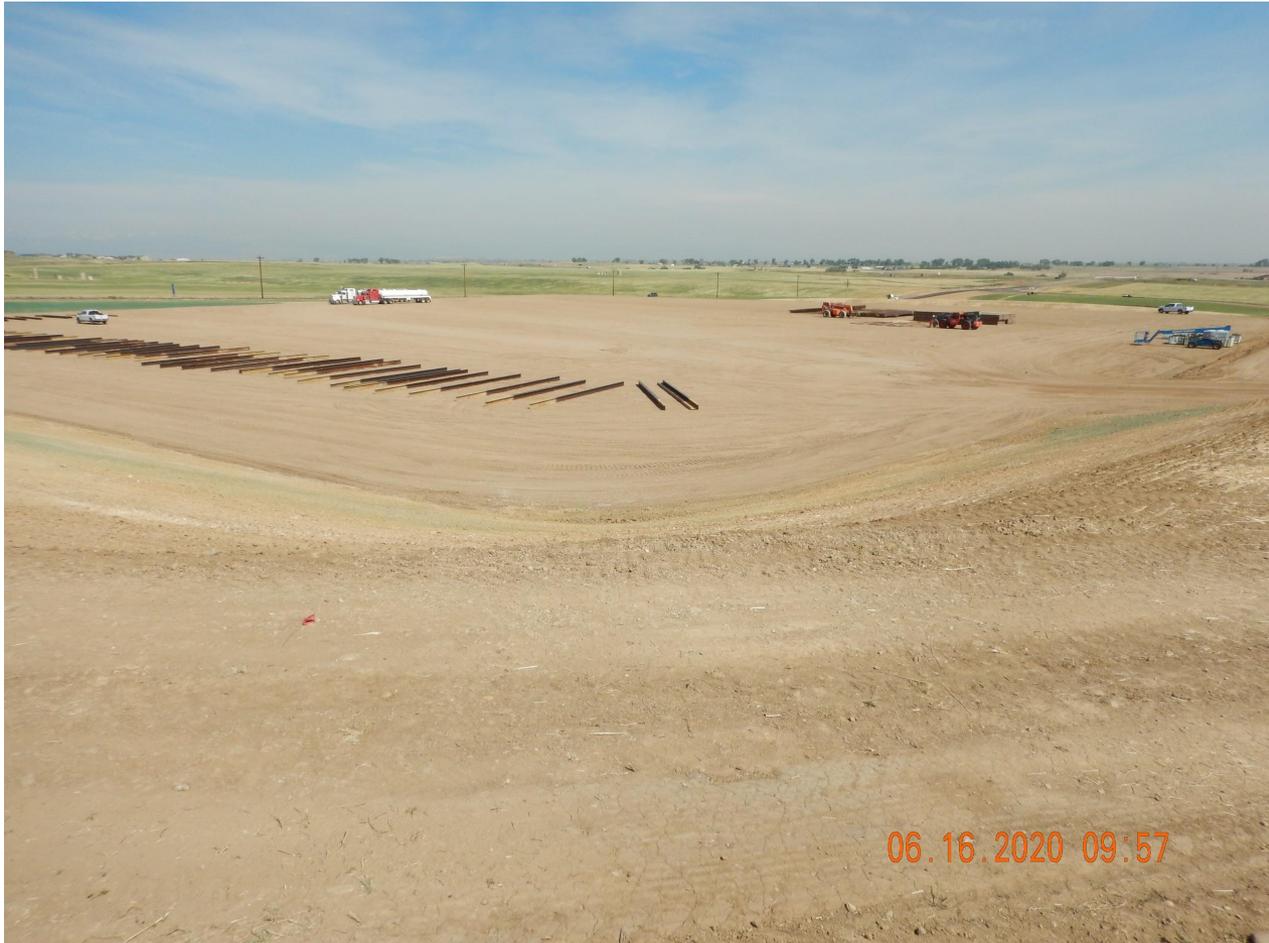
Photo 4. Photo taken from the southern location, facing Northwest. Photo equipment and supplies being staged for the sound wall installation.

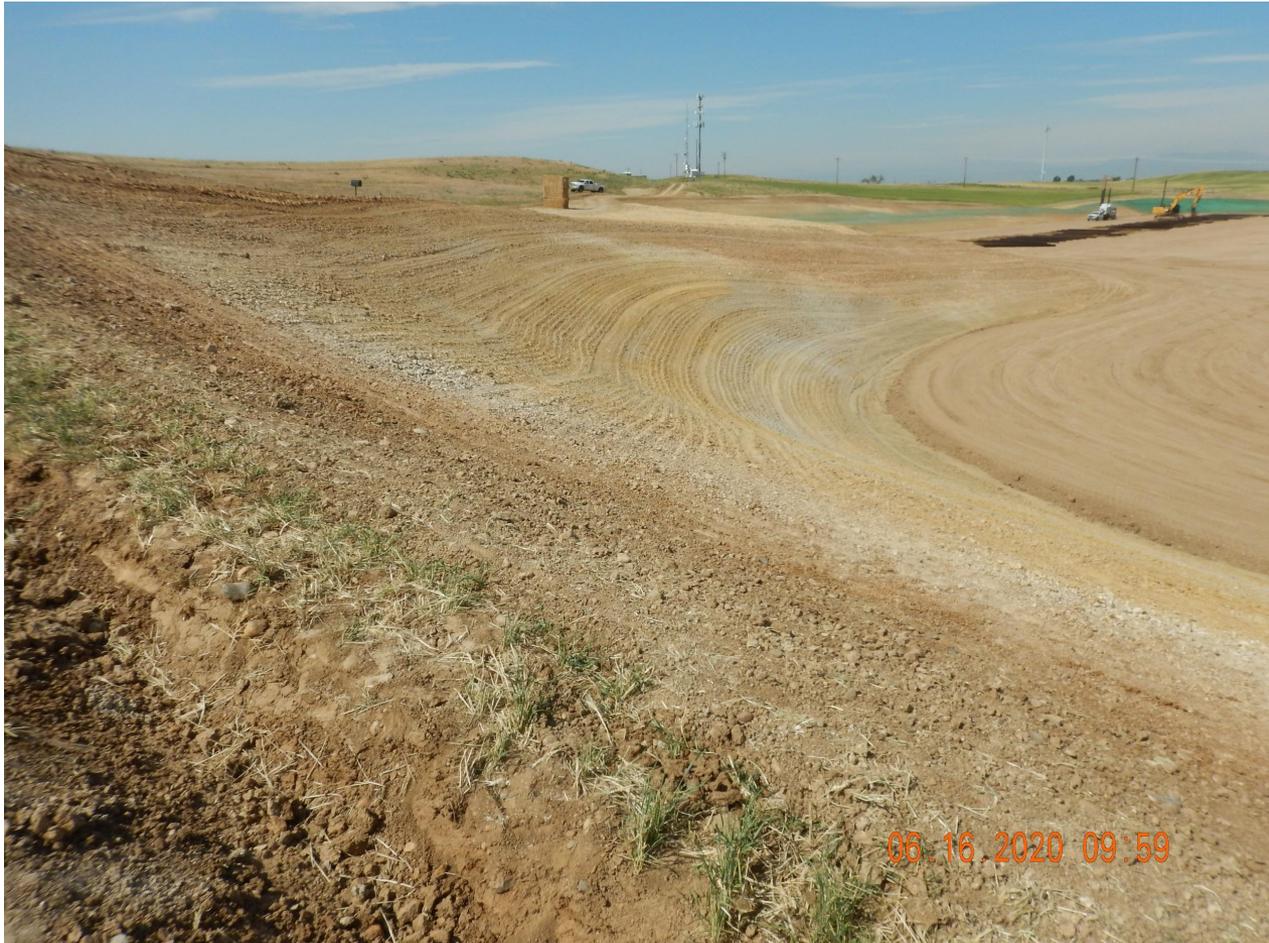
Photo 5. Photo taken from the southeastern location, facing Southwest. Photo illustrates Operator has temporarily stabilized the cut slope areas of the production facility.

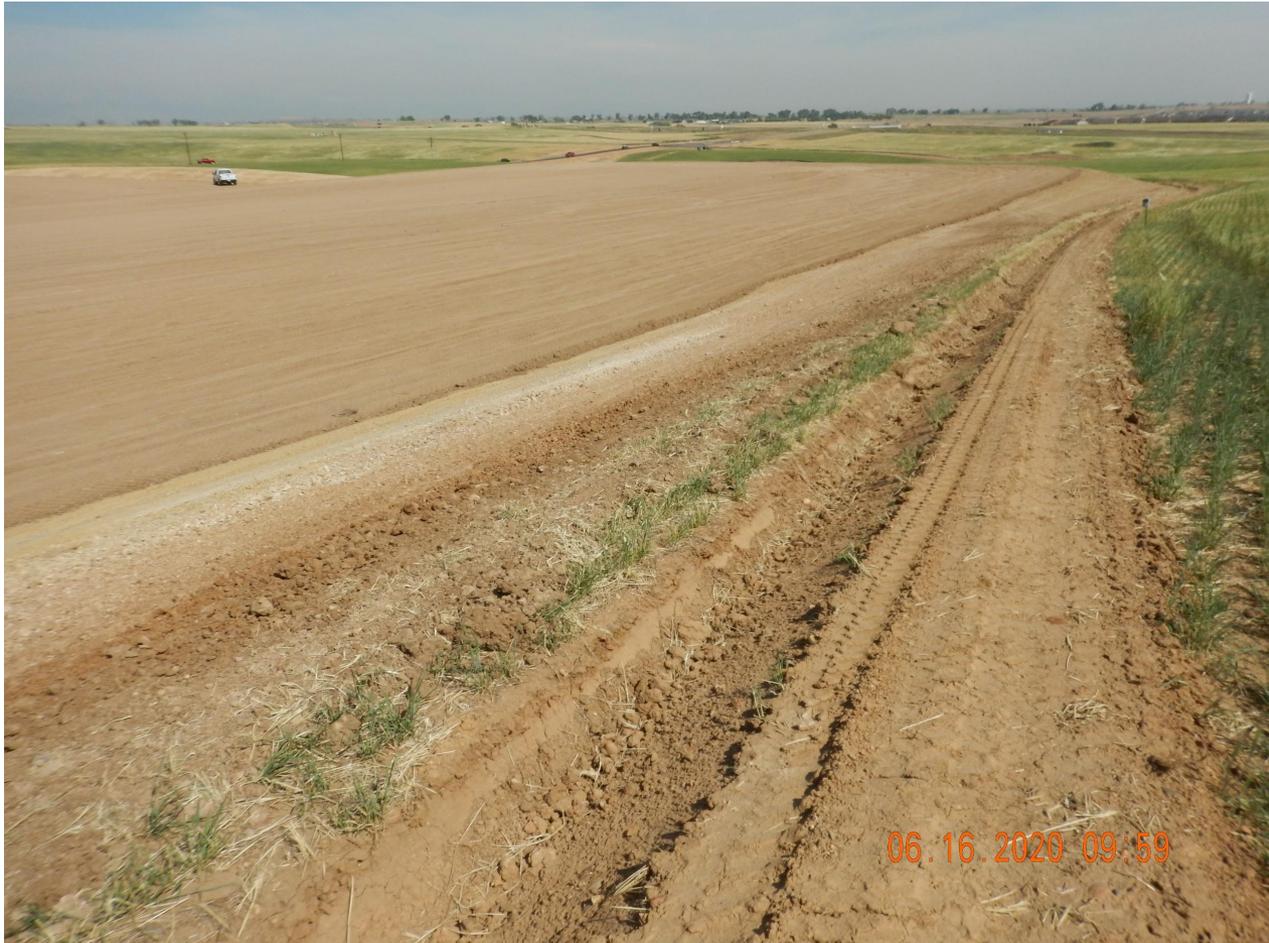
Photo 6. Photo taken from the southeastern location, facing Southwest. See comments under Photo 4. Photo also illustrates the ditch and berm BMP that has been installed around the entire perimeter of location.

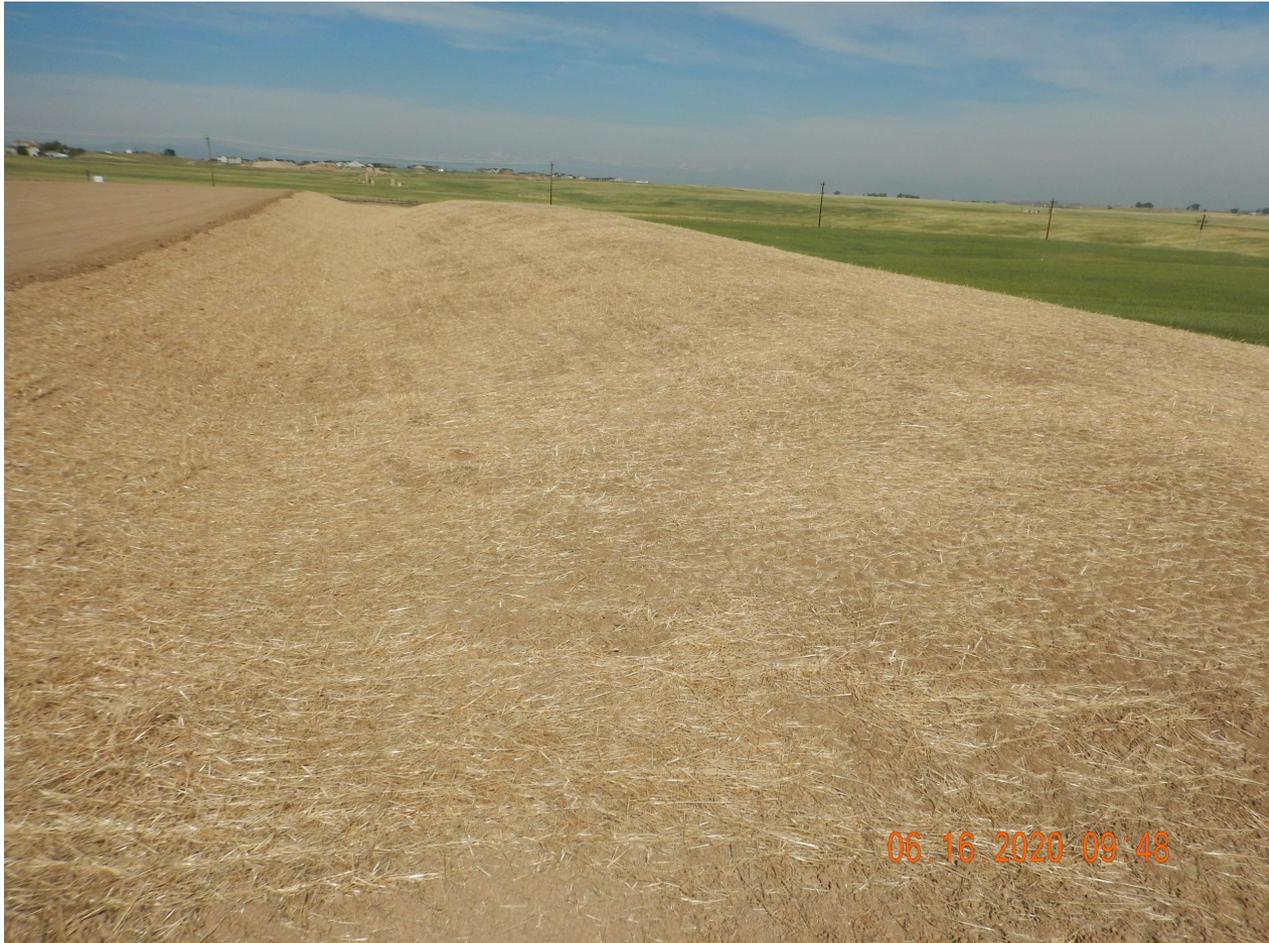
Photo 7. Photo taken from the northern location, facing West. Photo illustrates topsoil has been temporarily stabilized with equipment tracking and straw crimped mulch.

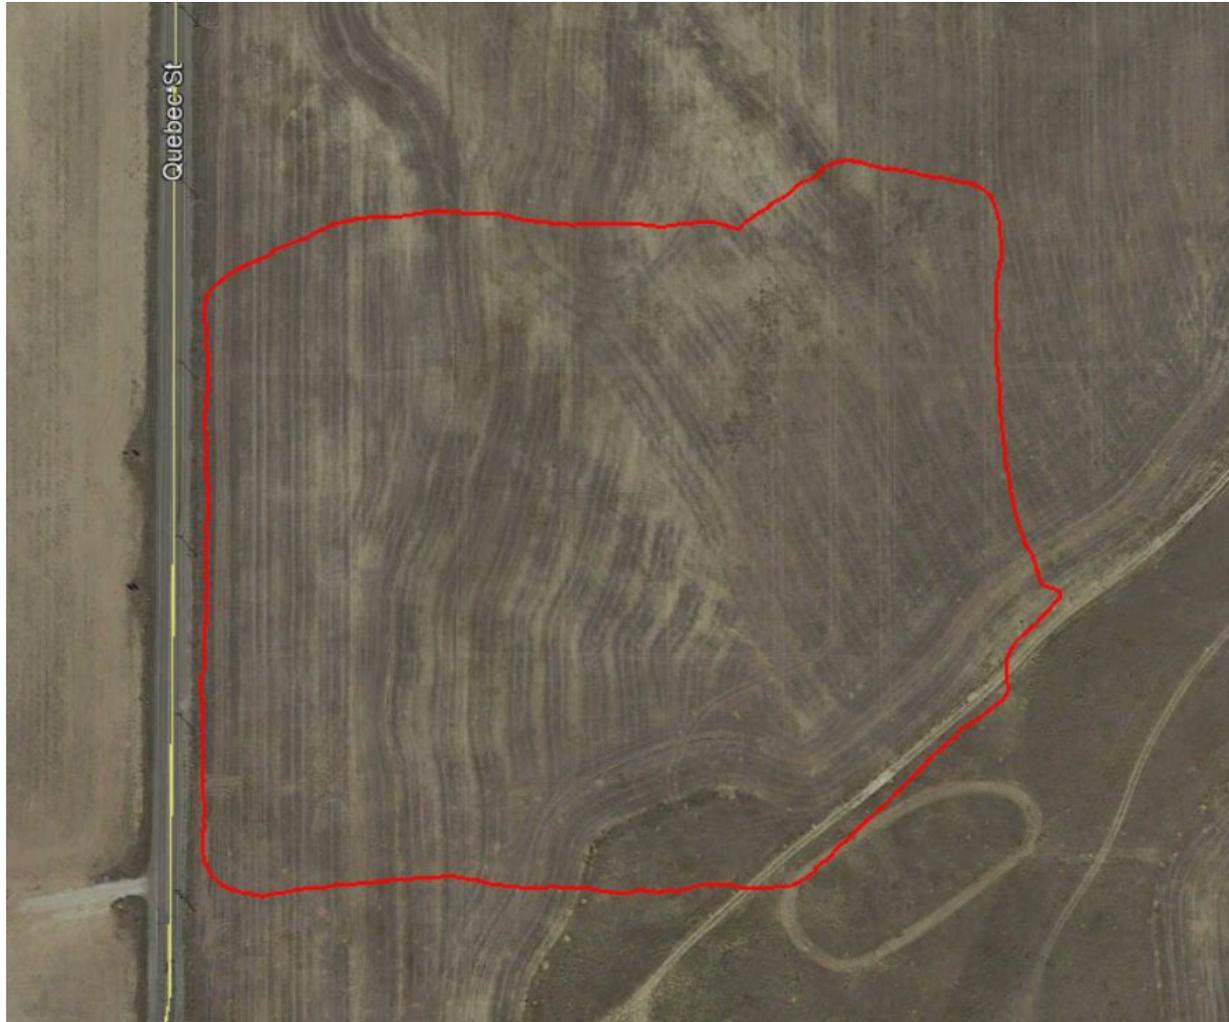
Photo 8. Google Earth aerial imagery taken 9/12/2019. COGCC mapped the outer disturbance area (15.49 acres) using a Trimble Juno 3B handheld device (red line).
