Inspection Photos
Operator: Big Run
Operating
API: 067-06333
Date: 6/16/2020

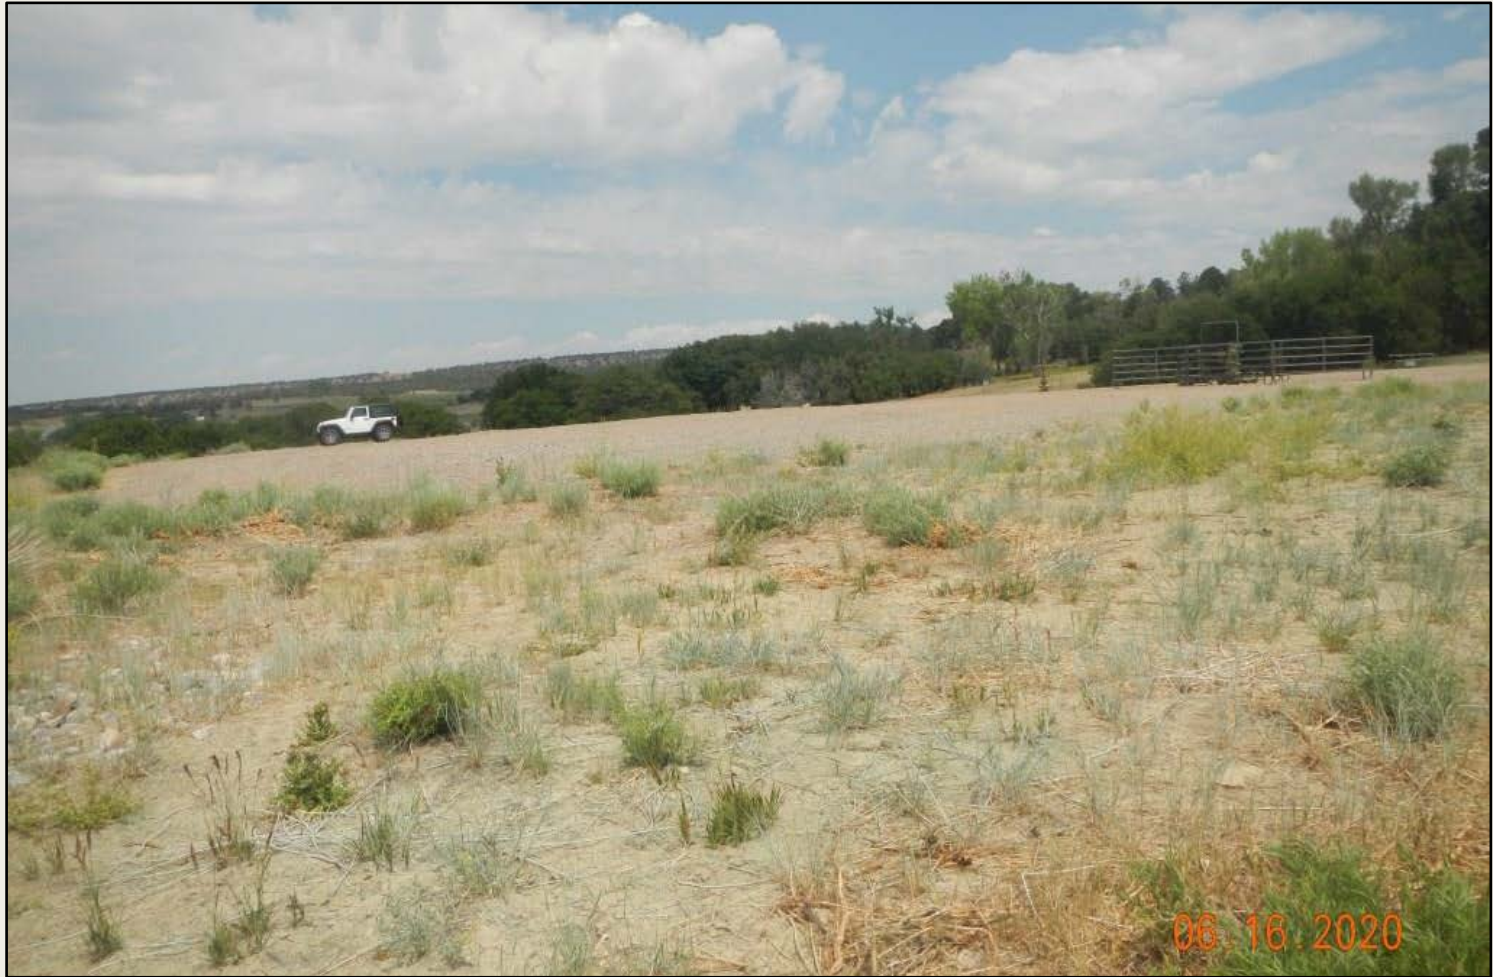
Photo 1. View of the project area from the southeastern corner facing center.

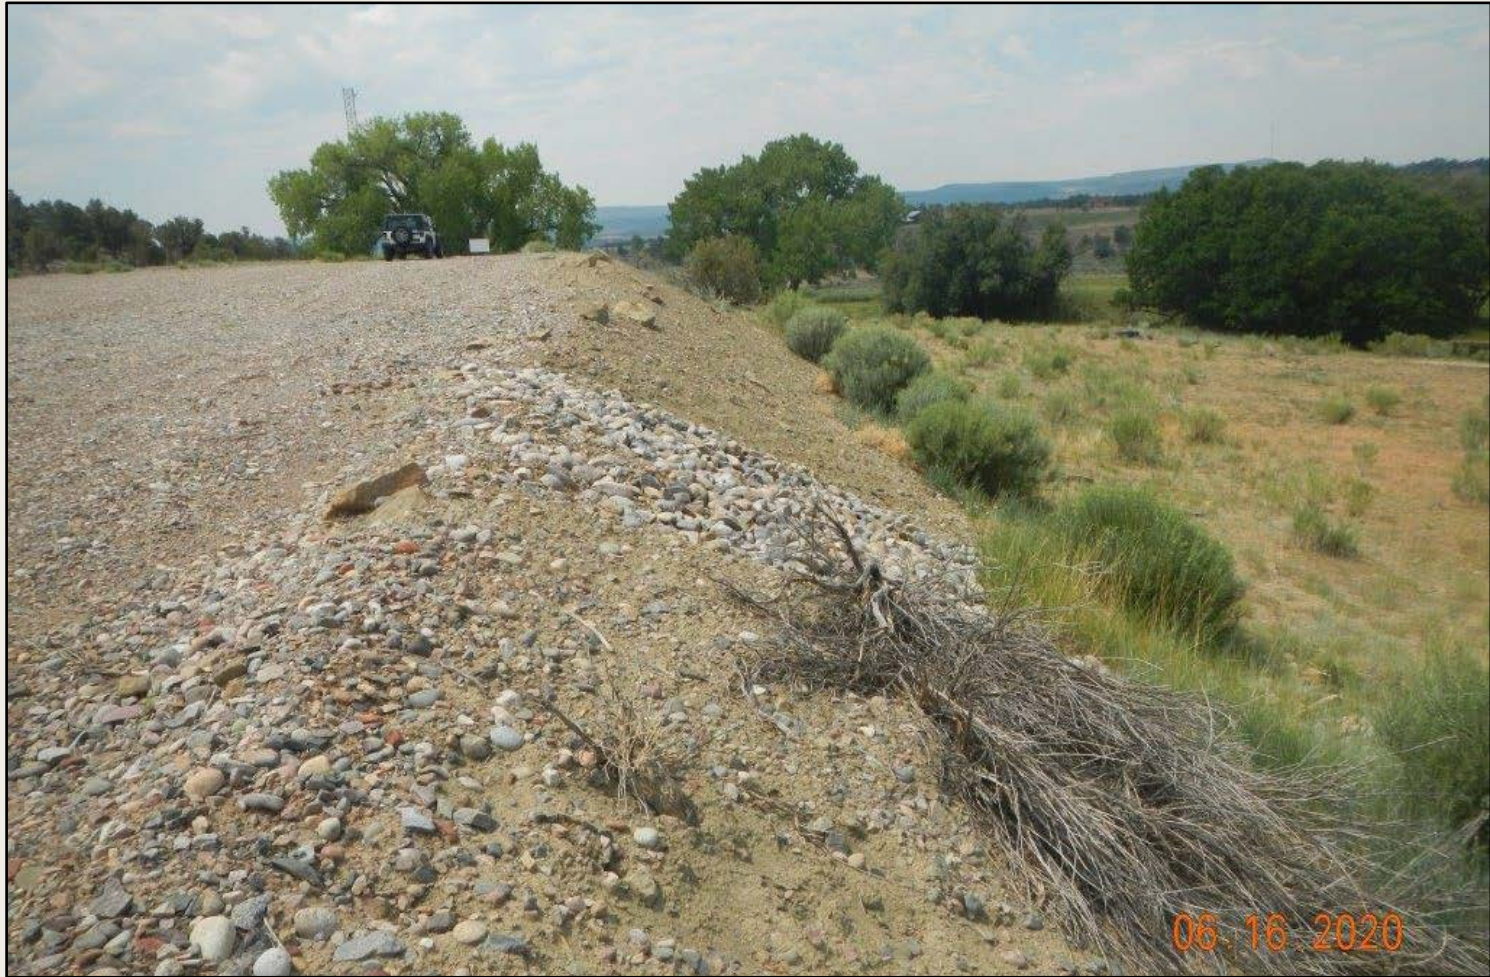
Photo 2. View of the western fill slope from the northwestern corner facing southward. Sparse revegetation observed on well pad fill slopes, stabilization measures are needed.

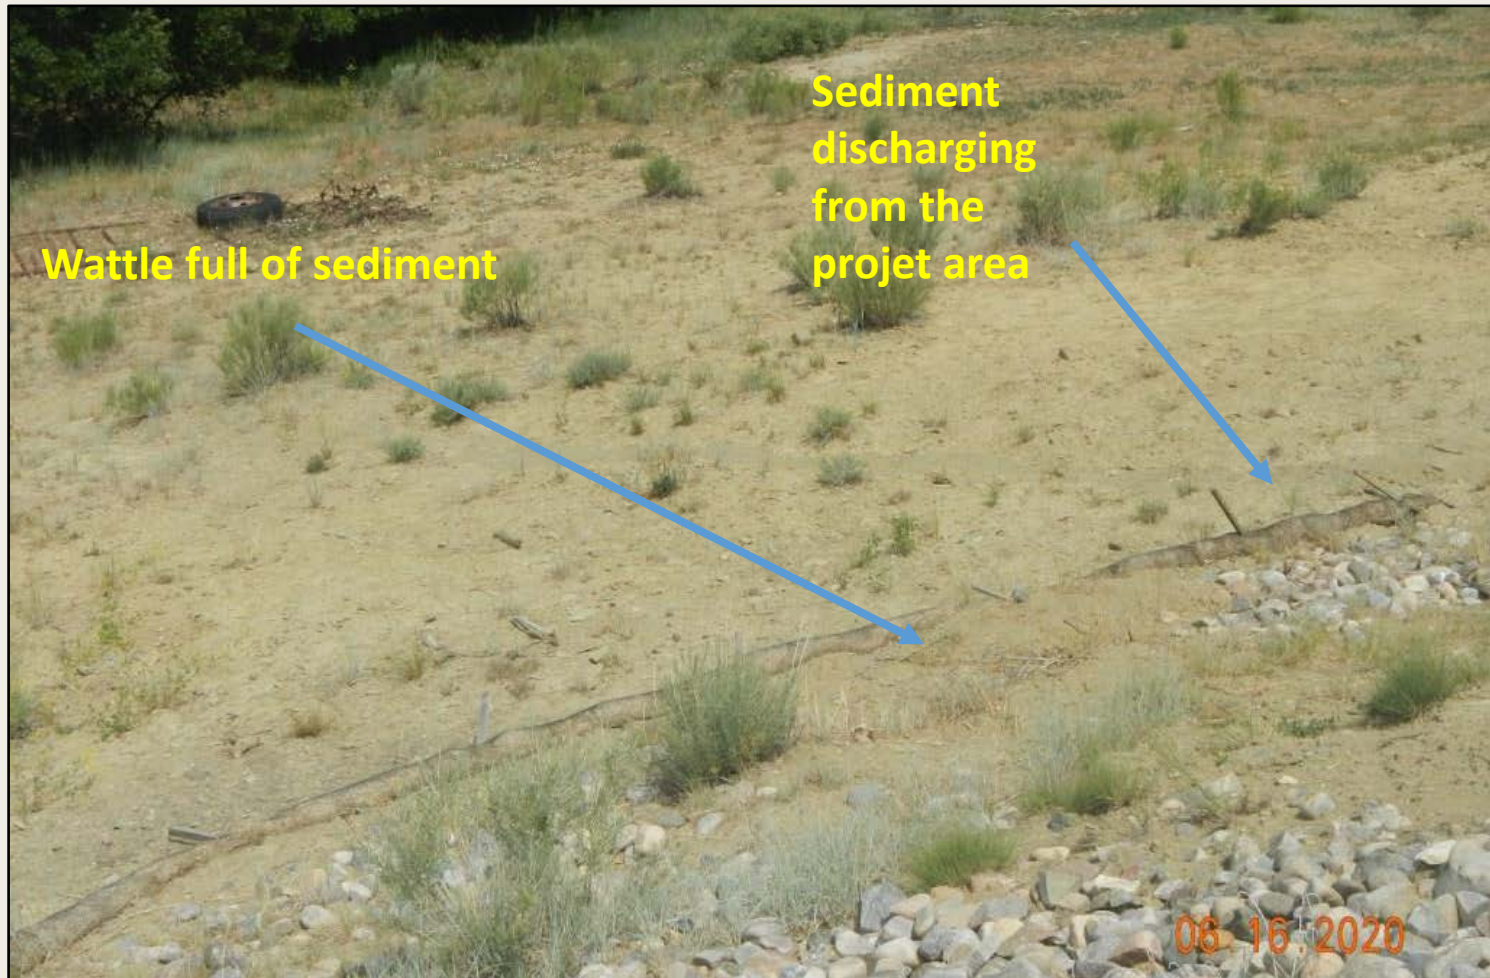
Photo 3. View of wattle full of sediment, and sediment deposition down slope from the western fill slope.

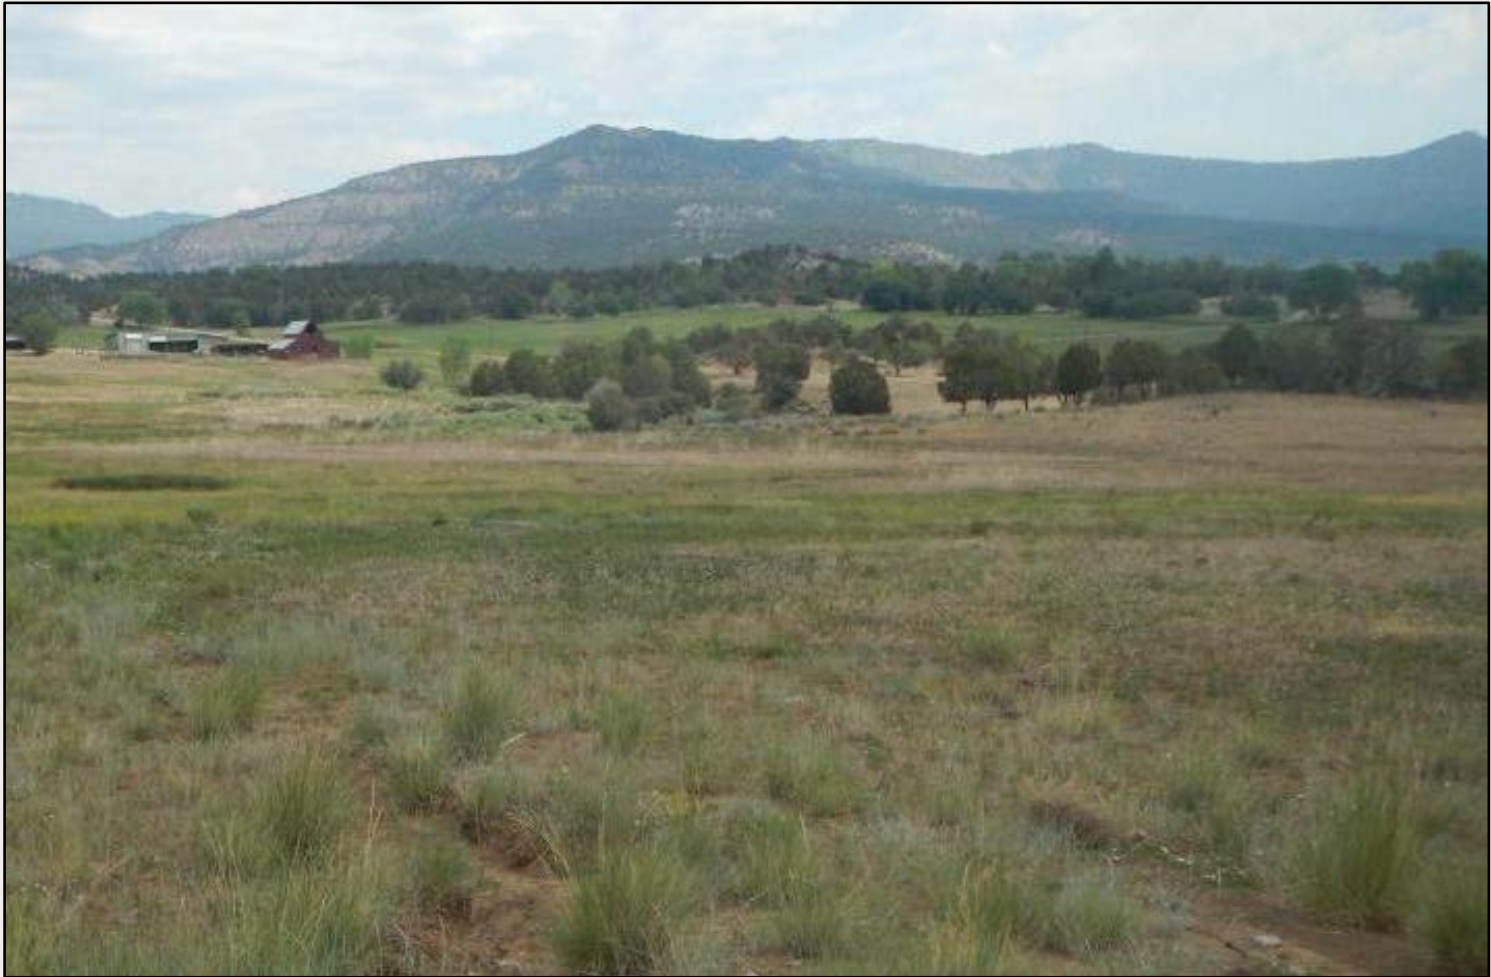
Photo 4. View of the reference area, comprised of open grass field with grasses such as western wheatgrass, Indian ricegrass, and smooth brome.
