Inspection Photos
Operator: BP America
API: 067-08779
Date: 6/16/2020

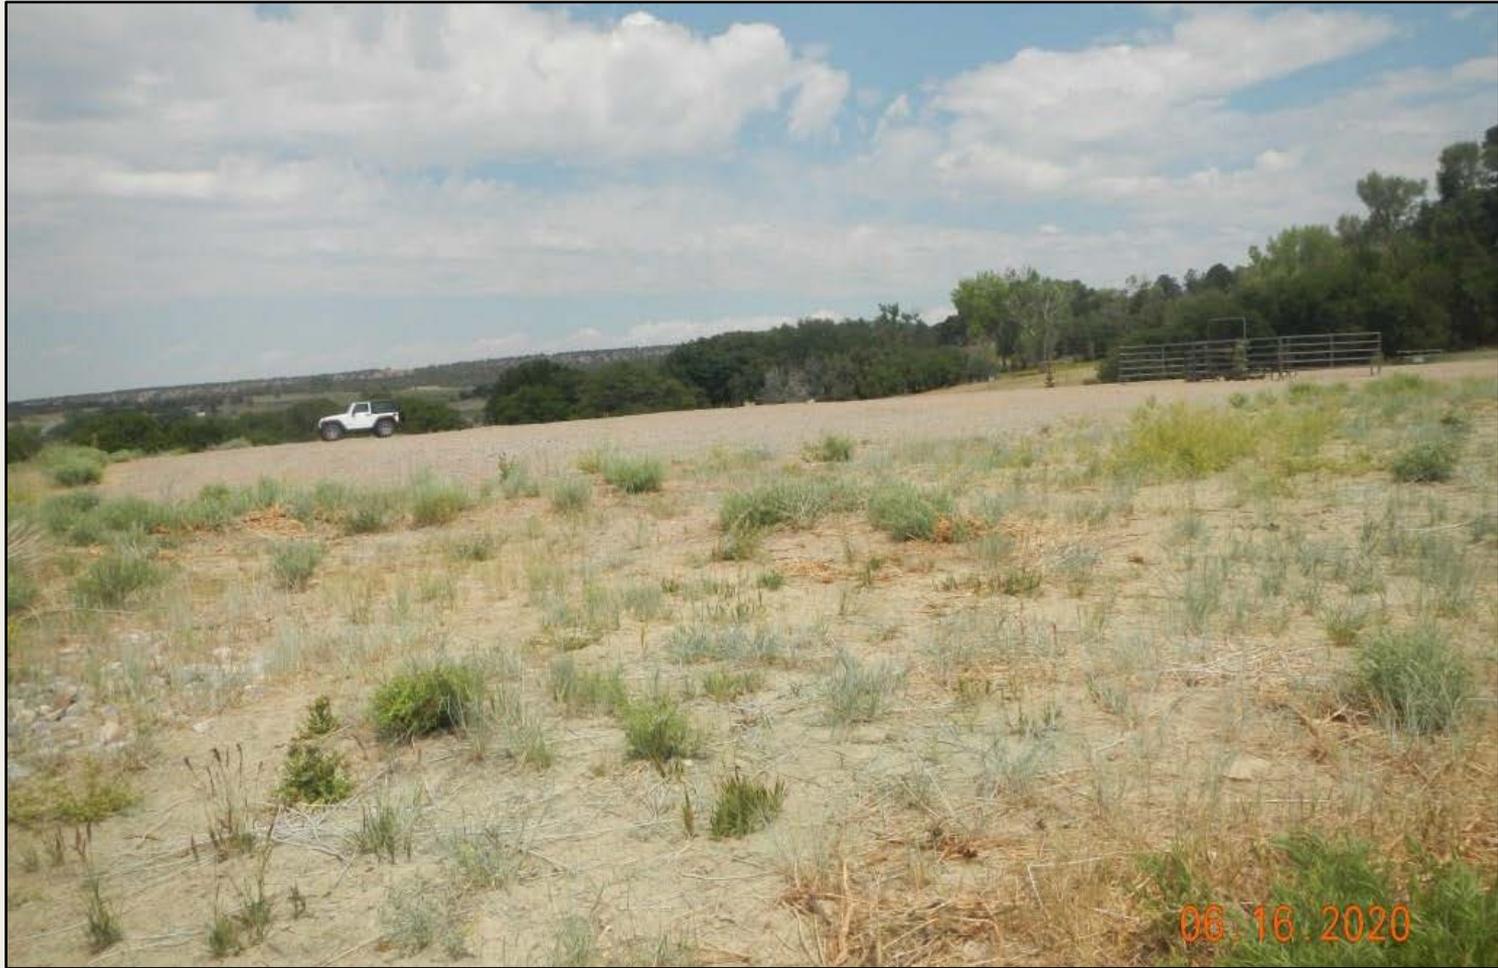
Photo 1. View of the project area from the southeastern corner facing center.

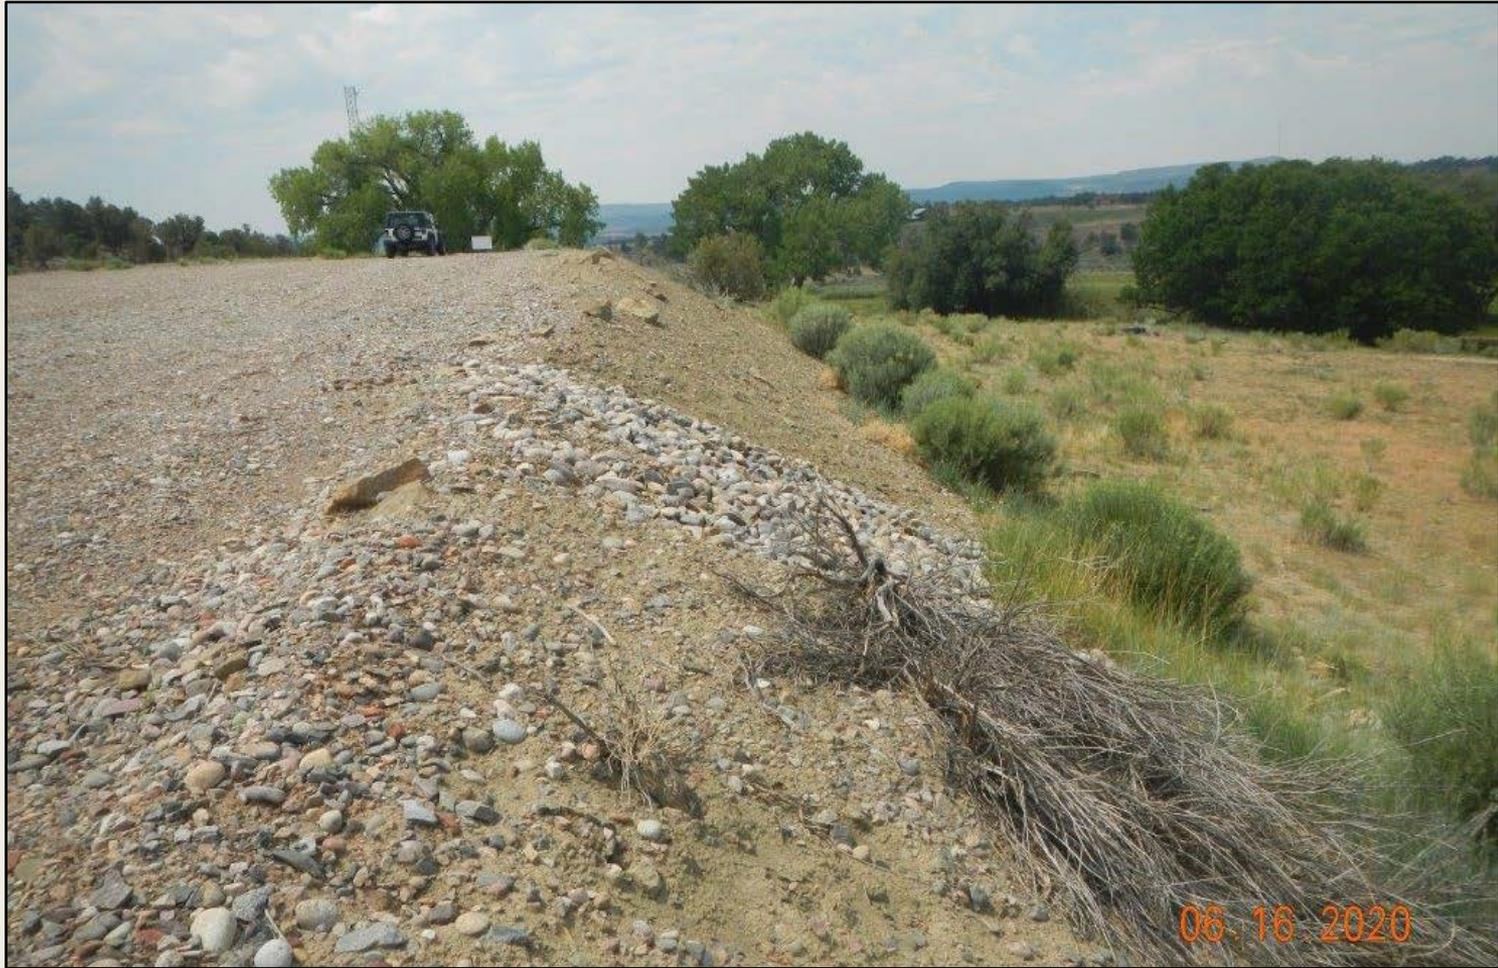
Photo 2. View of the western fill slope from the northwestern corner facing southward. Sparse revegetation observed on well pad fill slopes, stabilization measures are needed.

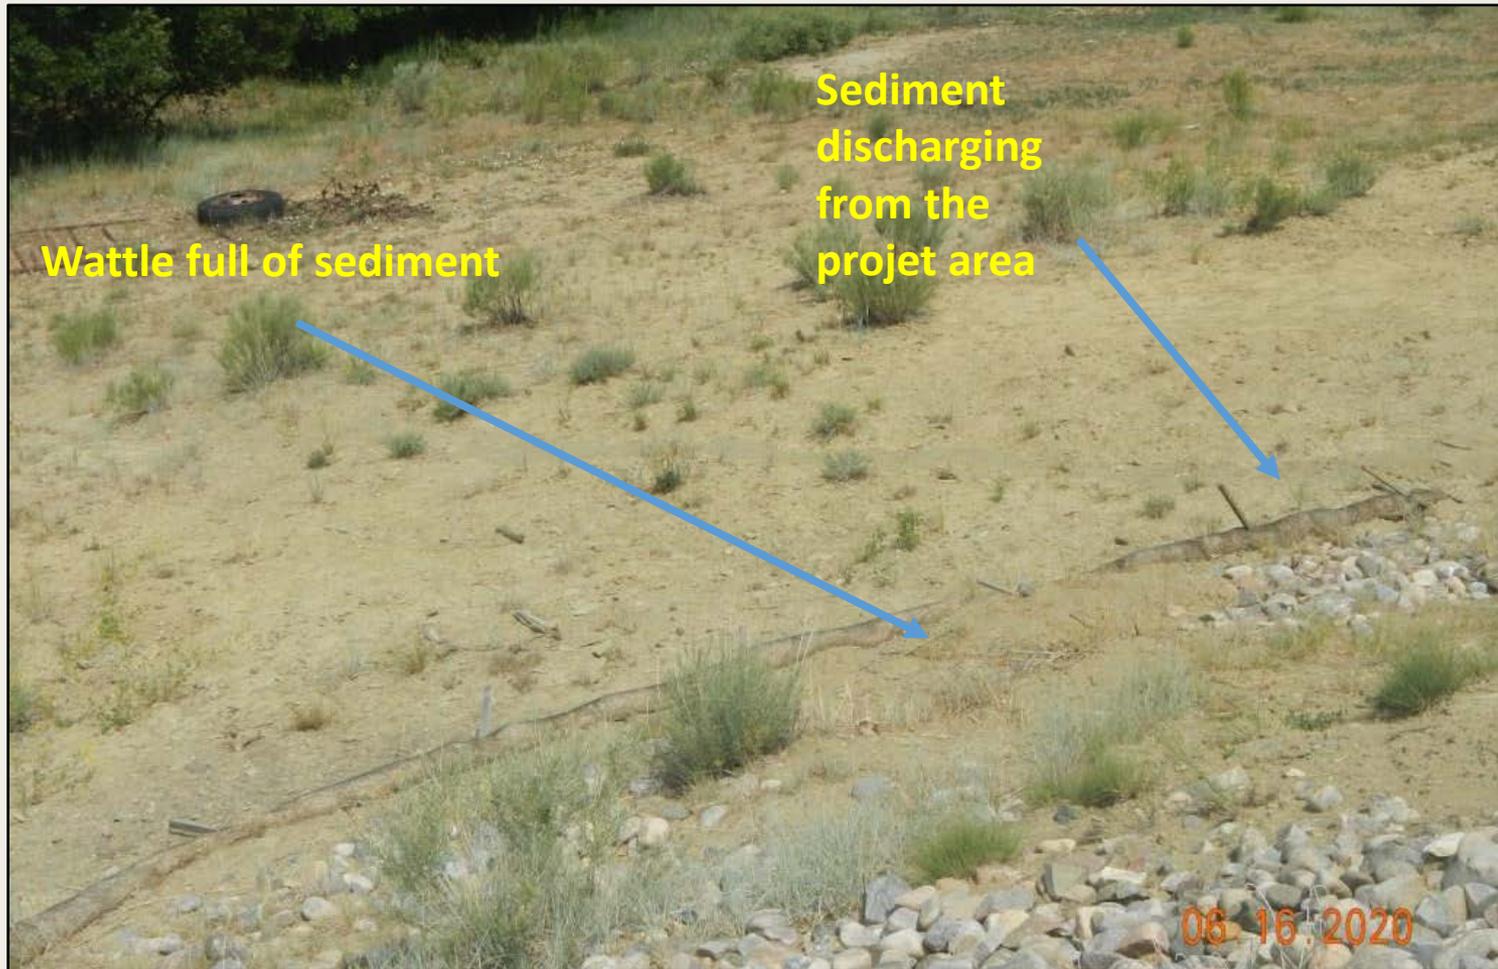
Photo 3. View of wattle full of sediment, and sediment deposition down slope from the western fill slope.

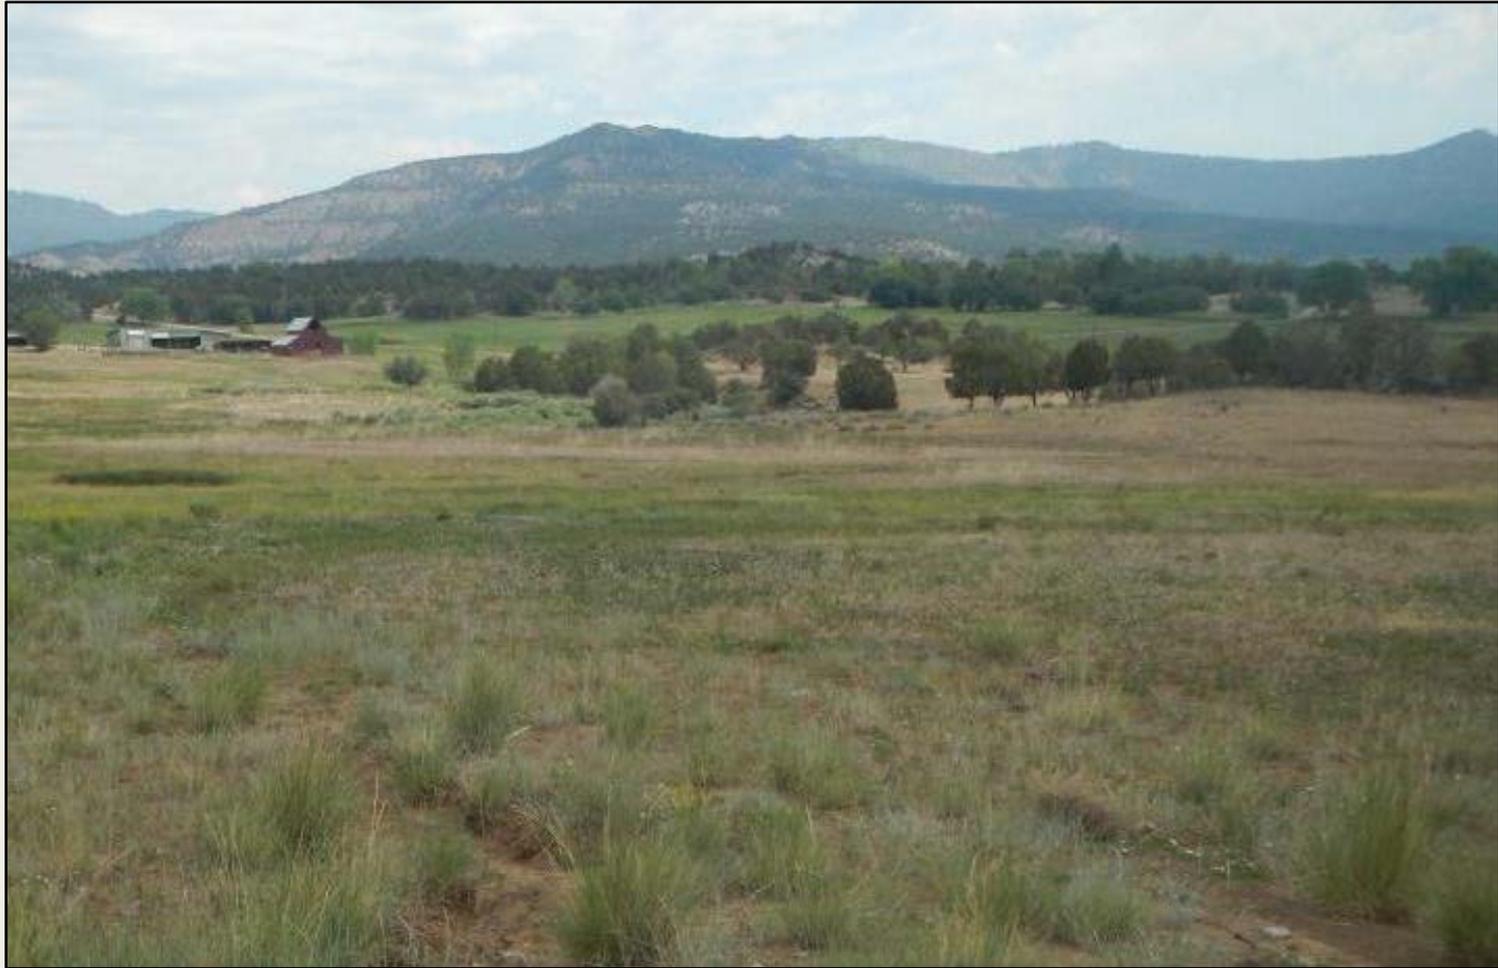
Photo 4. View of the reference area, comprised of open grass field with grasses such as western wheatgrass, Indian ricegrass, and smooth brome.
