Inspection Photos
Operator: BP America
API: 067-06909
Date: 6/19/2020

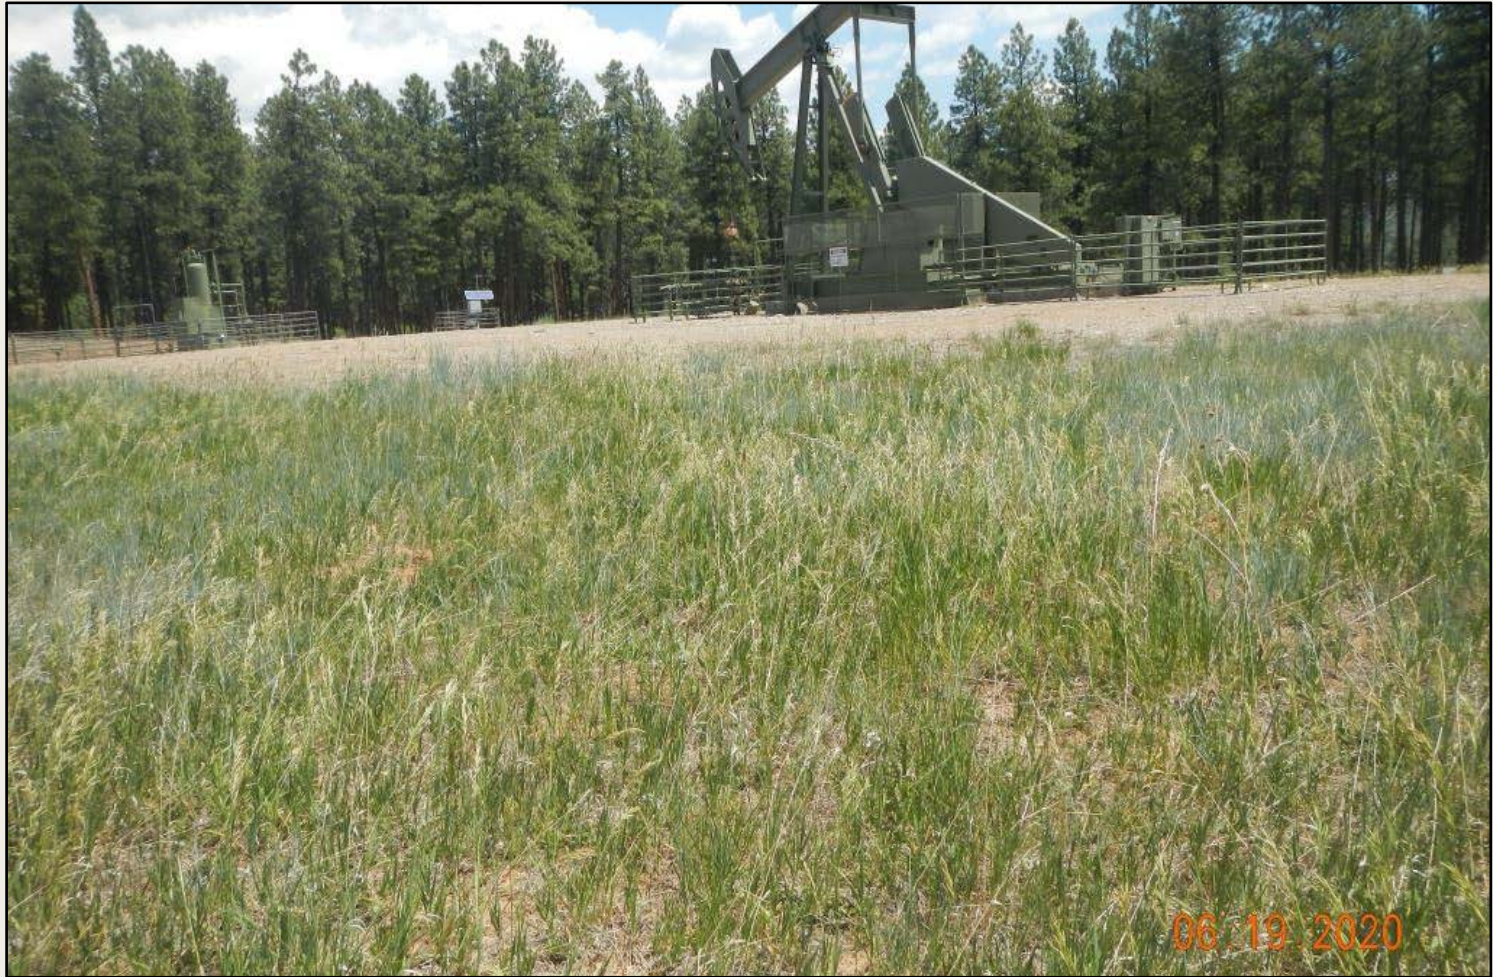
Photo 1. View of the project area from the southwestern corner facing center.

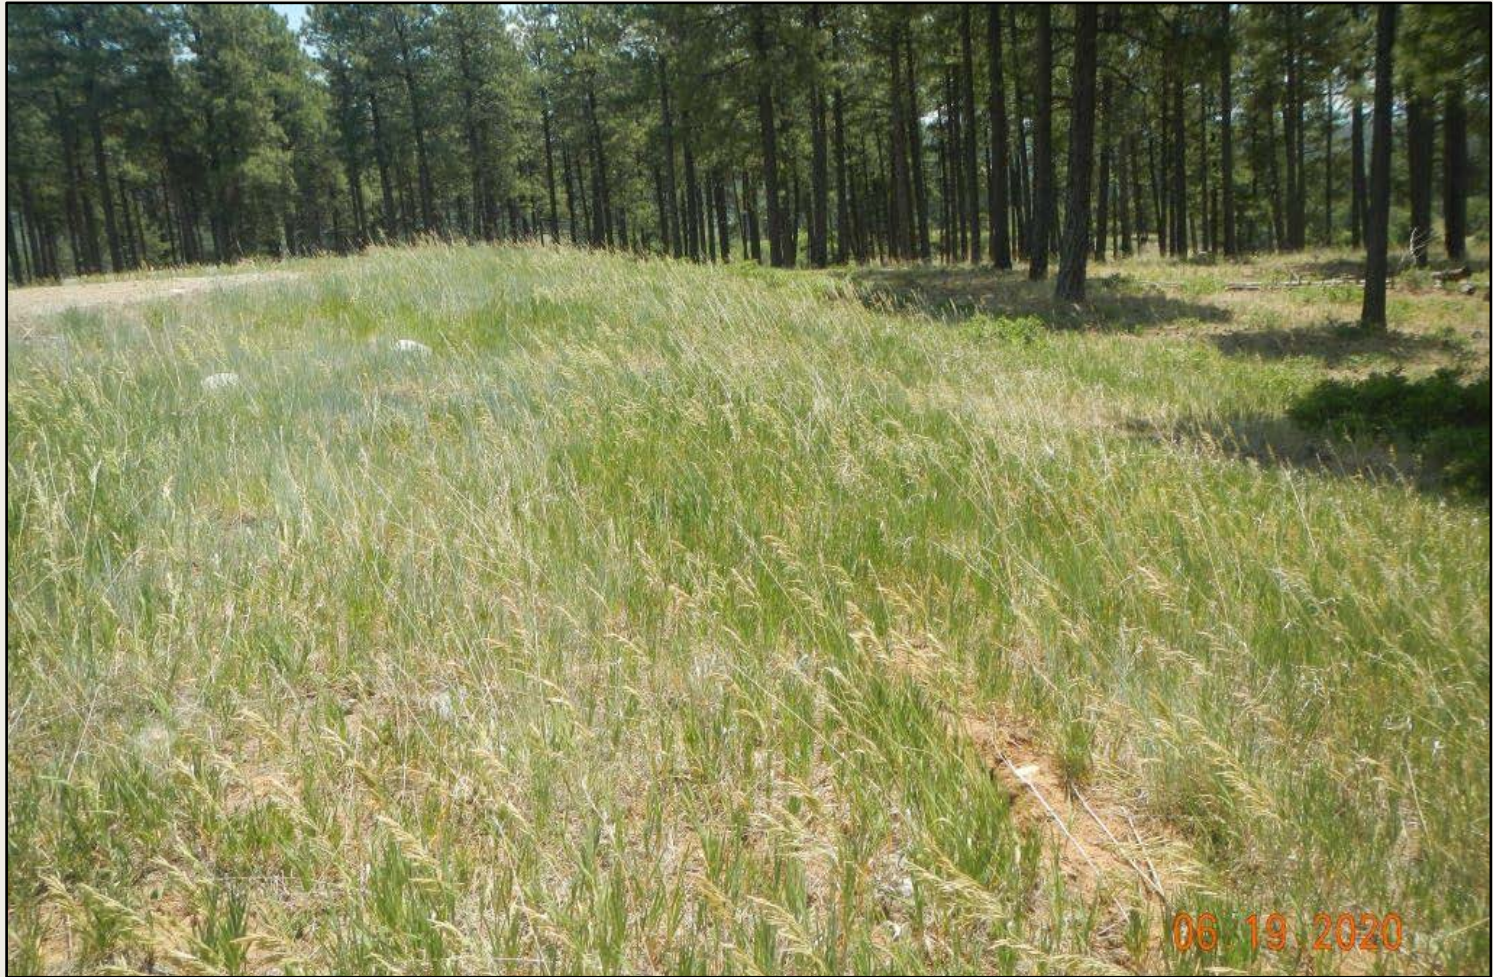
Photo 2. View of the southern fill slope from the southwestern corner facing eastward. Revegetation is progressing, largely with smooth brome and western wheatgrass.

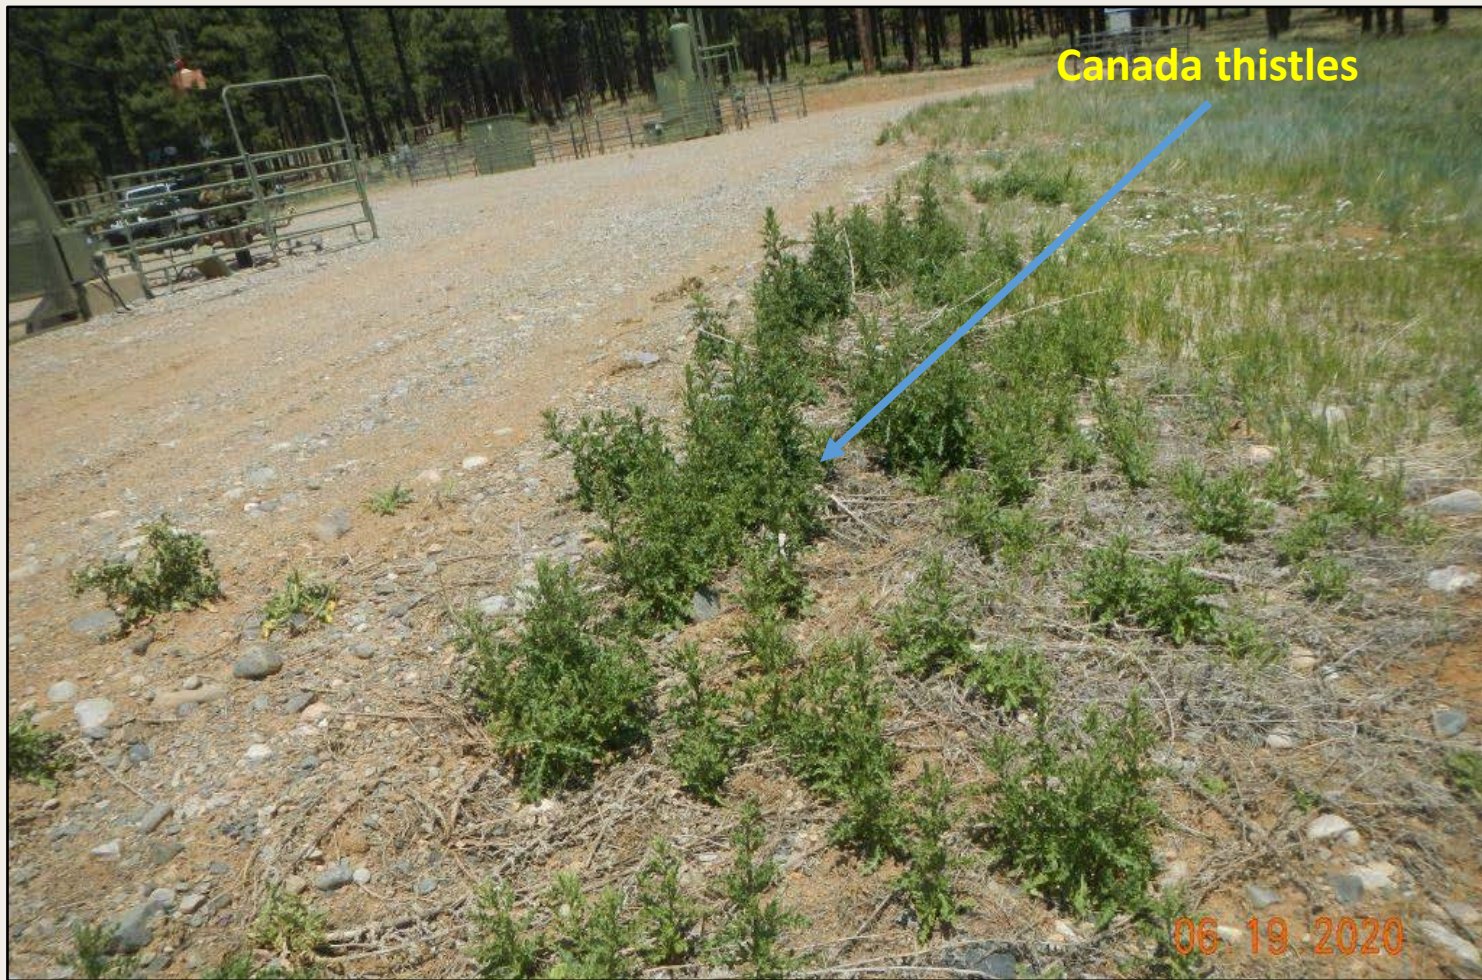
Photo 3. View of Canada thistles within the eastern project area. Approximately 150 individuals observed.

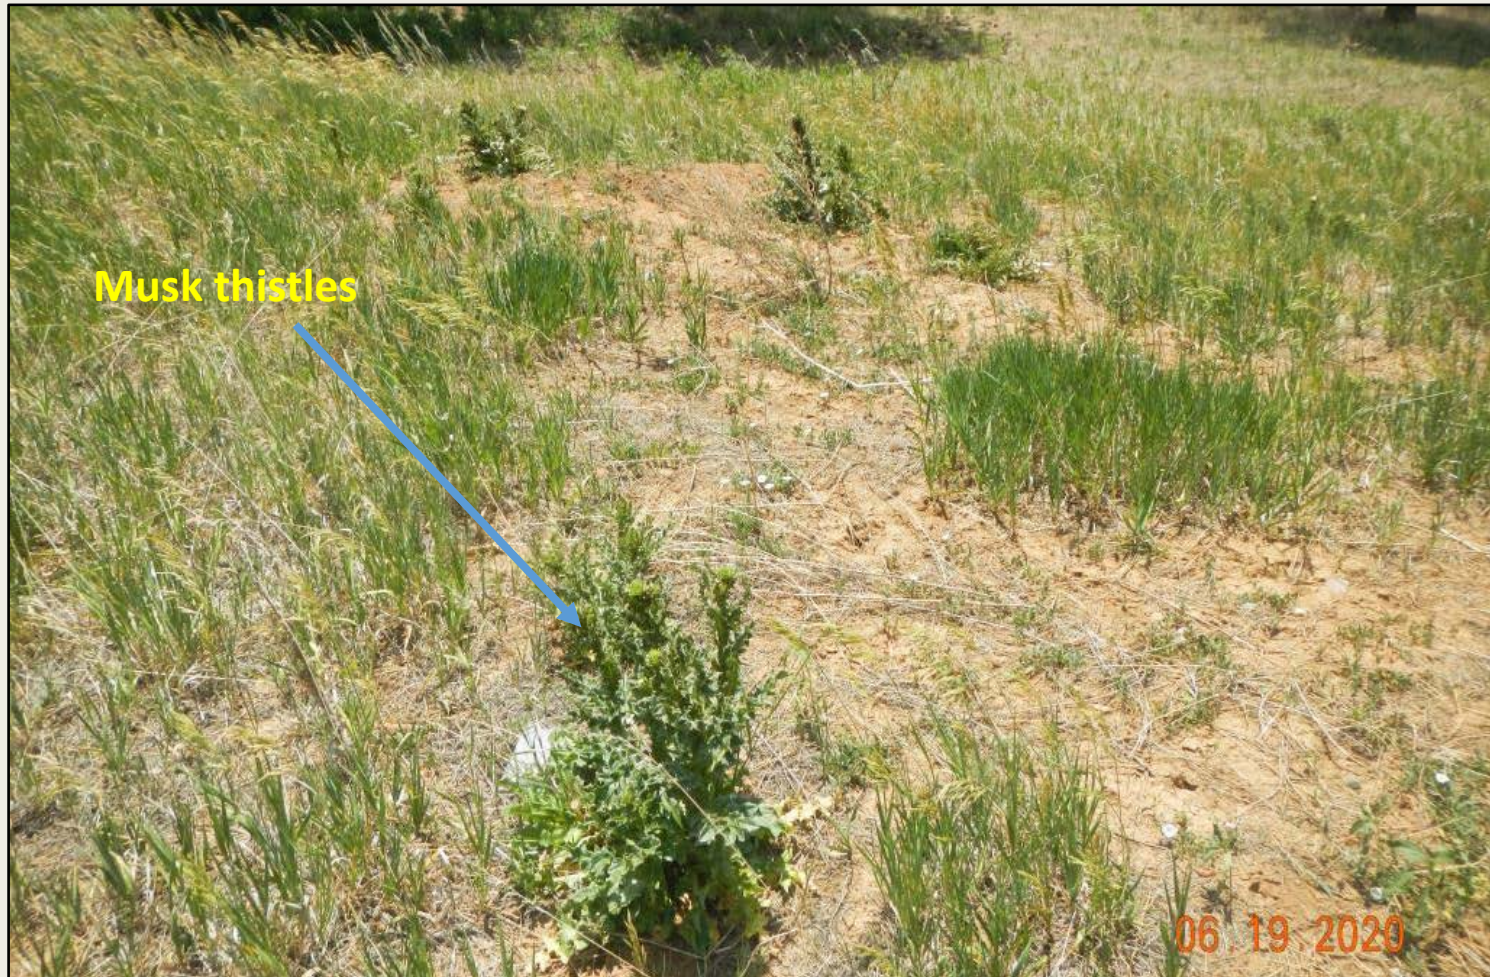
Photo 4. View of musk thistles within the southwestern corner of the interim reclamation area. Approximately 50 individuals observed.

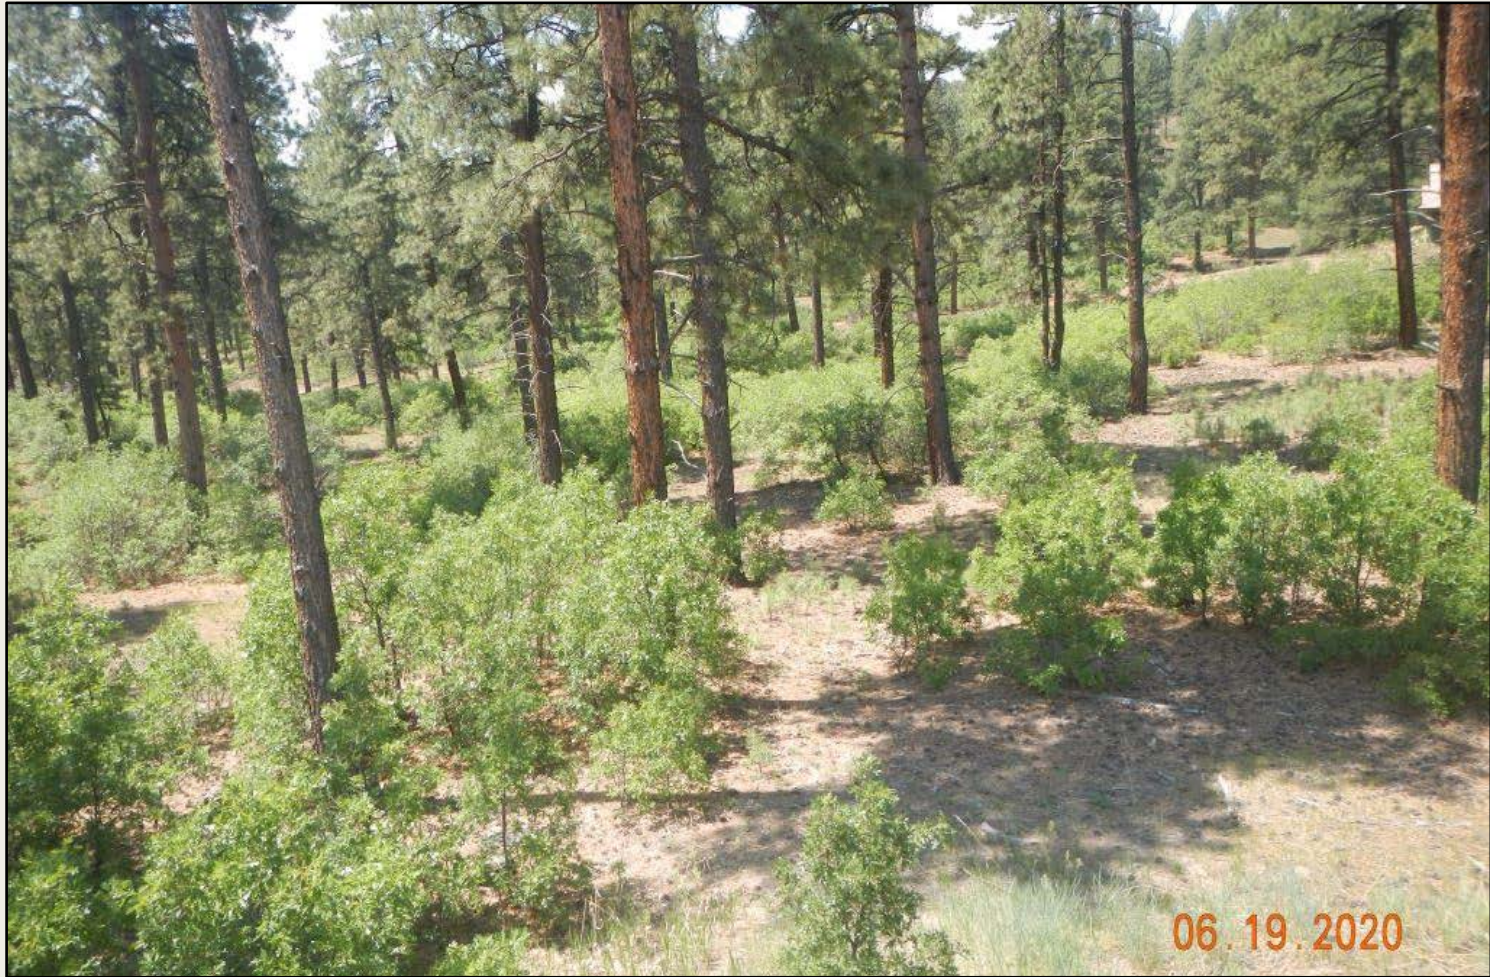
Photo 5. View of the reference area, comprised of ponderosa pine forest with a gambel oak, Sandberg bluegrass, and penstemon.
