Final Reclamation Inspection

Operator: PDC ENERGY INC - 69175

Location ID: 320417

Inspection Photos
Location Name: MCELWAIN #41-17
Location ID: 320417

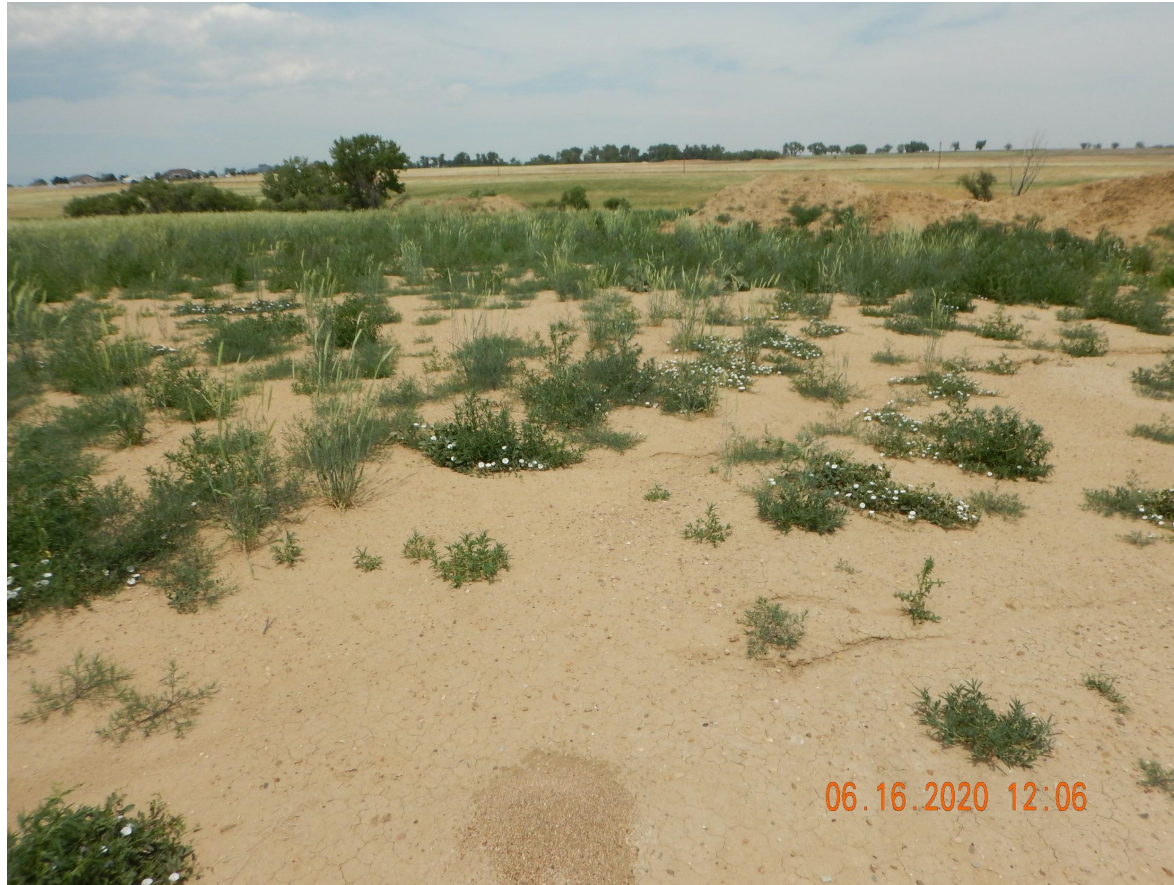
Photo 1. Photo taken from the southern well location, facing Northwest. Photo illustrates no crop growth observed with soil stockpiles. Location has not been properly contoured.

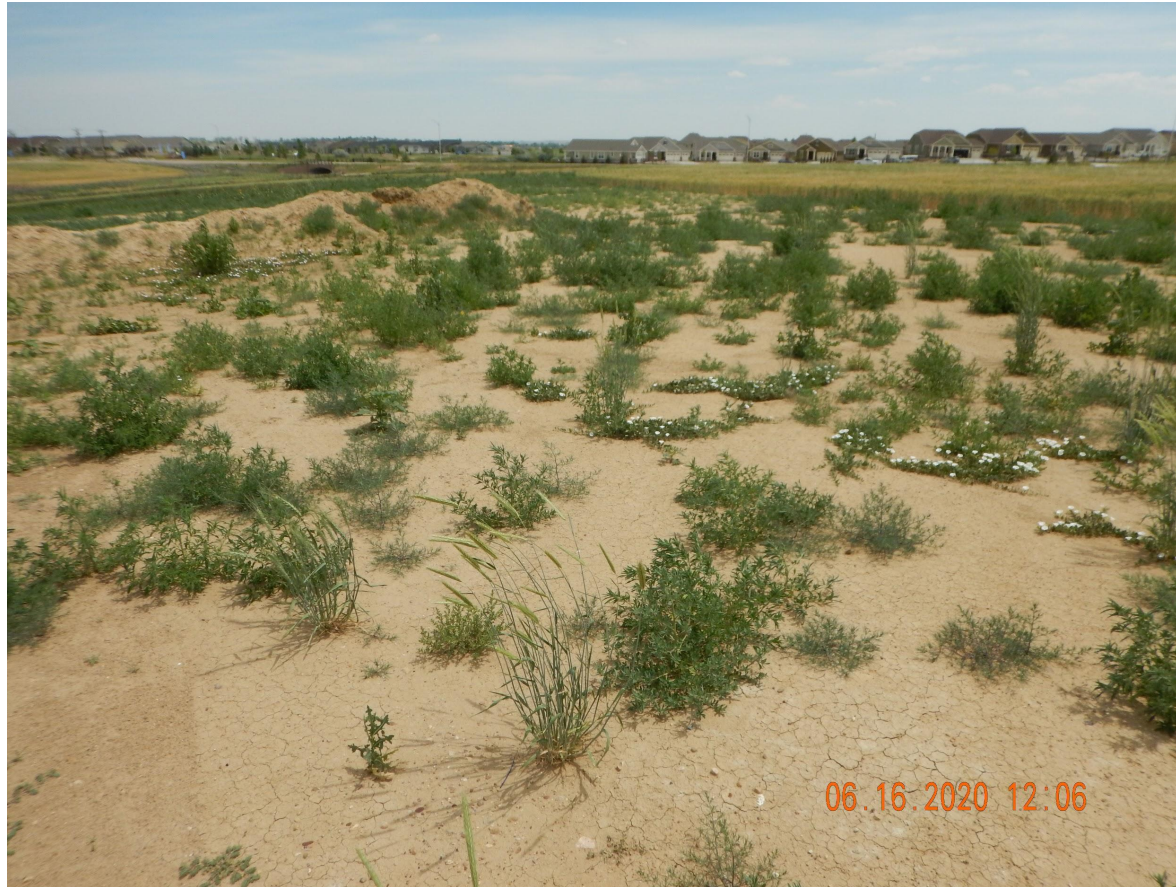
Photo 2. Photo taken from the southern well location, facing Northeast. See comments under Photo 1.

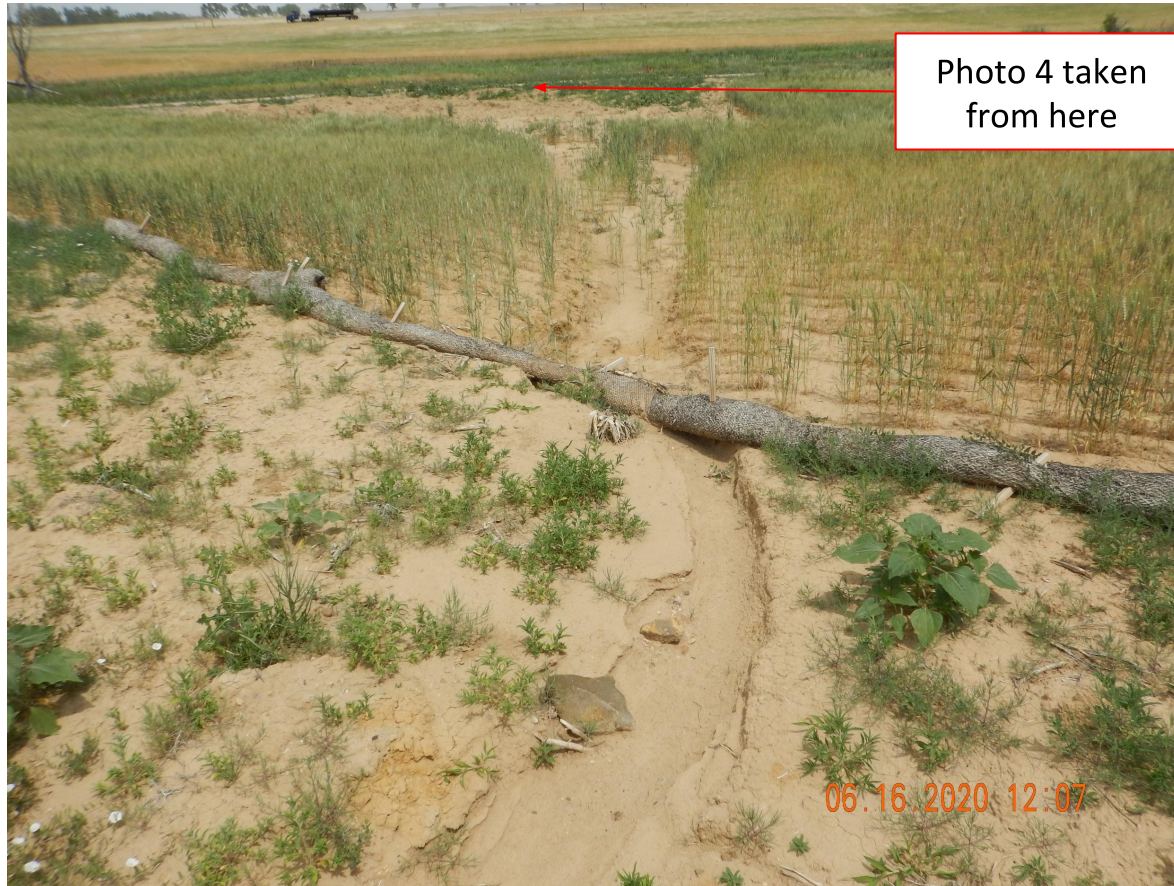
Photo 3. Photo taken from the northeastern well location, facing North. Photo illustrates stormwater erosion discharging from location. Current BMPs are not in proper functioning condition.

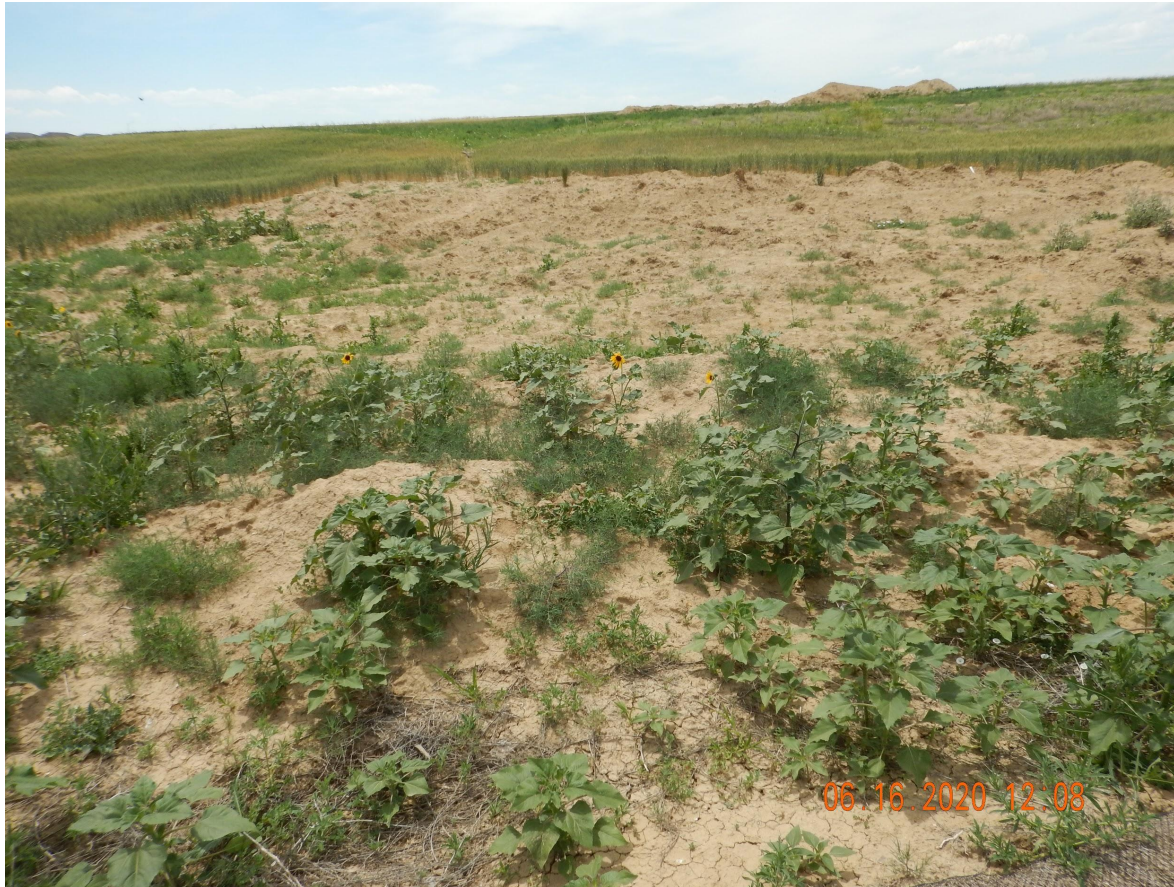
Photo 4. Photo taken north of the well location, facing South. Photo illustrates an area of disturbance where stormwater erosion is directed to.

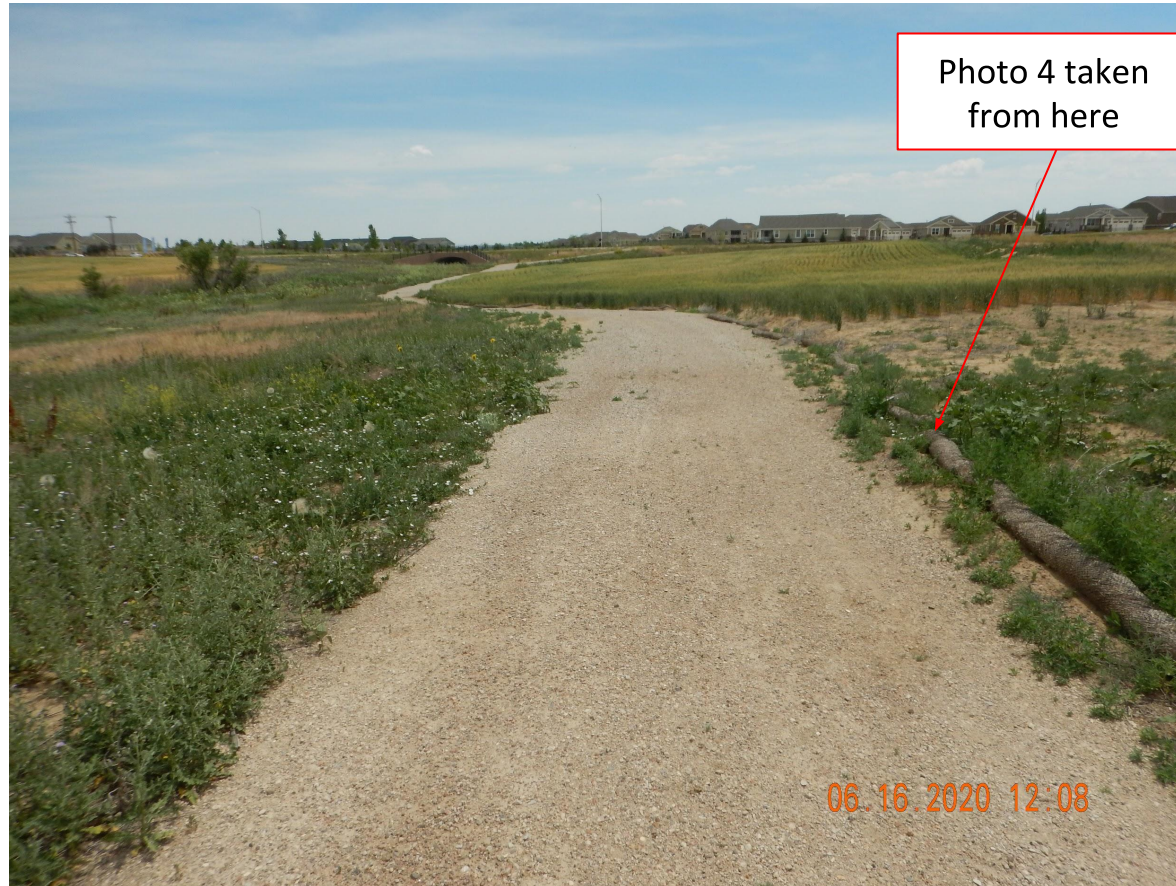
Photo 5. Photo taken north of the well location, facing East. Photo illustrates stormwater BMPs (wattles) that have been installed. There does not appear to be any sediment discharge beyond this point.

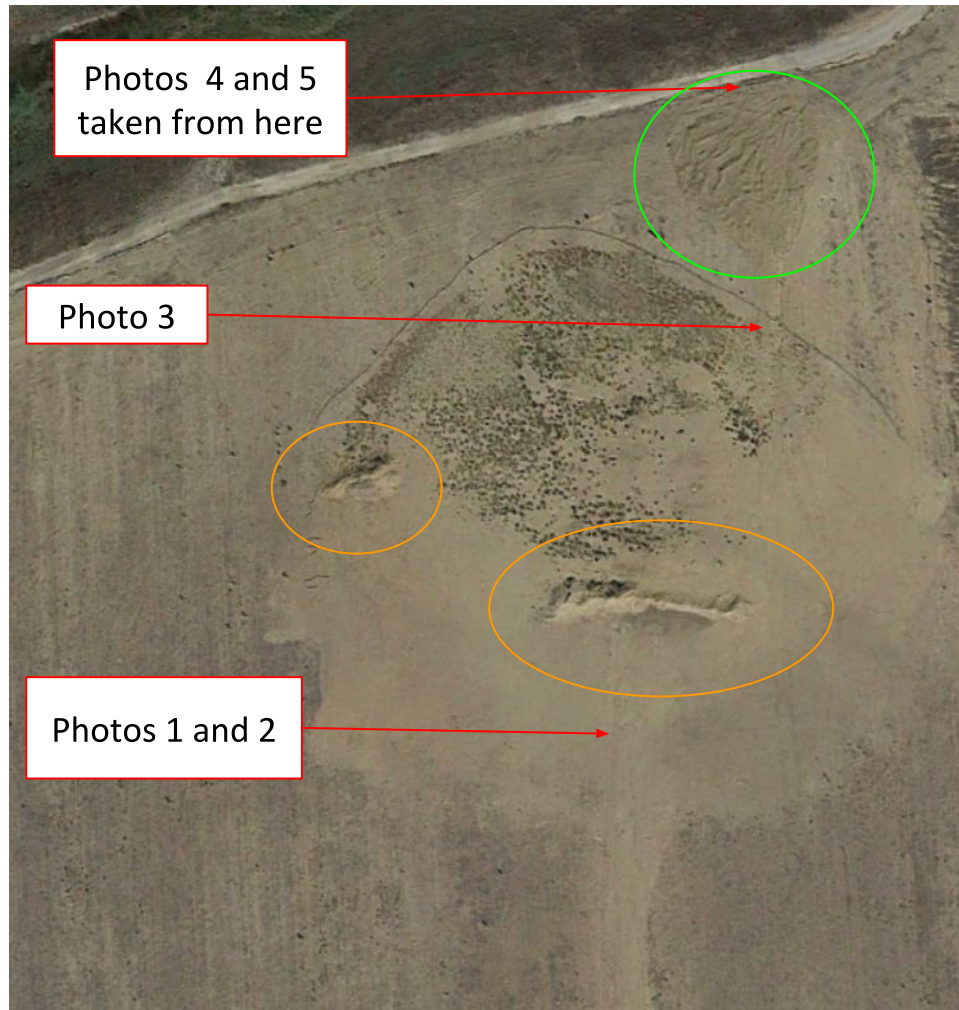
Photo 6. Google Earth aerial imagery taken 9/12/2019 during ongoing remediation efforts. At the time of this inspection, the soil stockpiles (orange circle) still remain in addition to the northern disturbance area (green circle). Imagery also illustrates where approximate photos were taken from during this inspection.
