Inspection Photos

Operator: OXY USA WTP LP - 66571

Location ID: 323892

Garfield County, CO

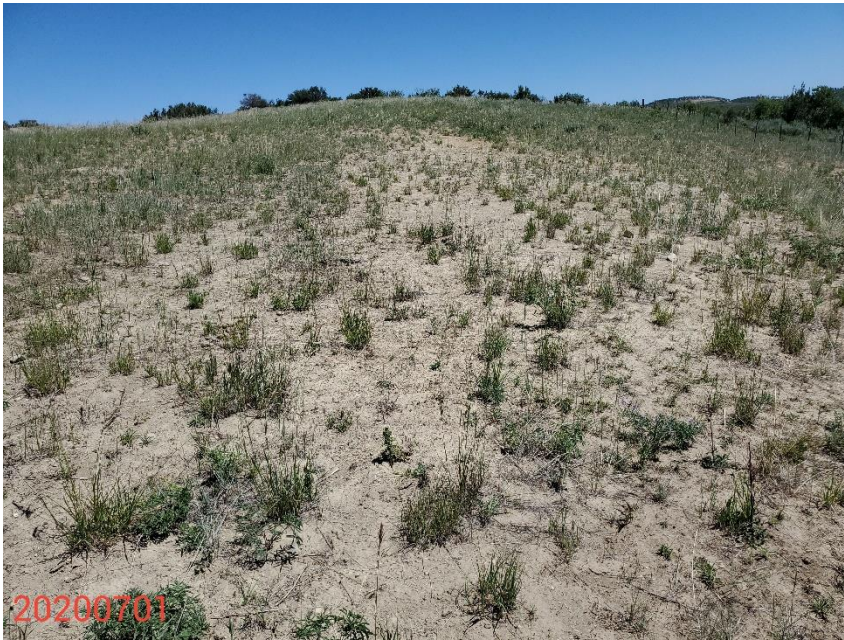
Photo 1: Photo taken from the south end of the Location, facing north. Photo shows areas on the south end of the Location where uniform vegetative establishment has not been achieved. Livestock grazing pressure evident and may be hindering reclamation.

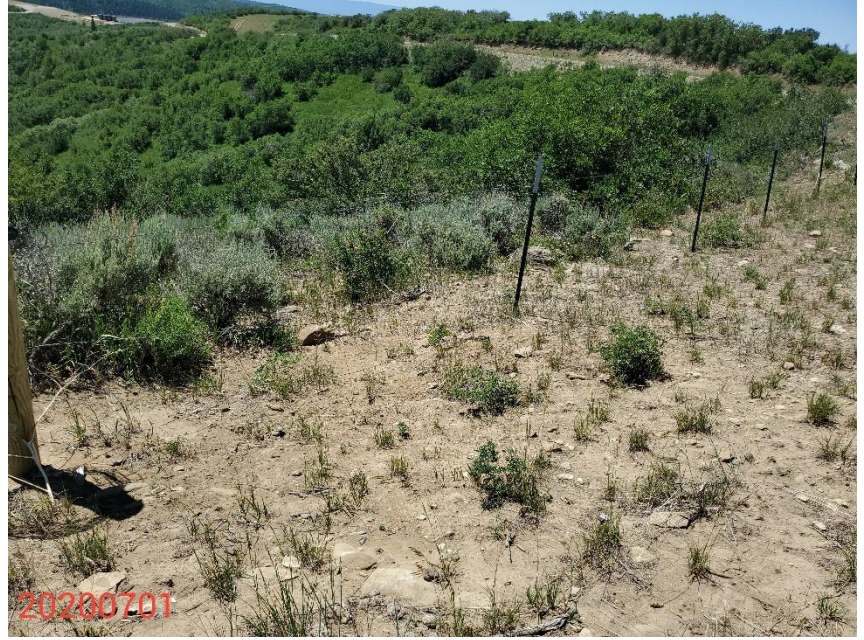
Photo 2: Photo taken from the west end of the Location, facing south. Photo shows example of areas where perimeter fence is in disrepair.

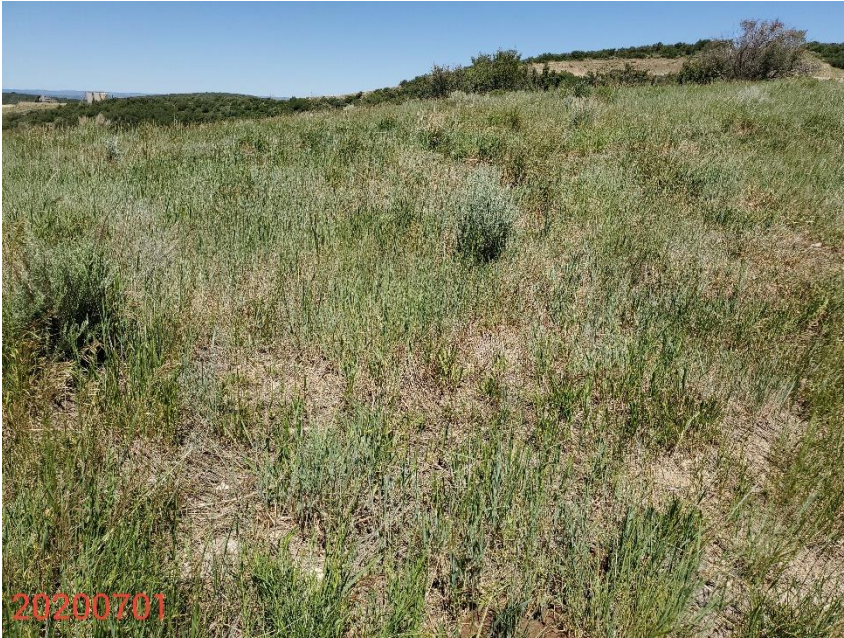
Photo 3: Photo taken from the north end of the Location, facing west. Photo shows reclamation on the north end of the Location appears to have achieved uniform vegetative establishment.

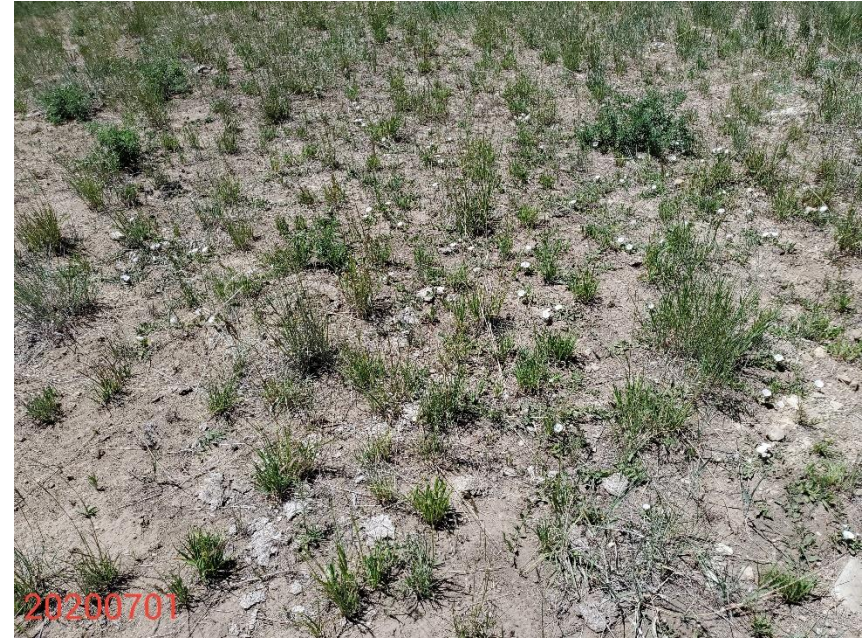
Photo 4: Photo taken from the south end of the Location. Photo shows Field Bindweed has established on the Location. This is a Colorado State listed noxious weed and needs to be managed.

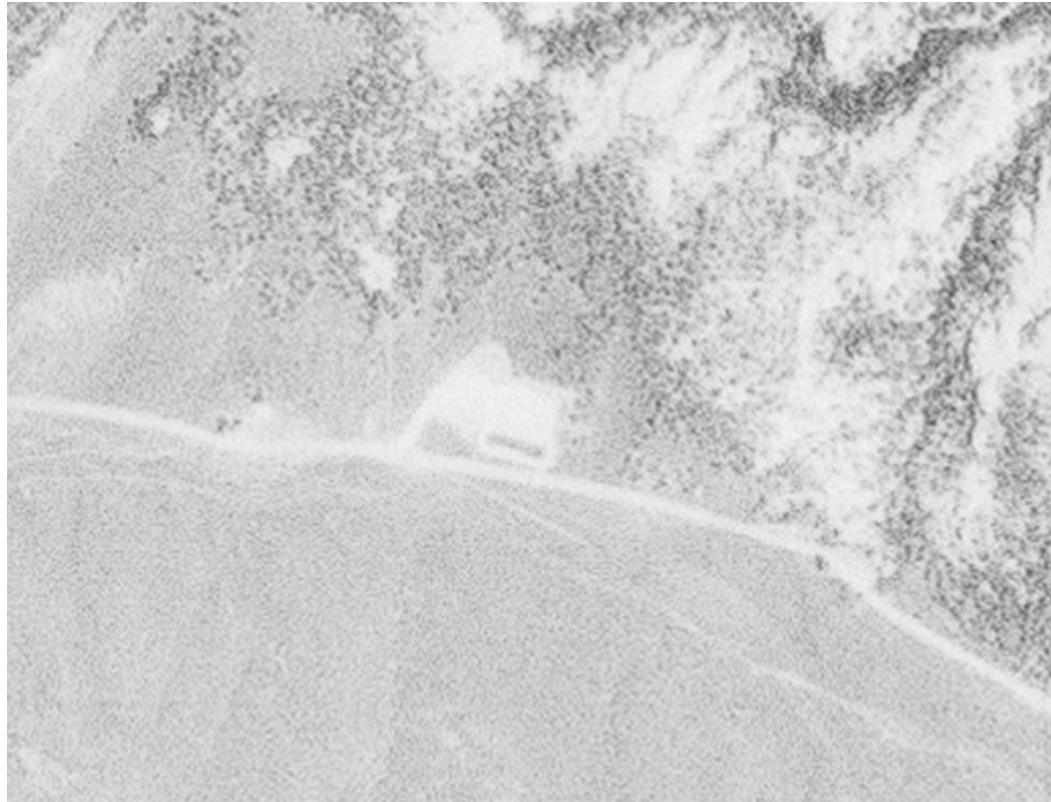
Photo 10: USGS Aerial Imagery Dated 9/2/1980. Well was SPUD 4/4/1980. Photo shows the disturbance area of this Location ~ 5 months post drilling activities.
