# Inspection Photos

Operator: CAERUS PICEANCE LLC - 10456

Location ID: 312408

Mesa County, CO

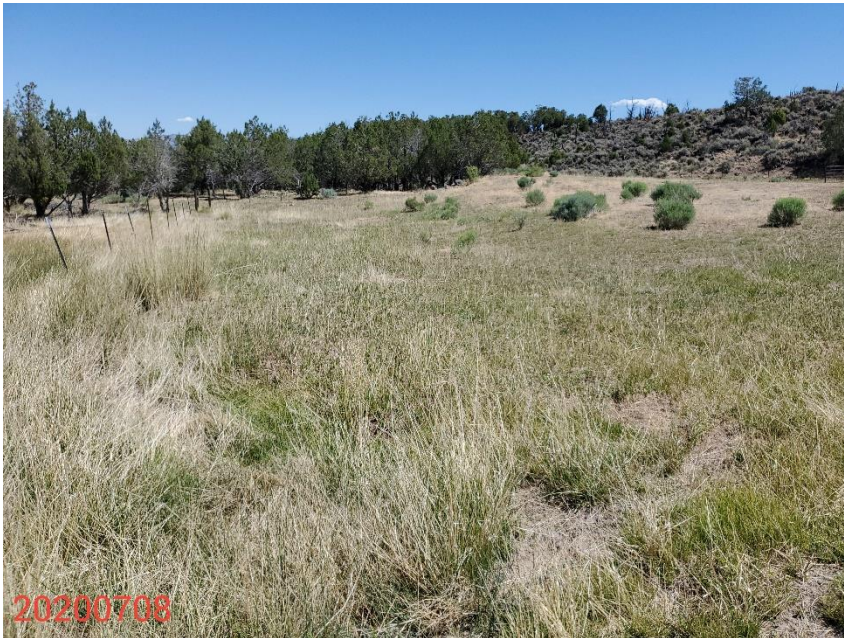
**Photo 1:** Photo taken from the west end of the Location, facing north. Photo provides an overview of the Location. Vegetation on the outer interim areas of the Location appear to be uniform.

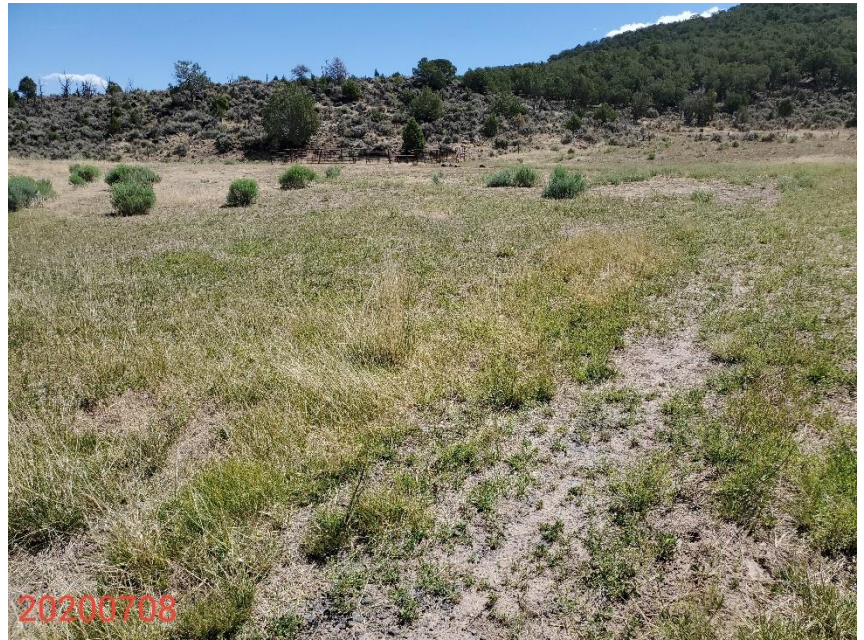
**Photo 2:** Photo taken from the west end of the Location, facing east. Photo provides an overview of the Location. Vegetation on the outer interim areas of the Location appear to be uniform.

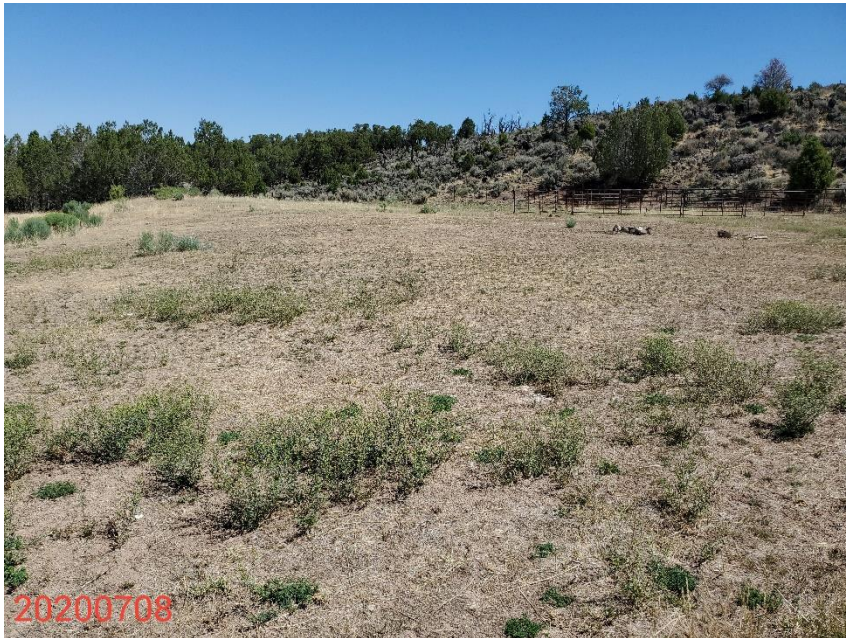
**Photo 3:** Photo taken from the central areas of the Location, facing north. Photo shows vegetation establishment does not appear to be progressing towards 1004 reclamation standards.

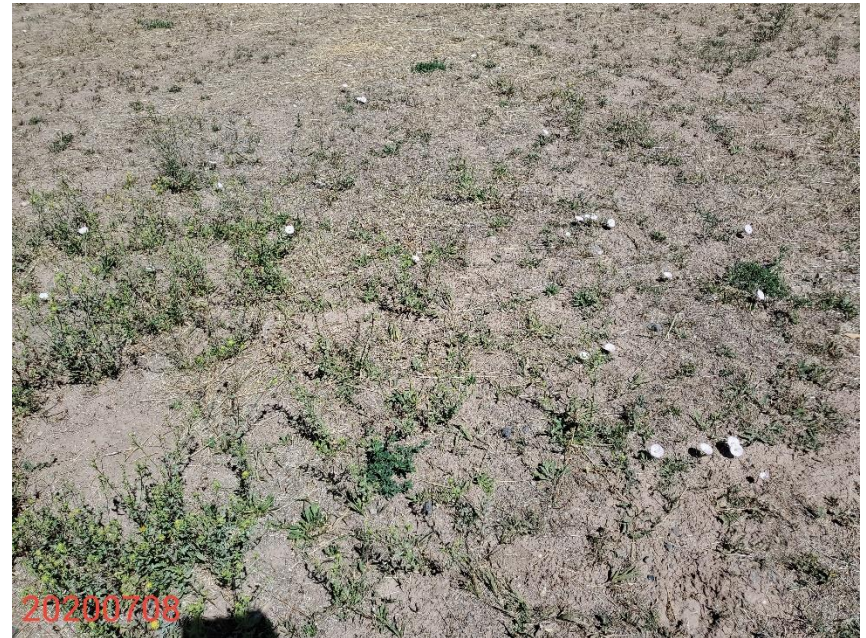
**Photo 4:** Photo taken from the Location. Photo shows Field Bindweed has established on the Location. This is a Colorado State listed noxious weed.

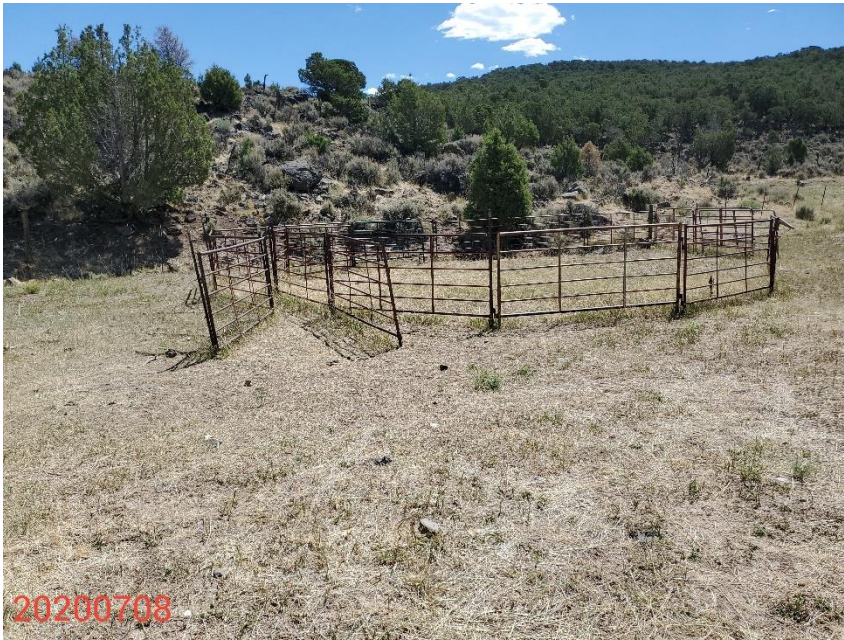
**Photo 5:** Photo taken from the Location, facing east. Photo shows cattle panels on the Location. Areas of the Location appear to be in use and the added disturbances may be hindering reclamation/revegetation of the Location.

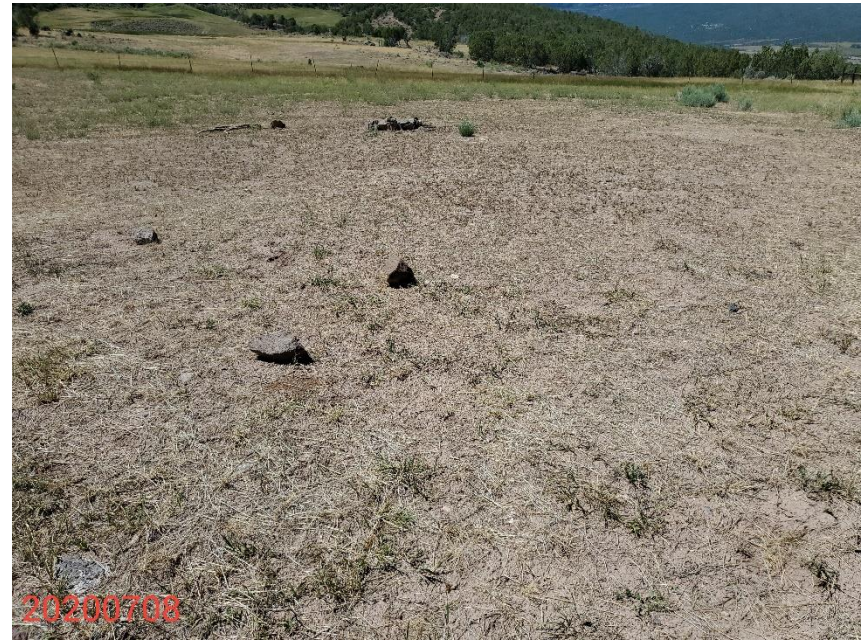
**Photo 6:** Photo taken from the central areas of the Location, facing south. Photo shows vegetation establishment does not appear to be progressing towards 1004 reclamation standards. Photo also shows fire ring; Areas of the Location appear to be in use and the added disturbances may be hindering reclamation/revegetation of the Location

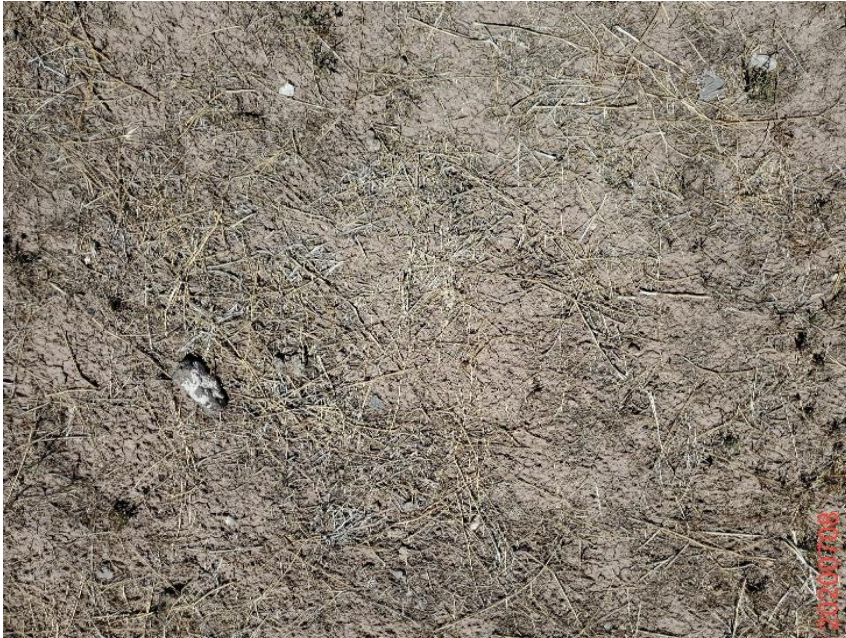
**Photo 7:** Close up photo of the reclamation of the Location. Photo shows revegetation of the Location is not progressing towards 1004 standards.

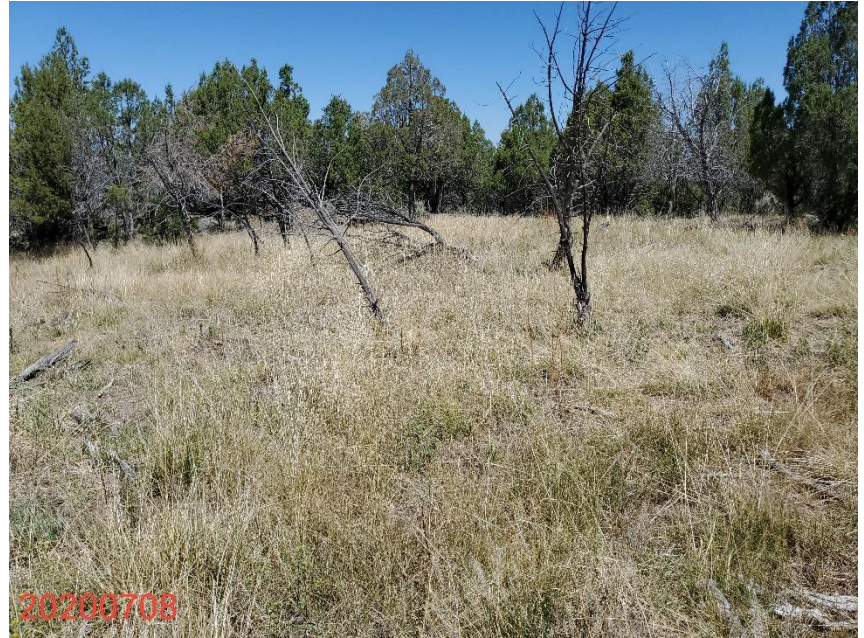
**Photo 8:** Photo taken from the adjacent reference area. Photo to provide comparison/contrast of the reclamation and reference areas.

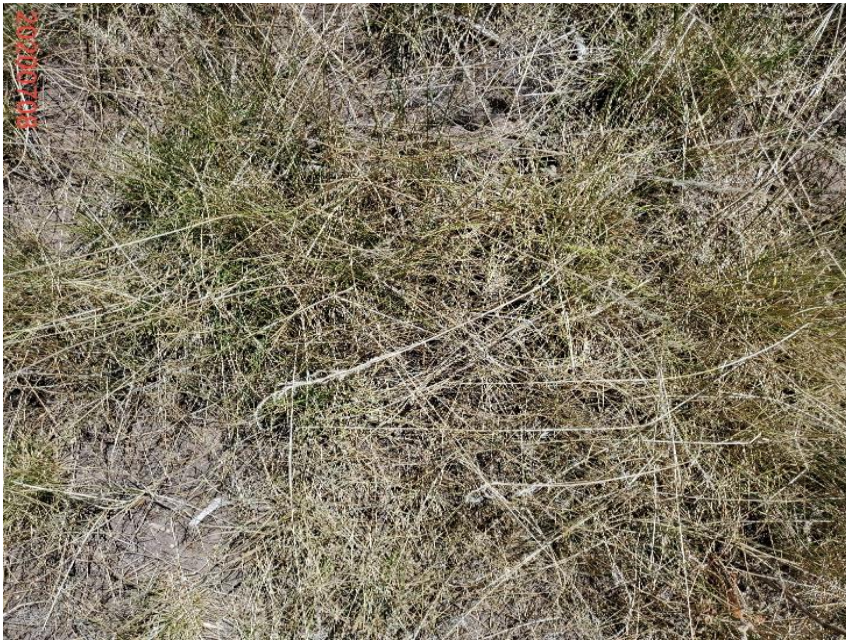
**Photo 9:** See comments under photo 8.

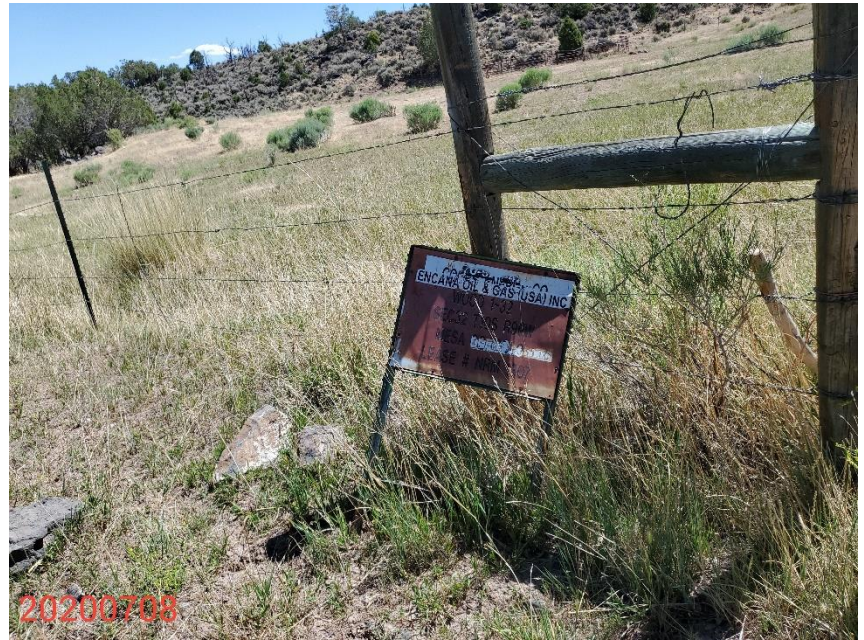
**Photo 10:** Photo taken from the Location entrance. Photo shows signage with incorrect Operator information.

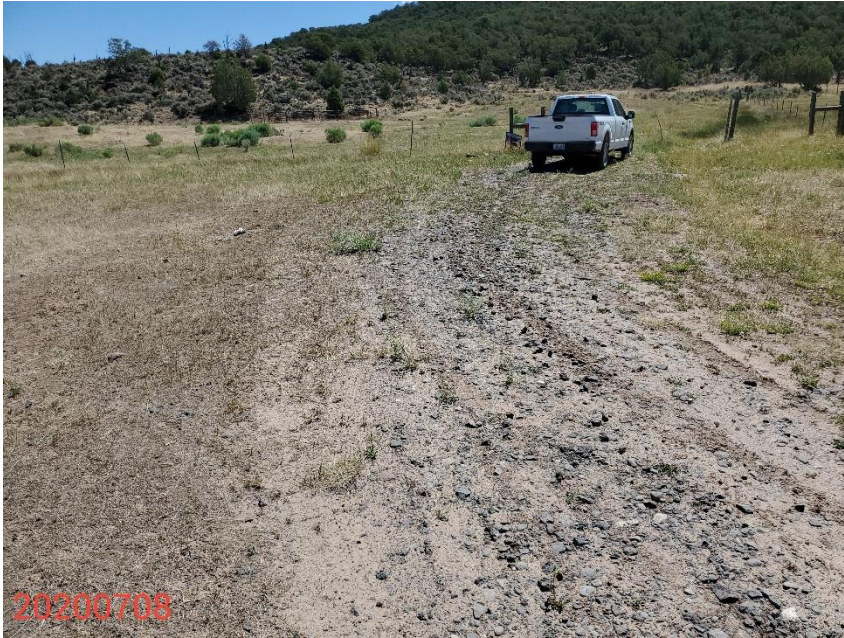
**Photo 11:** Photo taken from the access road, west of the Location facing east.

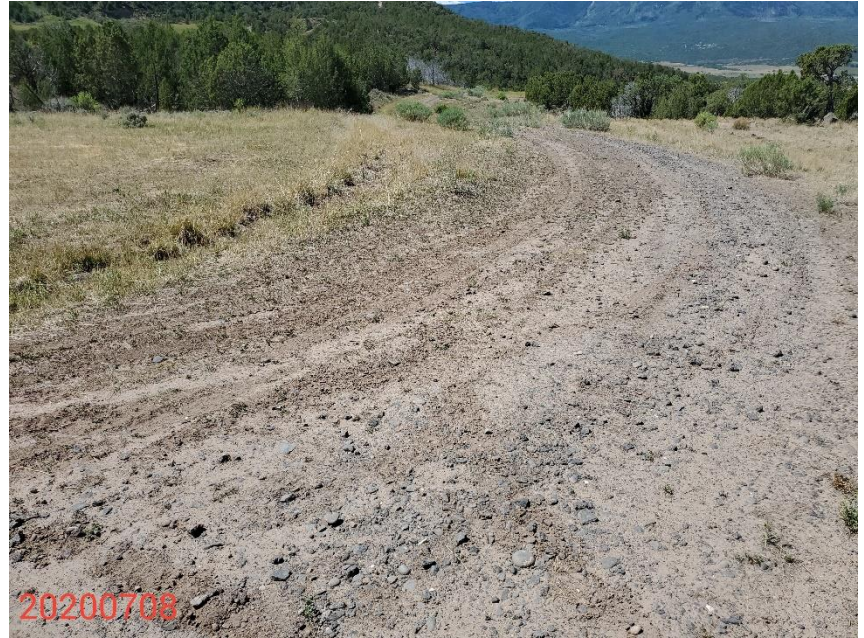
**Photo 12:** Photo taken from the access road, west of the Location, facing south.

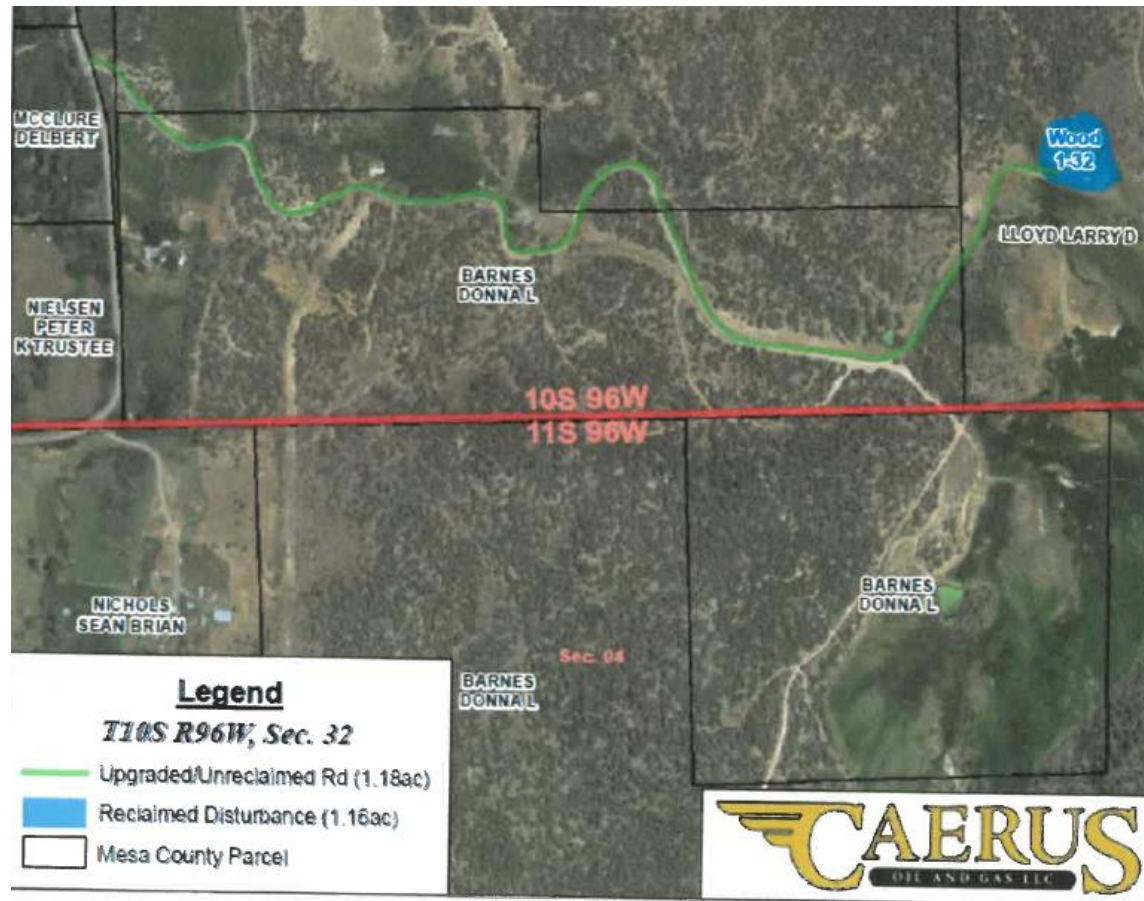
**Photo 13:** Figure provided by Caerus shows access road for which a 502.b SOVR to waive reclamation requirements has been submitted.

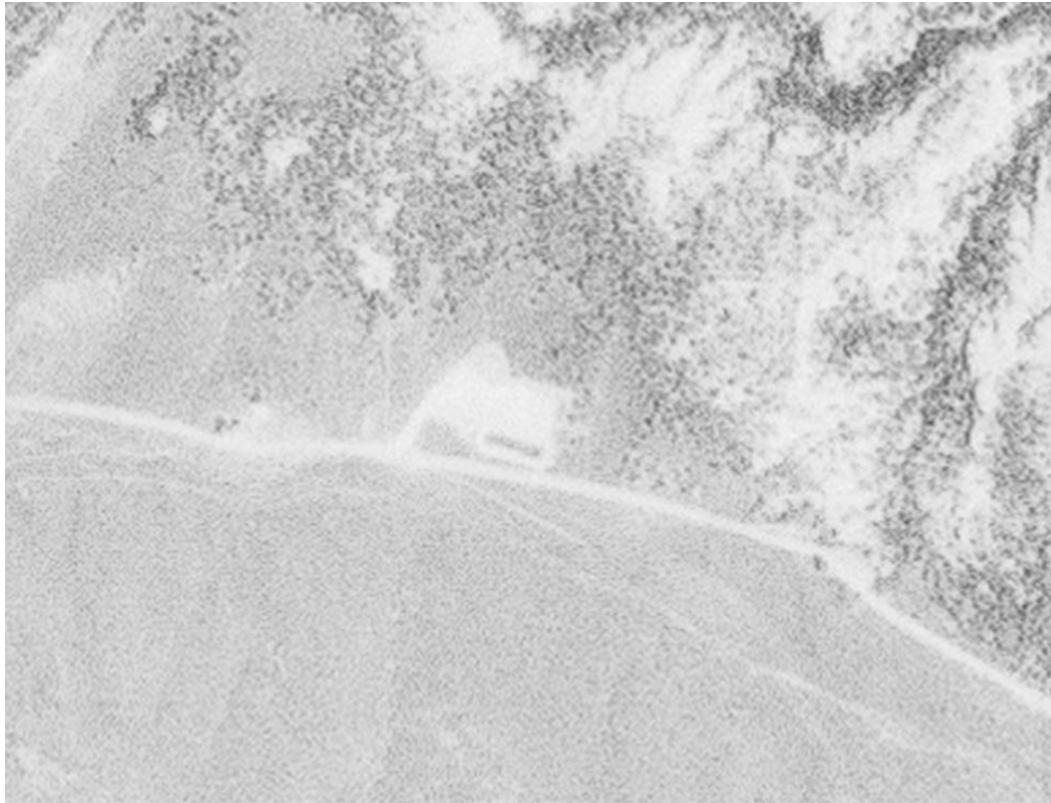
**Photo 10:** USGS Aerial Imagery Dated 9/2/1980. Well was SPUD 4/4/1980. Photo shows the disturbance area of this Location ~ 5 months post drilling activities.
