Inspection Photos
Operator: Kinder Morgan
API: 083-06574
Date: 7/9/2020

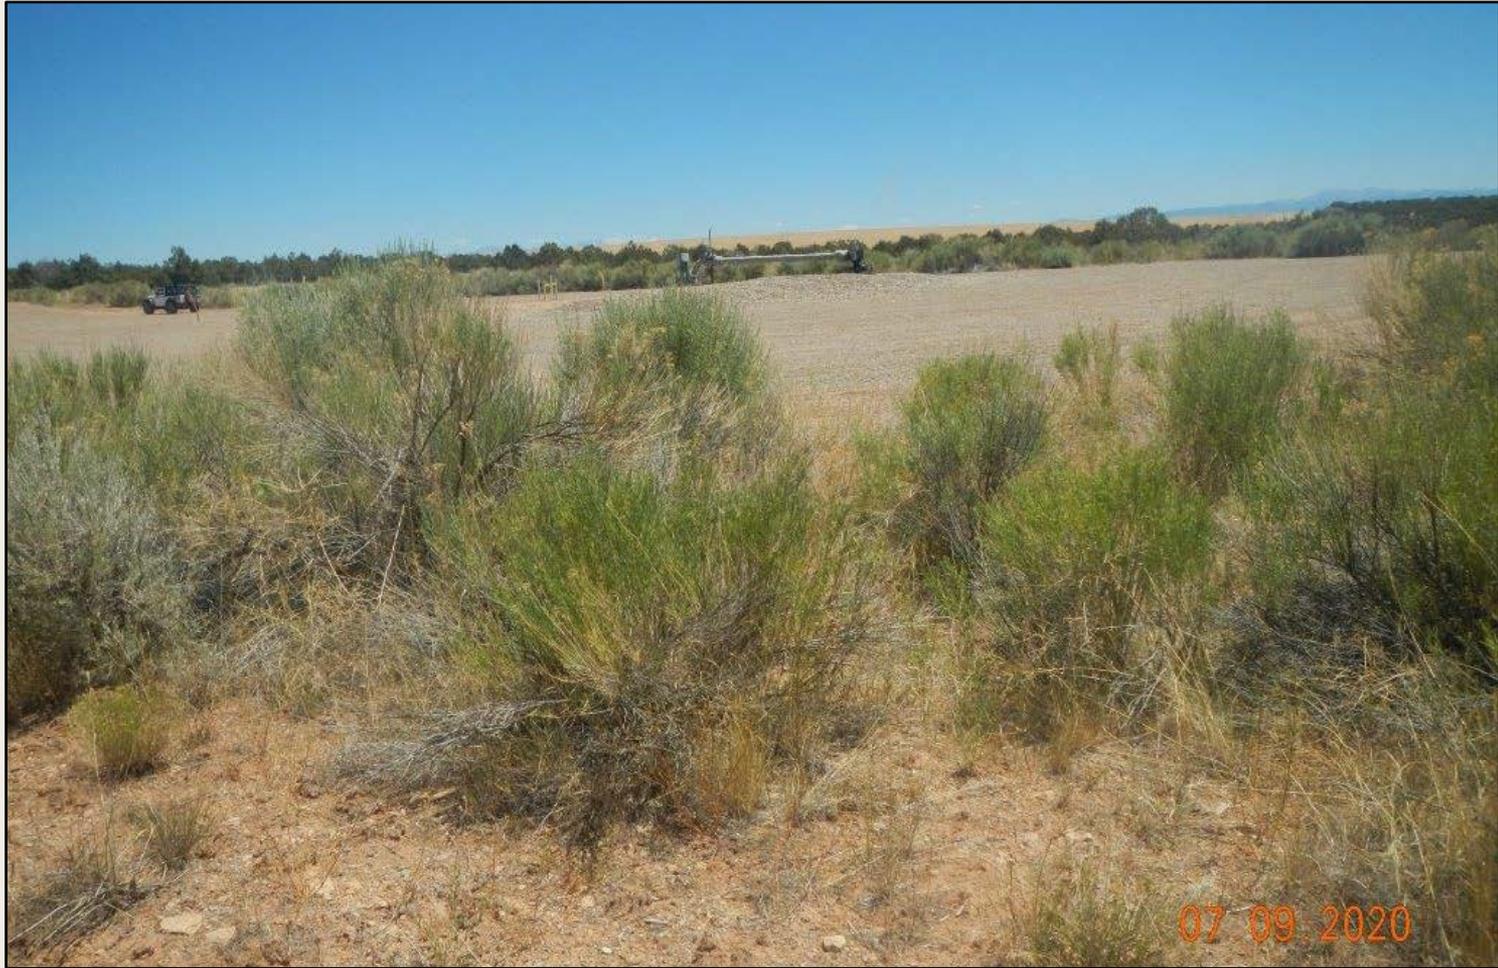
Photo 1. View of the project area from the northeastern corner facing center.

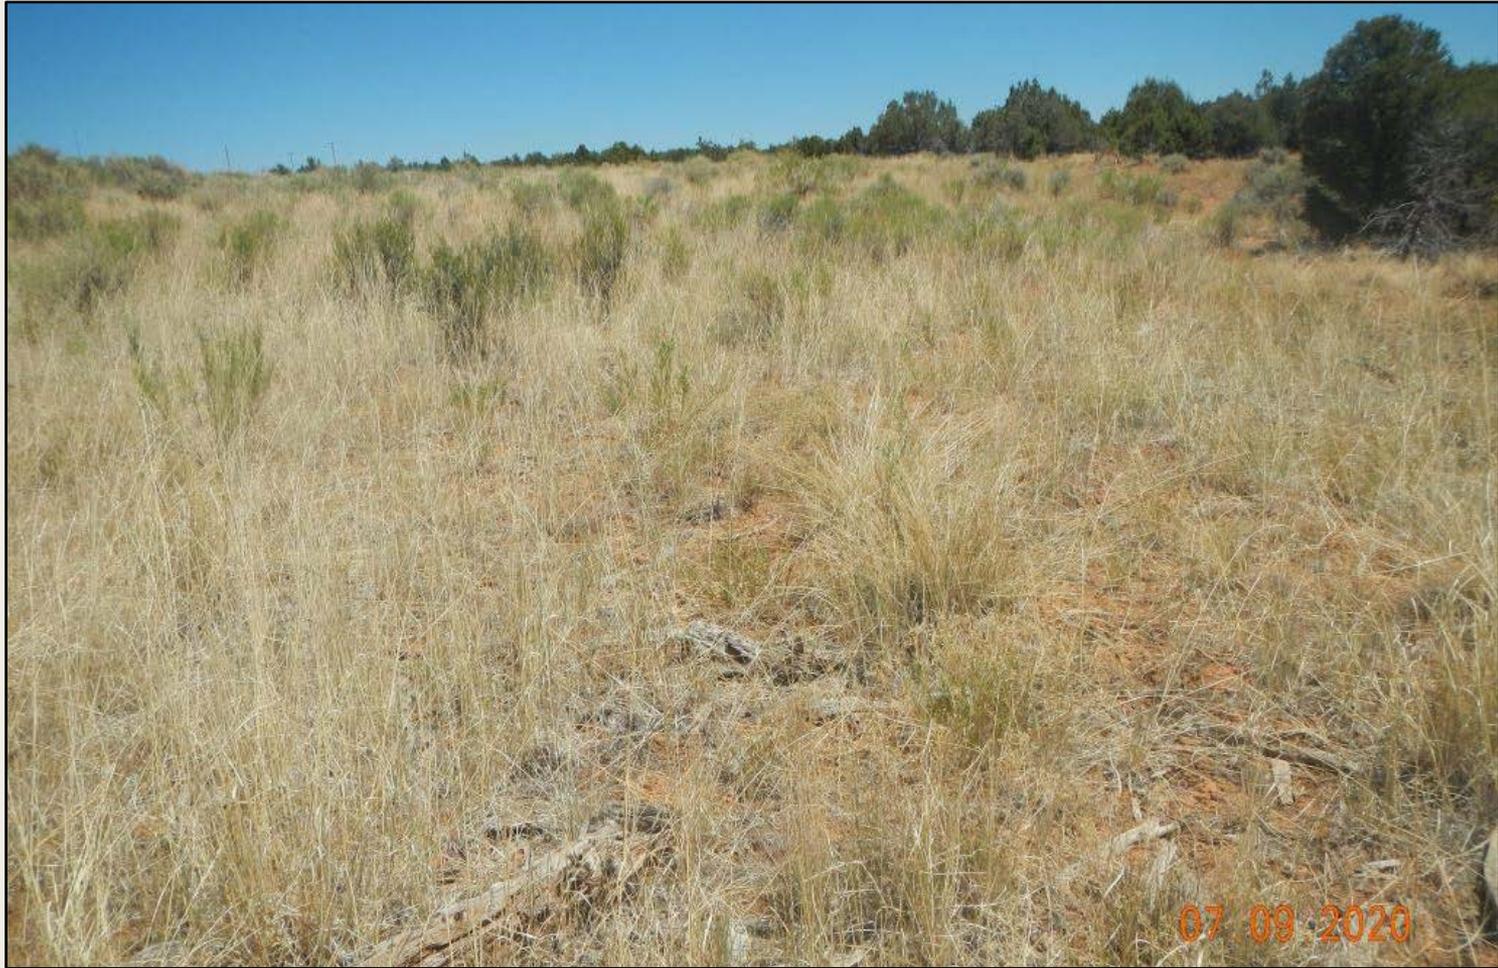
Photo 2. View of the southern project area facing westward. Revegetation is progressing with crested wheatgrass, and western wheatgrass, rubber rabbitbrush, and fourwing saltbush.

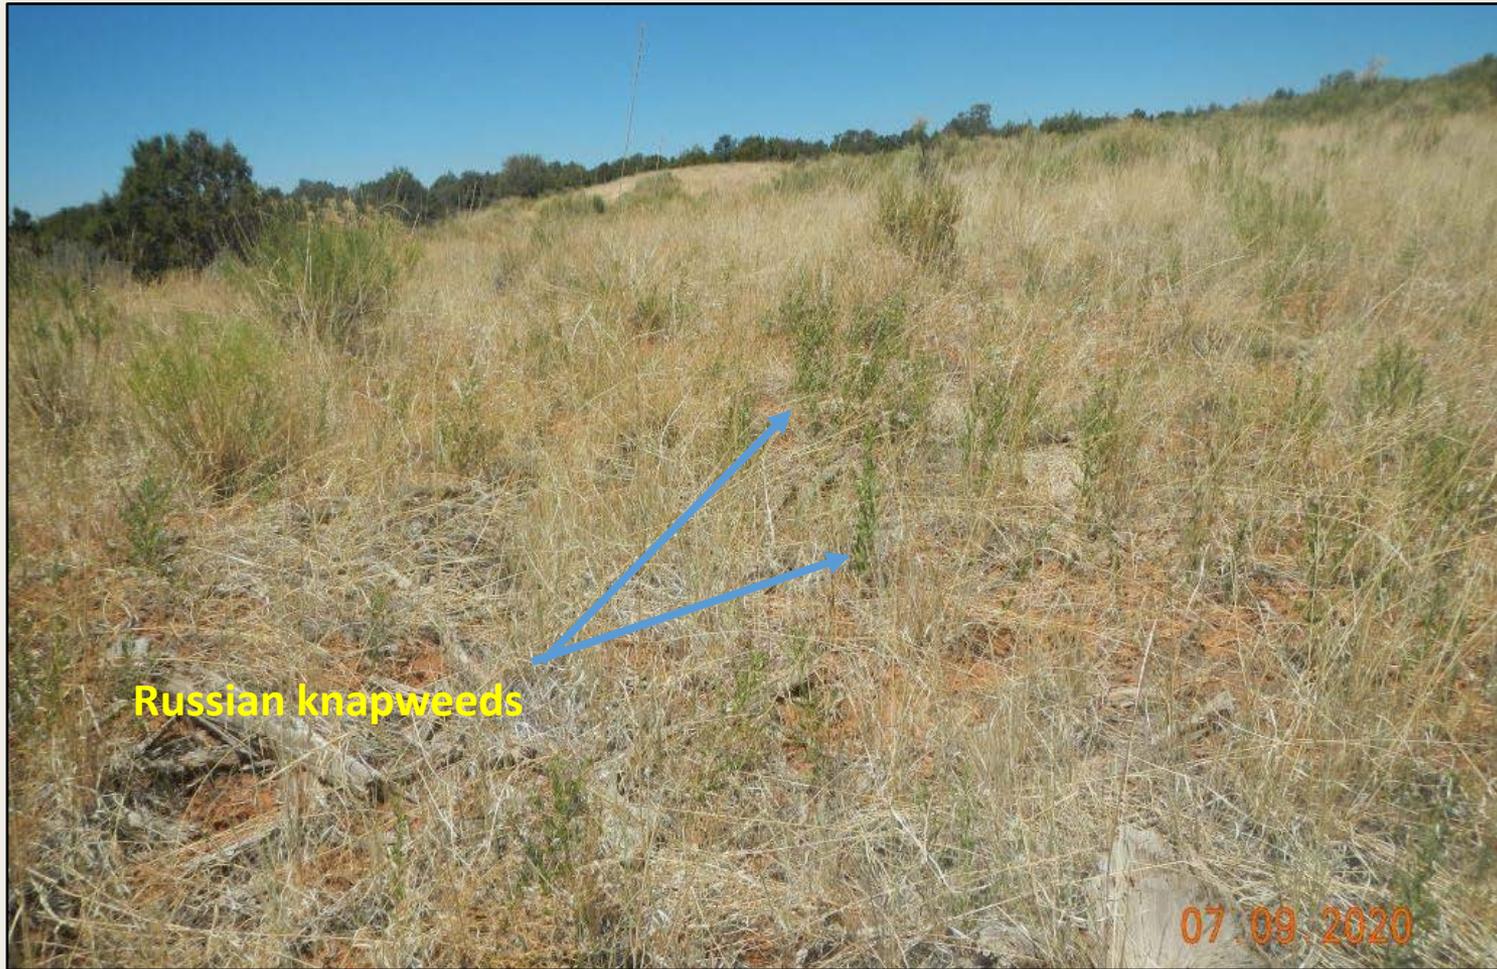
Photo 3. View of the western project area facing northward. Scattered Russian knapweeds observed throughout the project area. Approximately 2000 individuals observed.

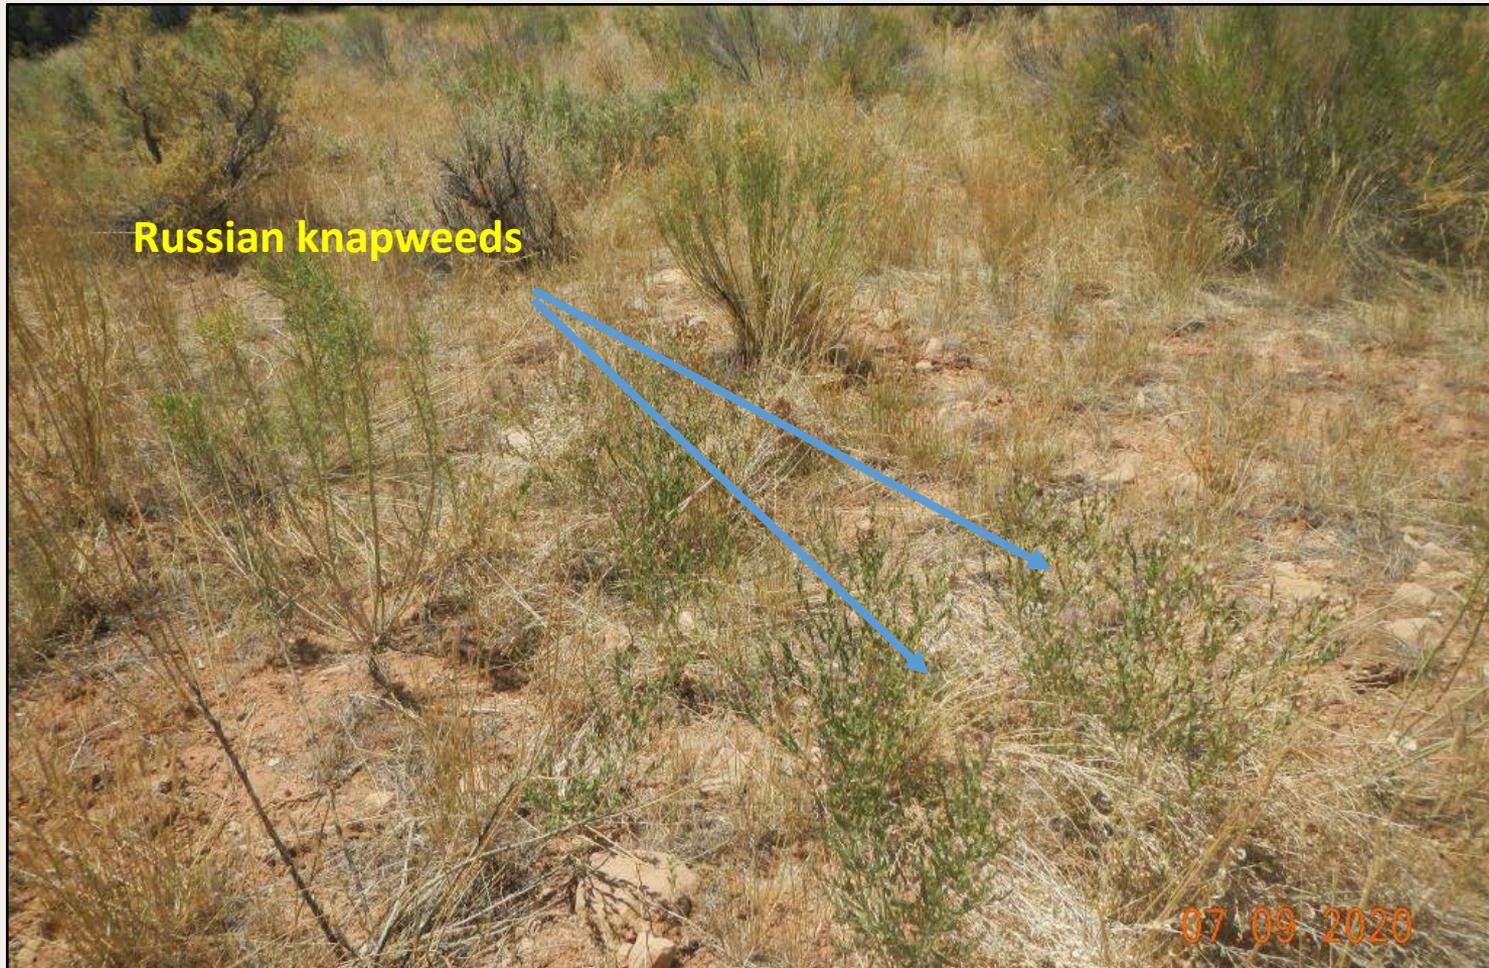
Photo 4. Another view of Russian knapweeds within the project area.

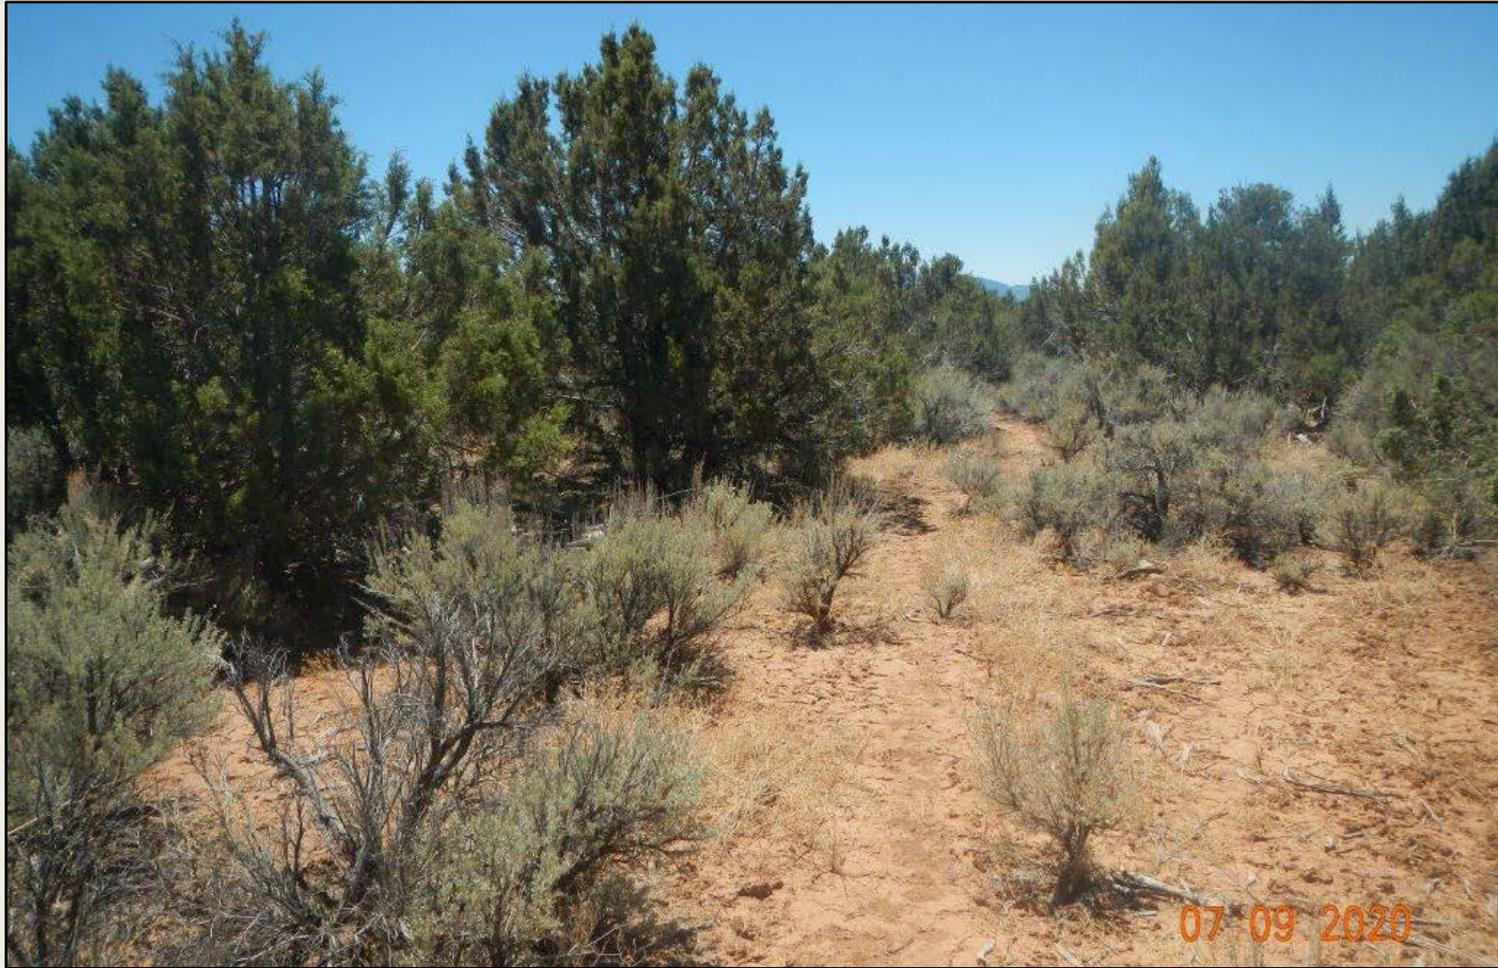
Photo 5. View of the reference area, comprised of pinyon juniper woodland with sagebrush understory and grasses/forbs such as Indian ricegrass, snakeweed, and penstemon.
