Inspection Photos

Operator: Kinder Morgan
API: 083-06339
Date: 7/9/2020

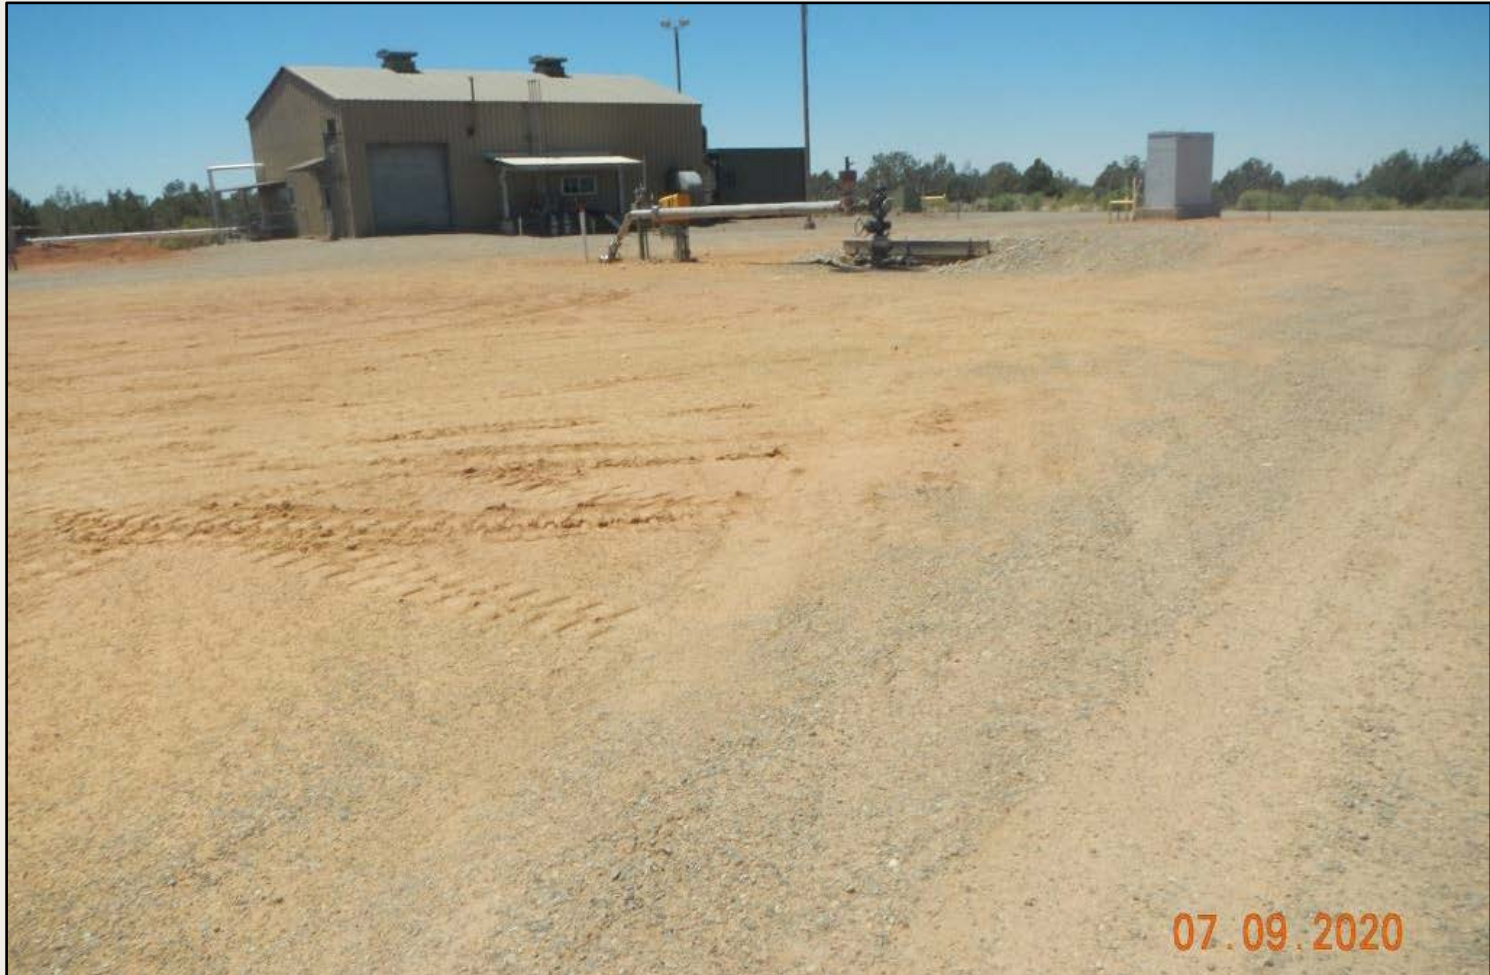
Photo 1. View of the project area from the well pad entrance facing center.

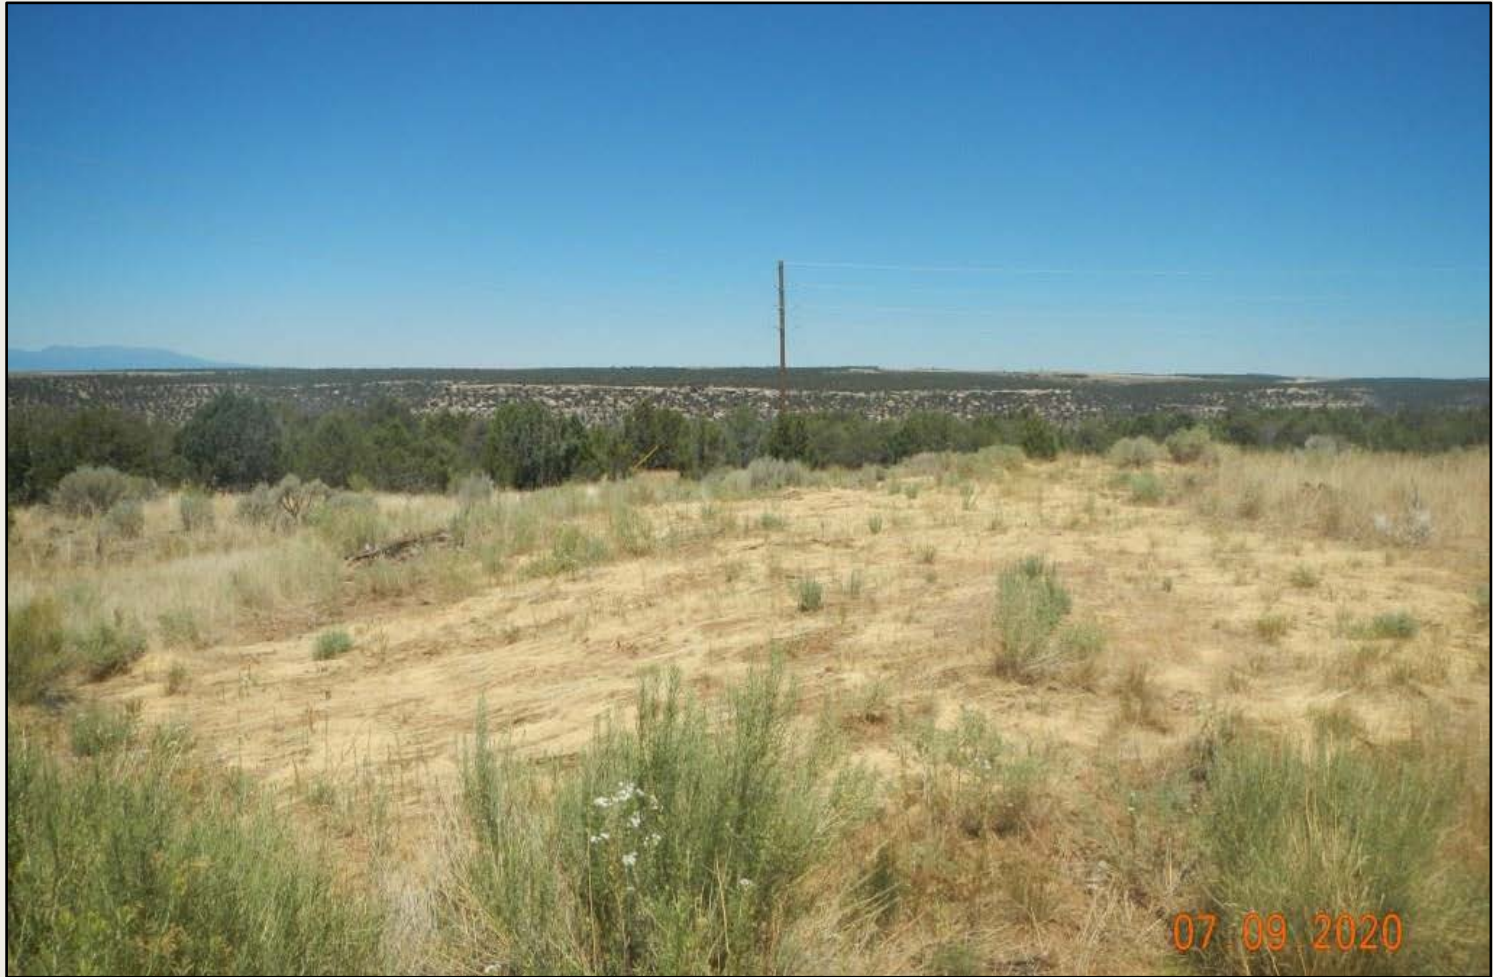
Photo 2. View of area in the northern project area where revegetation is recently conducted. Hay mulch and young grasses observed within the revegetation areas.

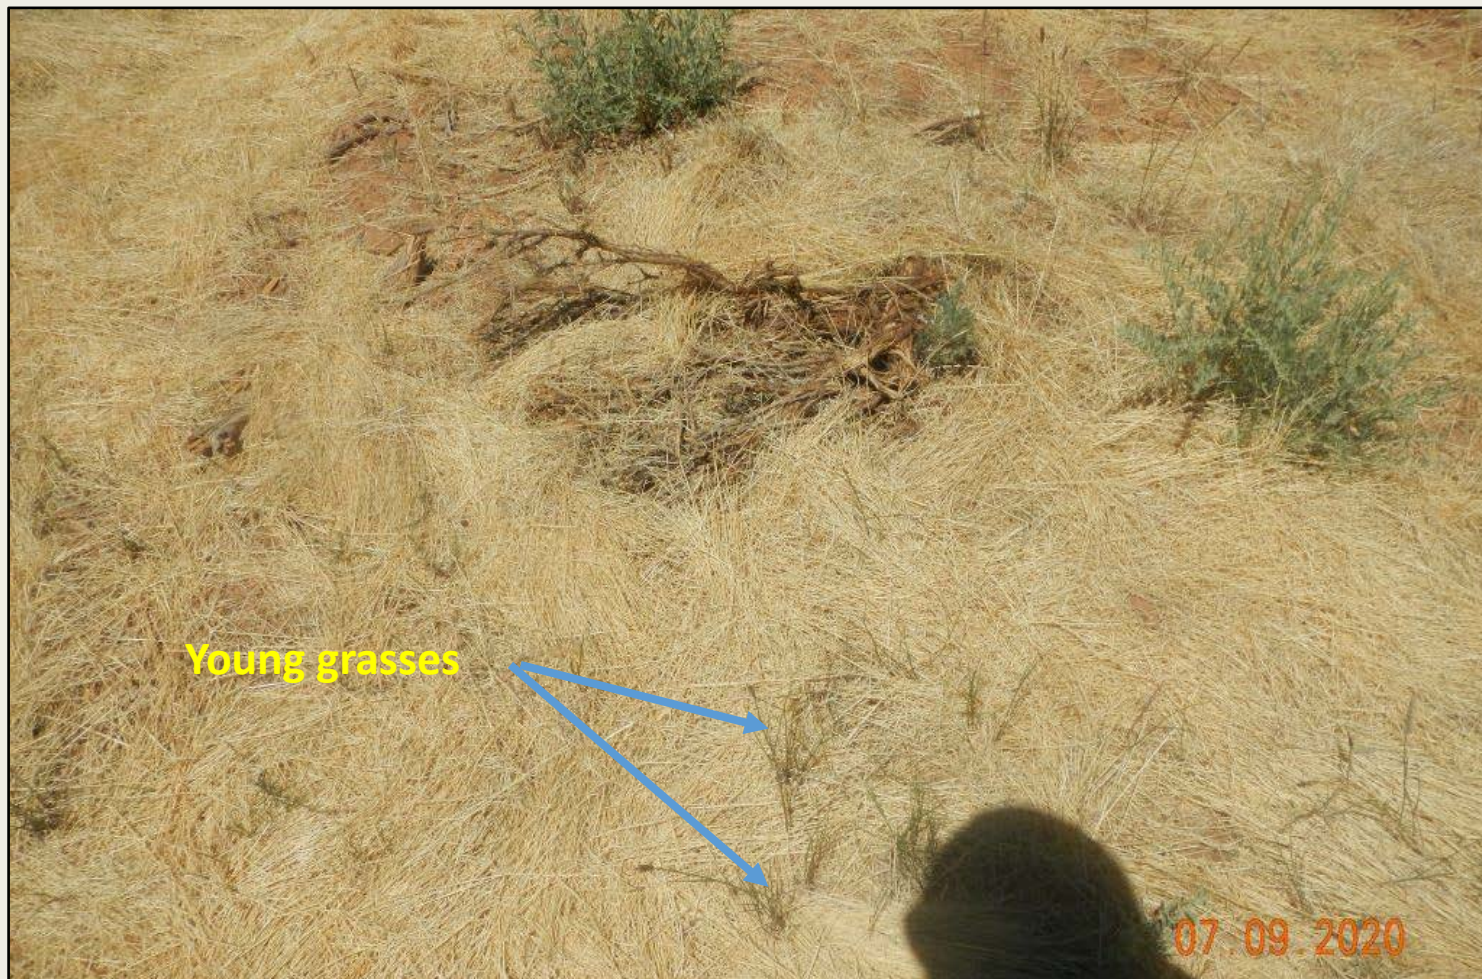
Photo 3. Birdseye view of hay mulch and young grass seedlings in the northern project area.

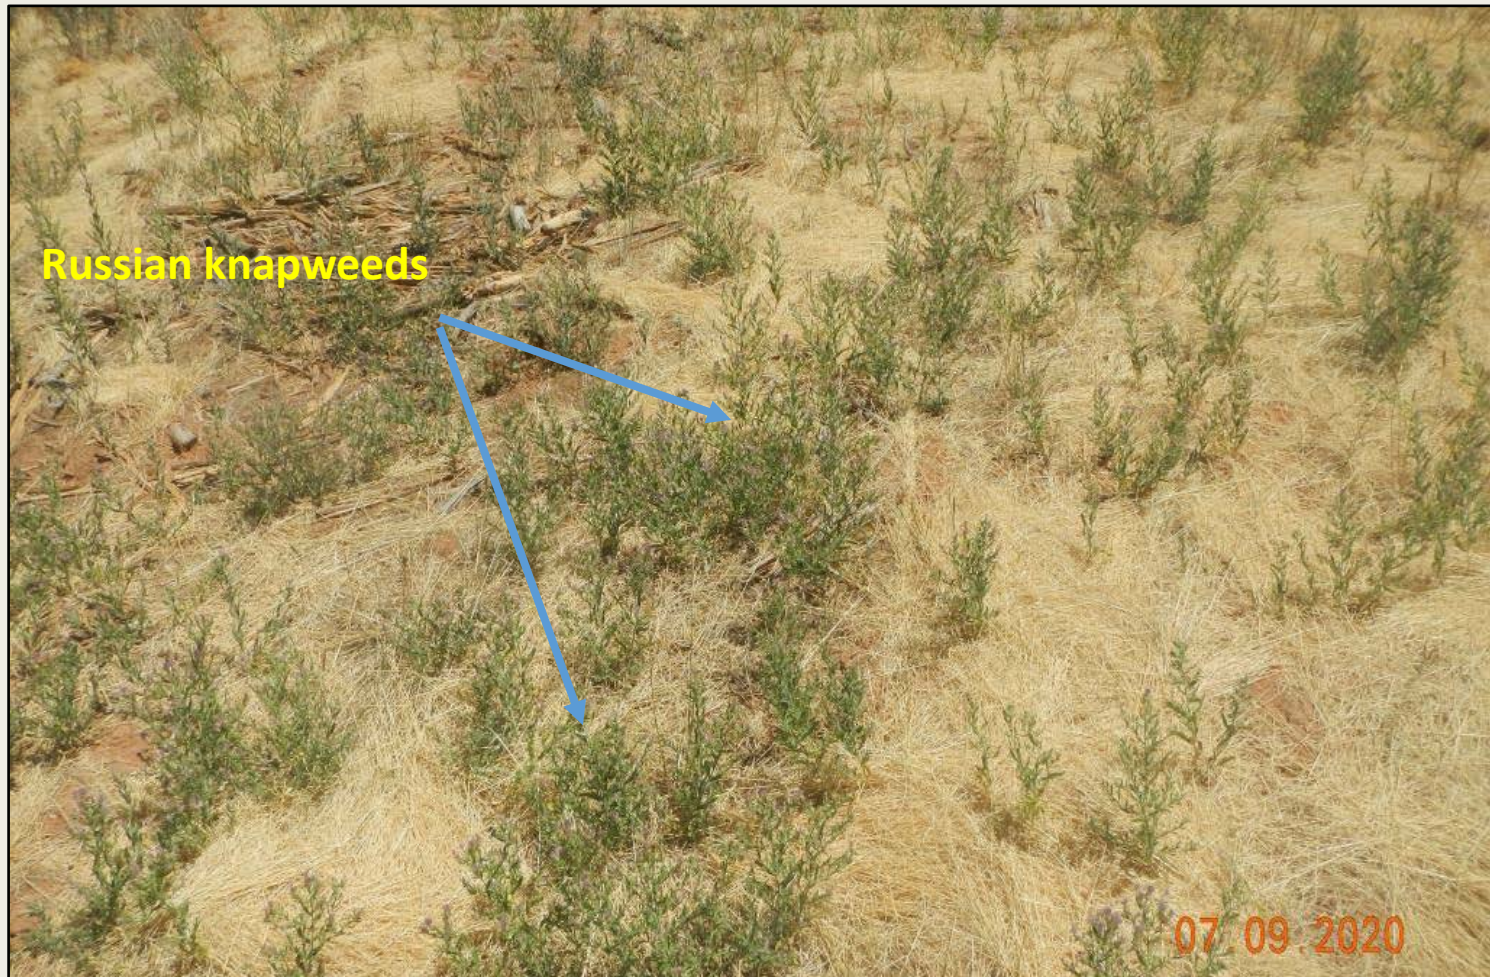
Photo 4. View of dense Russian knapweeds within the northern project area. Approximately 2000 individuals observed.

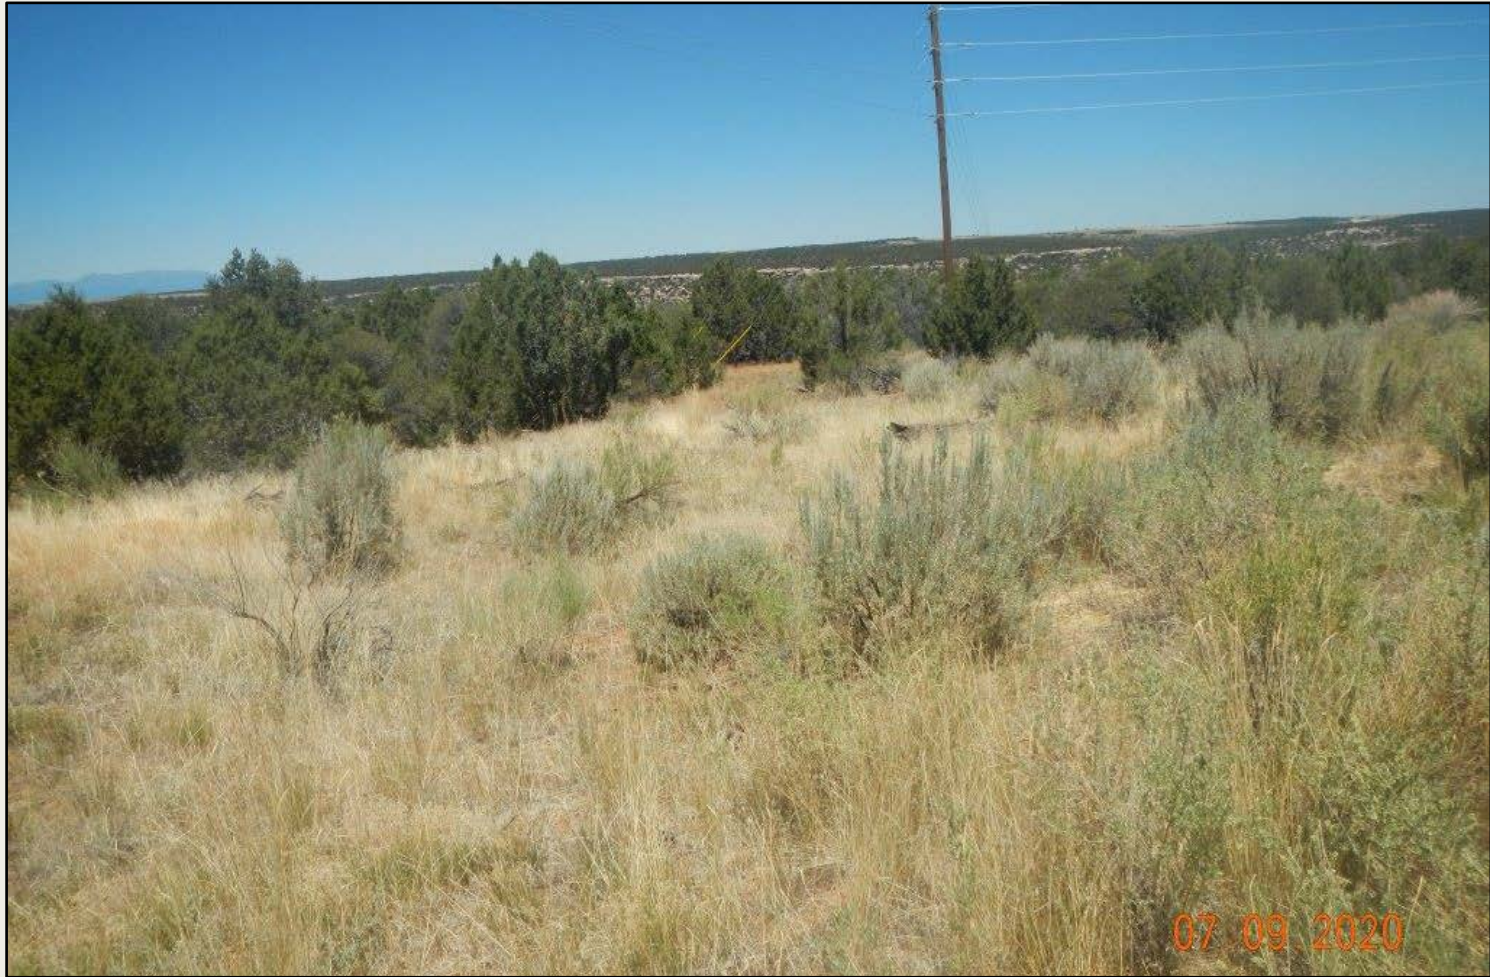
Photo 5. View of the northern project area from the norwestern corner facing eastward. Revegetation is progressing in portions with grasses such as crested wheatgrass and shrubs such as fourwing saltbush and rubber rabbitbrush.

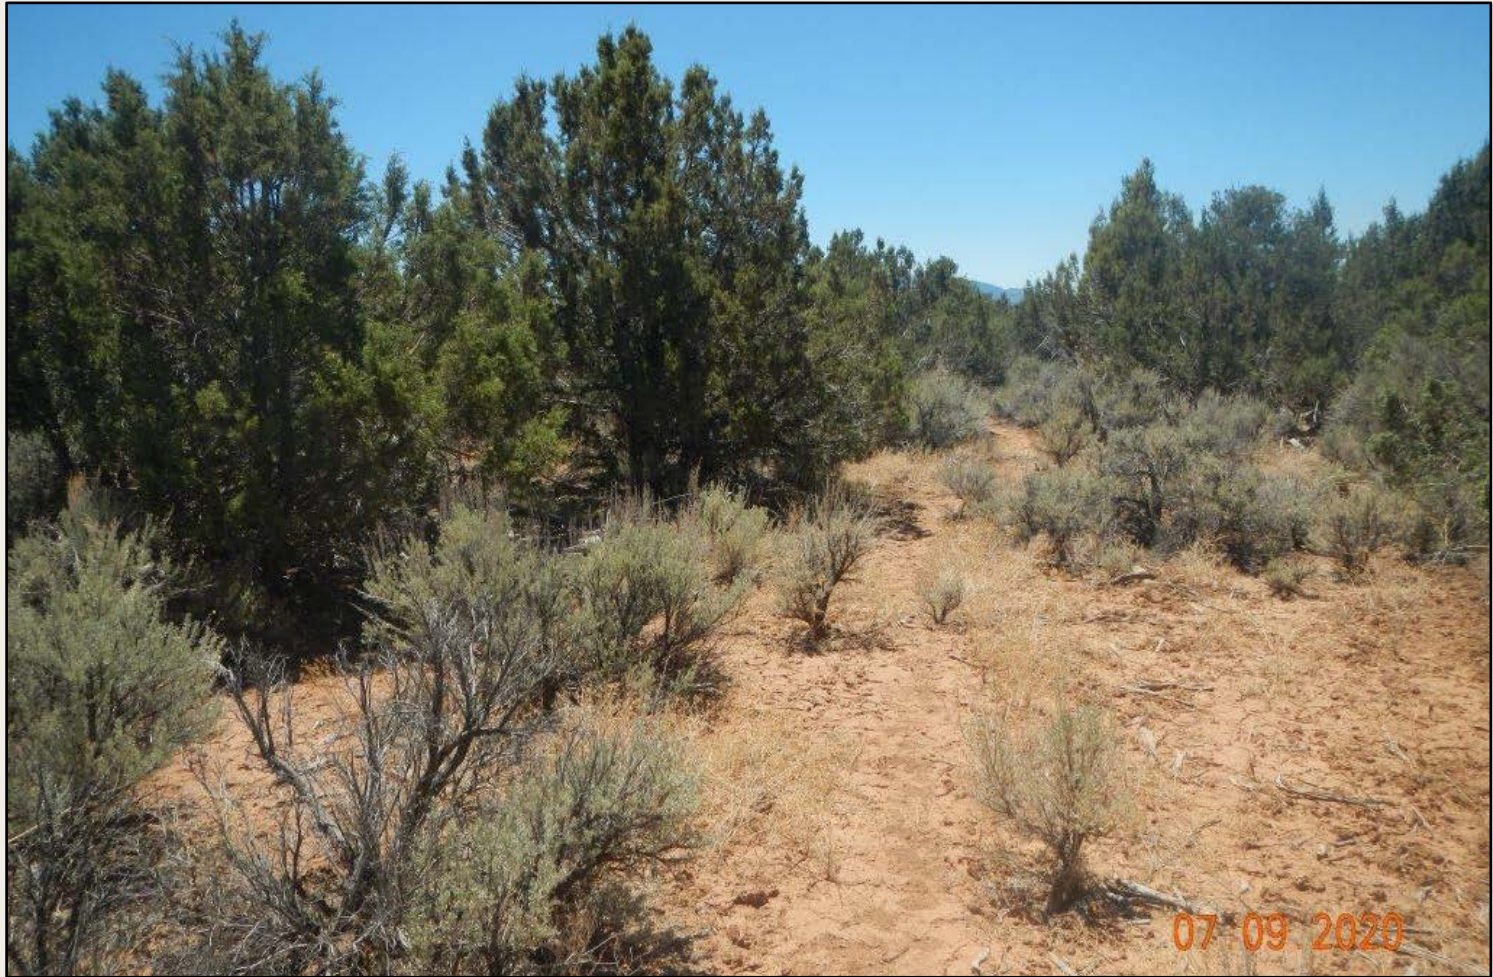
Photo 6. View of the reference area, comprised of pinyon juniper woodland with sagebrush understory and grasses/forbs such as Indian ricegrass, snakeweed, and penstemon.
