Inspection Photos
Operator: Kinder Morgan
API: 083-06593
Date: 7/9/2020

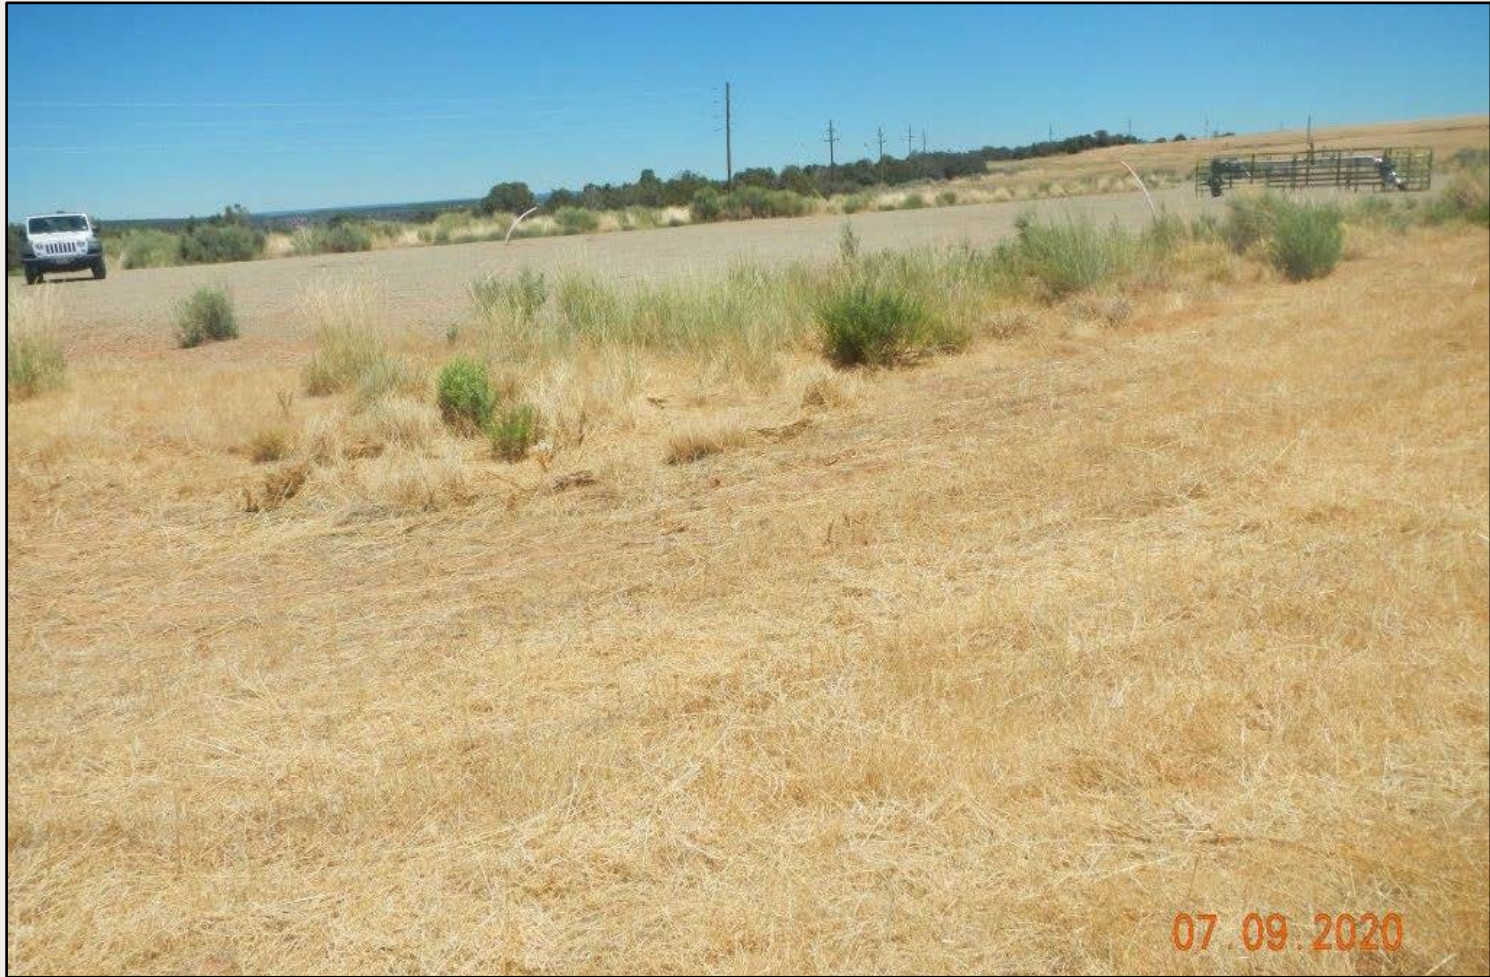
Photo 1. View of the project area from the southwestern corner facing center.

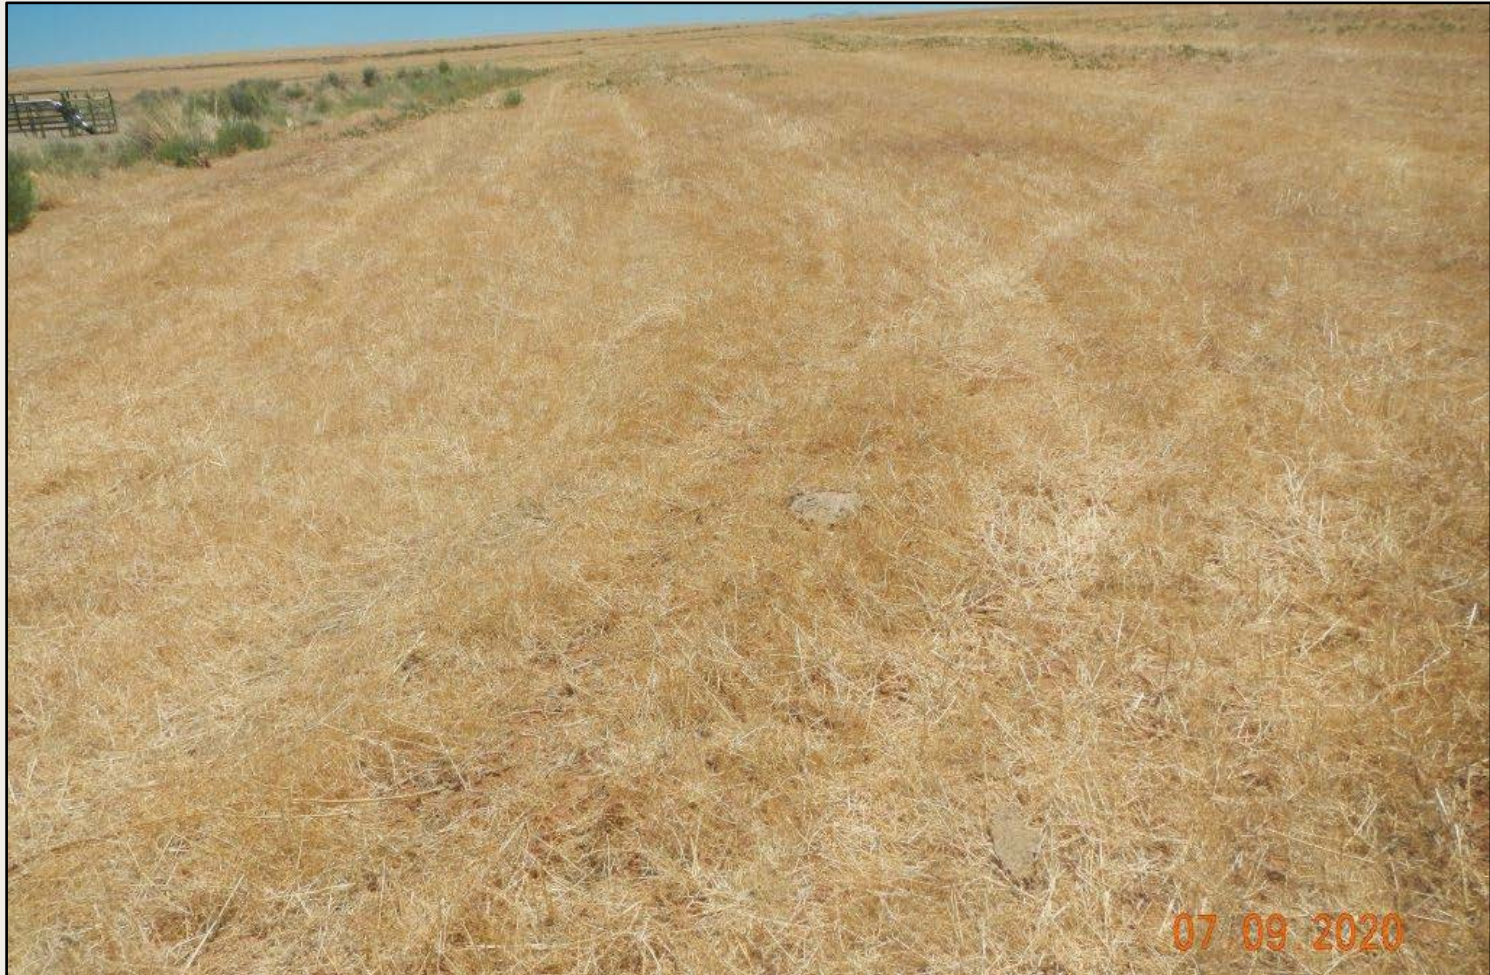
Photo 2. View of the southern project area facing eastward from the southwestern corner. Vegetation is within a dryland wheat field in a mowed condition.

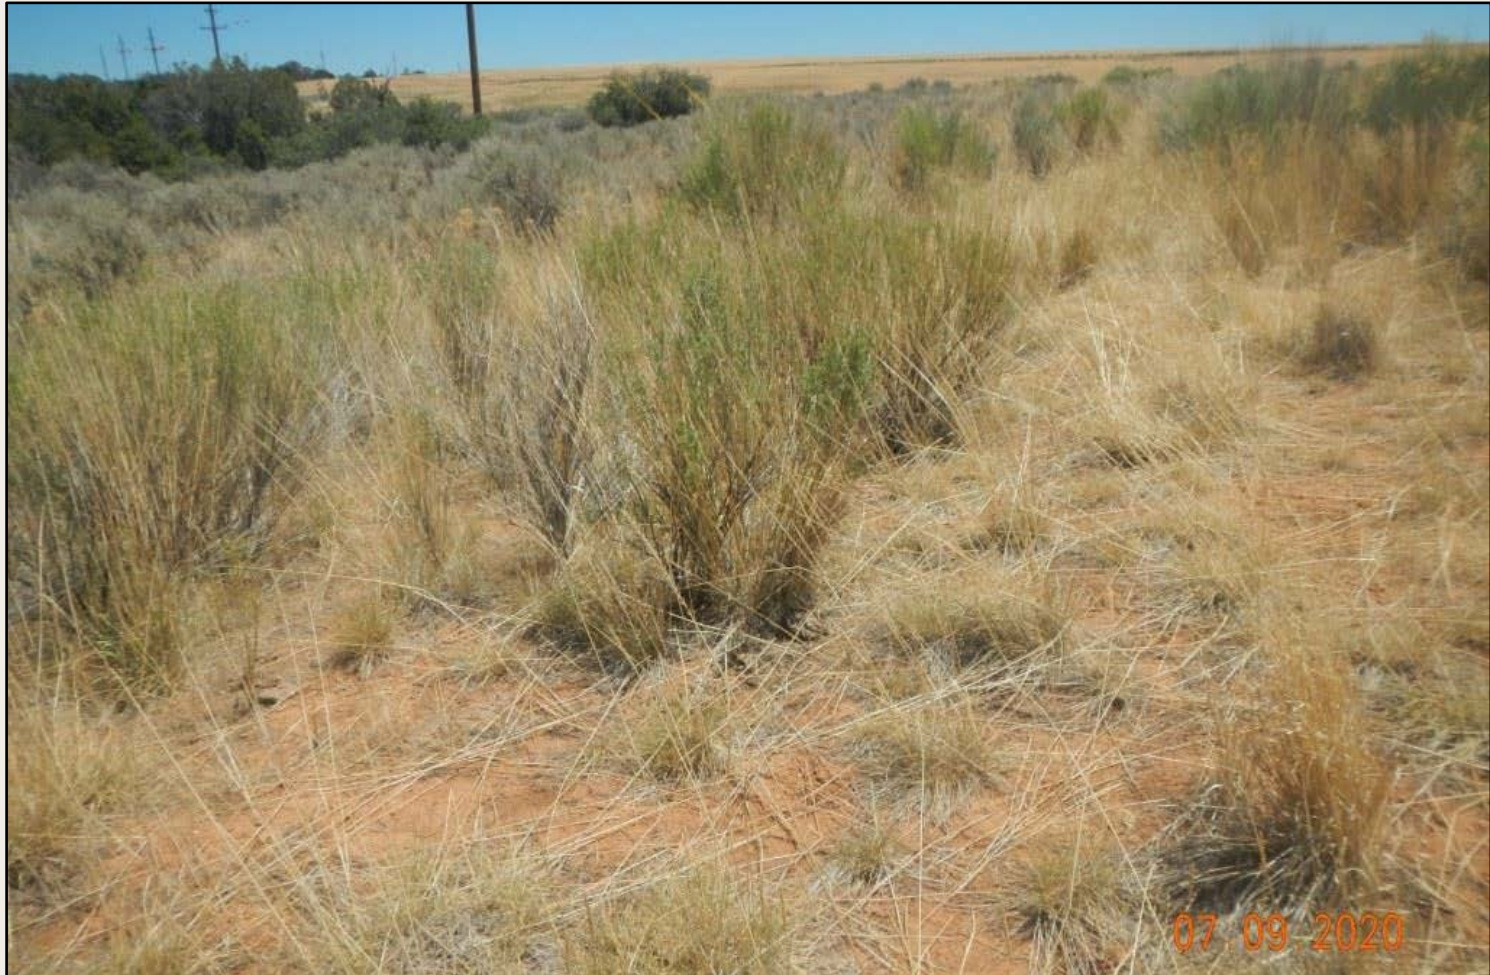
Photo 3. View of the northern project area facing eastward from the northwestern corner. Revegetation is progressing with grasses such as crested wheatgrass as well as shrubby rubber rabbitbrush.

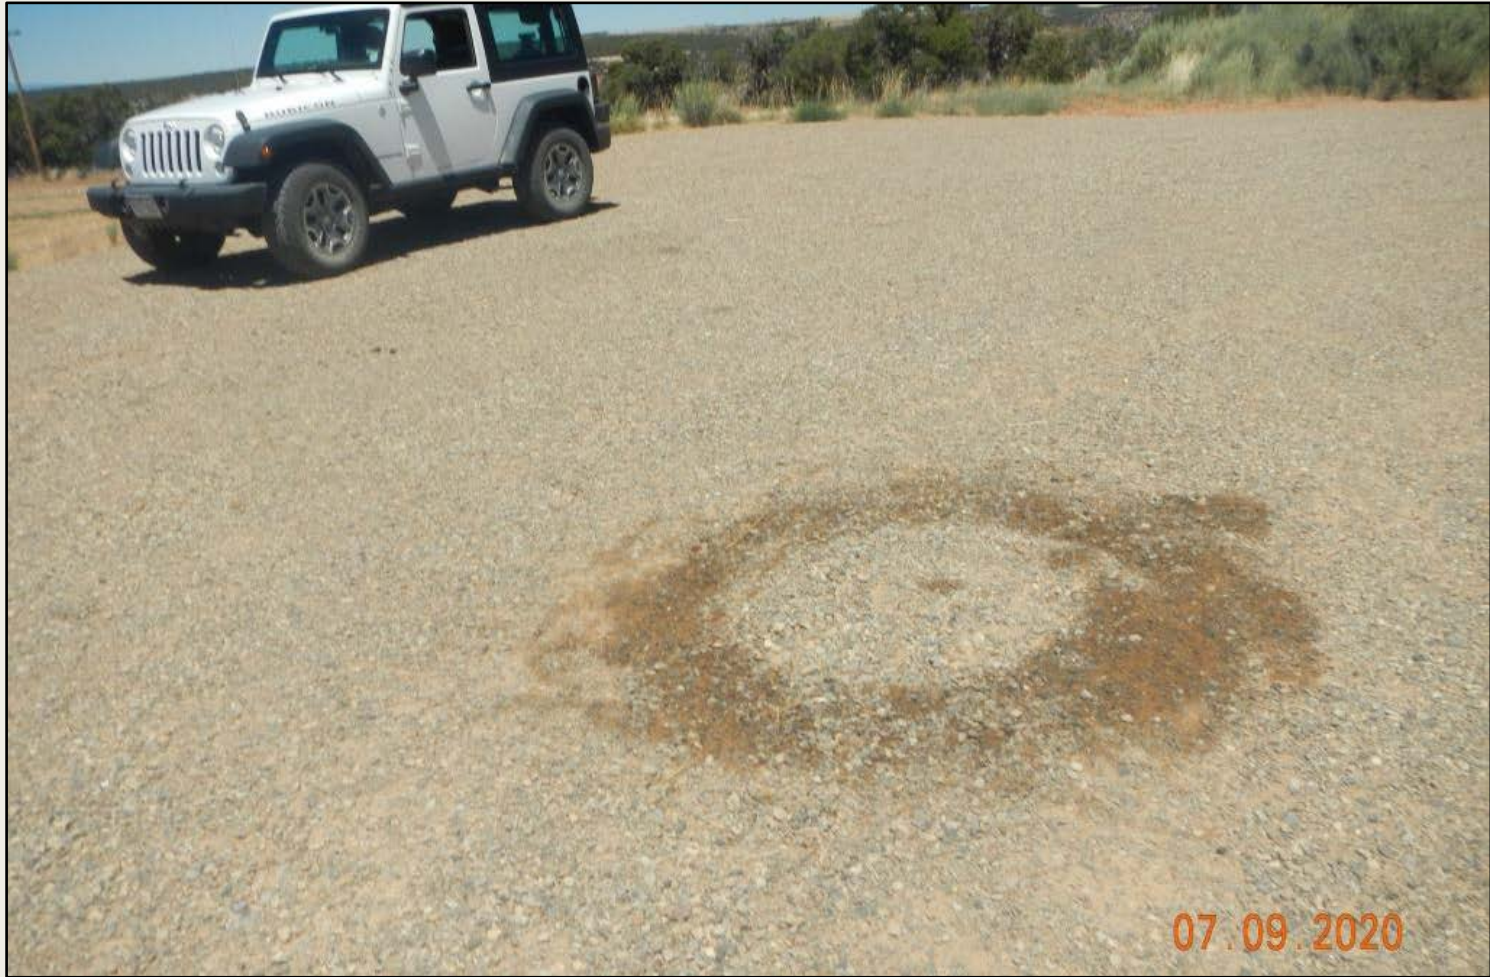
Photo 4. View of staining approximately 3 feet in diameter, within the northwestern portion of the well pad.

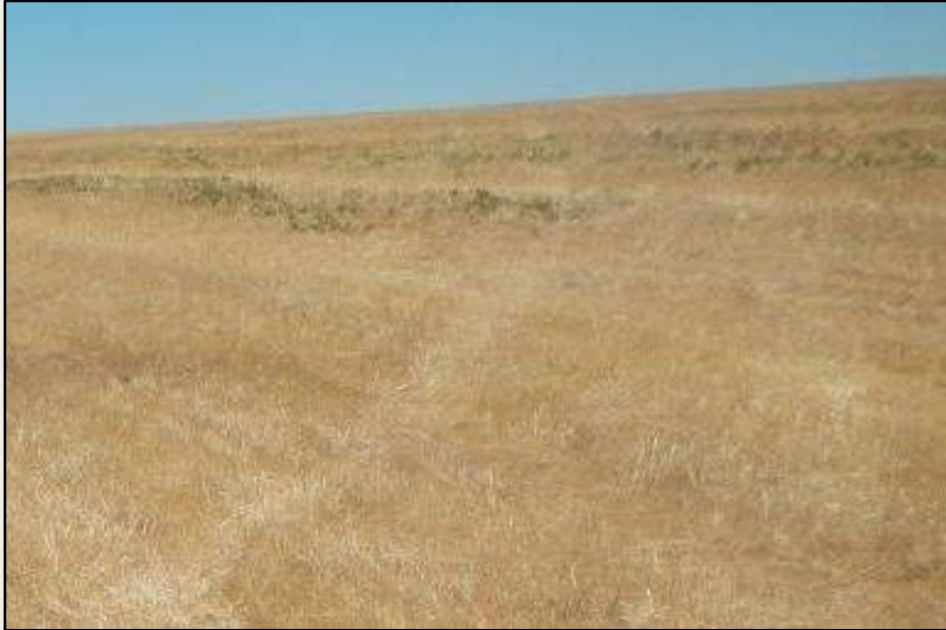
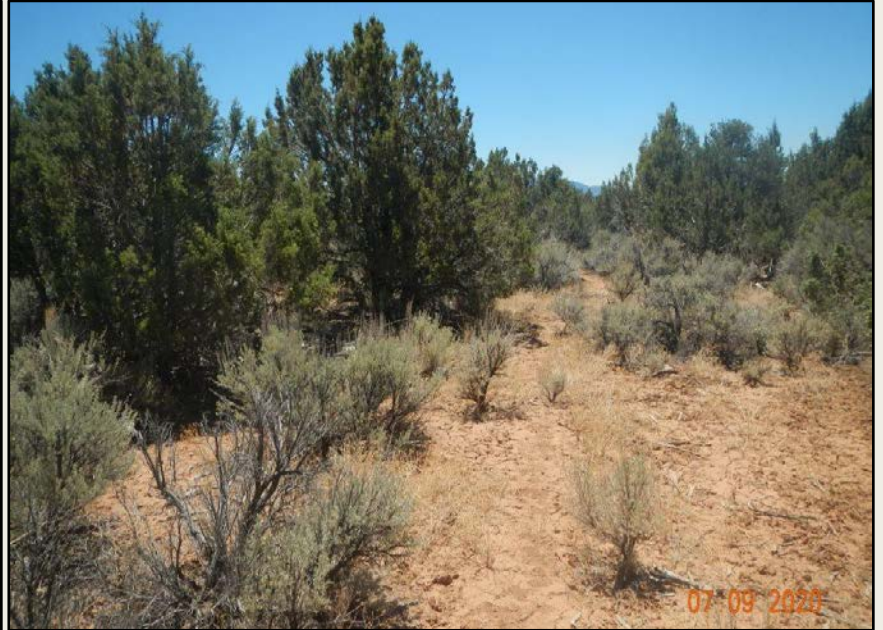
Photo 5/6. View of the reference area, comprised of both dryland wheat field, and pinyon juniper woodland with sagebrush understory and grasses/forbs such as Indian ricegrass, snakeweed, and penstemon.
