Inspection Photos

Operator: CAERUS PICEANCE LLC - 10456

Location ID: 391243

Mesa County, CO

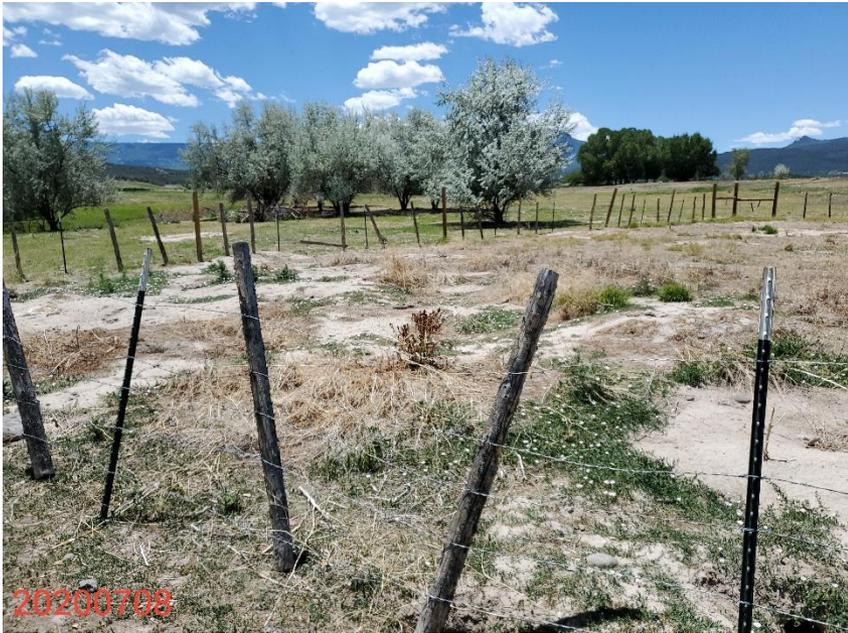
Photo 1: Photo taken from the north end of the Location, facing southeast. Photo shows additional reclamation activities and weed management does not appear to have been conducted.

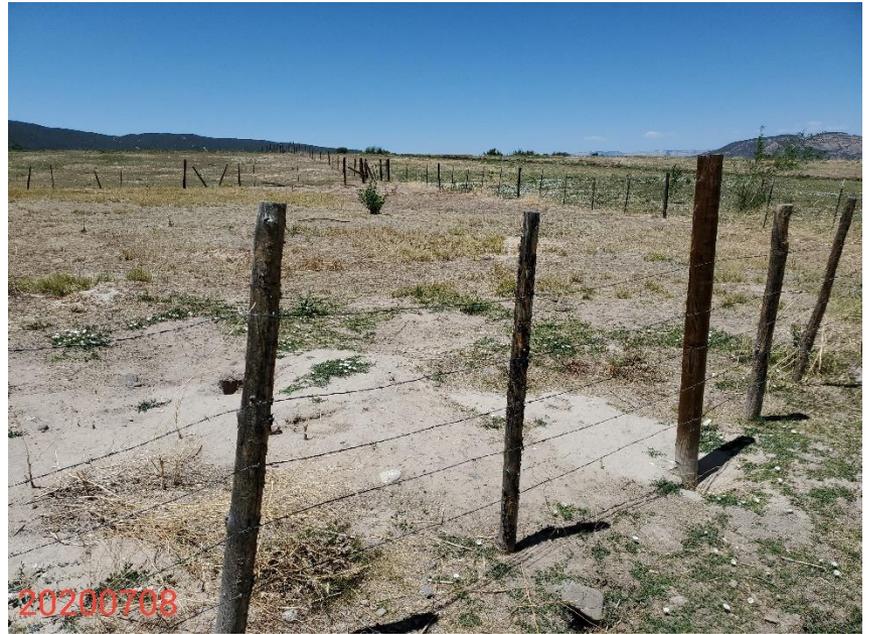
Photo 2: Photo taken from the north end of the Location, facing southwest. Photo shows additional reclamation activities and weed management does not appear to have been conducted.

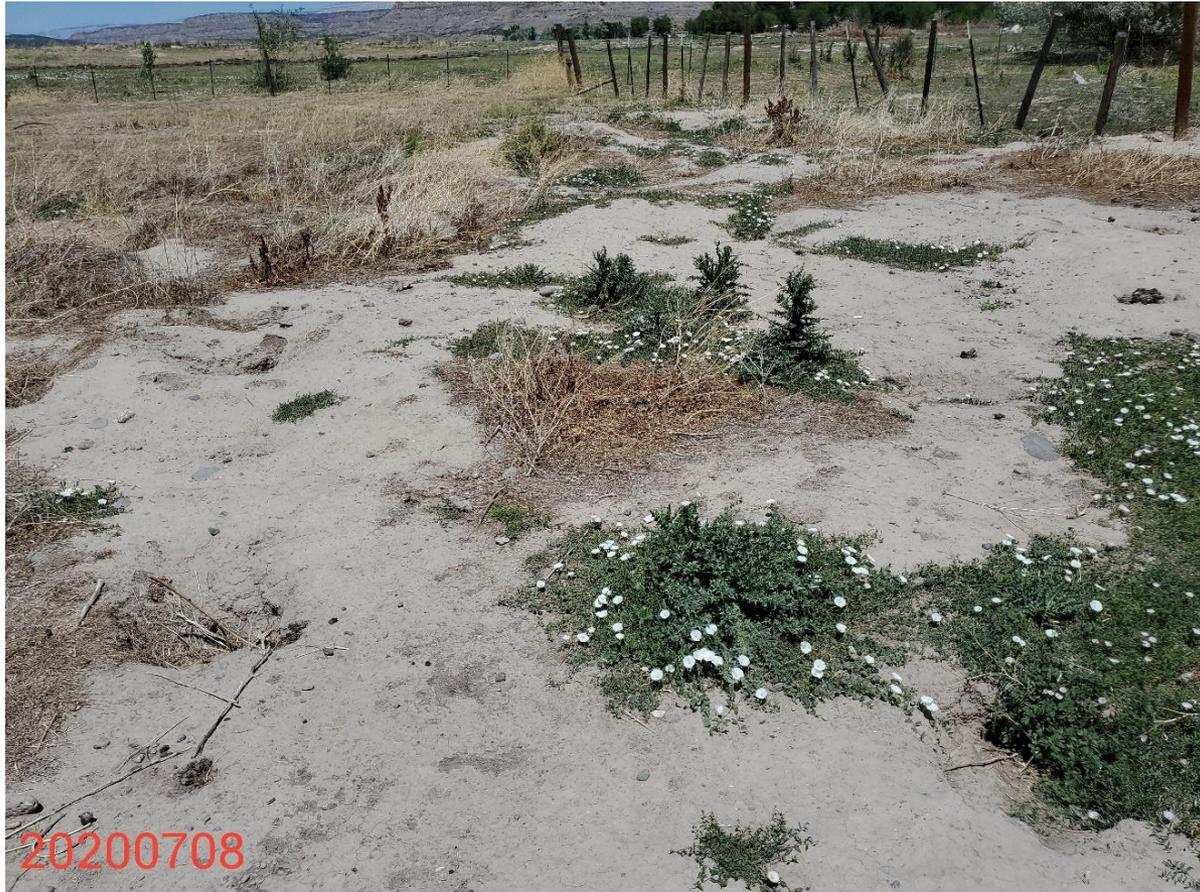
Photo 3: Photo of the Location. Photo shows what appears to be Musk thistle and field bindweed. These are Colorado State listed noxious weeds.
