Inspection Photos

Operator: LARAMIE ENERGY LLC - 10433

Location ID: 312473

Mesa County, CO

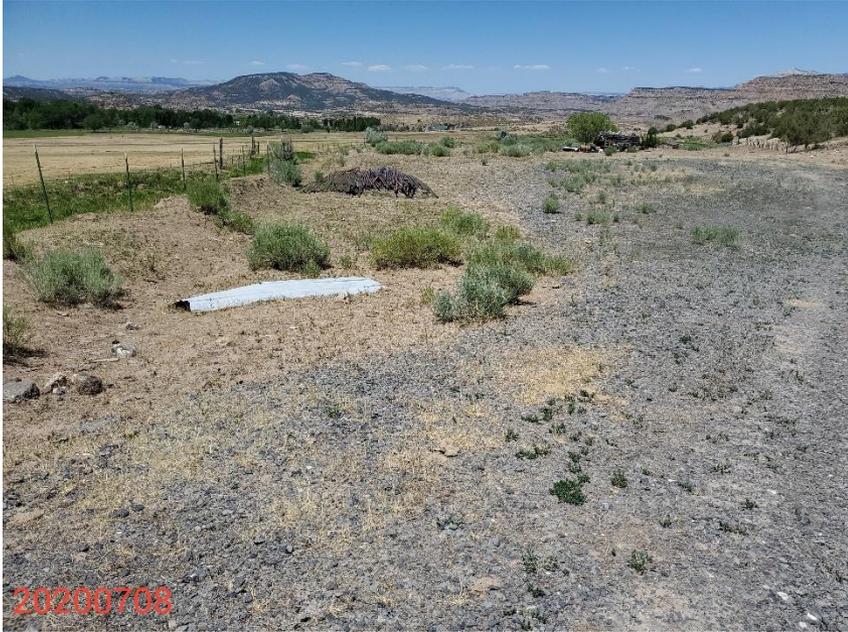
Photo 1: Photo taken from the south end of the Location, facing Northwest. Photo shows Location has not been reclaimed; Various pipe and debris appears to be stored on the Location. Gravel has not been removed; Compaction alleviation, recontouring/regrading and revegetation activities have not been conducted.

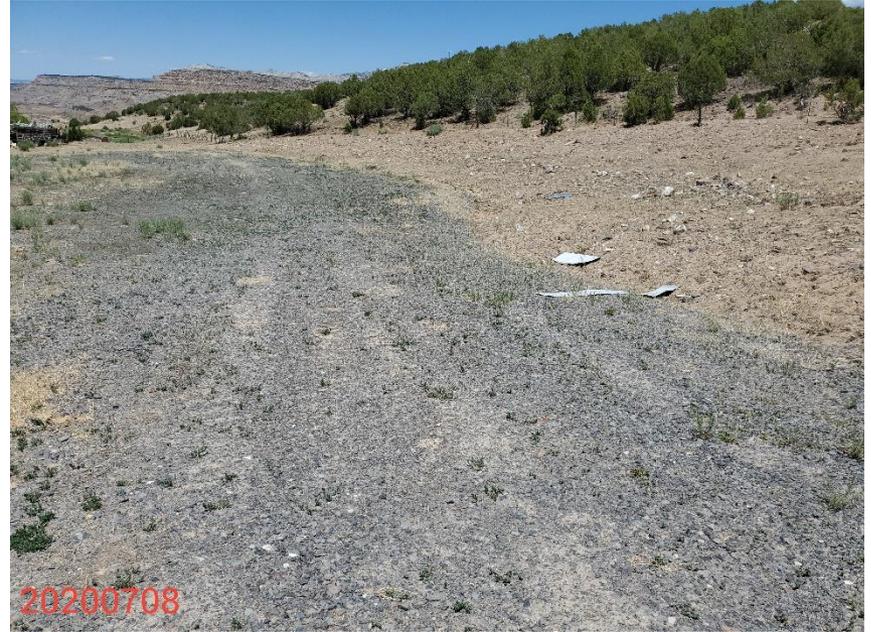
Photo 2: Photo taken from the south end of the Location, facing Northeast. See comments under photo 1.

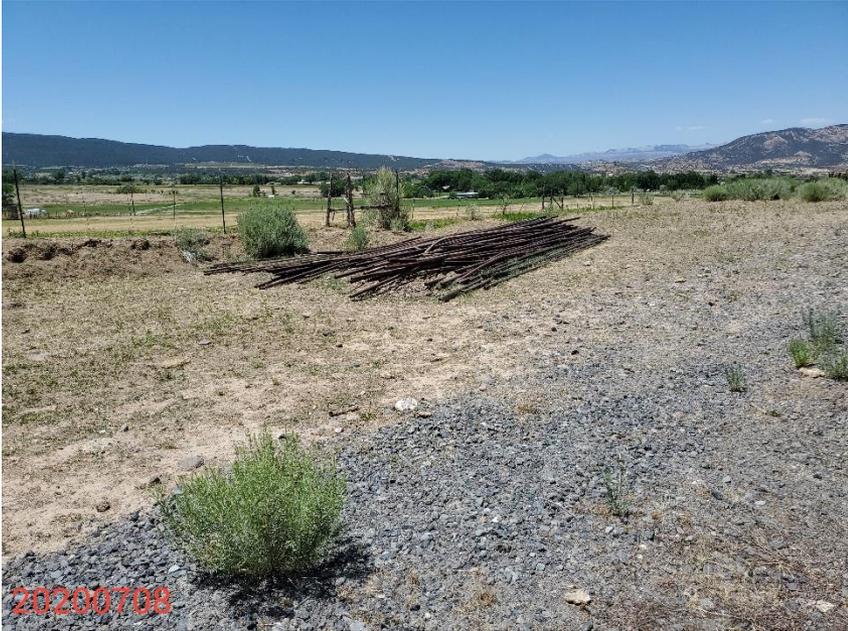
Photo 3: Photo of pipe stored on the west end of the Location.

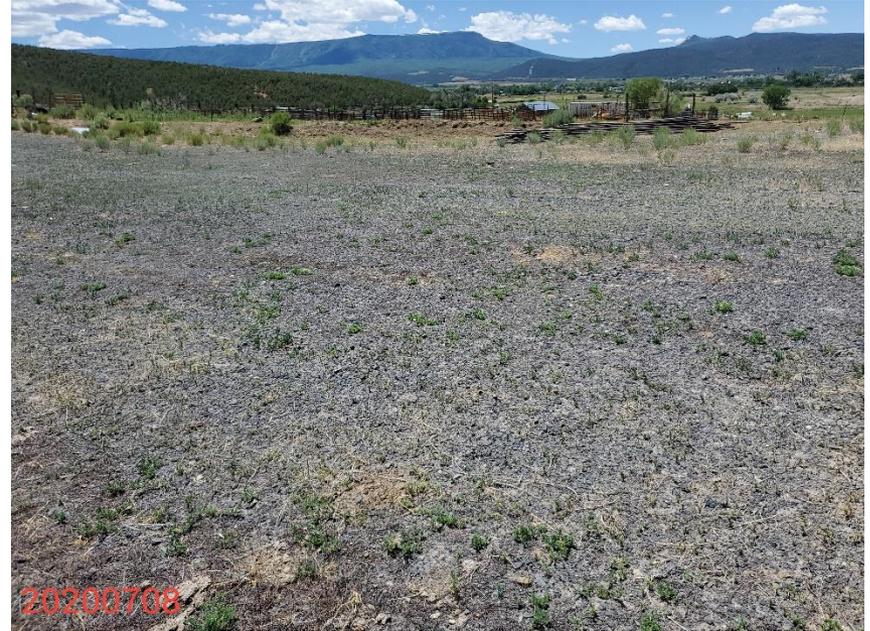
Photo 4: Photo taken from the east end of the Location, facing southwest. Photo shows Location has not been reclaimed in accordance with 1004 rules.

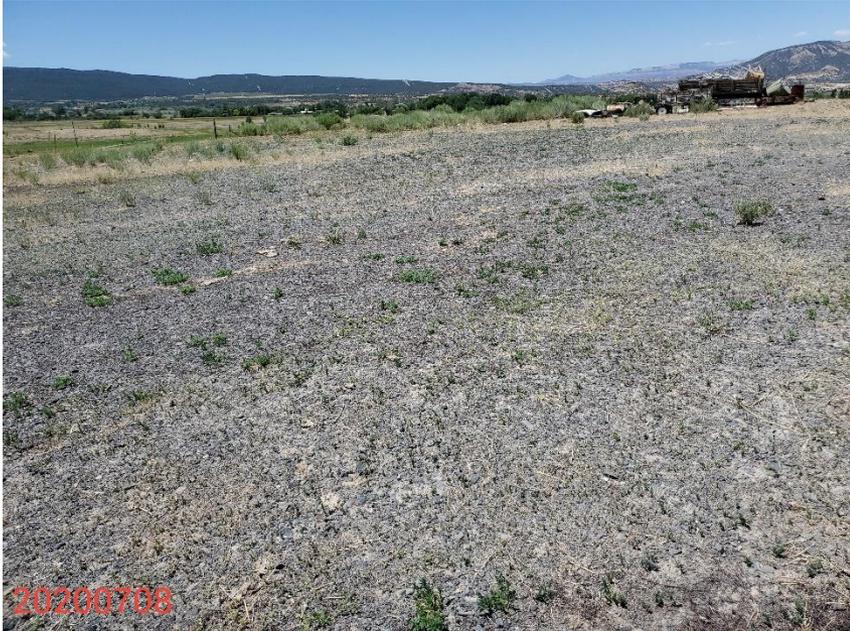
Photo 5: Photo taken from the east end of the Location, facing northwest. Photo shows Location has not been reclaimed in accordance with 1004 rules. Photo also shows various debris stored on the north end of the Location.

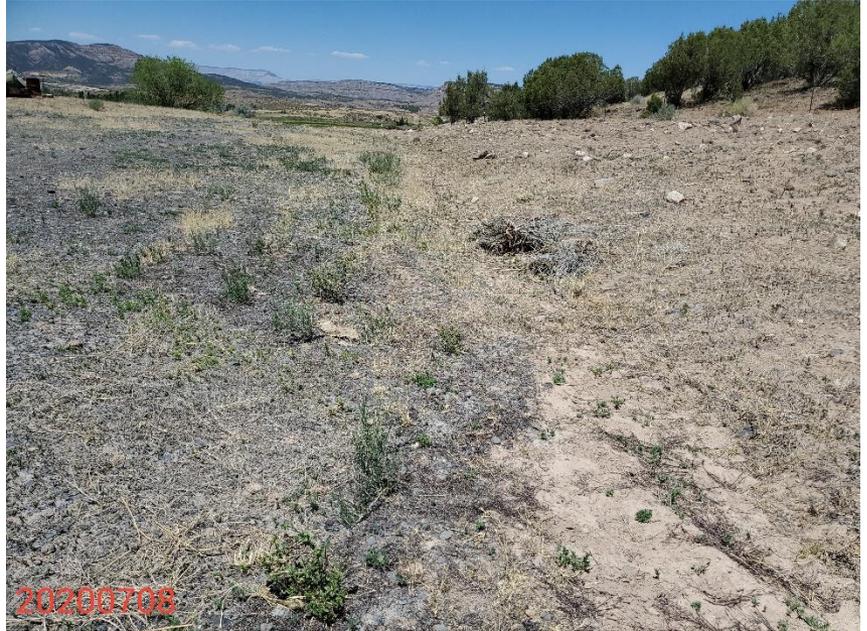
Photo 6: Photo taken from the east end of the Location, facing north. Photo shows Location has not been reclaimed in accordance with 1004 rules.
