Inspection Photos

Operator: CAERUS PICEANCE LLC - 10456

Location ID: 312455

Mesa County, CO

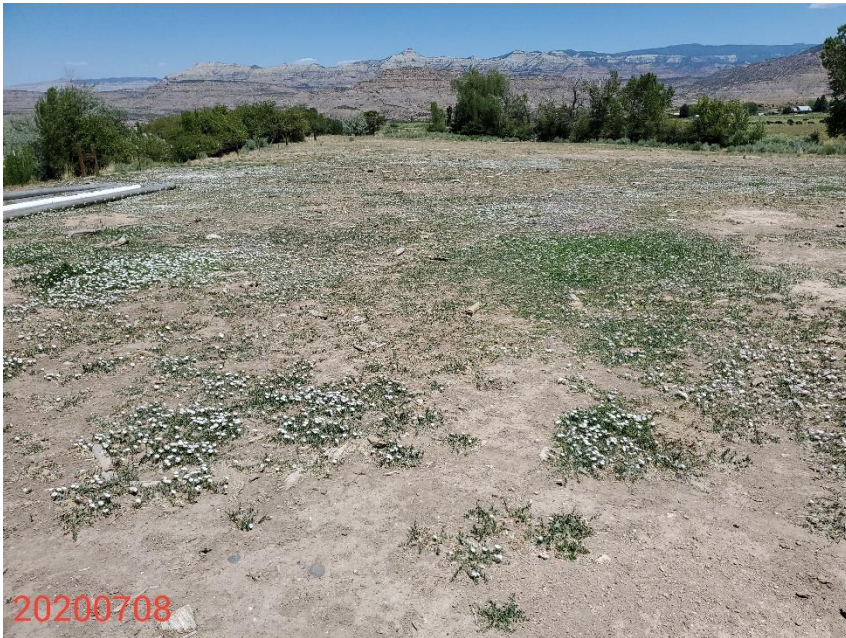
Photo 1: Photo taken from the southwest end of the Location facing north. Photo shows reclamation of the Location is not progressing toward COGCC 1004 standards; Vegetation seen in photo noxious weeds consisting of Field Bindweed or Houndstongue. Little to no desirable perennial vegetative establishment observed on Location.

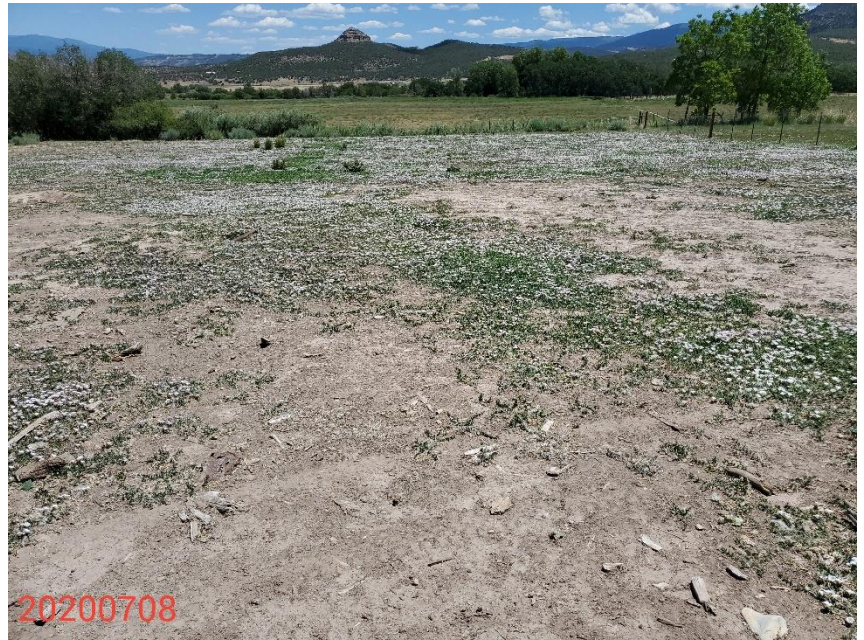
Photo 2: Photo taken from the southwest end of the Location facing east. See comments under photo 1.

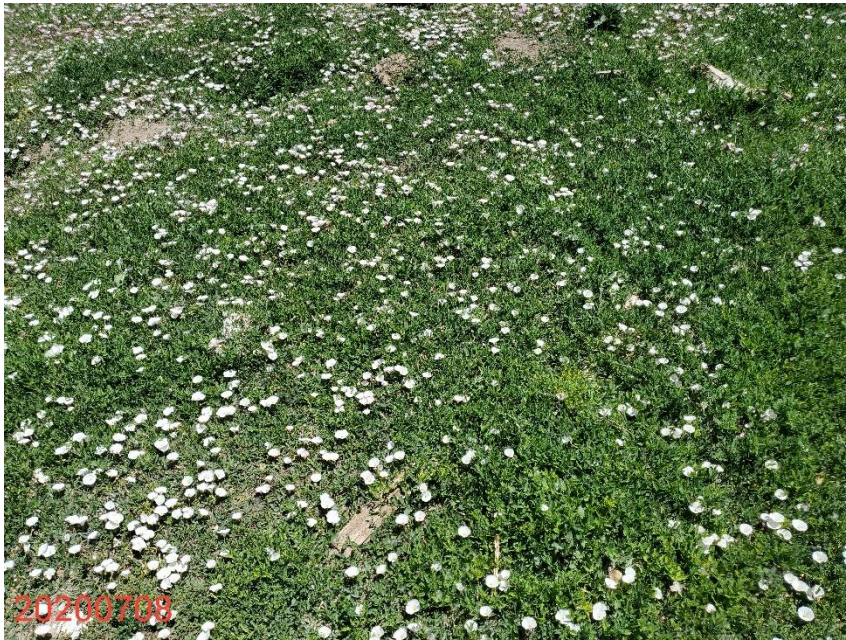
Photo 3: Photo of vegetation on Location; Vegetation observed on Location predominantly Field Bindweed or Houndstongue. Little to no desirable perennial vegetative establishment observed on Location.

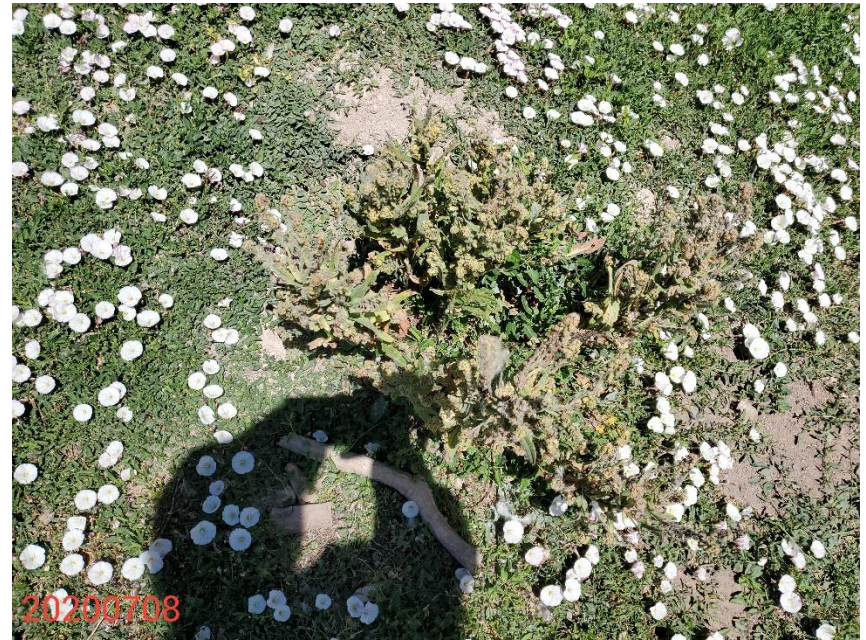
Photo 4: See comment under photo 3. .
