Inspection Photos

Operator: CAERUS PICEANCE LLC - 10456

Location ID: 312661

Mesa County, CO

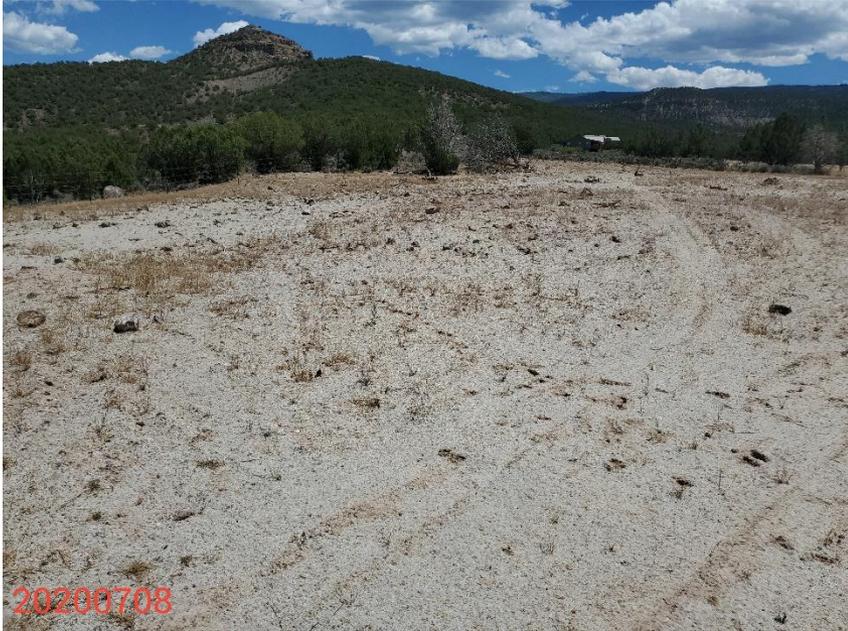
Photo 1: Photo taken from the north end of the Location facing southeast. Reclamation activities appear to have been conducted. Operator appears to utilized a hydromulch, or tackifier to stabilize the reclamation area. 2 spring growing seasons have passed since reclamation was required pursuant to 1004.a; Little to no desirable vegetative germination was observed. Additional seeding may be needed to facilitate reclamation.

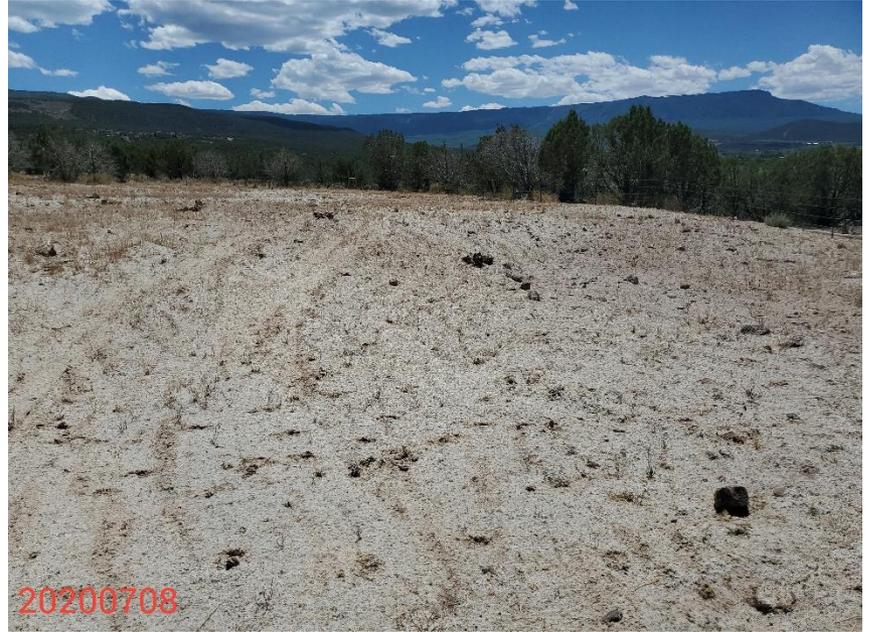
Photo 2: Photo taken from the north end of the Location facing southwest. See comments under photo 1.

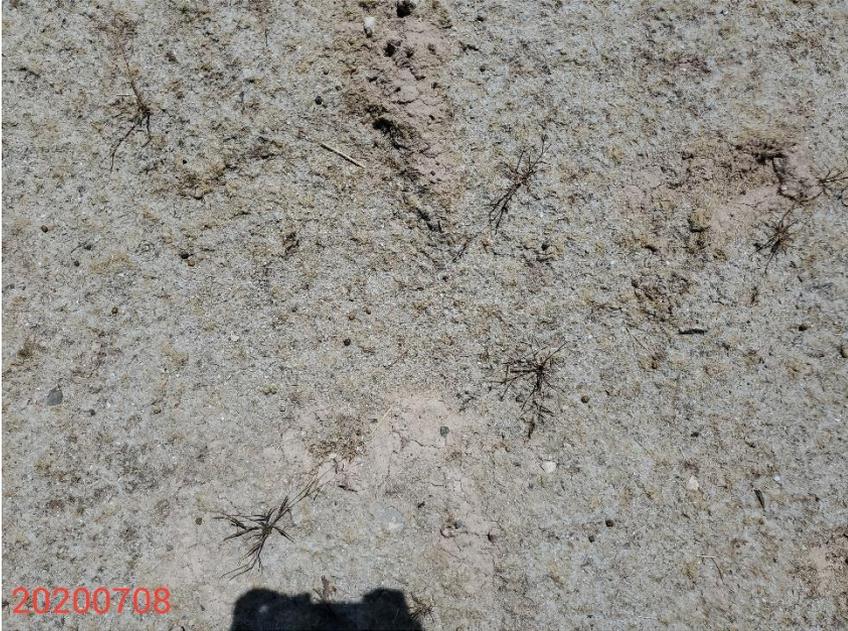
Photo 3: Photo of the Locations surface. Photo shows hydromulch has been implemented to stabilize soil surface. Photo also shows little to no desirable vegetative germination was observed. Vegetation observed in photo Cheatgrass. Additional seeding may be needed to facilitate reclamation.

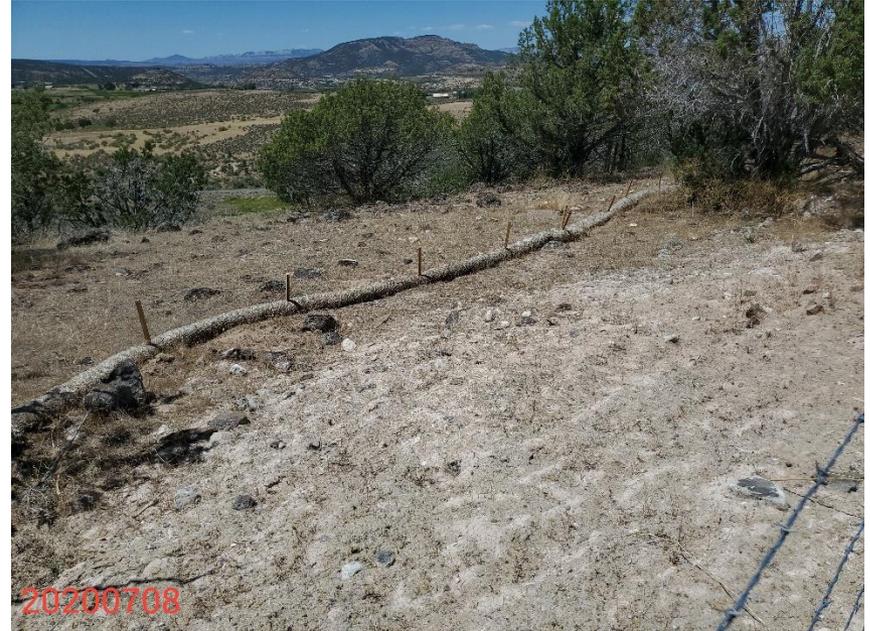
Photo 4: Photo shows Operator has implemented straw wattles along perimeter of the Location in conjunction with hydromulch.

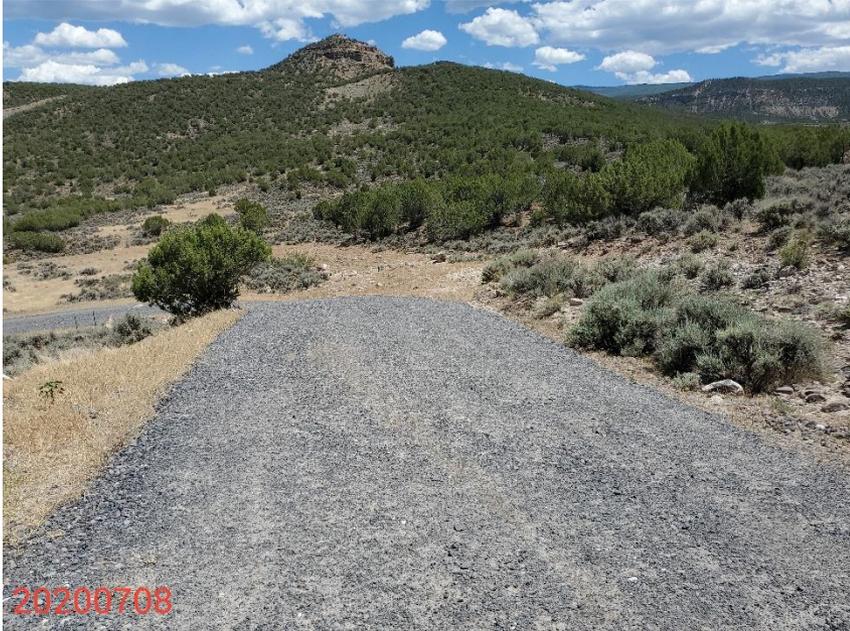
Photo 5: Photo taken from the access road, north of the Location facing southwest. Photo shows access road has not been reclaimed.

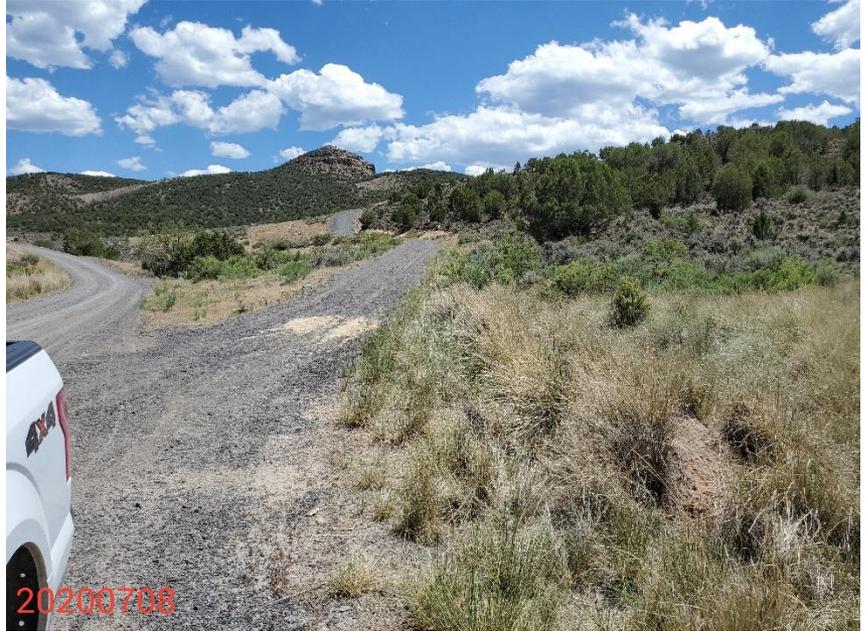
Photo 6: Photo taken from the access road entrance facing south. Photo shows access road to the Location has not been reclaimed.

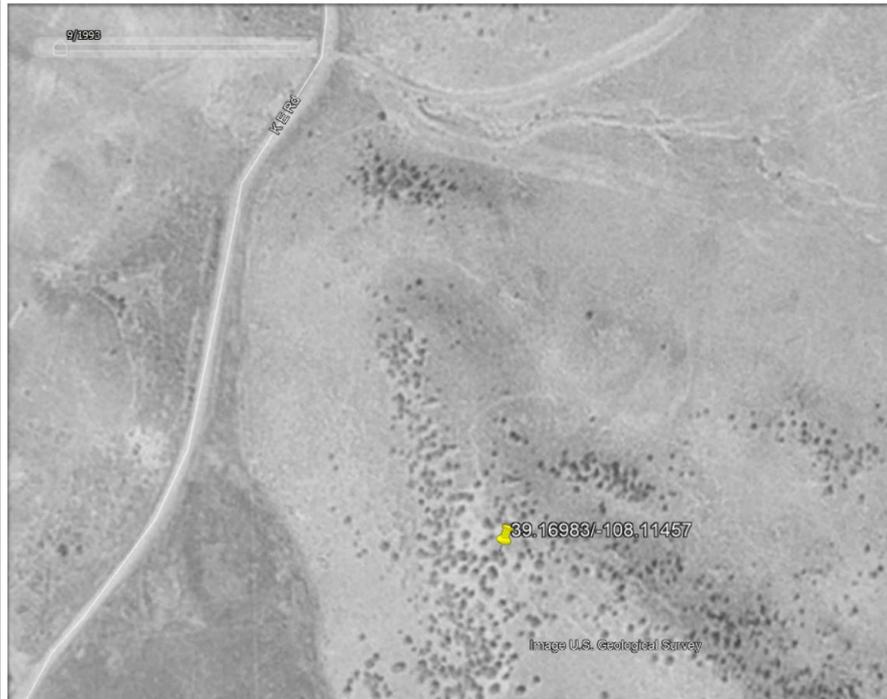
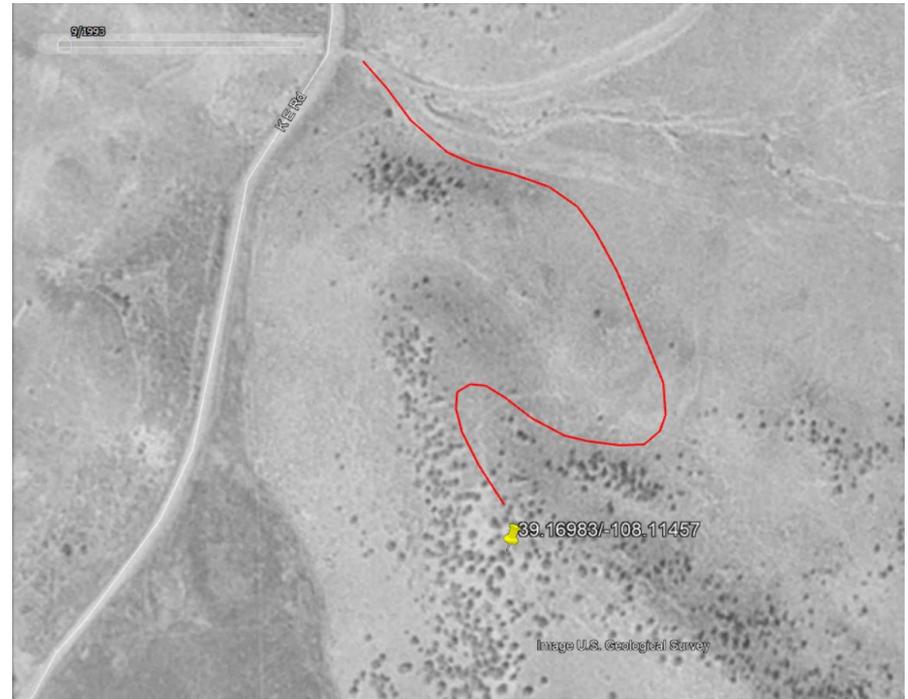
Photo 7: 1993 Google Earth aerial image. Well SPUD 1998. Photo shows Oil and gas access road did not pre-exist Oil and Gas Location; Access road subject to COGCC 1004 requirements. Red line in photo to right represents access road that was constructed (see photo 8).
