Inspection Photos
Location Name: KAHN 33-15
API#: 05-071-07444
INSP. #: 695102979

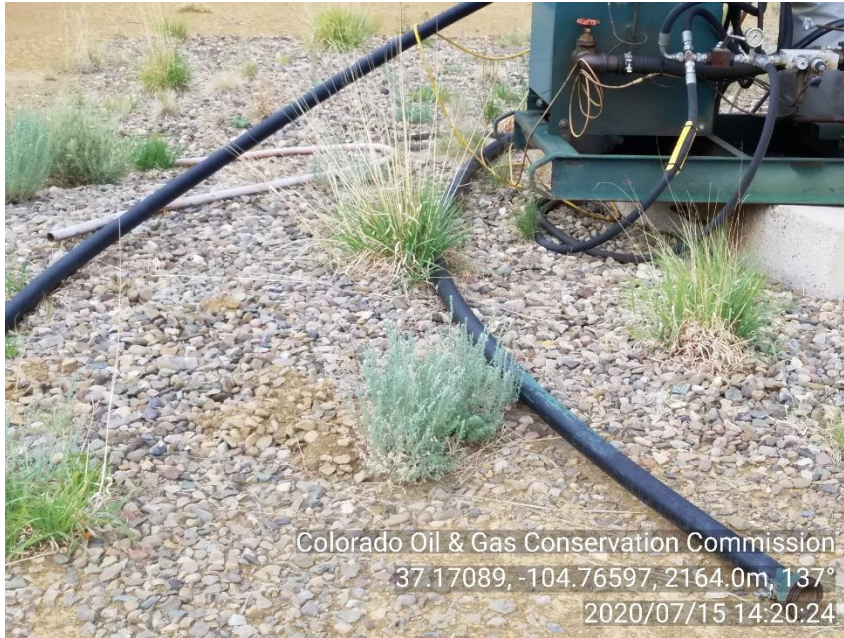
**PHOTO 3: UNUSED EQUIPMENT STORED ON LOCATION.
REMOVE UNUSED EQUIPMENT COMPLY WITH RULE 603.f.
CA DATE 10-15-20.**

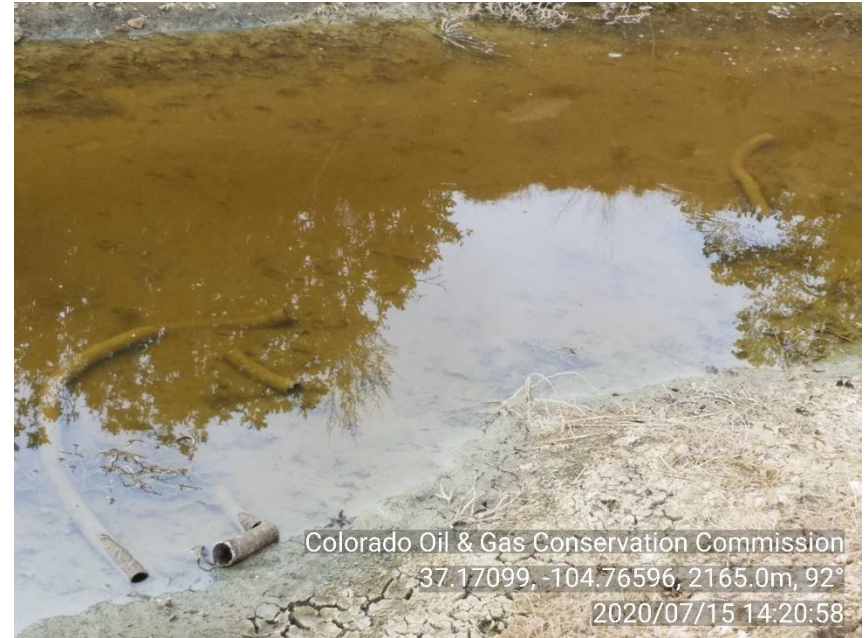
**PHOTO 4: TRASH IN PIT. REMOVE ALL TRASH OR DEBREE IN
PIT COMPLY WITH RULE 603.f. CA DATE 10-15-20.**

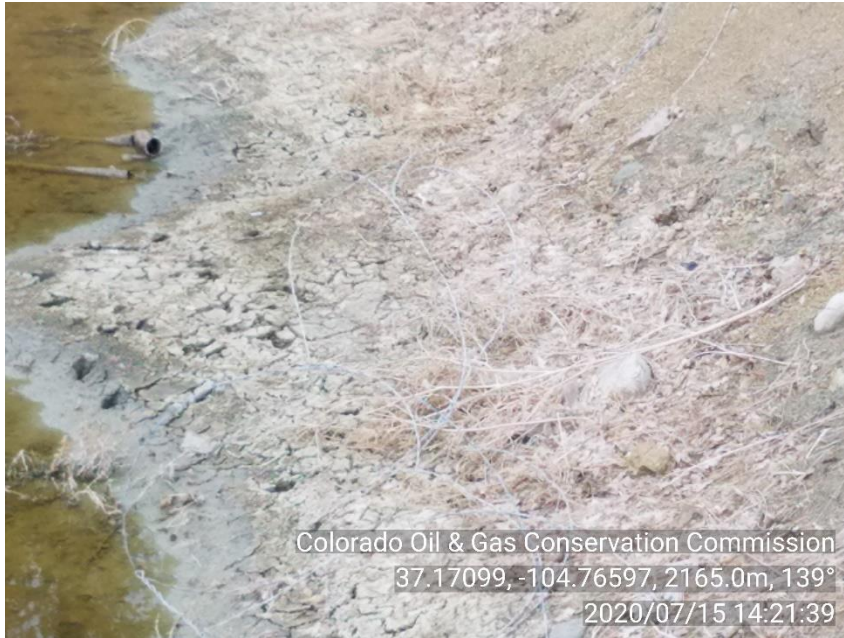
PHOTO 5: TRASH IN PIT (OLD WIRE FROM PIT FENCE THAT HAS BEEN TAKEN DOWN). REMOVE ALL TRASH OR DEBREE IN PIT COMPLY WITH RULE 603.f. CA DATE 10-15-20.

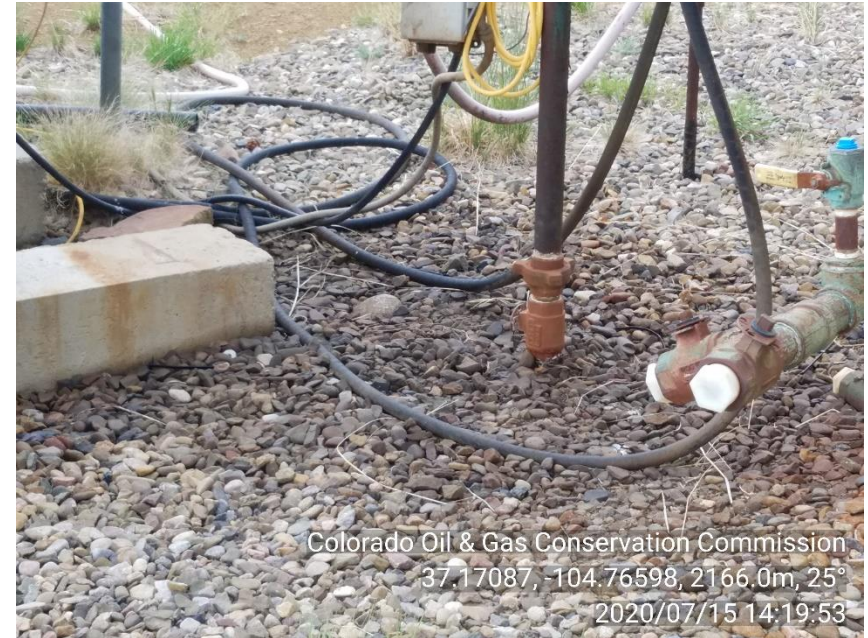
PHOTO 6: AREA OF STAINED SOIL AROUND ENGINE SKID BETWEEN WELLHEAD AND ENGINE SKID. Conduct maintenance on equipment, cleanup stained material and review self inspection processes. COMPLY WITH RULE 1002.f.(2).D. CA DATE 7-22-20.
