# Inspection Photos

7/17/2020

Operator: BERRY PETROLEUM COMPANY LLC  
- 10091

Location ID: 335964

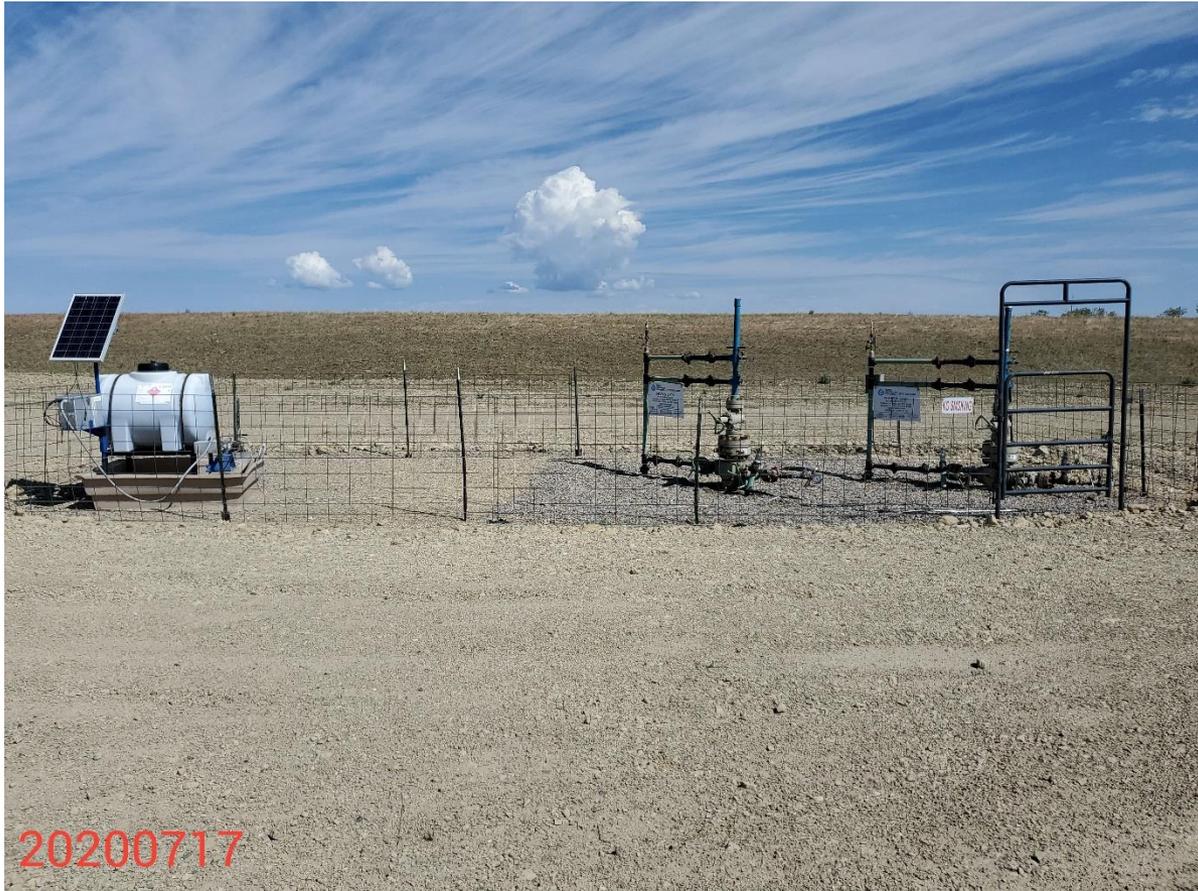
**Photo 1:** Photo shows the 2 active wells on the Location.

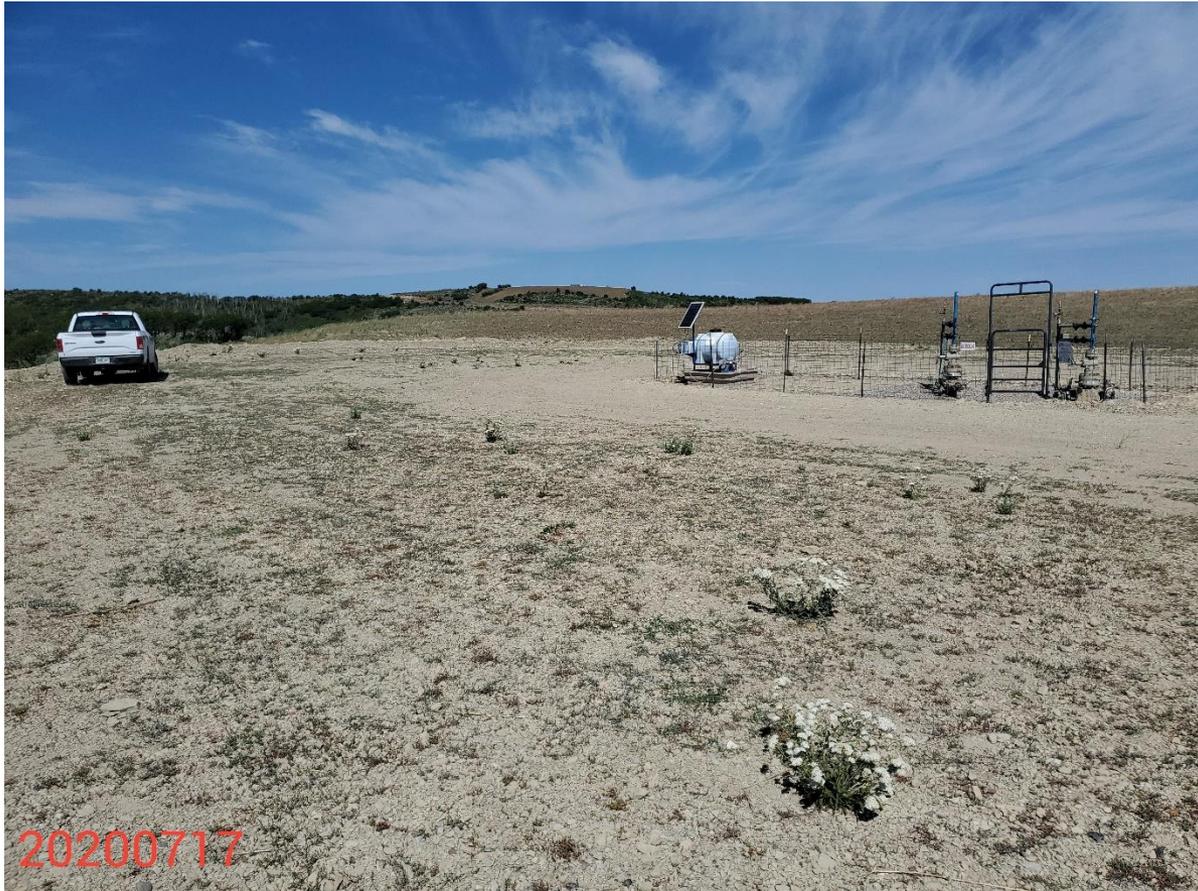
**Photo 2:** Photo taken from the south end of the Pad, facing west. Photos 2-4 provide an overview of the Location from west, north to east.

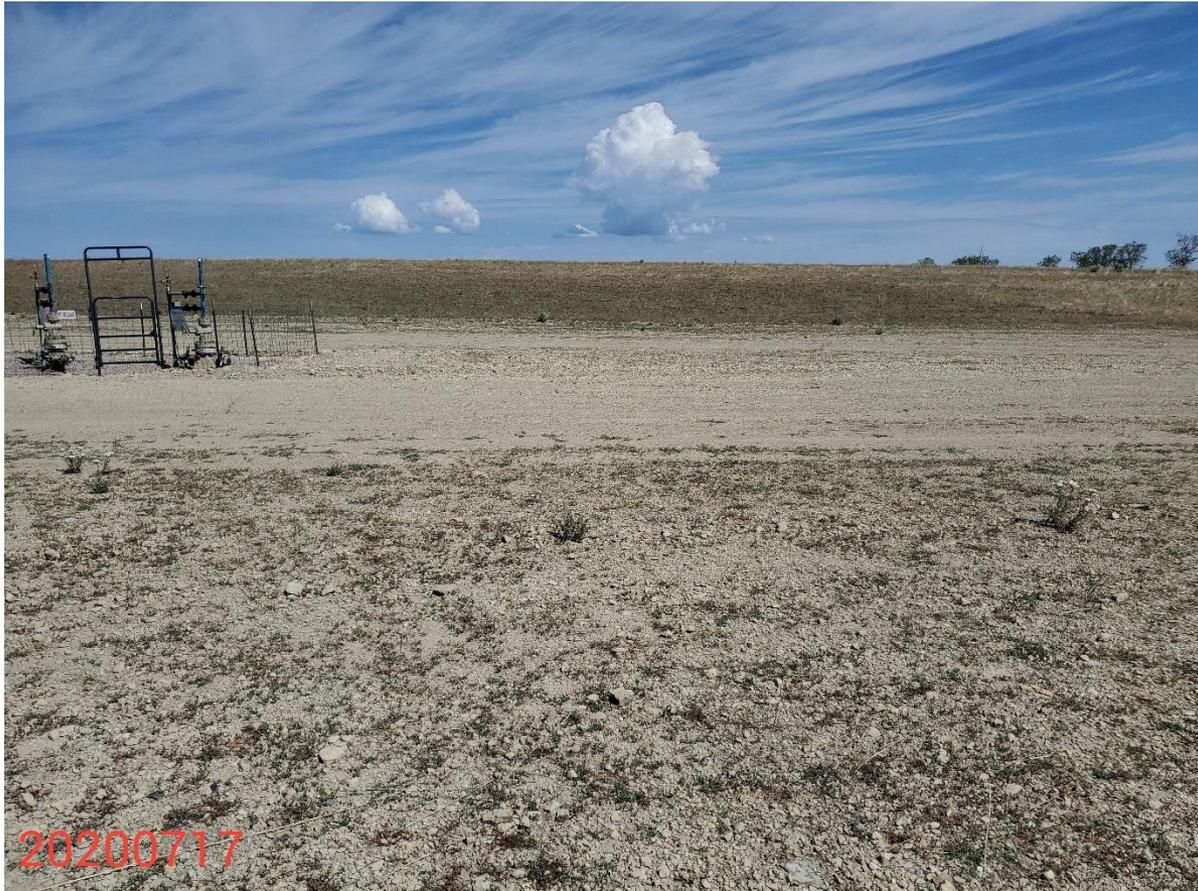
**Photo 3:** See comments under photo 2.

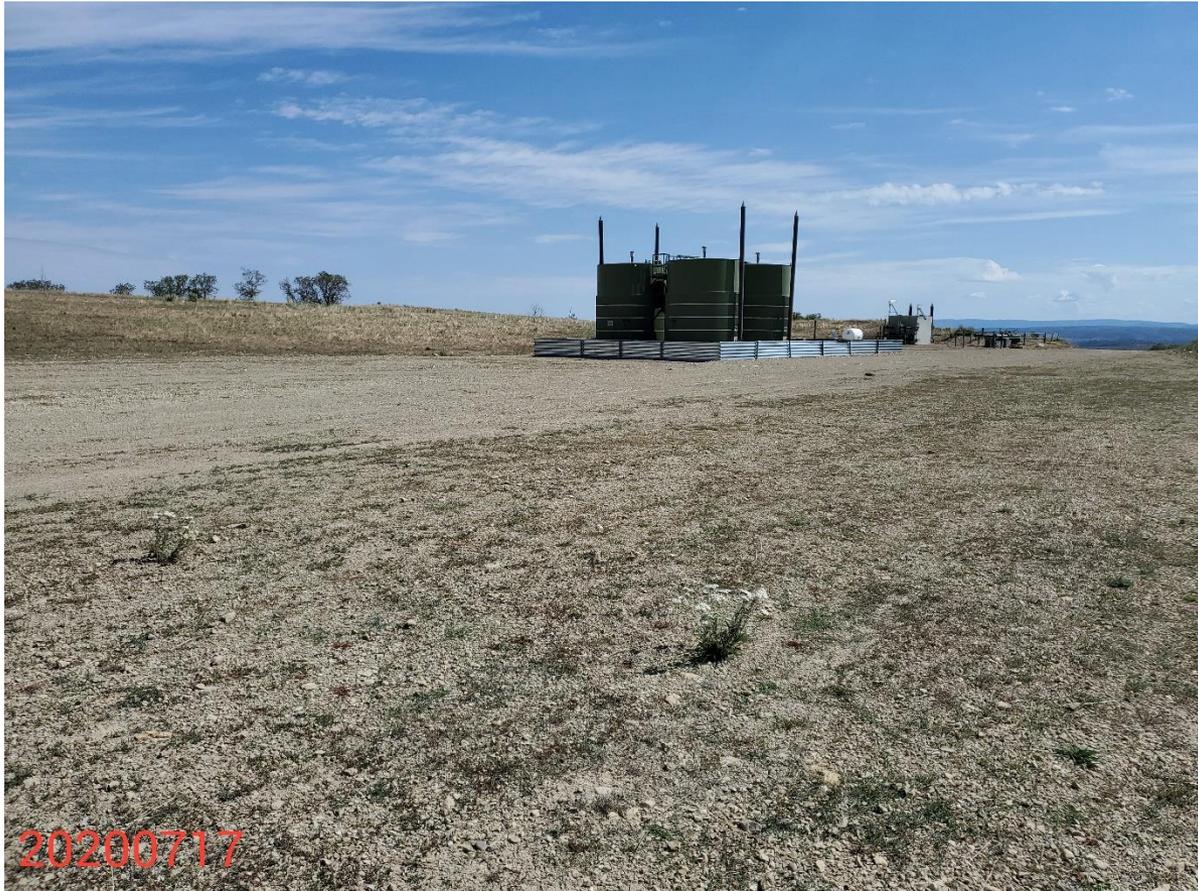
**Photo 4:** See comments under photo 2.

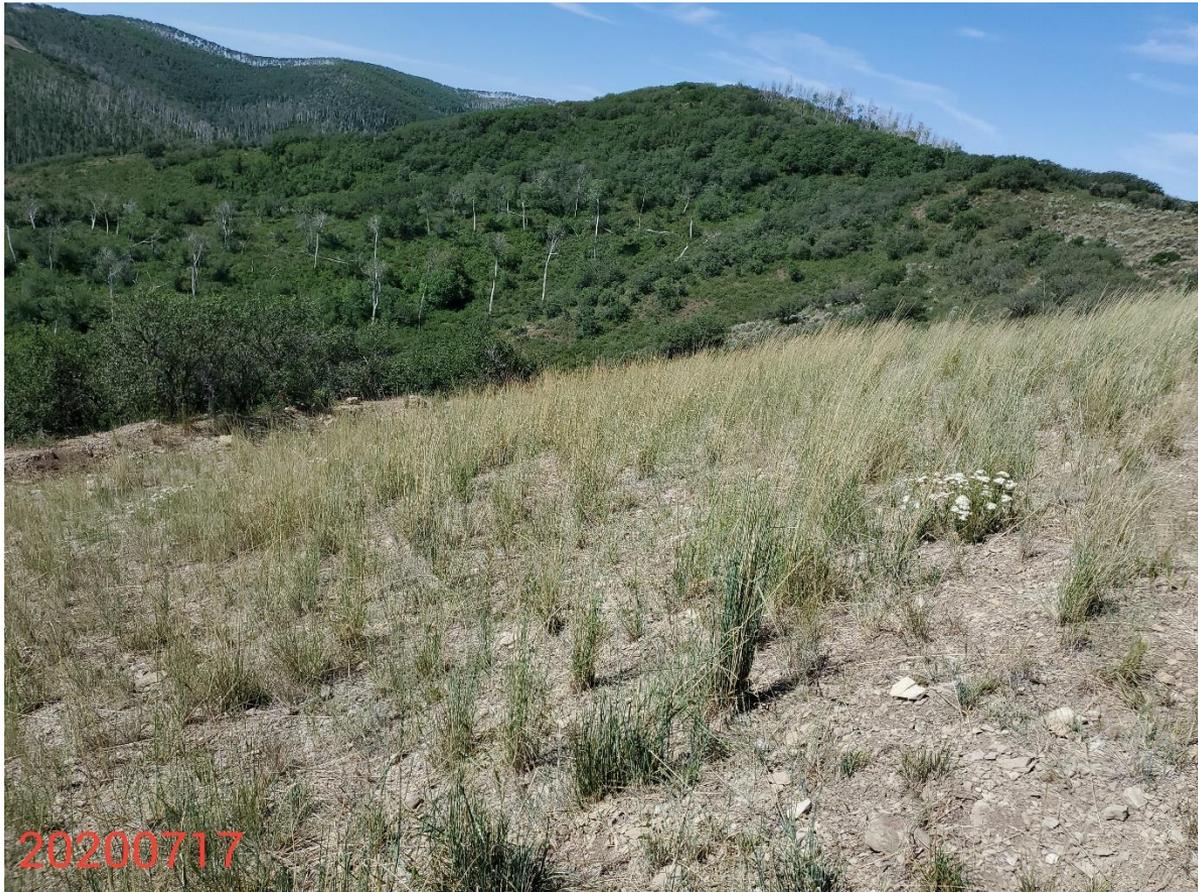
**Photo 5:** Photo taken from the southern interim areas, facing west. Photo shows desirable vegetative establishment appears to be progressing towards COGCC 1000 series requirements.

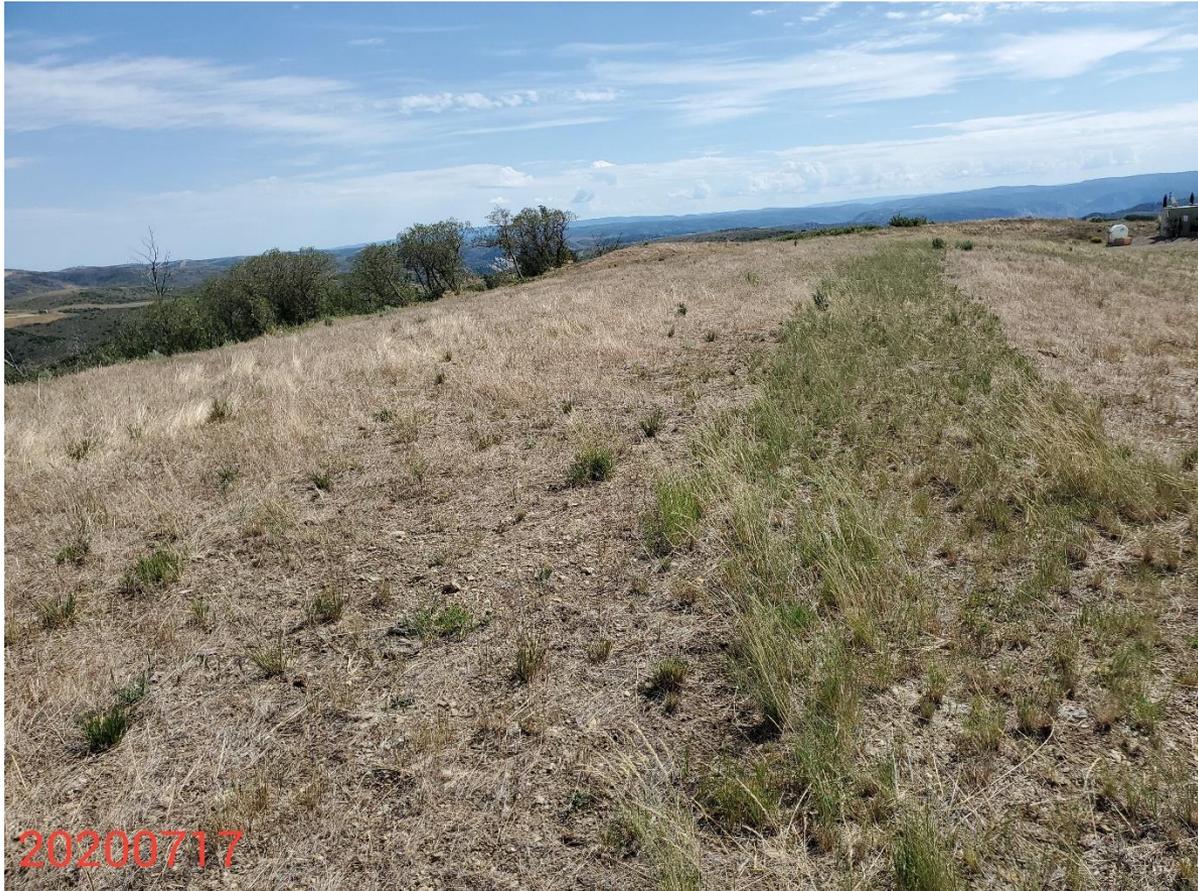
**Photo 6:** Photo taken from the northern interim areas, facing east. Photo shows desirable vegetative establishment DOES NOT appear to be progressing towards COGCC 1000 series requirements; Additional revegetation activities will likely be needed for areas to meet reclamation standards.

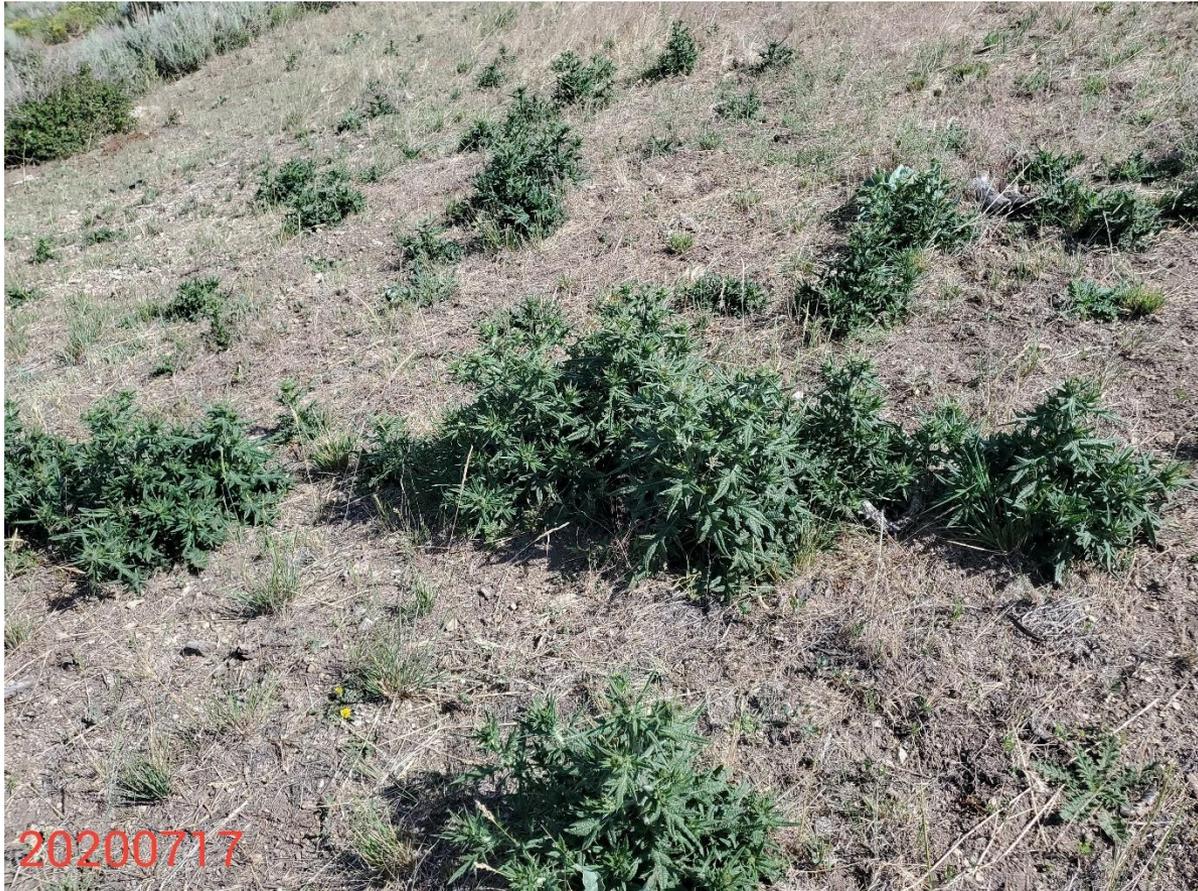
**Photo 7:** Photo taken from the northern interim areas. Photo shows Bull thistle (*Cirsium vulgare*) is establishing in the northern interim areas. This is a Colorado State listed noxious weed; Management required.

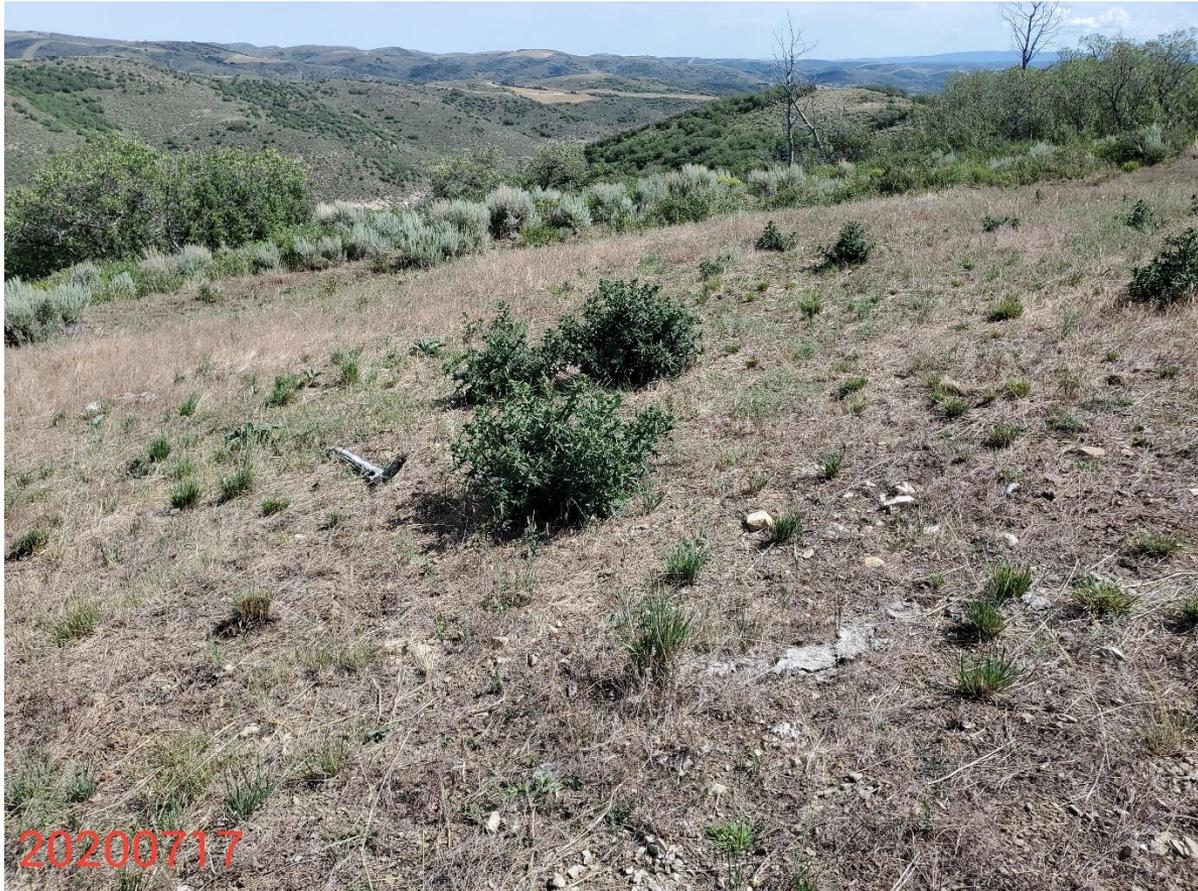
**Photo 8:** Photo taken from the northern interim areas, facing north. Photo shows Bull thistle (*Cirsium vulgare*) is establishing in the northern interim areas. This is a Colorado State listed noxious weed; Management required.
