# Interim Reclamation and Stormwater Inspection

Operator: KERR MCGEE OIL & GAS ONSHORE LP #47120

Location ID: 331598

Inspection Document #: 697501766

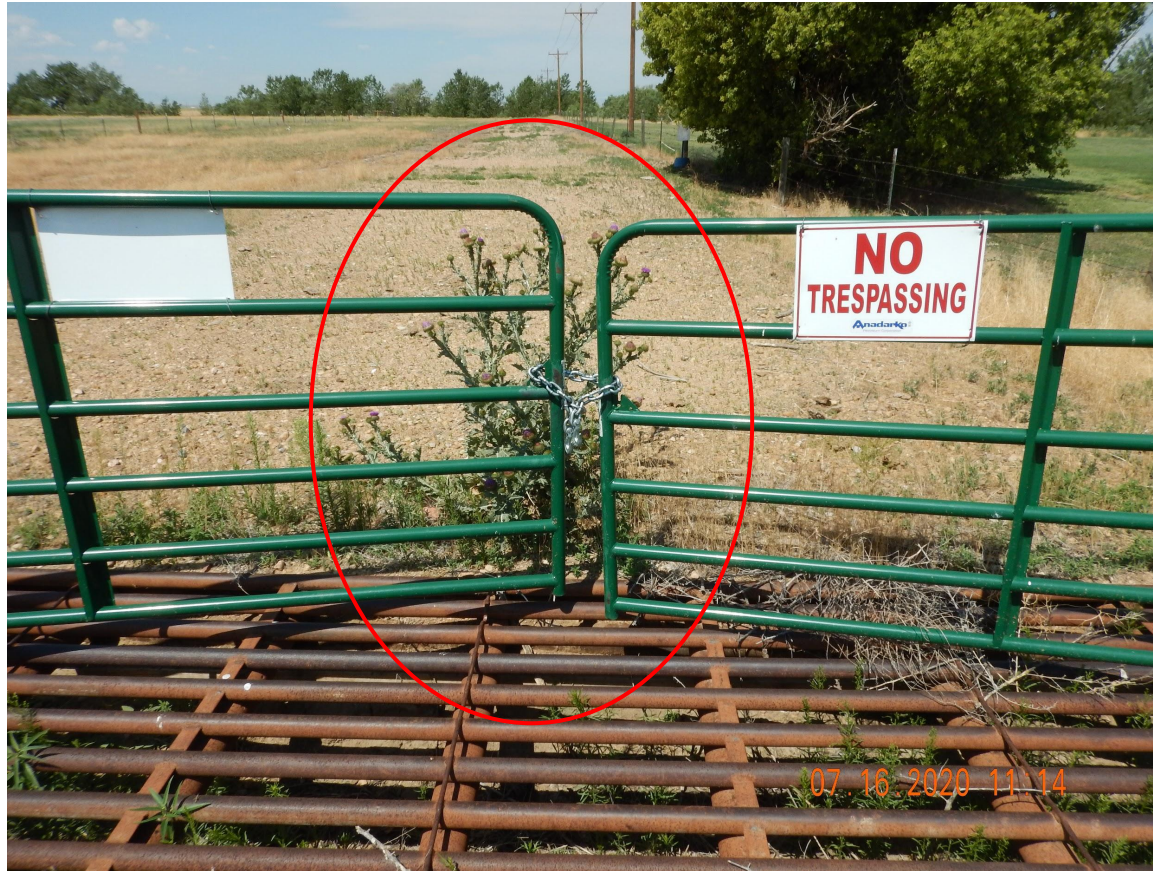
**Photo 1.** Photo taken from the northeastern location, facing West. Photo illustrates a List B Colorado noxious weed, Scotch thistle.

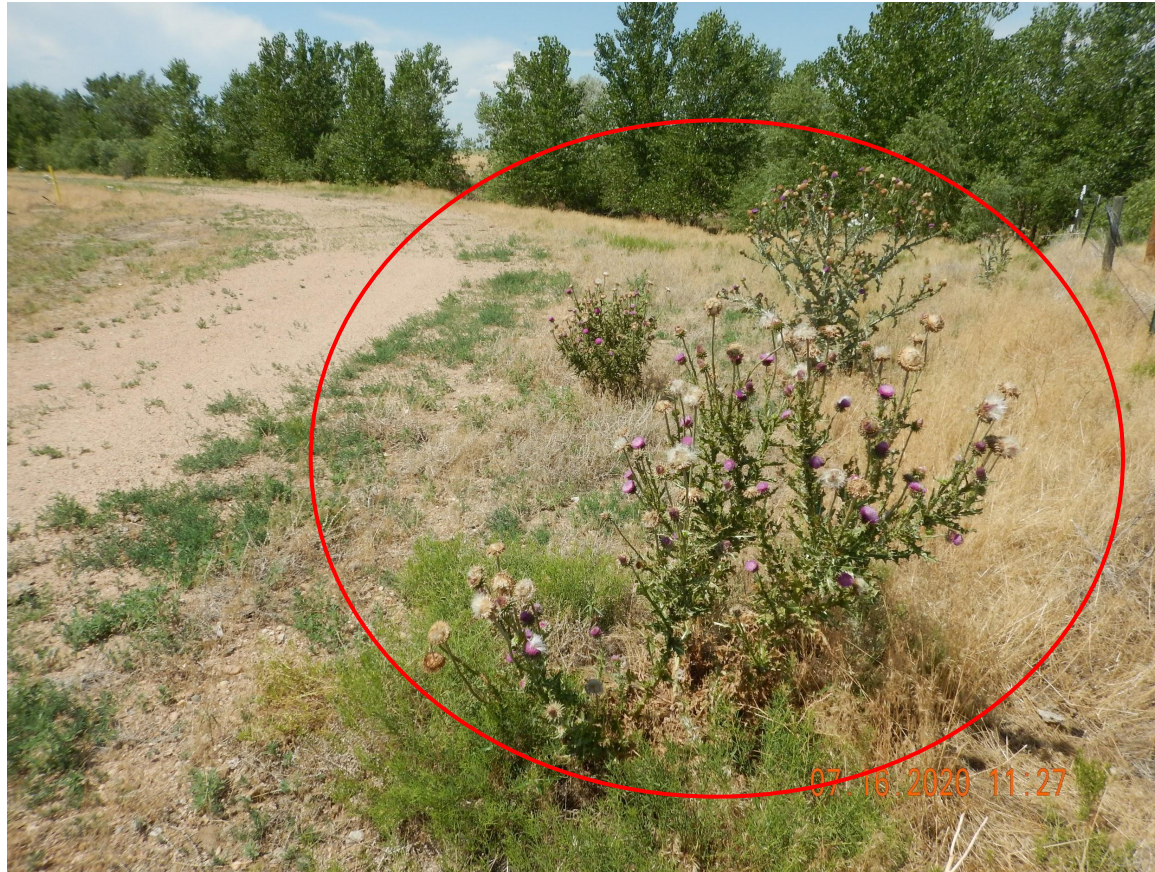
**Photo 2.** Photo taken along a portion of the northern access road, facing West. Photo illustrates a List B Colorado noxious weeds, Scotch thistle and Musk thistle.

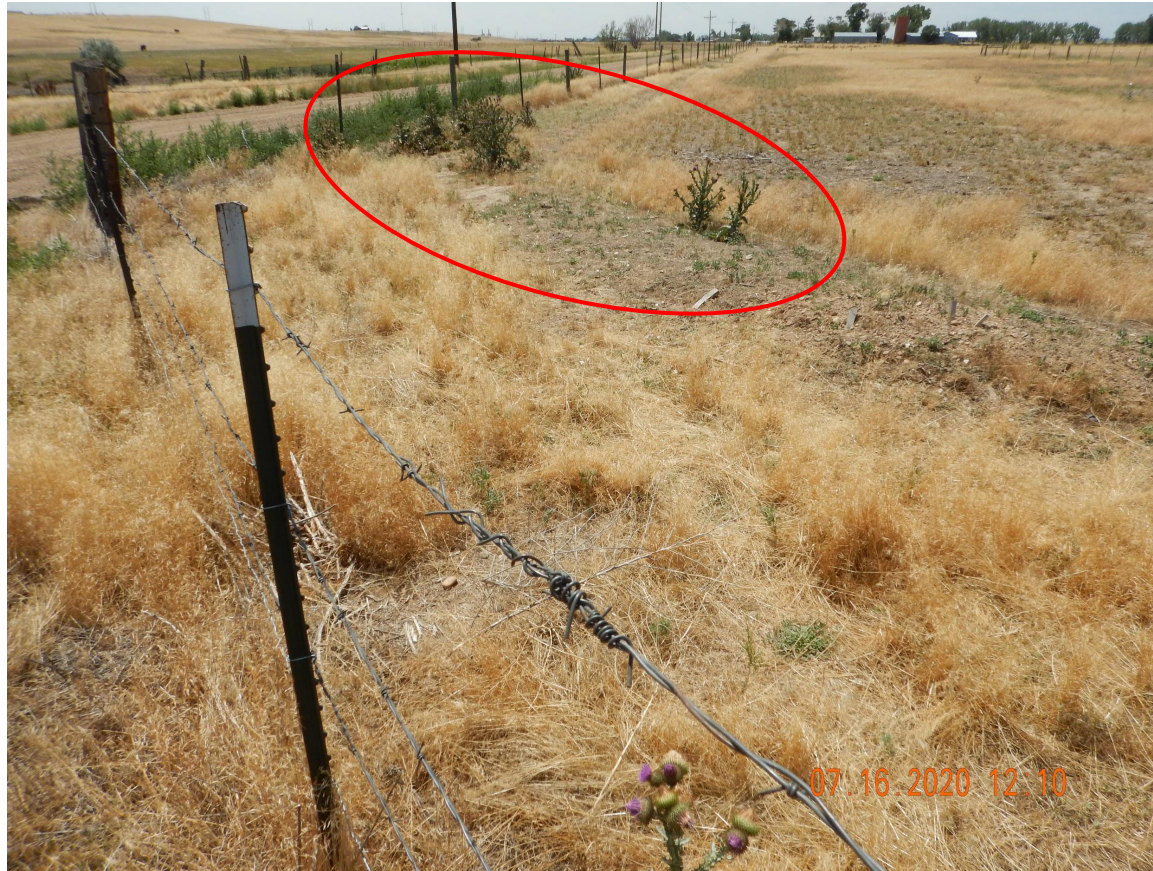
**Photo 3.** Photo taken along the northeastern location, facing South. Photo illustrates a List B Colorado noxious weed, Scotch thistle.

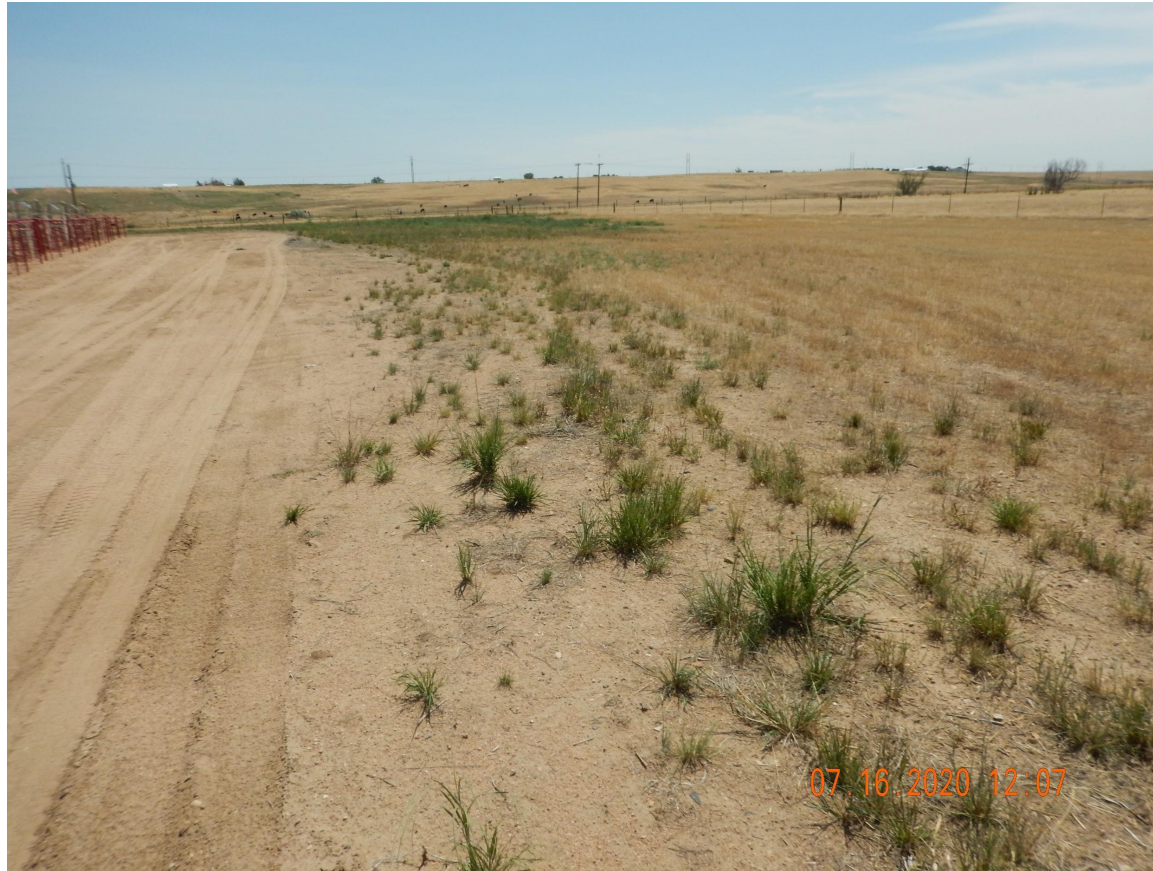
**Photo 4.** Photo taken from the entrance of location, facing East. Photo illustrates the Operator has performed interim reclamation activities to reduce all areas not needed for production operations. The southwestern and southern interim areas are dominated by cheatgrass.

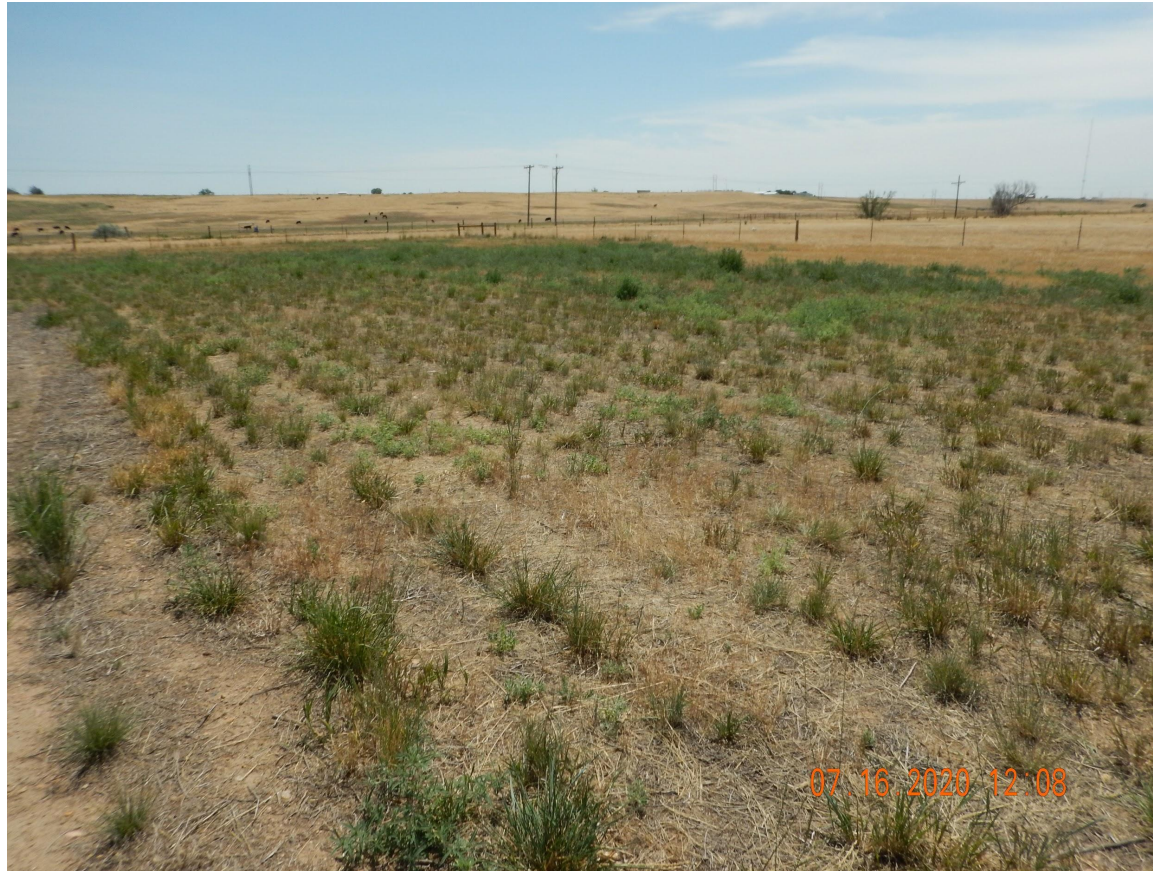
**Photo 5.** Photo taken from the southeastern location, facing East. Photo illustrates the establishment of desirable plant species. Some establishment of Kochia was observed but it appears the Operator is performing ongoing weed management, as it appears the location has been recently mowed.

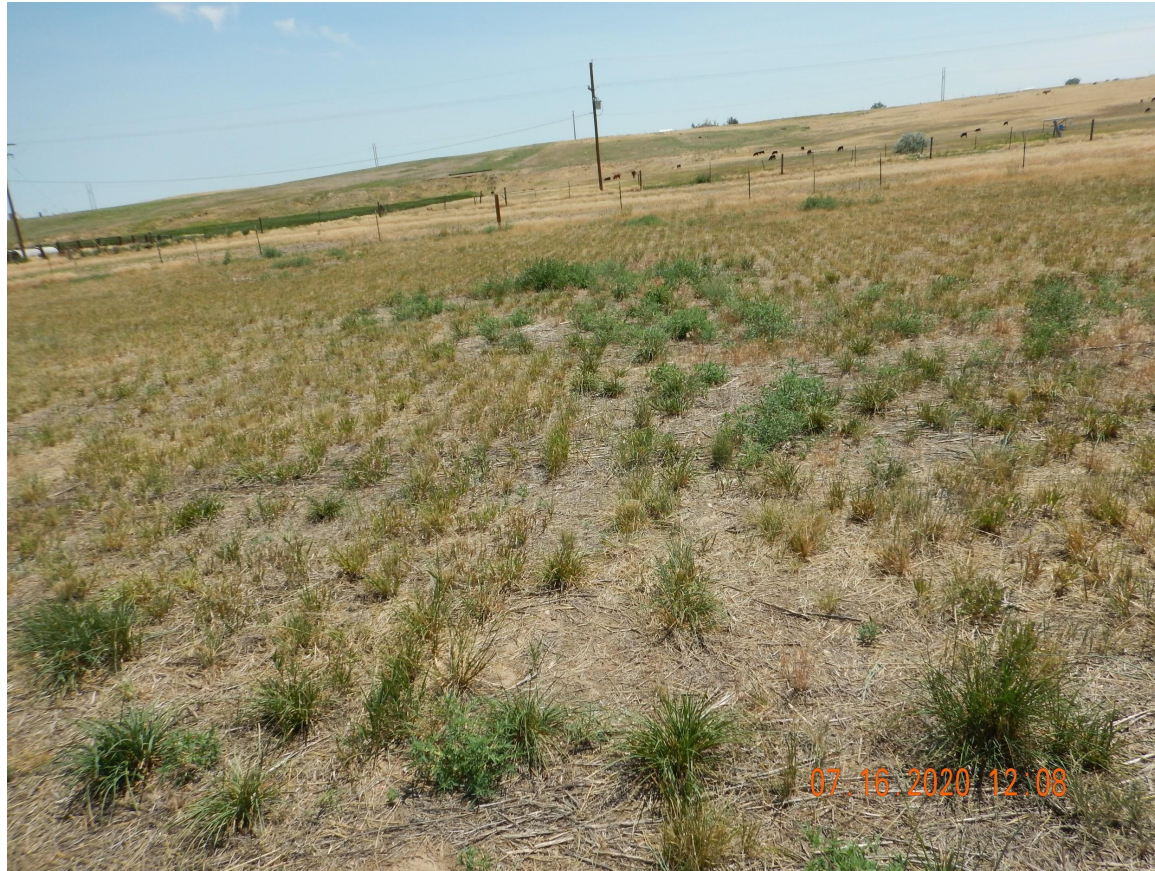
**Photo 6.** Photo taken from the eastern location, facing East. See comments under Photo 5.

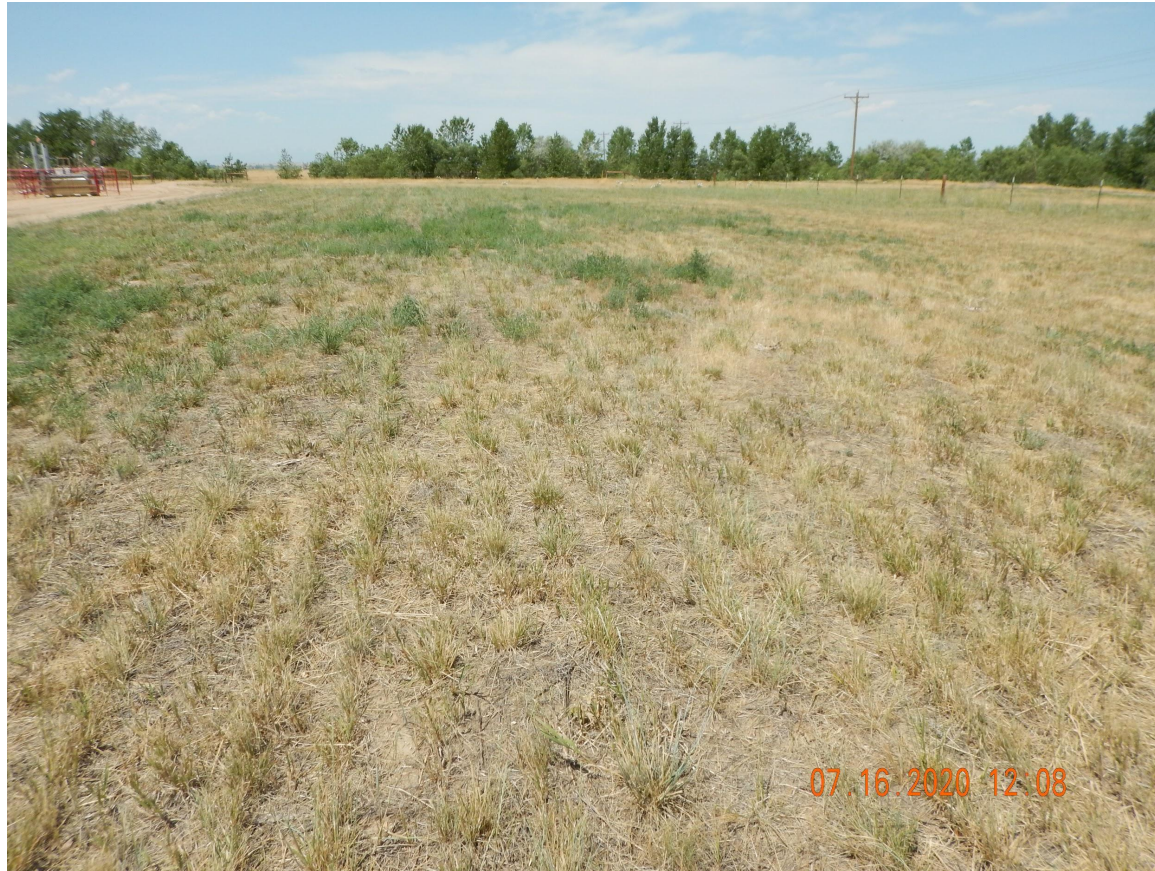
**Photo 7.** Photo taken from the northeastern location, facing West. See comments under Photo 5.

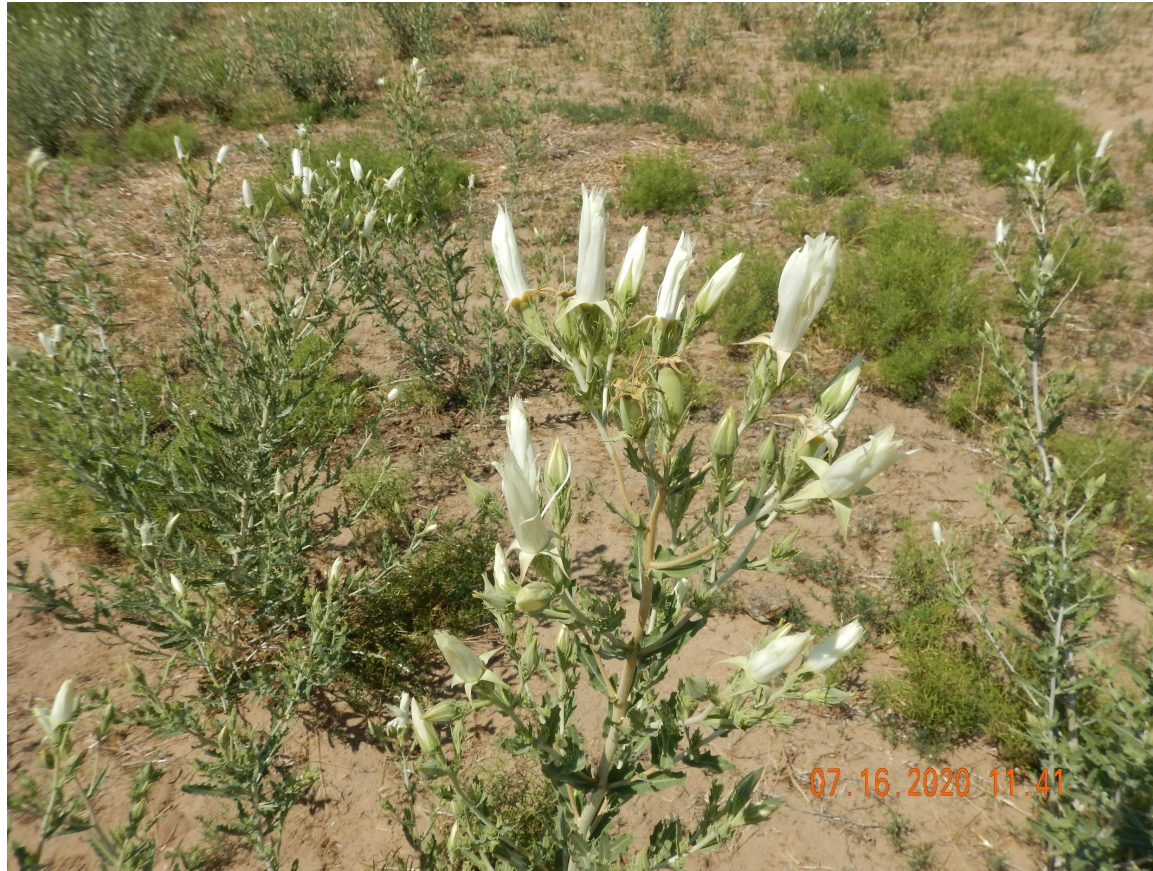
**Photo 8.** Photo taken from a portion of a flowline area. Photo illustrates a white-flowered blazingstar (*Mentzelia nuda*), which is a common native plant species to the eastern plains and foothills. This is the first of two plant species of concern for the complainant.

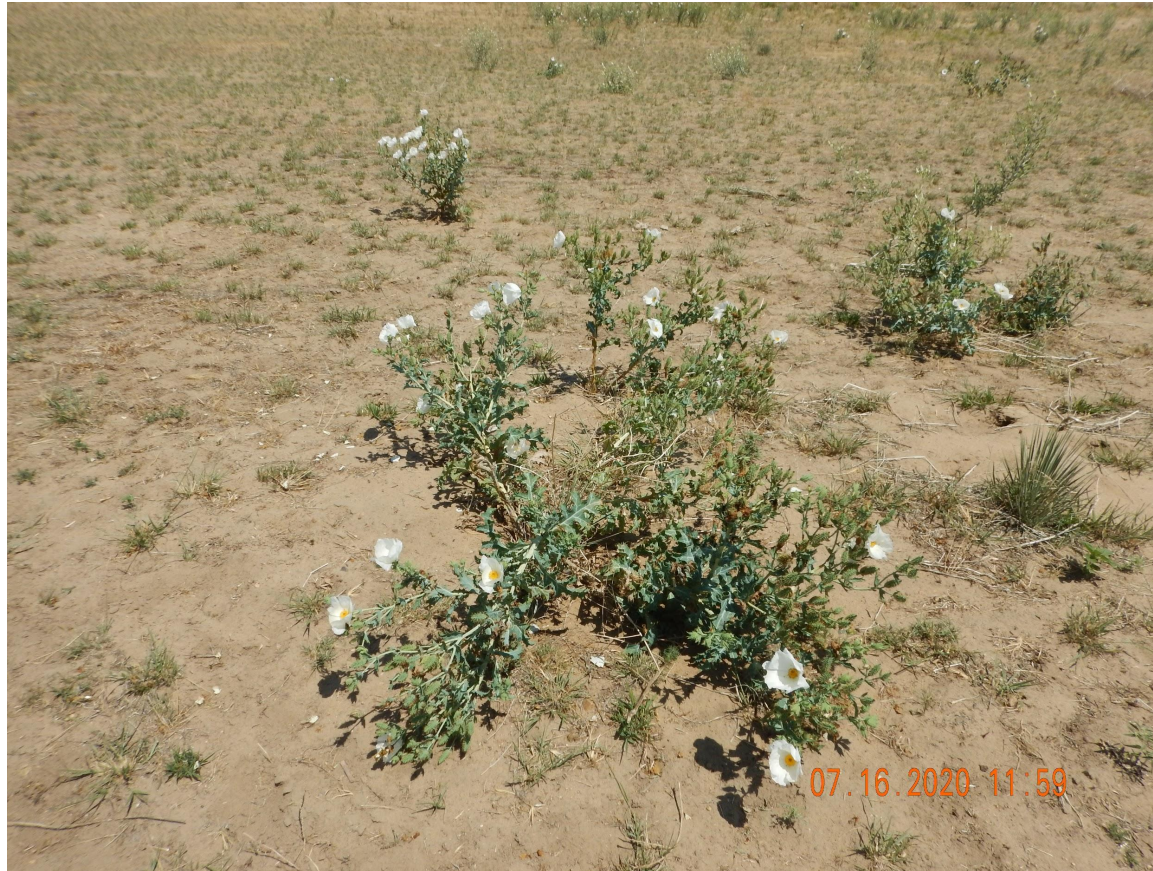
**Photo 9.** Photo taken from the interim reclamation area. Photo illustrates a crested prickly-poppy (*Argemone polyanthemus*), which is a common native plant species in sandy soil of grasslands. This is second of two plant species of concern for the complainant.

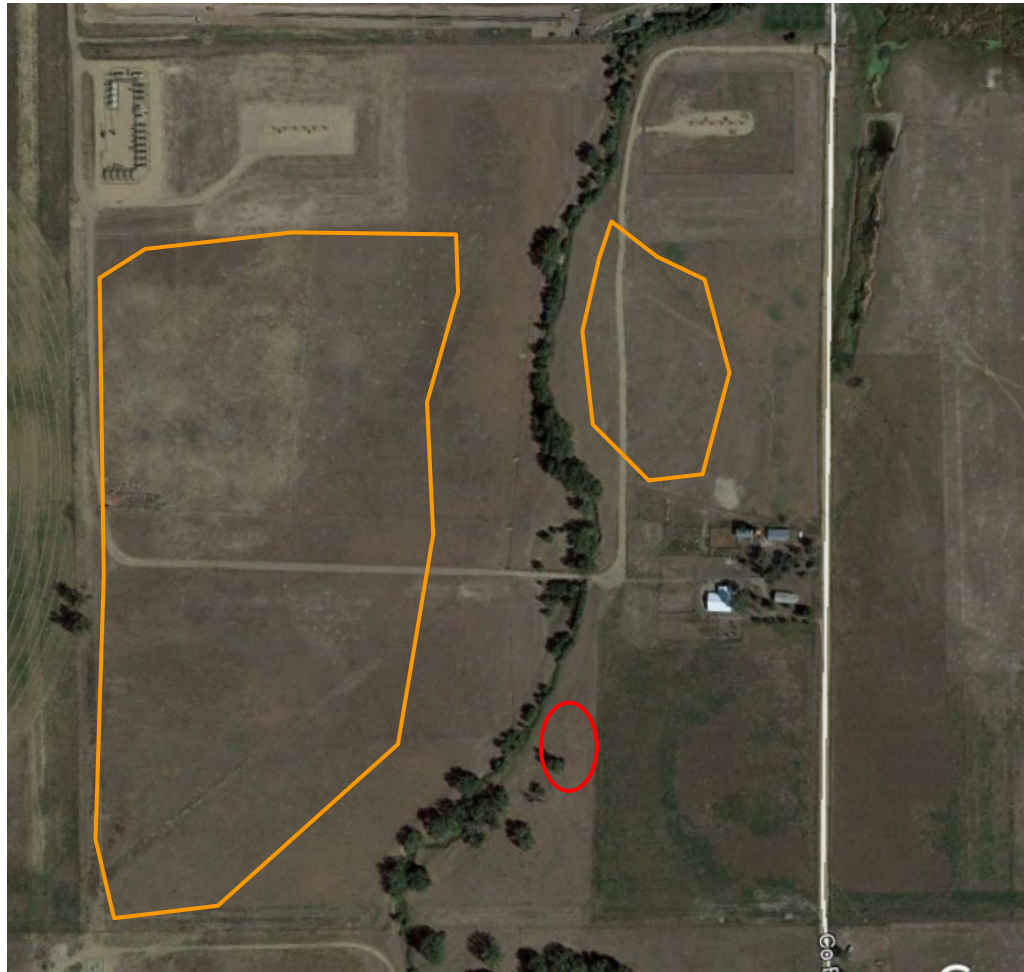
**Photo 10.** Google Earth aerial imagery taken 9/12/2019. Complaint had concerns about Scotch thistle within the red circled area and plant species within the orange circled areas. Based on a review, there was no oil and gas disturbance related to the red circled area; therefore, it is not the responsibility of the Operator. There were two native plant species of concern, White-flowered blazingstar and Prickly poppy, within the orange circled area. These plant species are not considered noxious and are not on the Colorado noxious weed list; therefore, the Operator does not have to perform control measures.
