Interim Reclamation and Stormwater Inspection

July 16, 2020

Operator: ANADARKO WATTENBERG OIL COMPLEX LLC #10600

Location ID: 466426

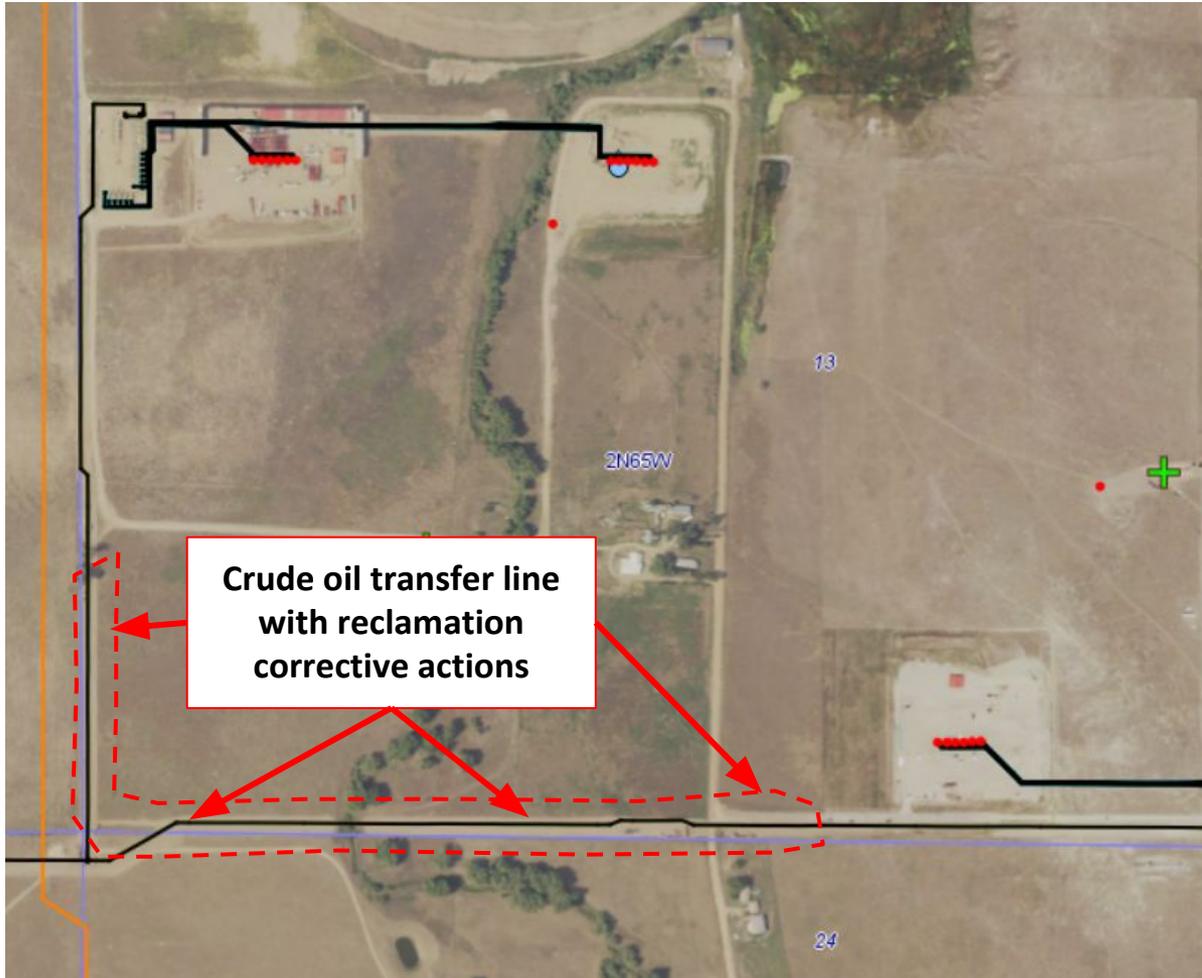
Photo 1. COGCC GISOnline aerial imagery taken 2017. Imagery illustrates a section of a crude oil transfer line with reclamation corrective actions. A List B Colorado noxious weed, Scotch thistle, was observed within the transfer line disturbance. Also, in general, the transfer line appears to consist mostly of annual, weedy vegetation.

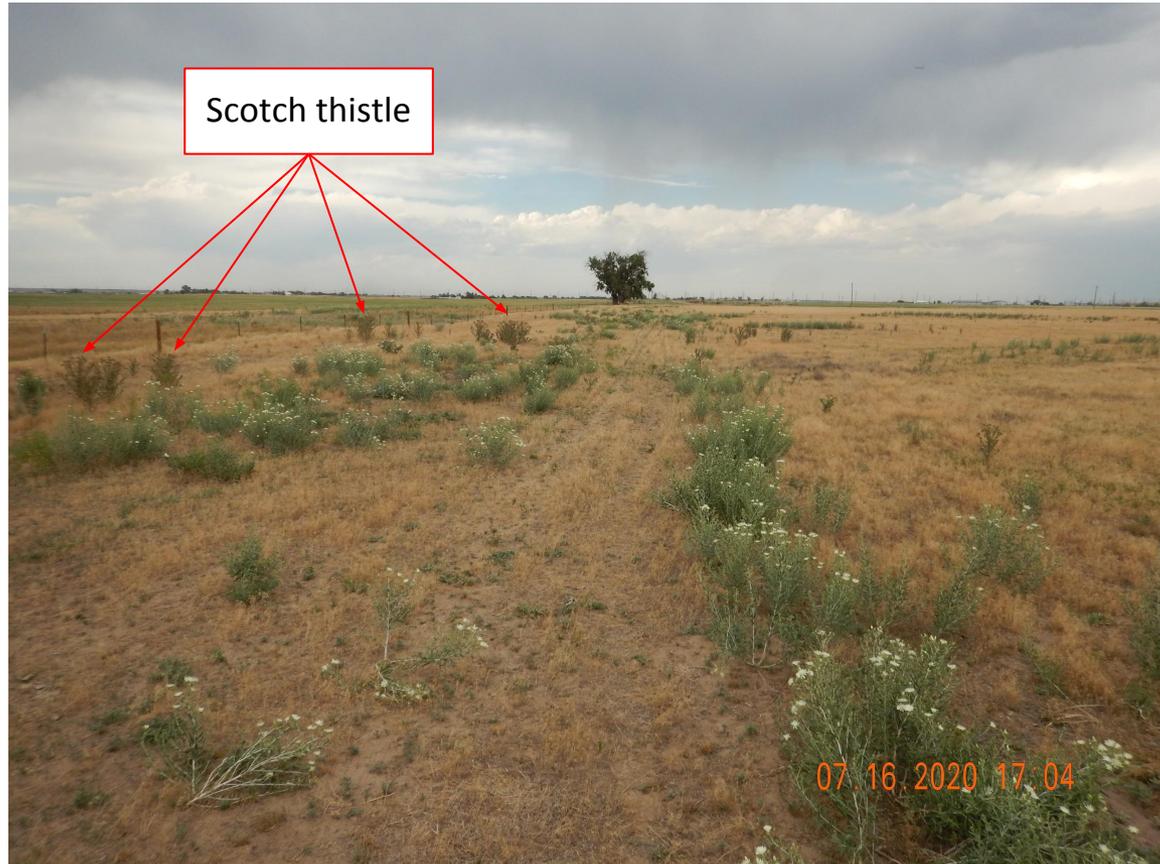
Photo 2. Photo taken from the southwestern crude oil transfer line, facing North. Photo illustrates a List B Colorado noxious weed, Scotch thistle. Scotch thistle was observed throughout portions of the western and southern transfer line.

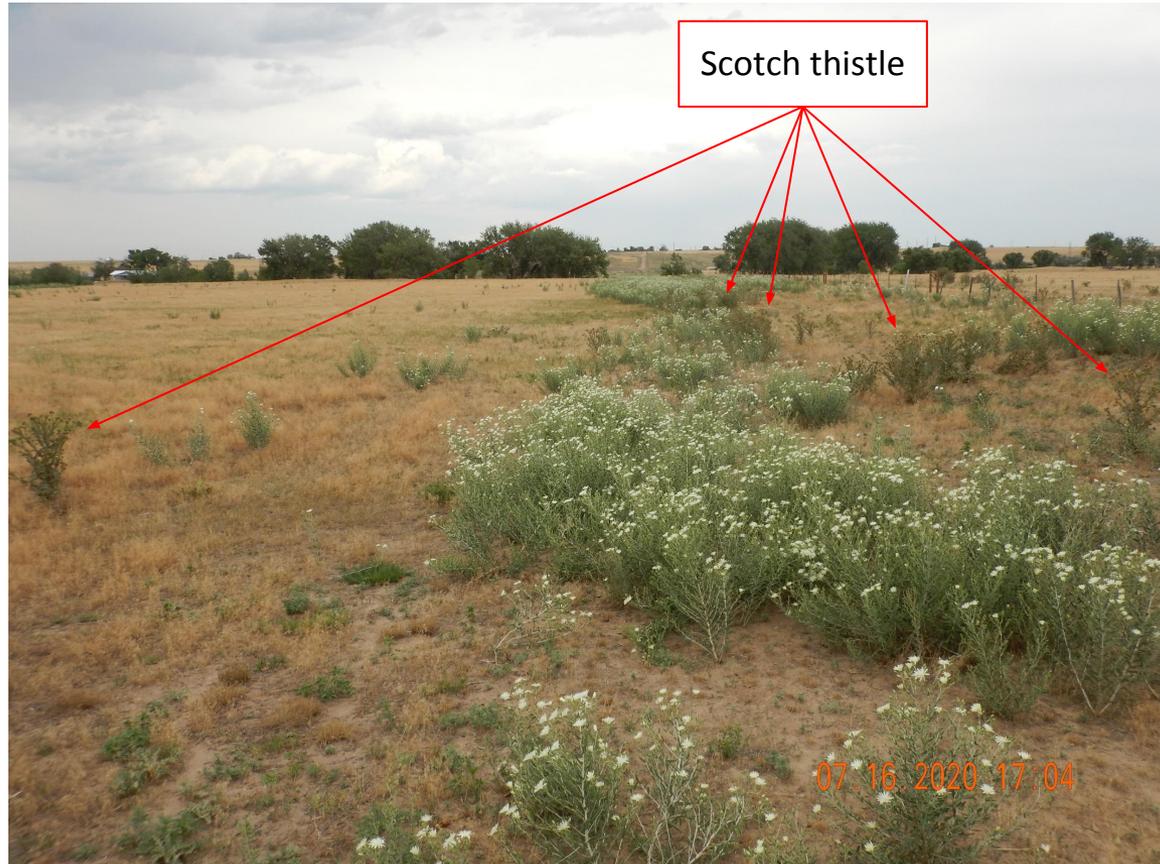
Photo 3. Photo taken from the southwestern crude oil transfer line, facing East. See comments under Photo 2.

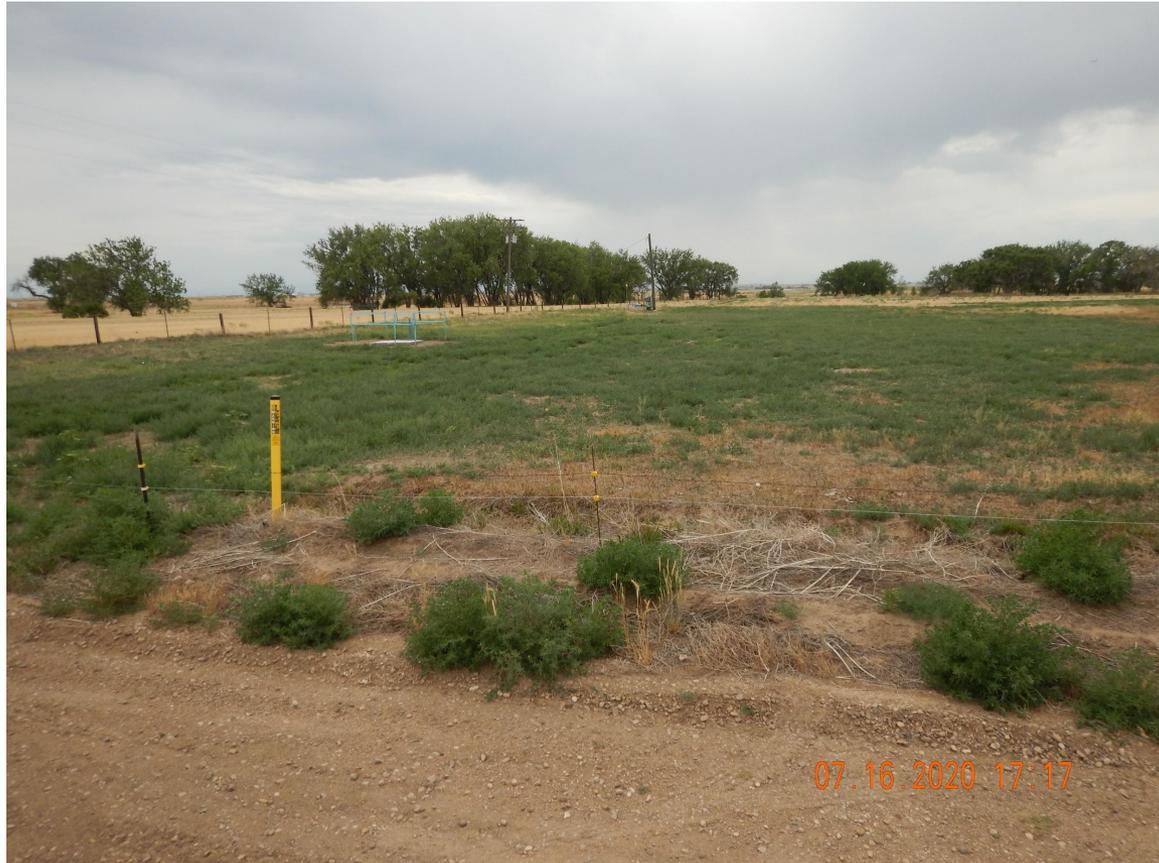
Photo 4. Photo taken along CR 47 1/2, facing West. Photo illustrates the establishment of Kochia and Russian thistle (green vegetation), both annual, weedy species, along the crude oil transfer line.

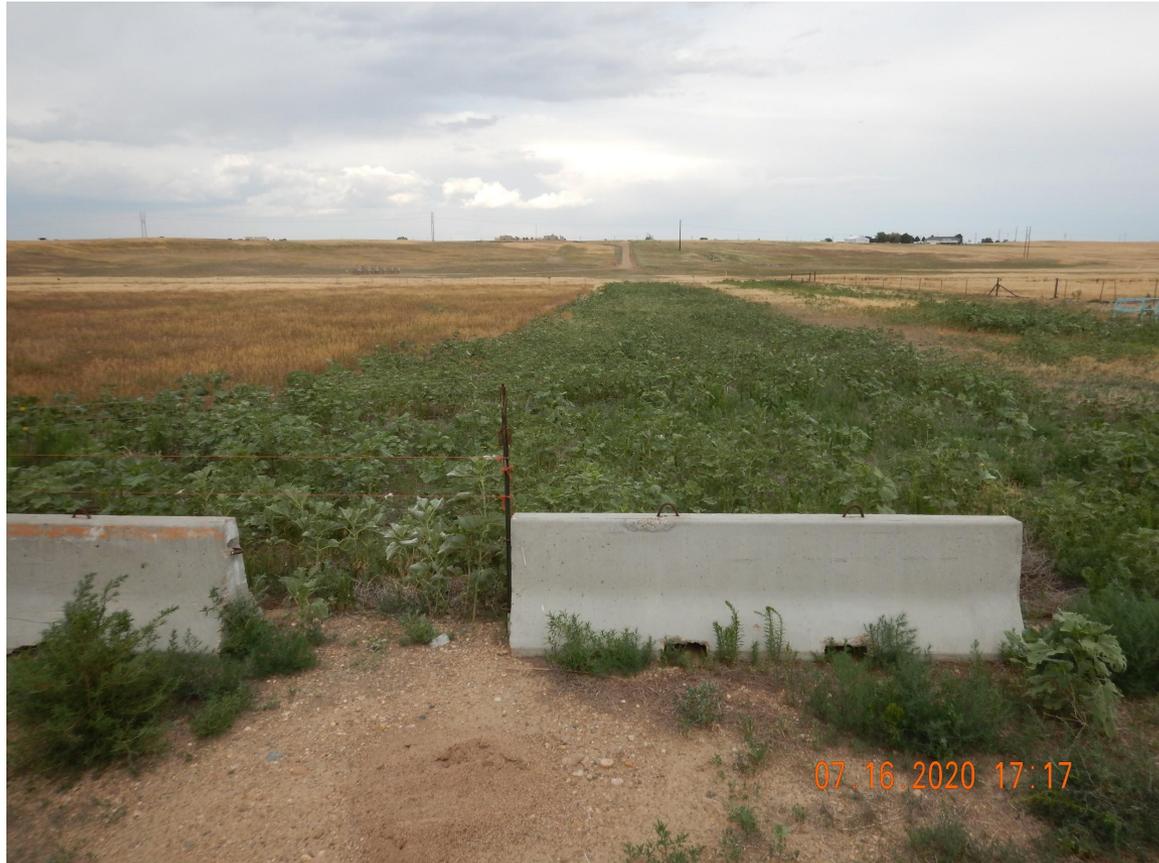
Photo 5. Photo taken along CR 47 1/2, facing East. See comments under Photo 4. This photo has additional species like sunflower and horseweed.

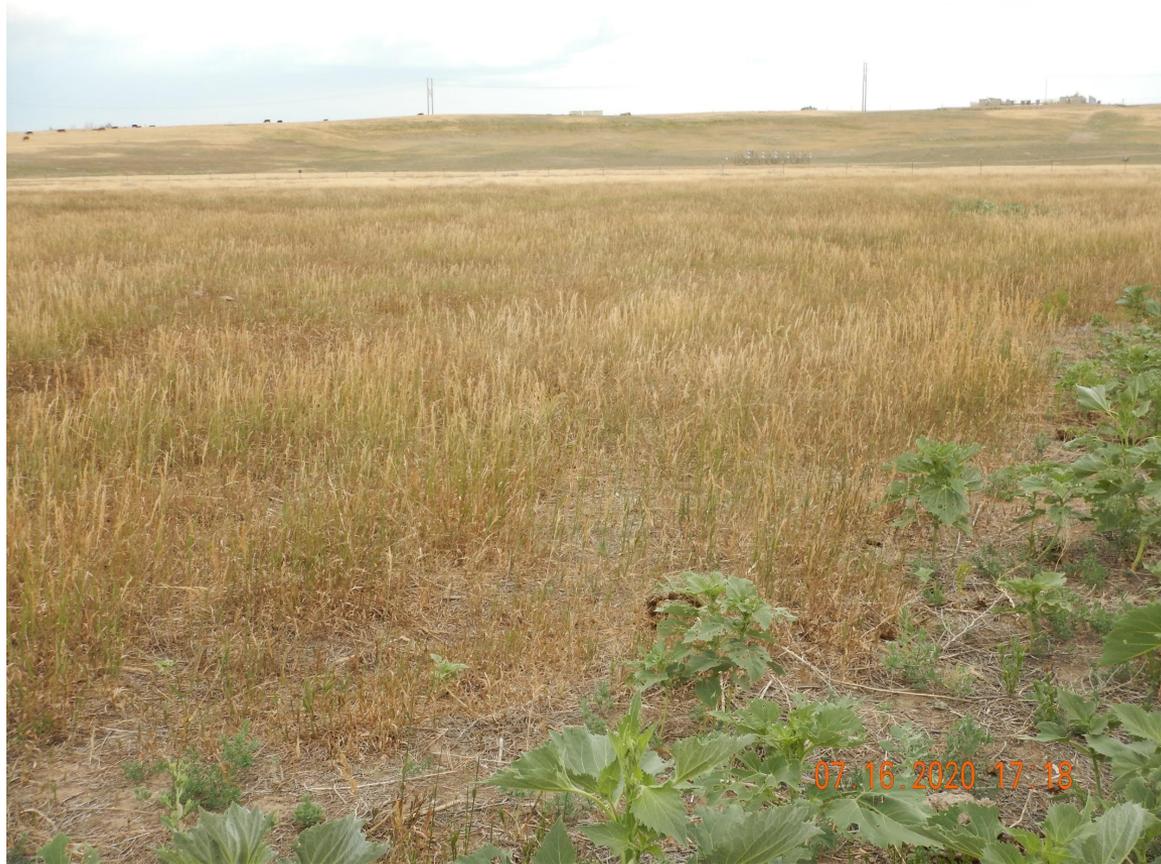
Photo 6. Reference photo taken along the eastern crude oil transfer line, facing East. Photo illustrates Smooth brome within the reference areas which was not observed along the crude oil transfer line.
