Inspection Photos

Operator: Paradox Upstream
API: 113-06126
Date: 7/14/2020

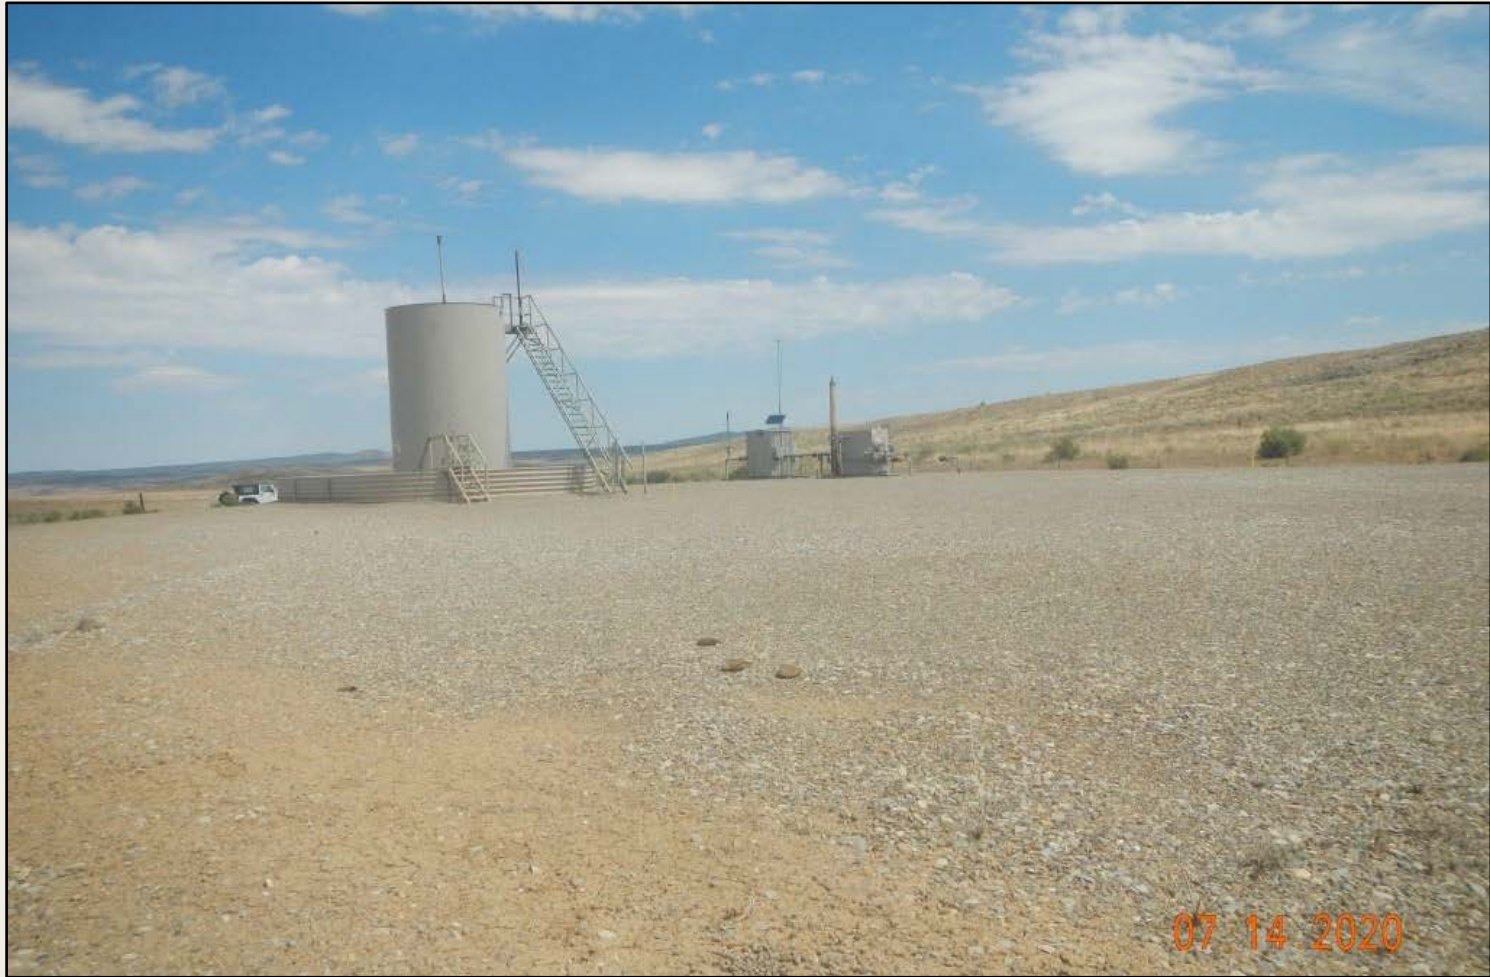
Photo 1. View of the project area from the southeaster corner facing center.

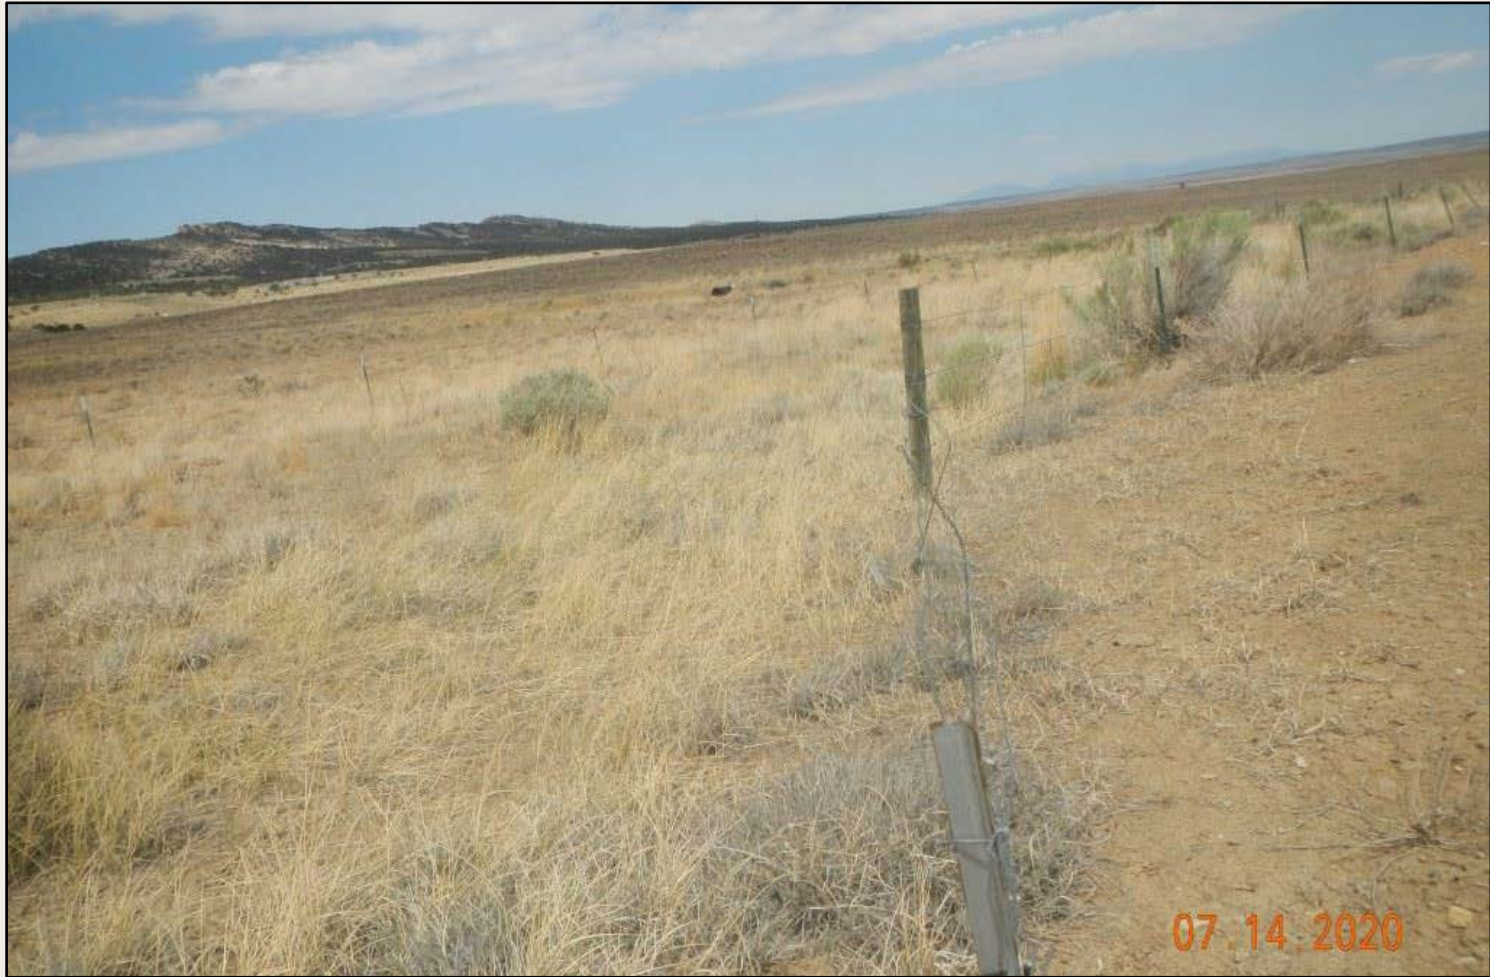
Photo 2. View of the southern interim reclamation area, facing westward, comprised of western wheatgrass, rubber rabbitbrush, sand dropseed, and James galleta.

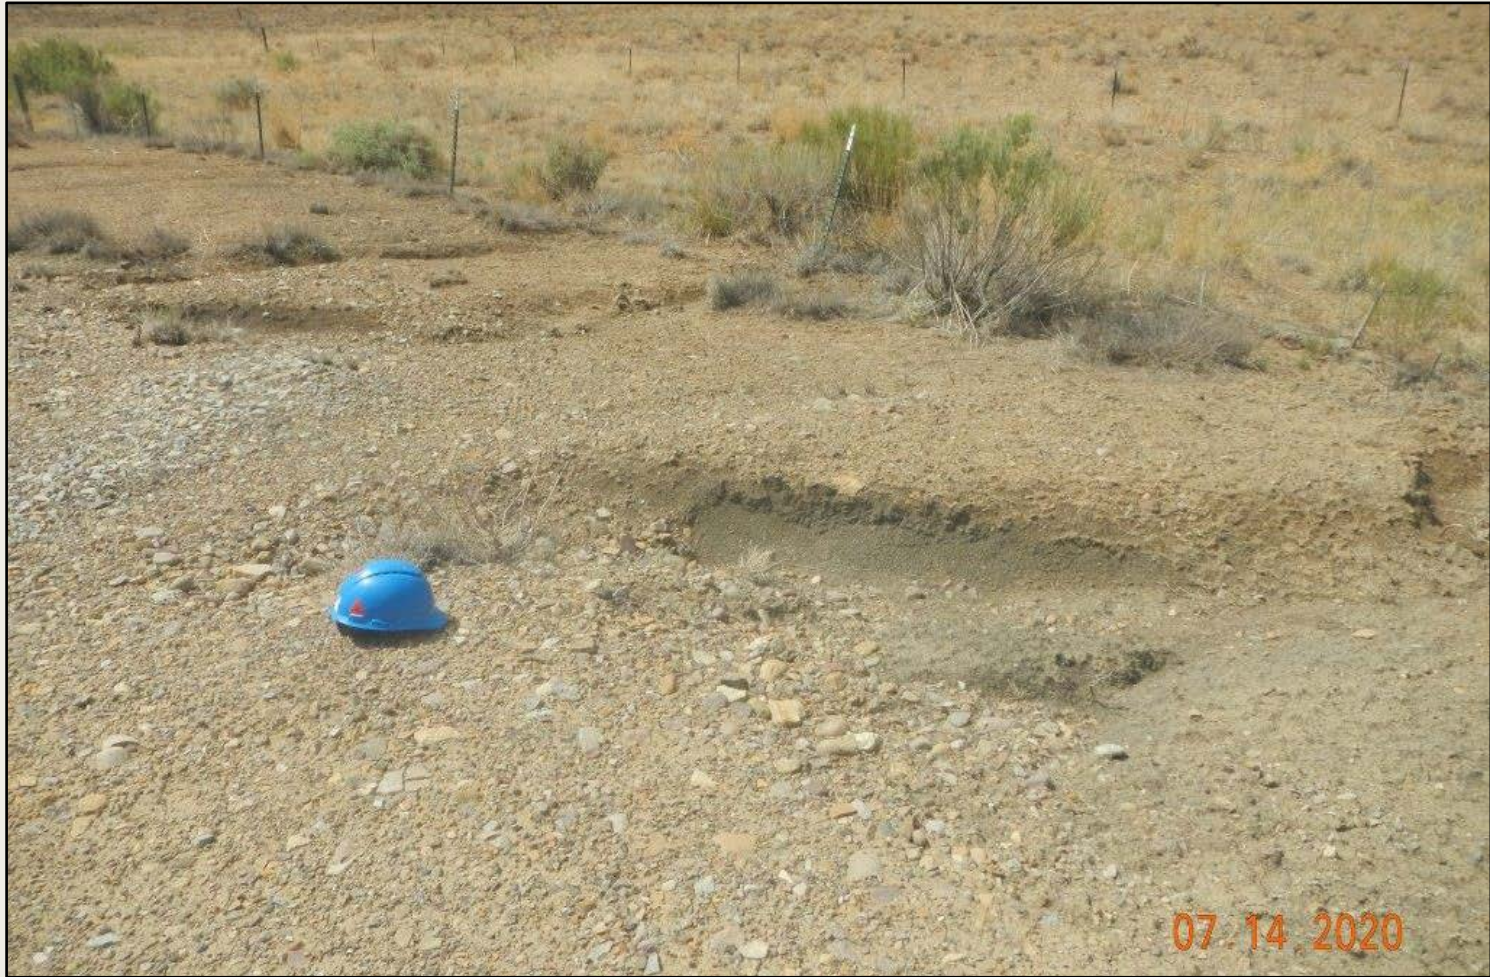
Photo 4. View of erosional channels flowing off of the southern portion of the well pad. Channels are approximately 1-2 feet deep and 2-4 feet wide and need stabilization.

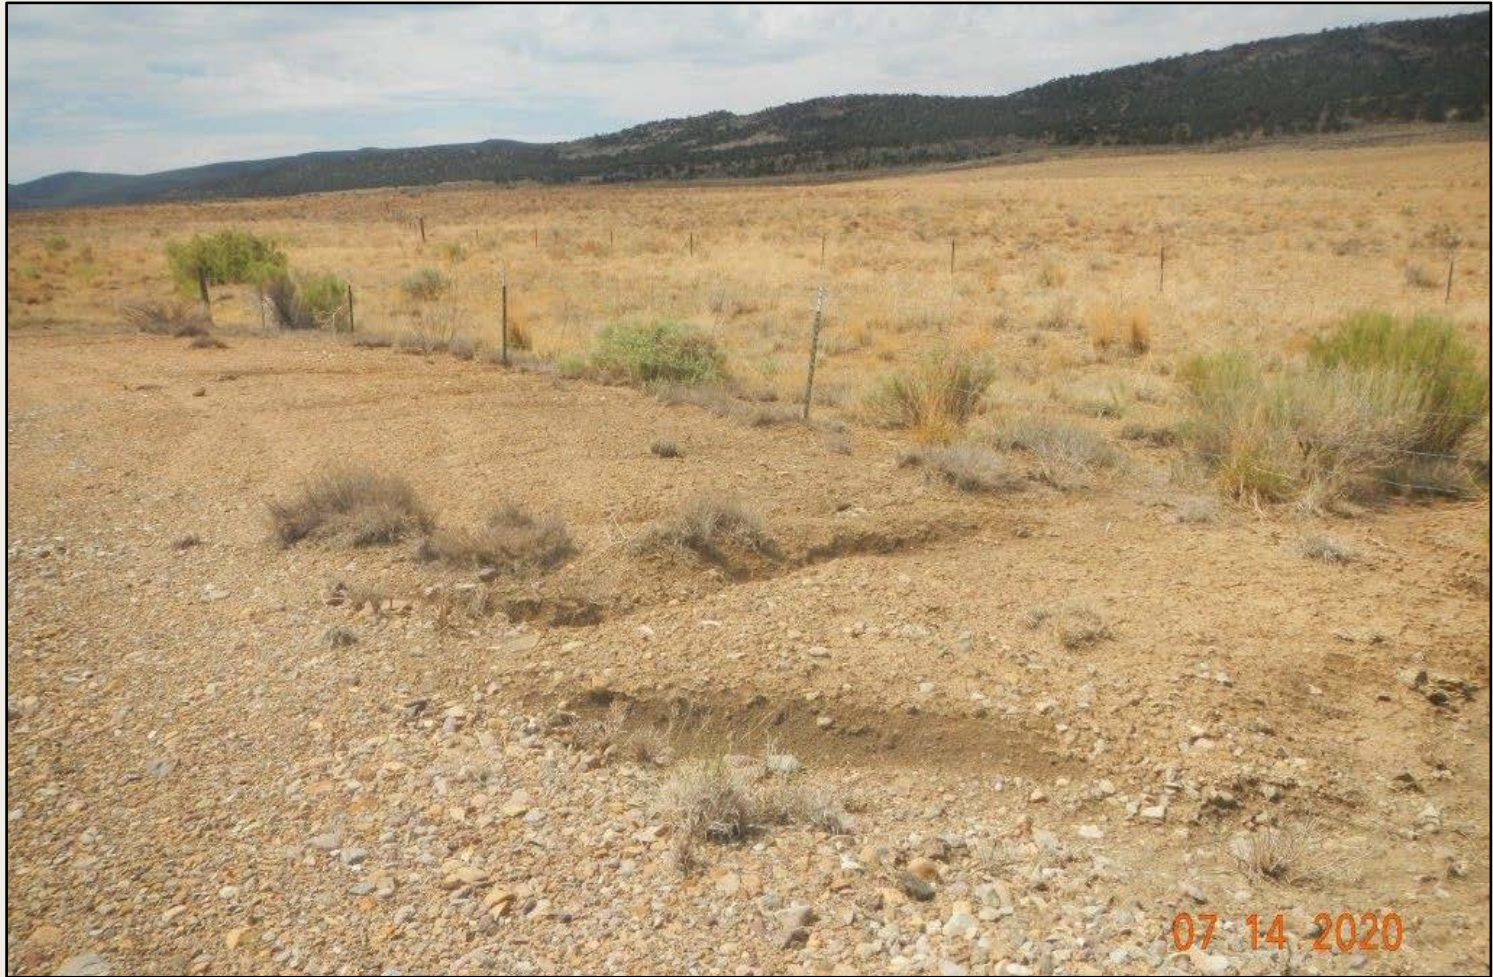
Photo 4. View of more erosional channels within the southern project area.

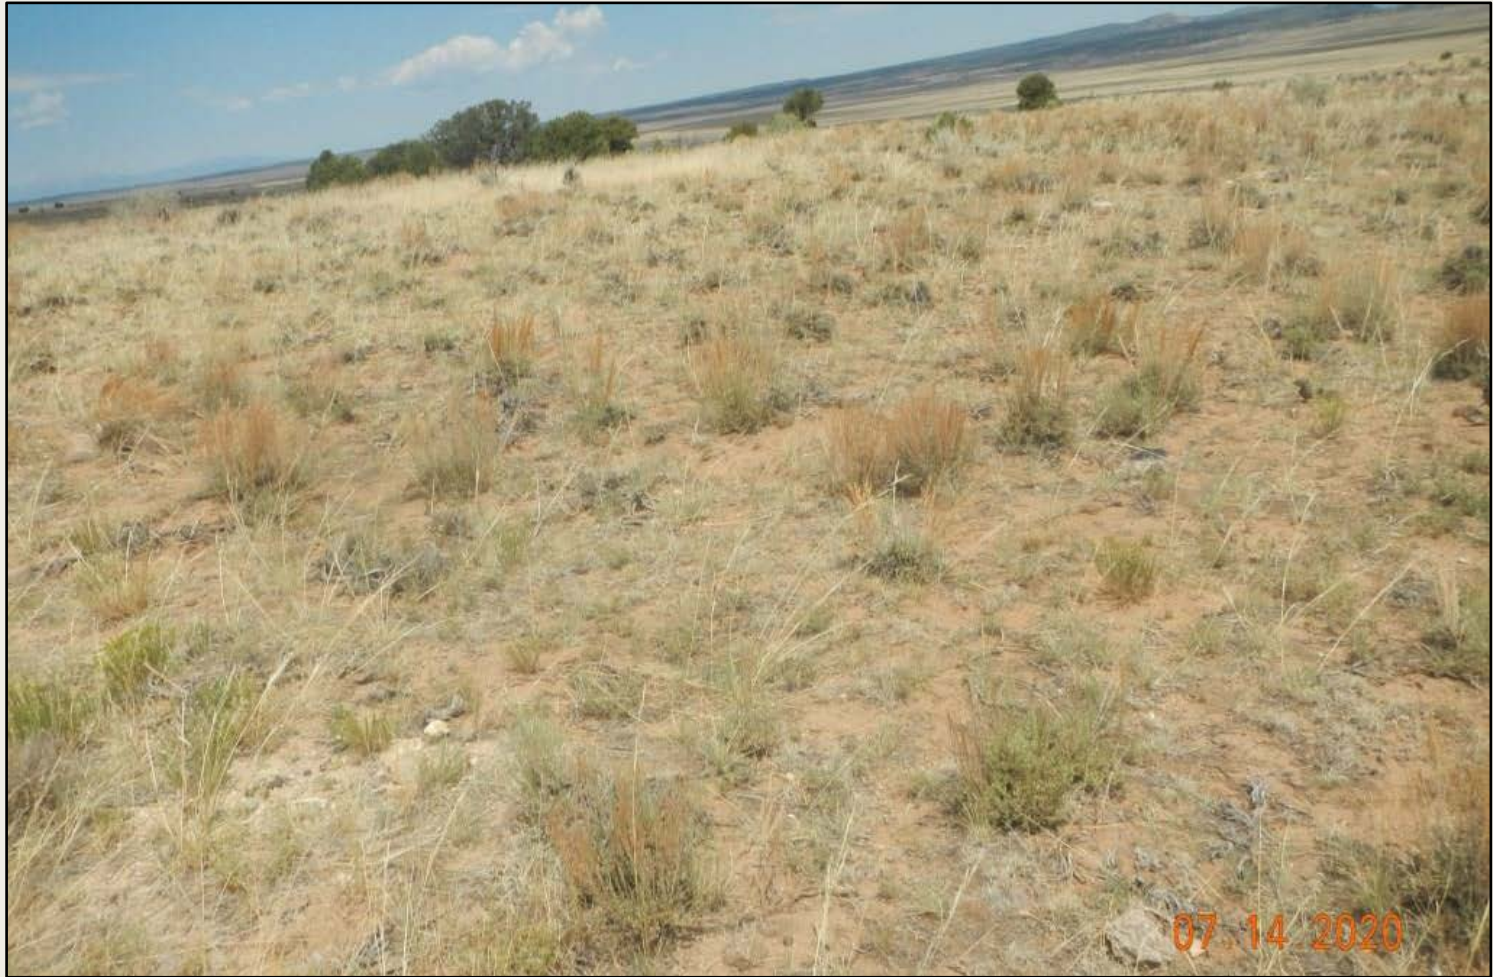
Photo 5. View of reference area comprised of black sage shrubland with needle and thread grass, blue grama, snakeweed, and sand heath.
