# Inspection Photos

Operator: Paradox Upstream  
API: 113-06252  
Date: 7/14/2020

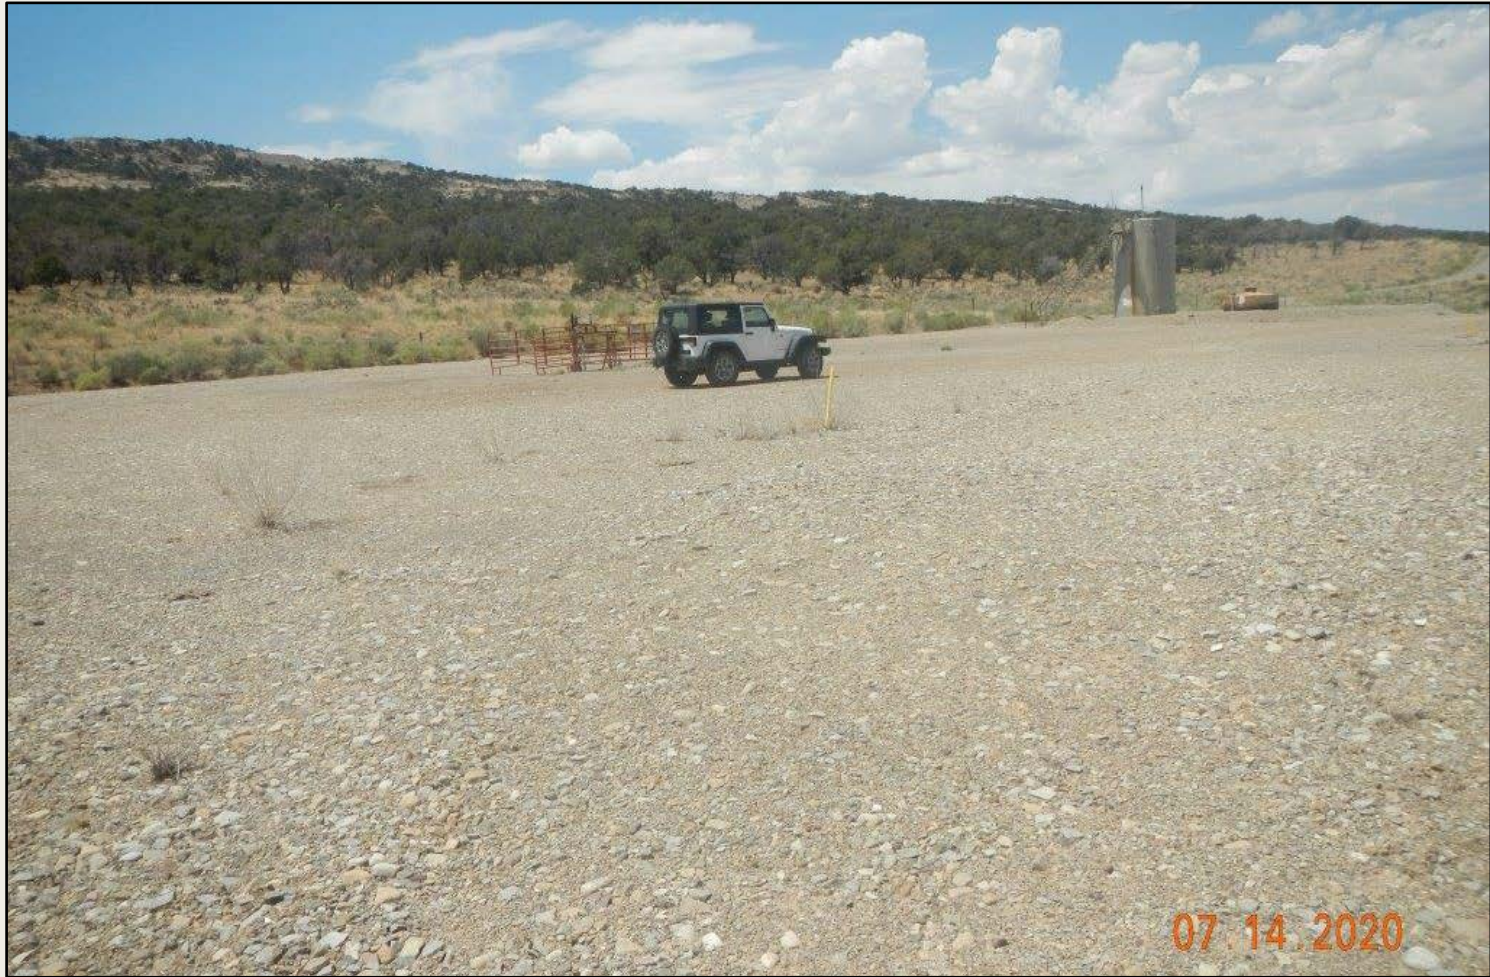
Photo 1. View of the project area from the northeastern corner facing center.

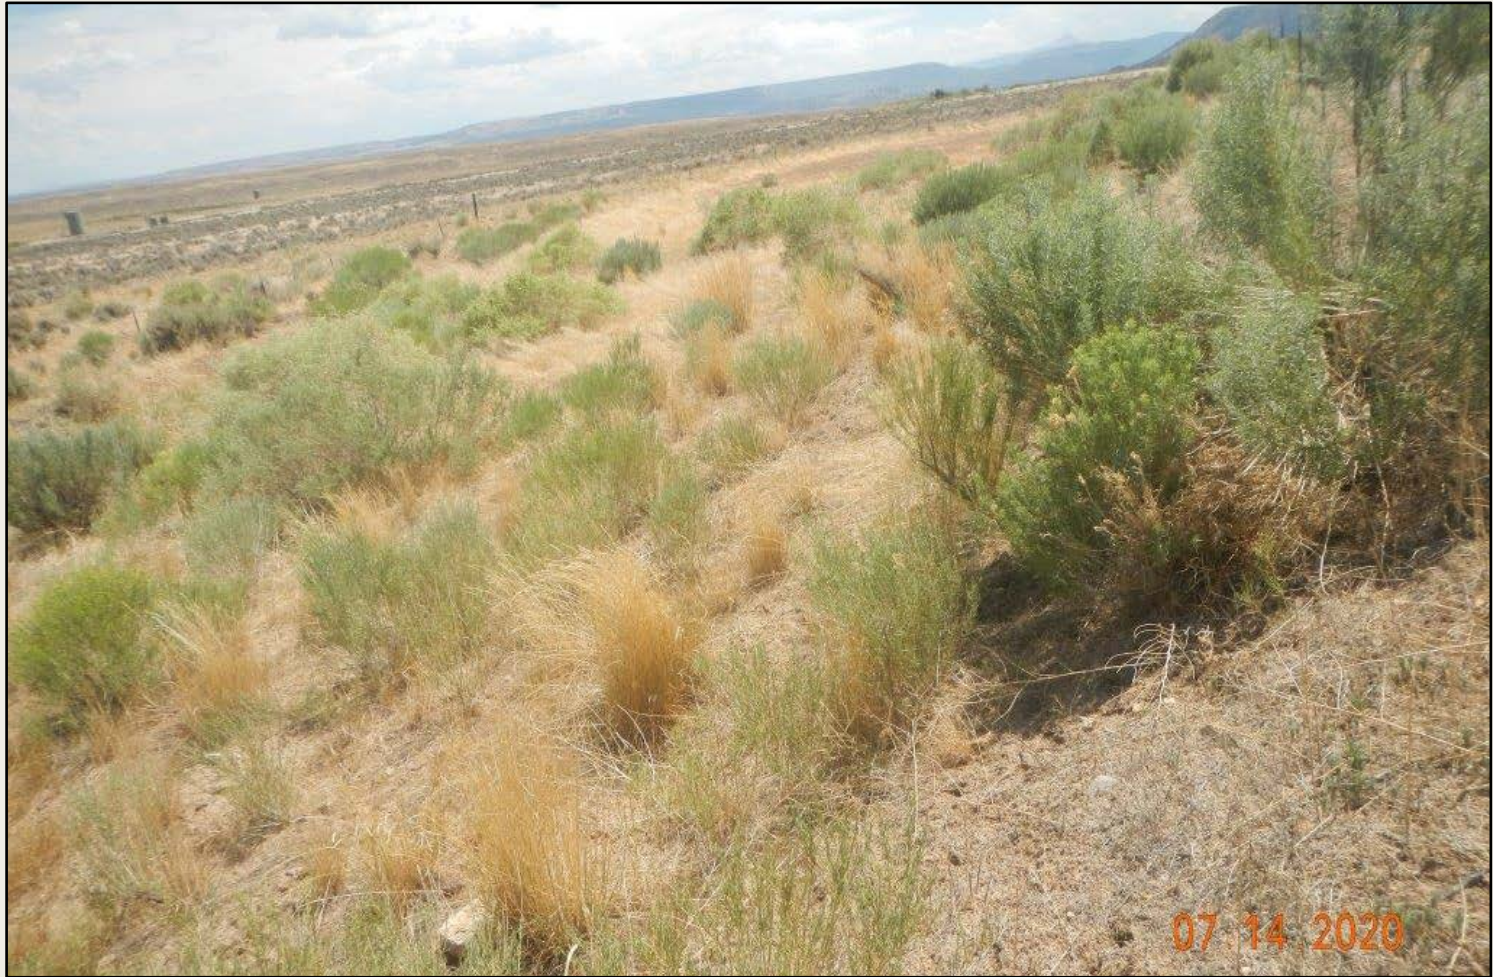
Photo 2. View of the northern fill slope from the northwestern corner facing eastward. Revegetation is progressing and is comprised of grasses and shrubs such as western wheatgrass, crested wheatgrass, fourwing saltbush, and rubber rabbitbrush.

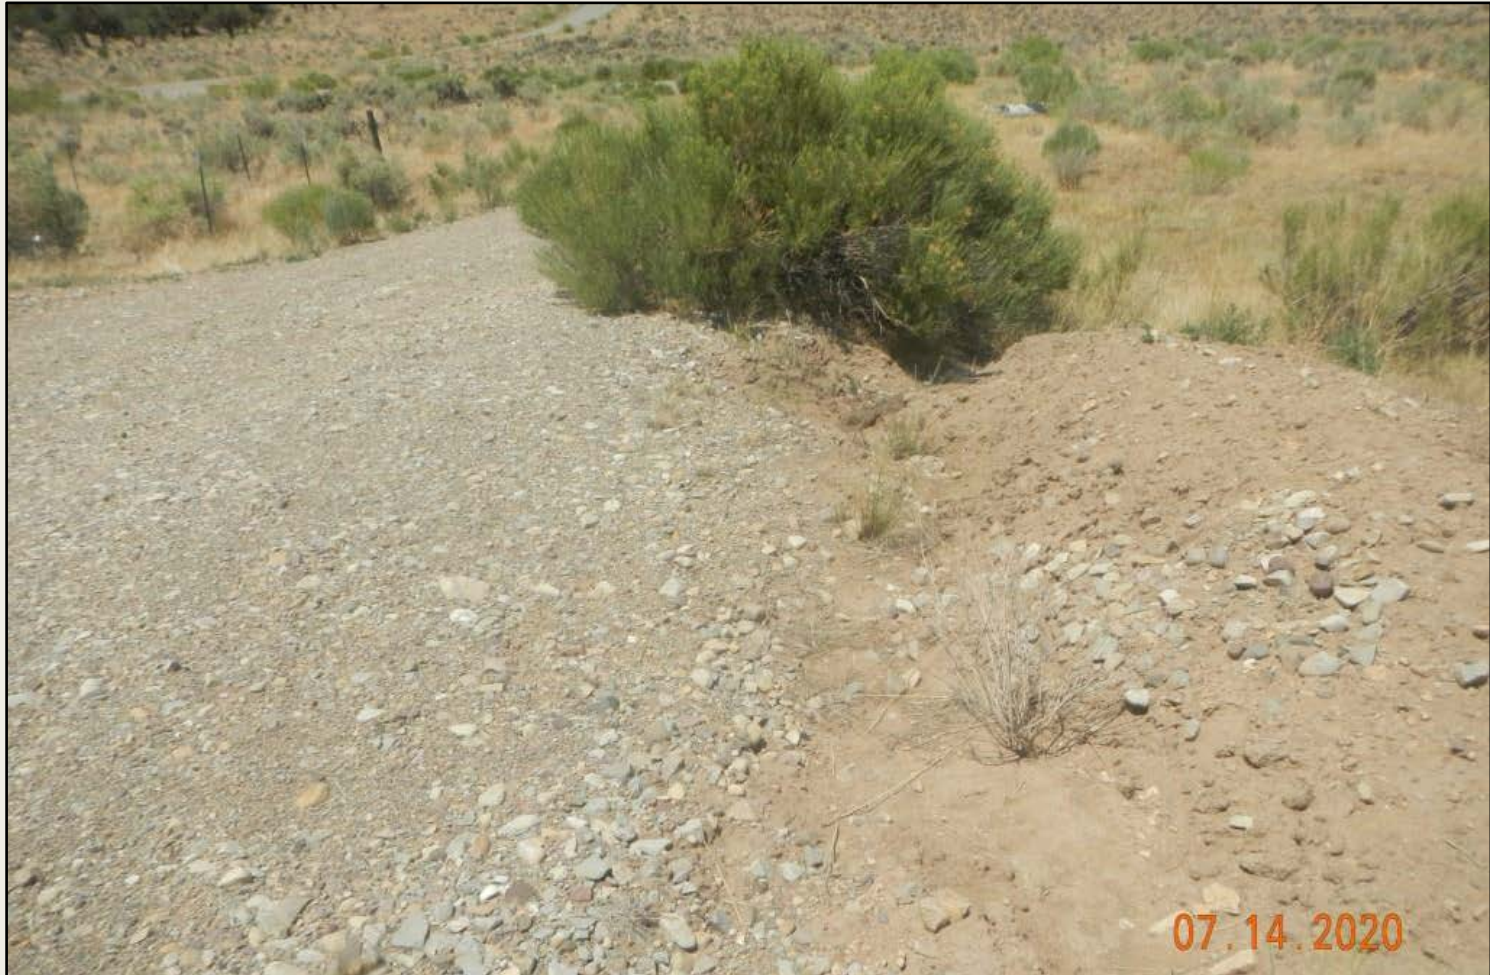
Photo 3. View of erosional channel forming at the well pad entrance. Channel is approximately 2 feet wide and 1 foot deep and needs stabilization.

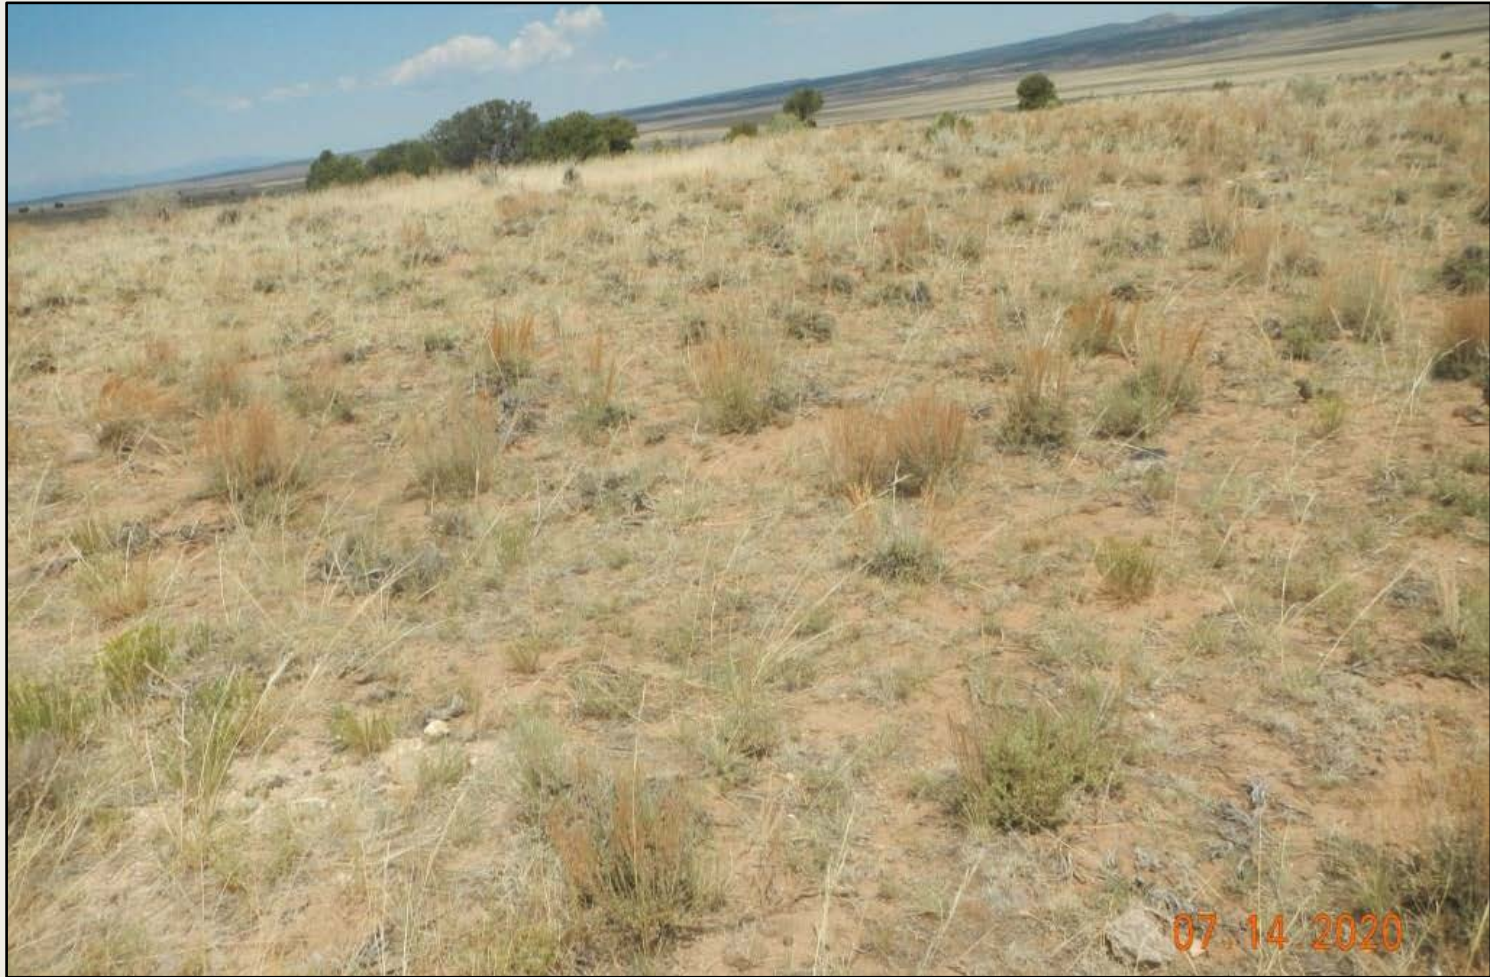
Photo 4. View of reference area comprised of black sage shrubland with needle and thread grass, blue grama, snakeweed, and sand heath.
