Inspection Photos

6/23/2020

Operator: TEP ROCKY MOUNTAIN LLC - 96850

Location ID: 335275

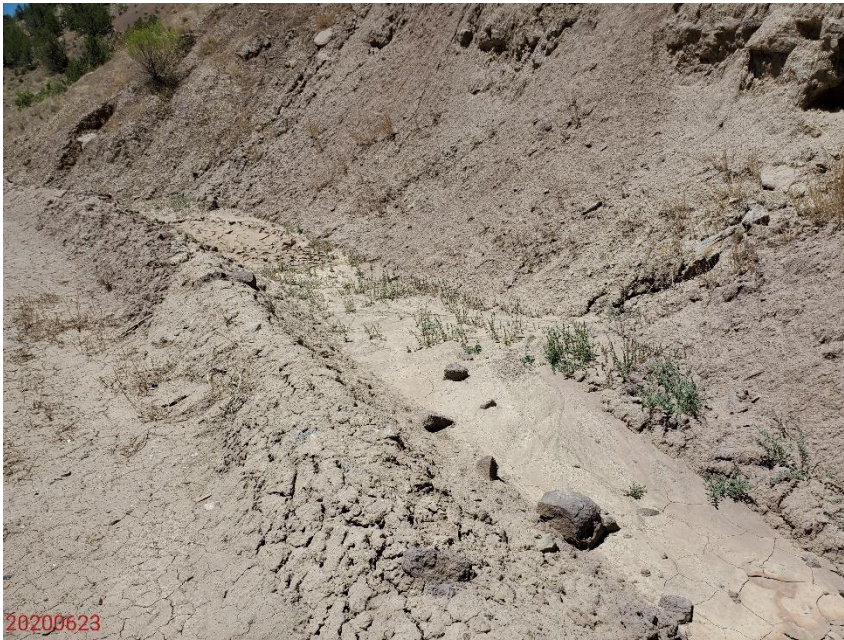
Photo 1: Photo taken from the west end of the Location, facing southwest. Photo shows areas of the stormwater diversion ditch where Halogeton was observed. Photo also shows sediment deposition within the ditch; Maintenance advised.

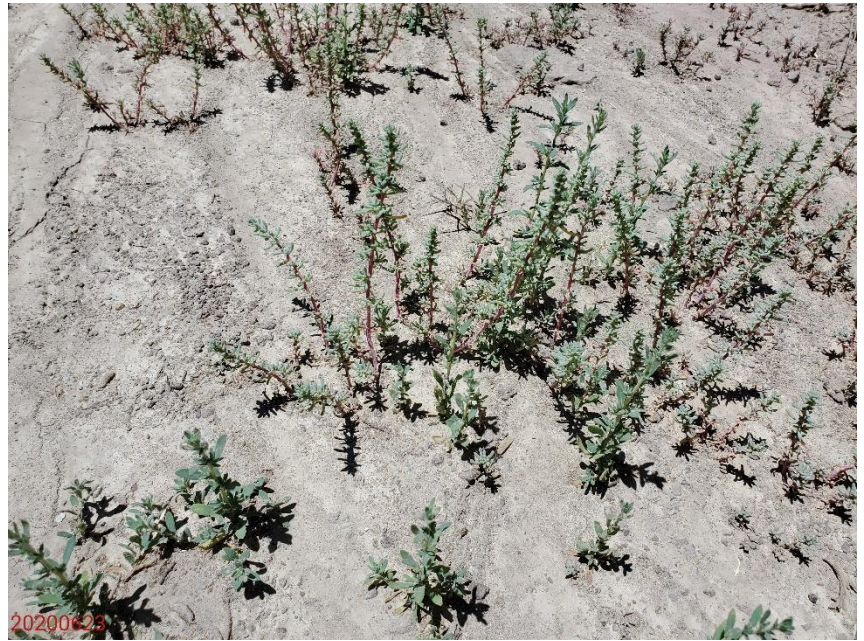
Photo 2: Continued from photo 1.

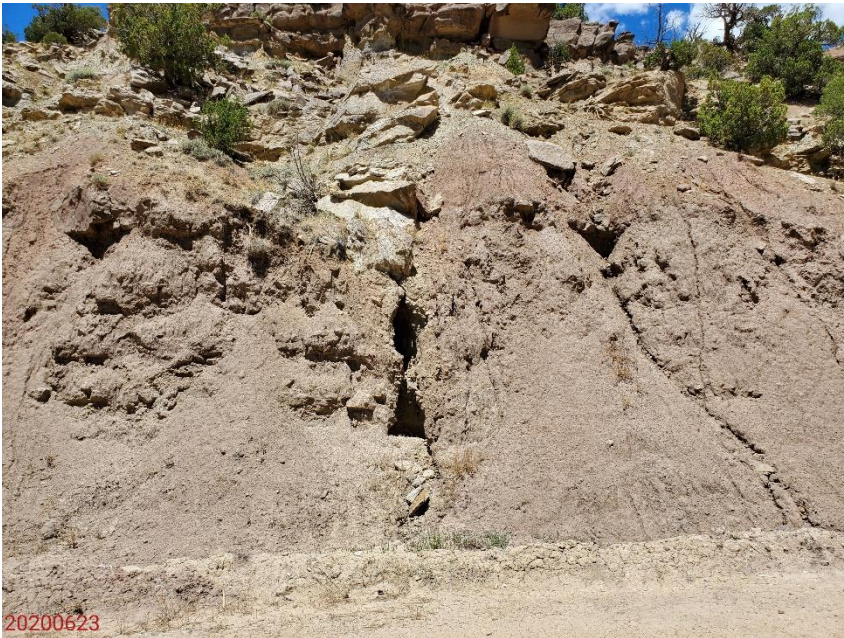
Photo 3: Photo taken from the west end of the Location, facing west. Photo shows slopes where stormwater appears to be undercutting rocks on the slopes. COGCC strongly recommends that appropriate precautions are taken by the Operator due to potential rock fall from these areas not disturbed during construction.

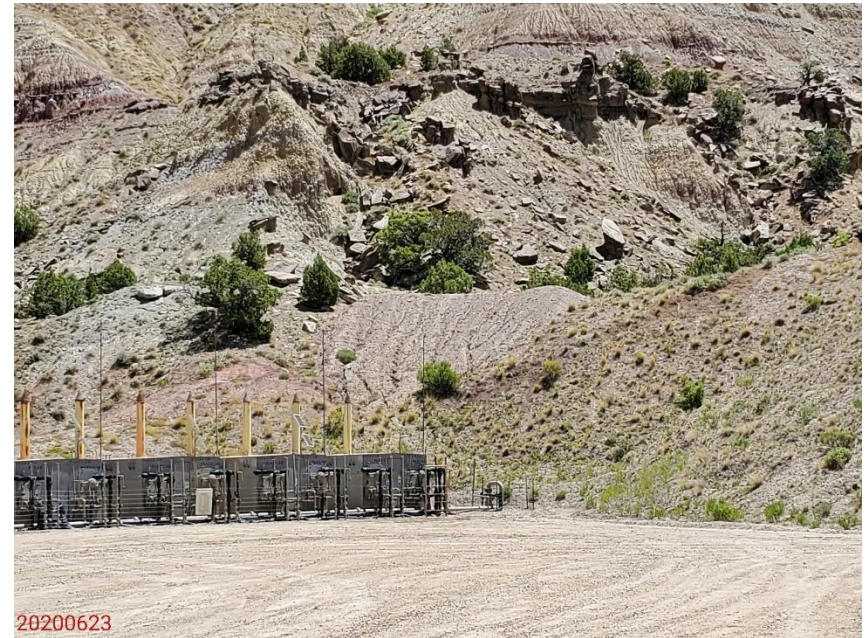
Photo 4: Photo taken from the Location facing northeast. Photo shows slopes on the northeast end of the Location with insufficient or missing BMPs to stabilize and protect slopes/soils.
