Inspection Photos

Operator: Paradox Upstream
API: 113-06054
Date: 7/16/2020

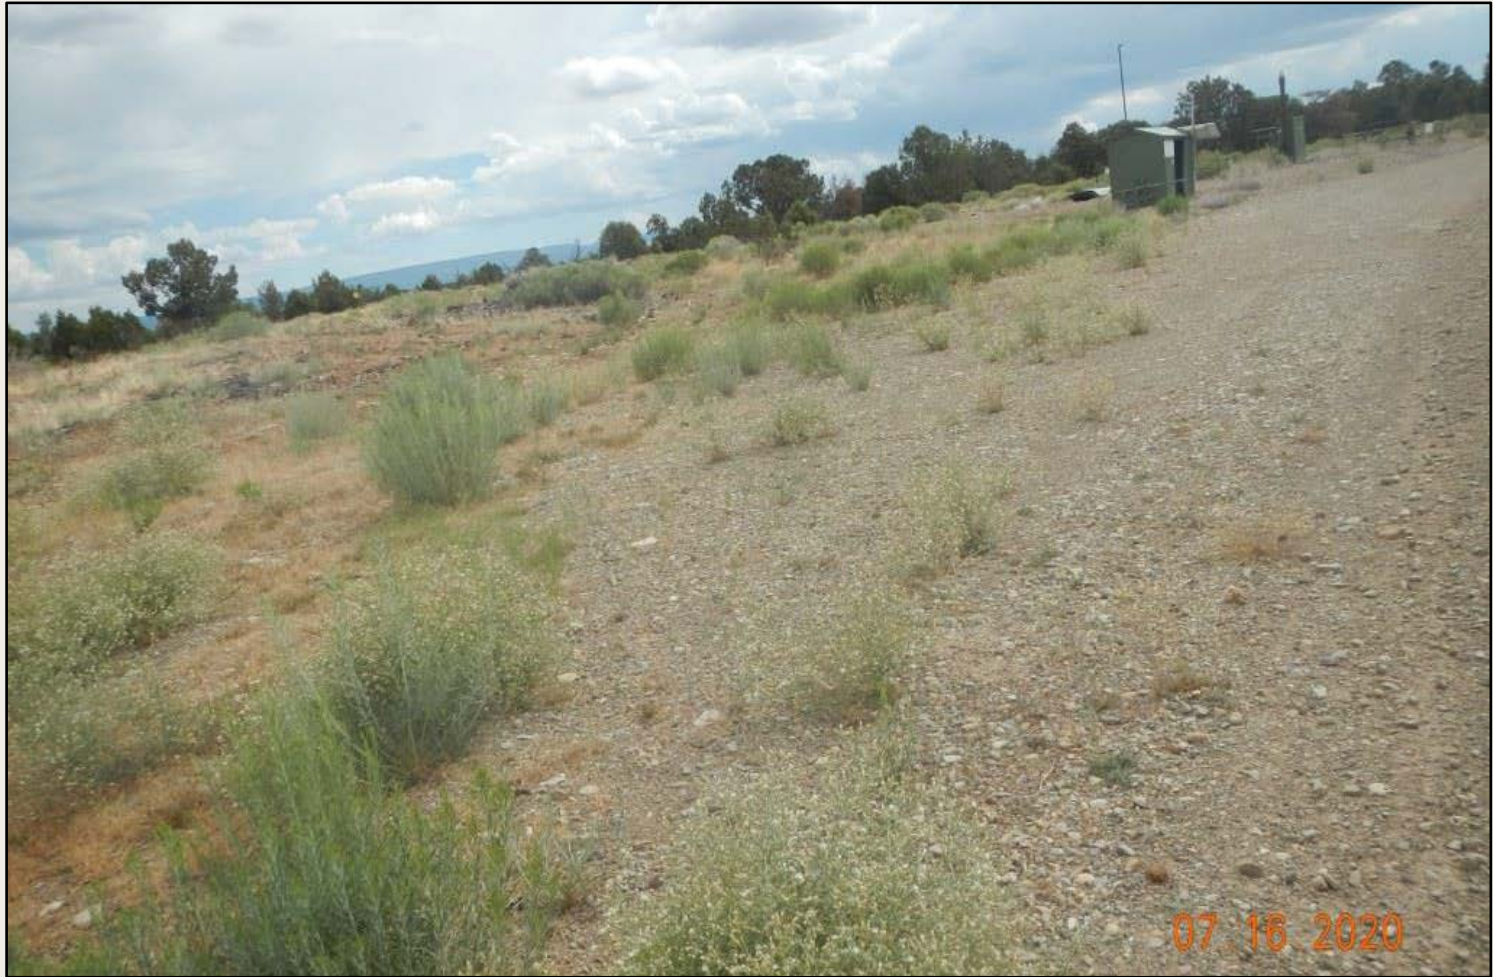
Photo 1. View of the project area from the southwestern corner facing center.

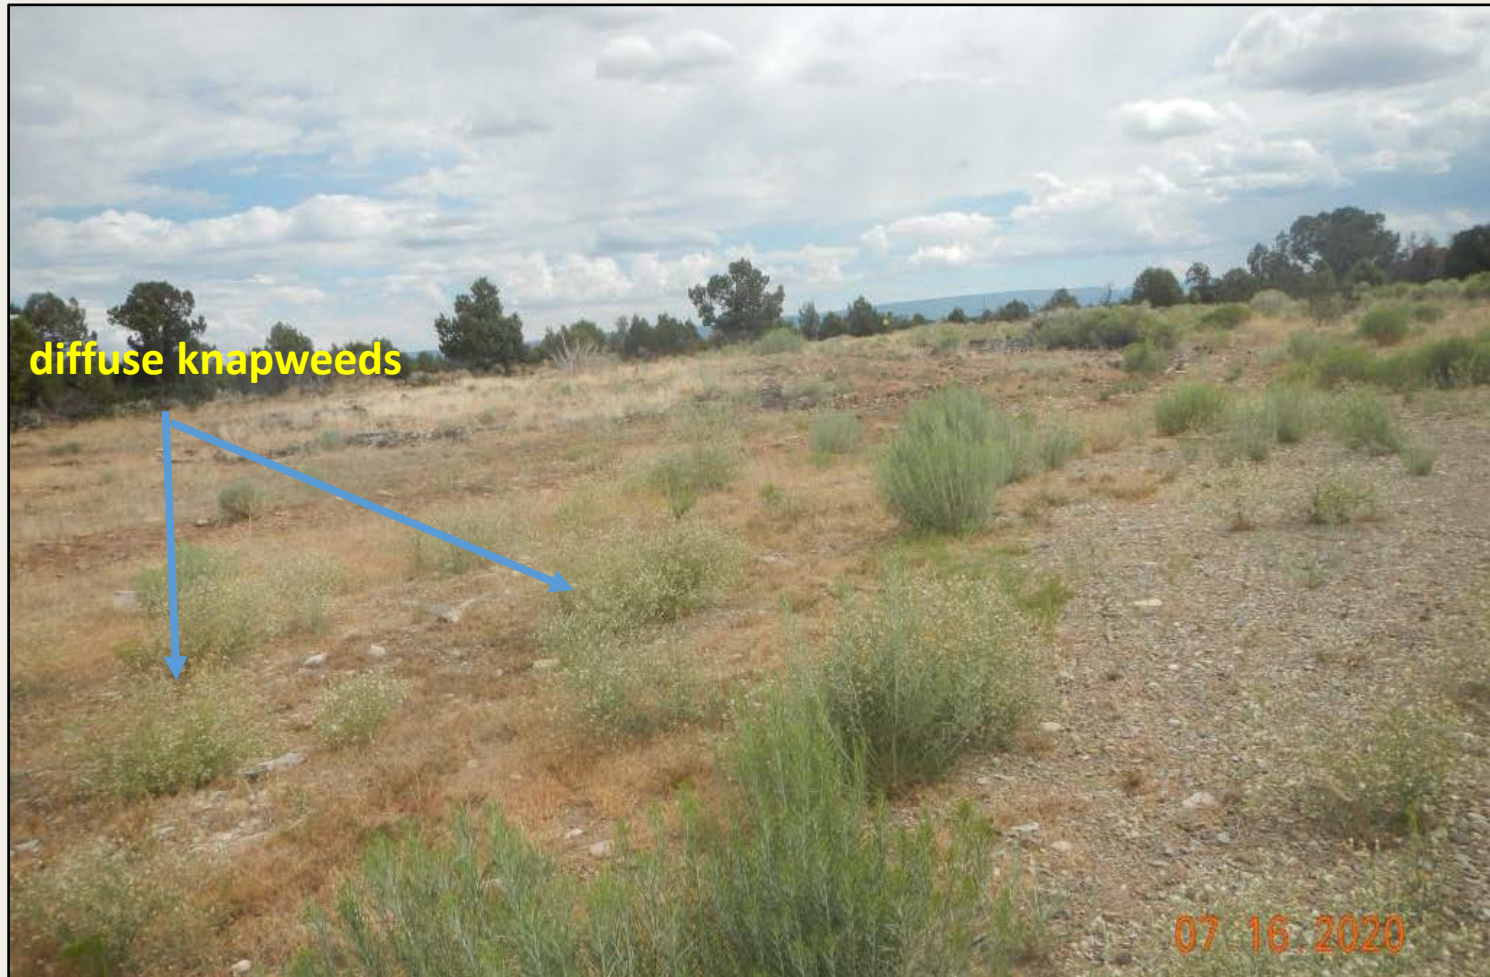
Photo 2. View of the northern project area from the southwestern corner facing northeastward. Revegetation is progressing and is comprised of grasses and shrubs such as western wheatgrass, blue grama, and fourwing saltbush, as well as weeds such as cheatgrass. Location is infested with approximately 1000 diffuse knapweeds.

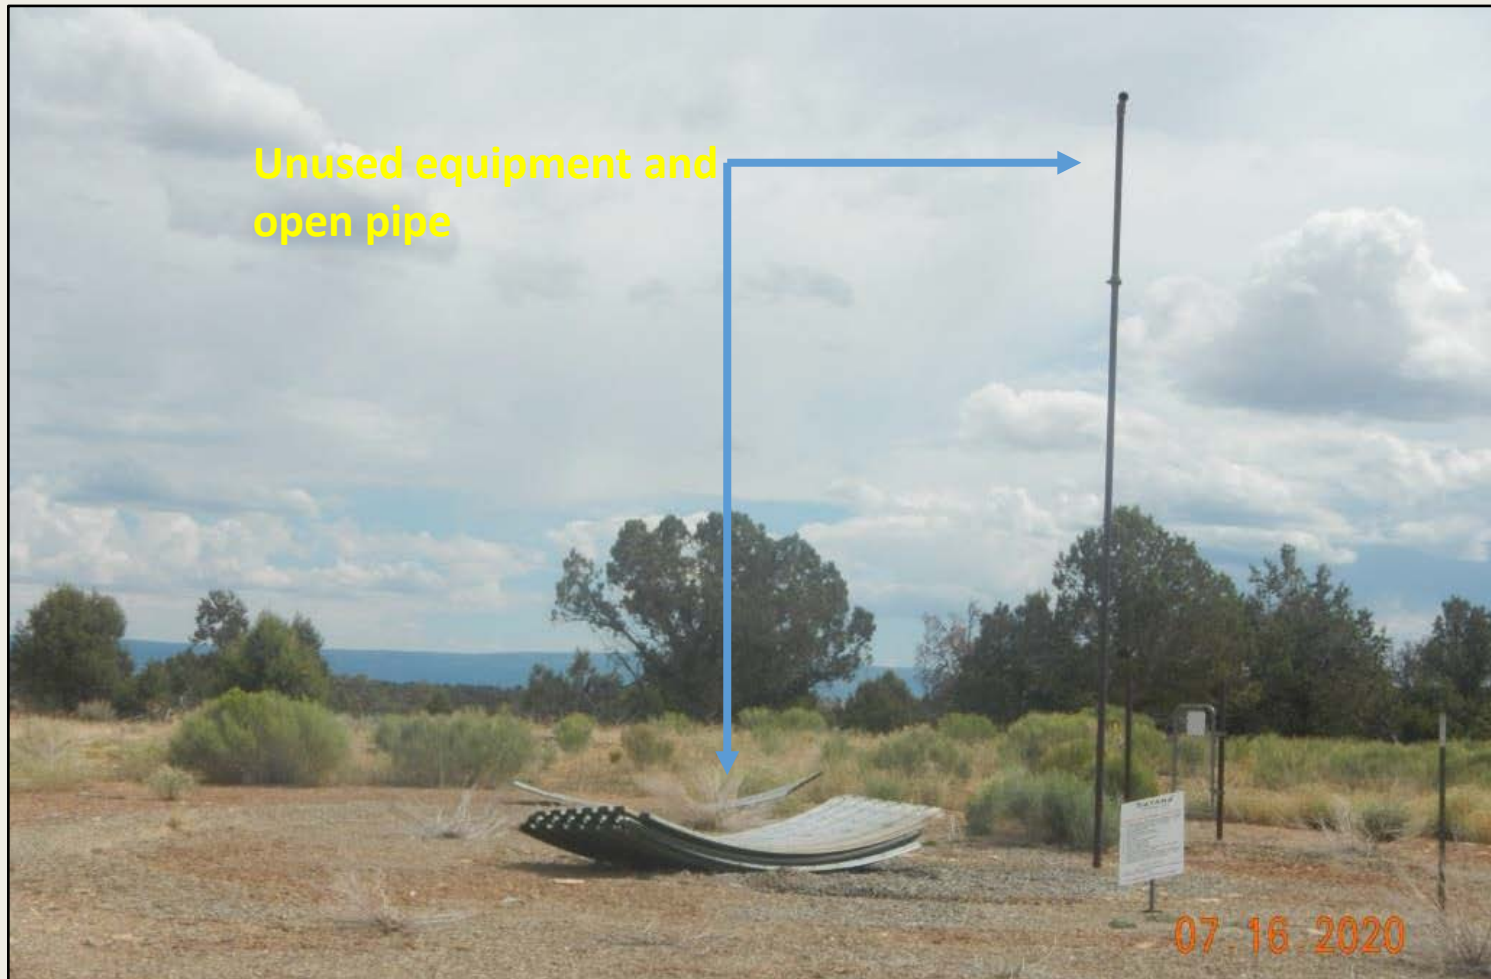
Photo 3. View of unused equipment and open pipe in the project area.

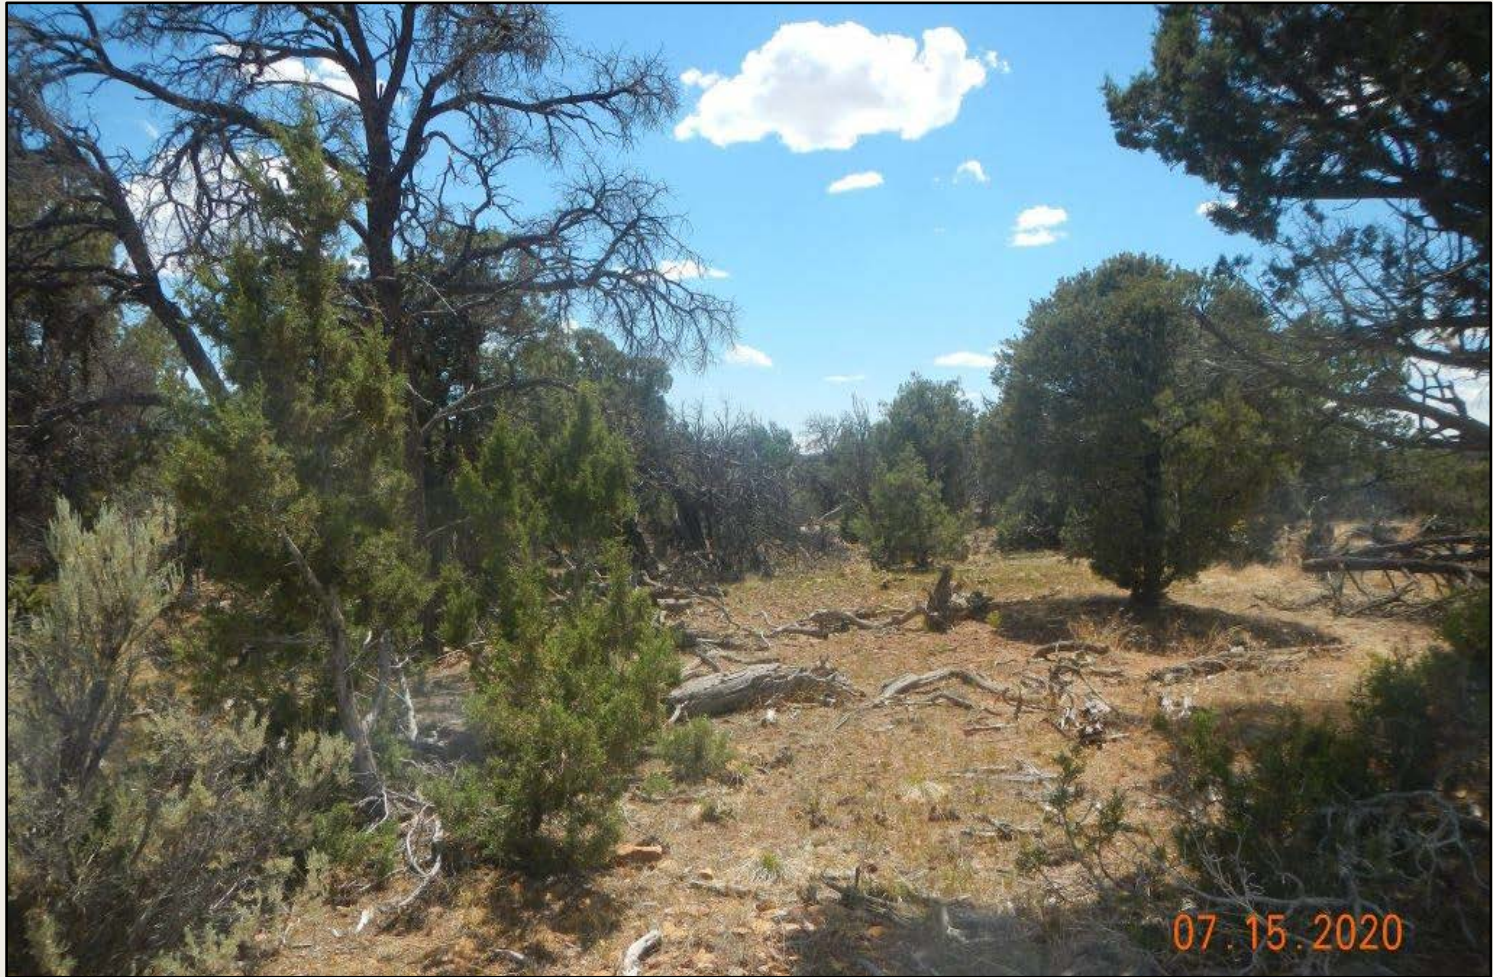
Photo 4. View of reference area comprised of pinyon and juniper woodland with understory of big sagebrush, blue grama, and sand heath.
