Final Reclamation Inspection

Operator: EXTRACTION OIL & GAS INC - #10459

Location ID: 446029

Location Name: Walton 8,17-25 Tank Battery

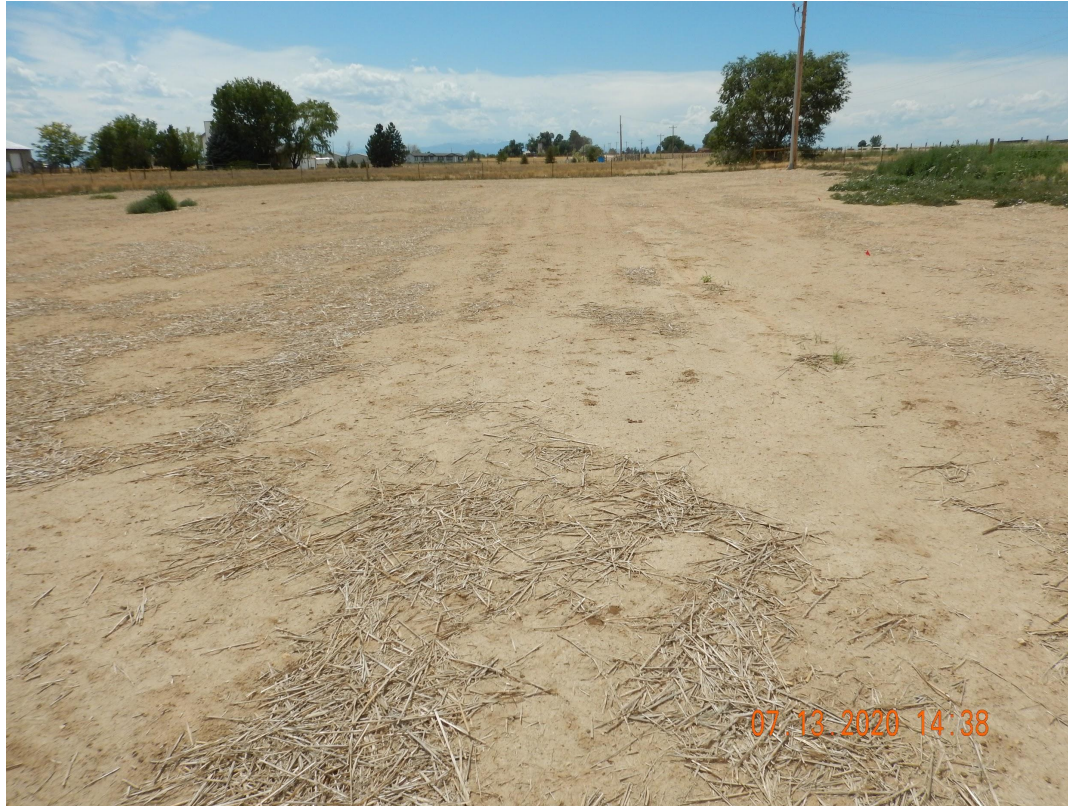
Photo 1. Photo taken from the eastern tank battery, facing West. Photo illustrates the tank battery is bare soil with no establishment of desirable vegetation, only some weed establishment.

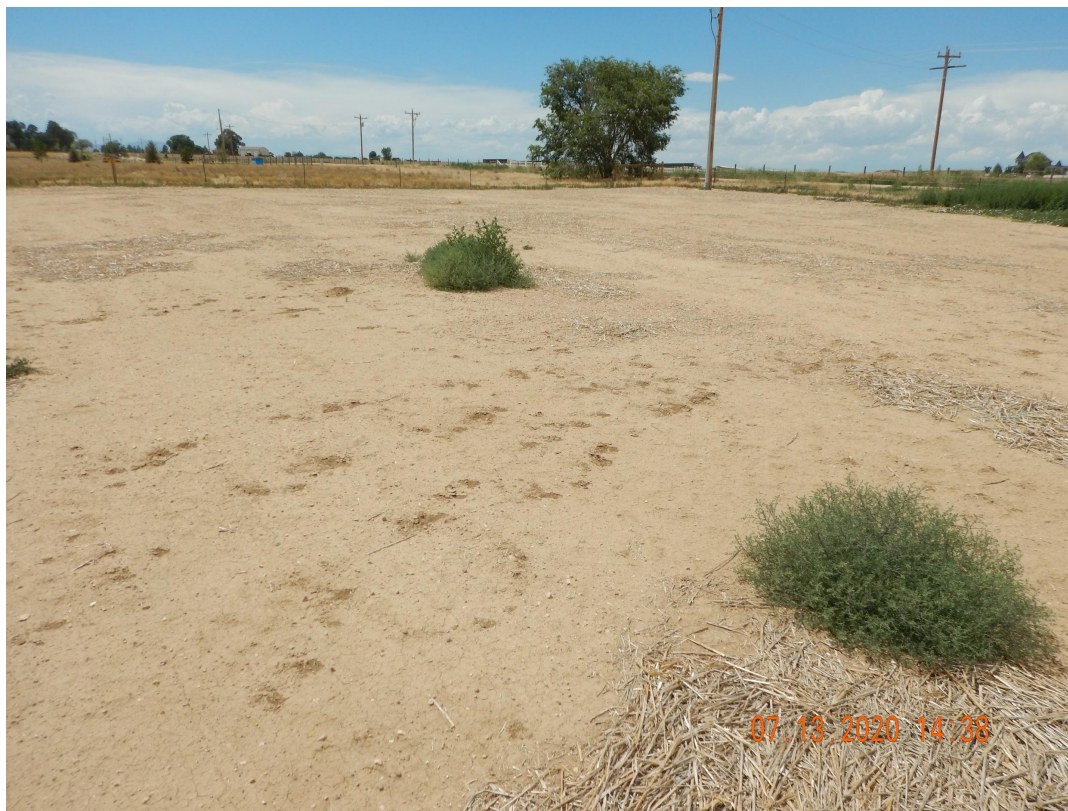
Photo 2. Photo taken from the central tank battery, facing Northwest.
See comments under Photo 1.

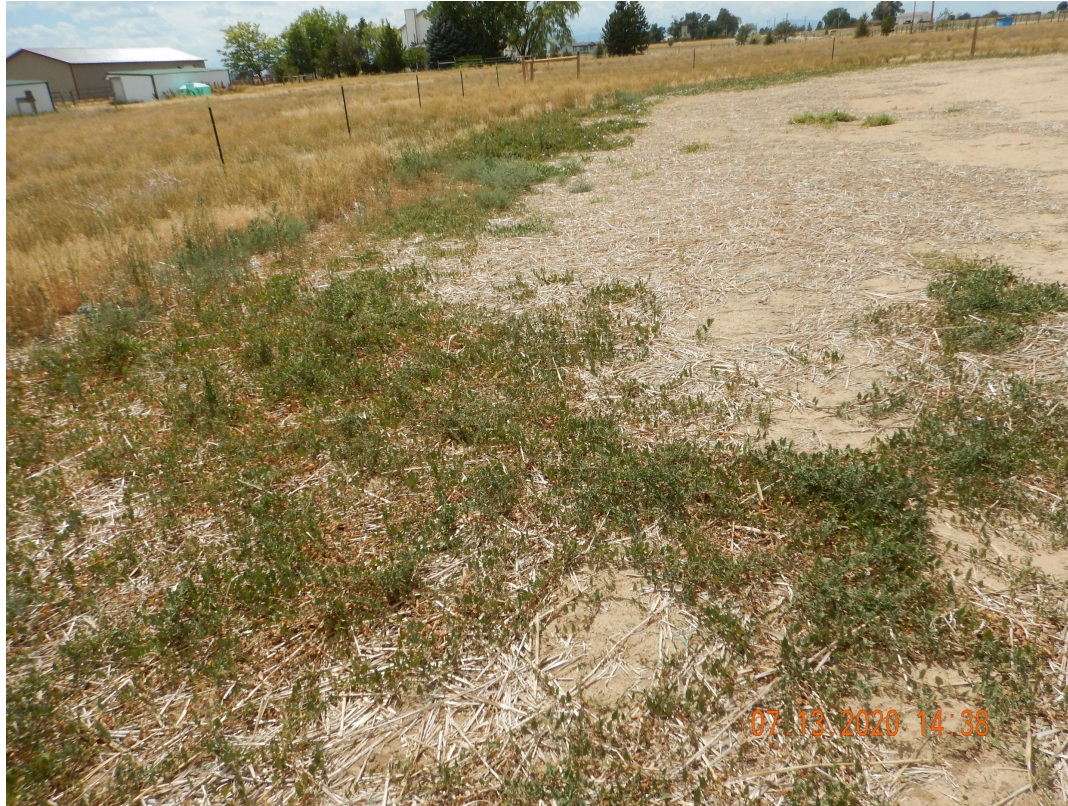
Photo 3. Photo taken from the southern tank battery, facing West. Photo illustrates the establishment of field bindweed, a List C Colorado noxious weed.
