Inspection Photos
Location Name: LE PLATT 1
API#: 05-067-06743
INSP. #: 695103001

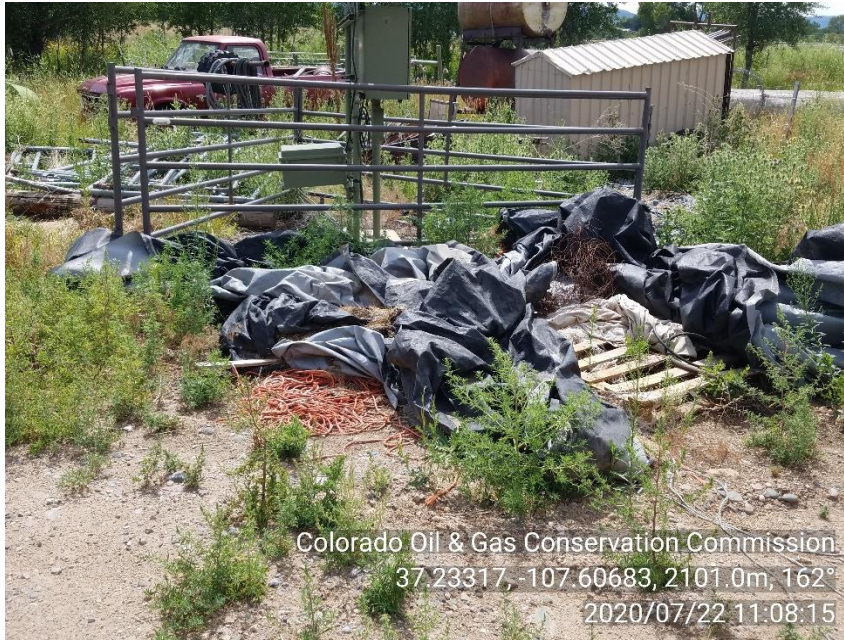
PHOTO 3: UNUSED EQUIPMENT STORED NEAR TELEMETRY EQUIPMENT FENCE (TARMPS AND PALLETS). REMOVE ALL UNUSED EQUIPEMNT PER RULE 603.f. CA DATE 10-22-20

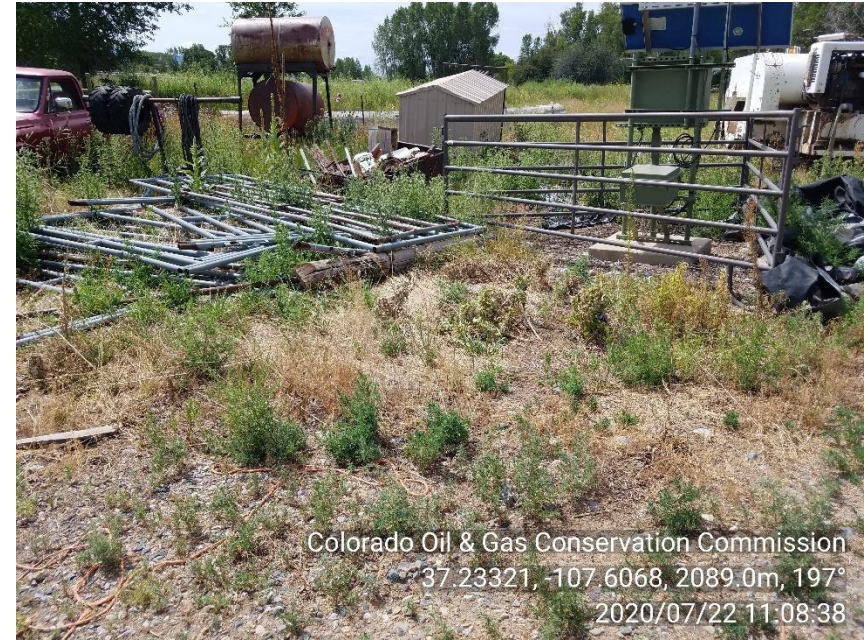
PHOTO 4: UNUSED EQUIPMENT STORED NEAR TELEMETRY EQUIPMENT FENCE (PORTABLE FENCE PANELS). REMOVE ALL UNUSED EQUIPEMNT PER RULE 603.f. CA DATE 10-22-20

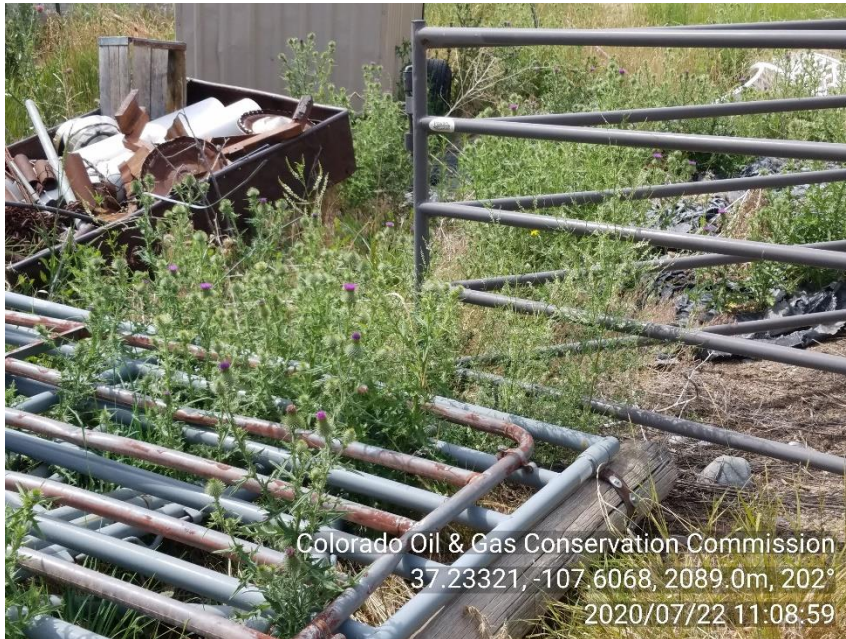
**PHOTO 5: NOXIOUS WEEDS AND OTHER VEGETATION
OVERGROWTH AROUND TELEMETRY EQUIPMENT. REMOVE
NOXIOUS WEEDS AND MAINTAIN ALL OTHER VEGETATION
PER RULE 603.f. CA DATE 8-4-20.**
