Inspection Photos
Location Name: LA PLATT B-1
API#: 05-067-08931
INSP. #: 695103003

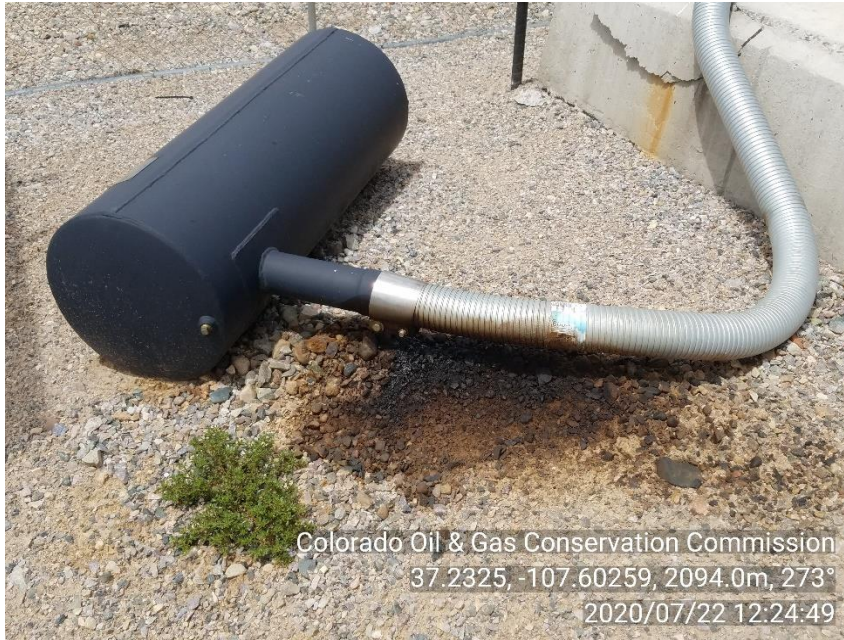
PHOTO 3: Natural gas powered engine exhaust is staining soil/gravel around area of muffler.

Remove stained soil/gravel and dispose. Comply with Rule 1102.f.(2) for best self inspection, maintenance and housekeeping to prevent breakdown or failure of BMP's. CA DATE IS ORIGINAL FROM PREVIOUS INSPECTION DOC#687904818

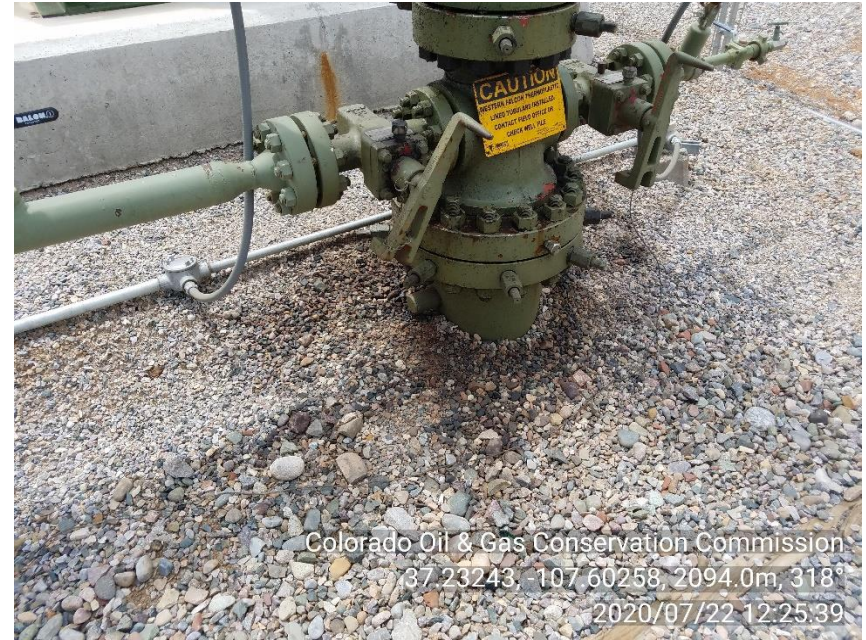
PHOTO 4: Approx 2' x 2' area of stained soil/gravel around base of wellhead. Clean-up and dispose of stained soil/gravel per Rule 1102.f.(2) and Rule 907.e.
CA DATE IS ORIGINAL FROM PREVIOUS INSPECTION DOC#687904818

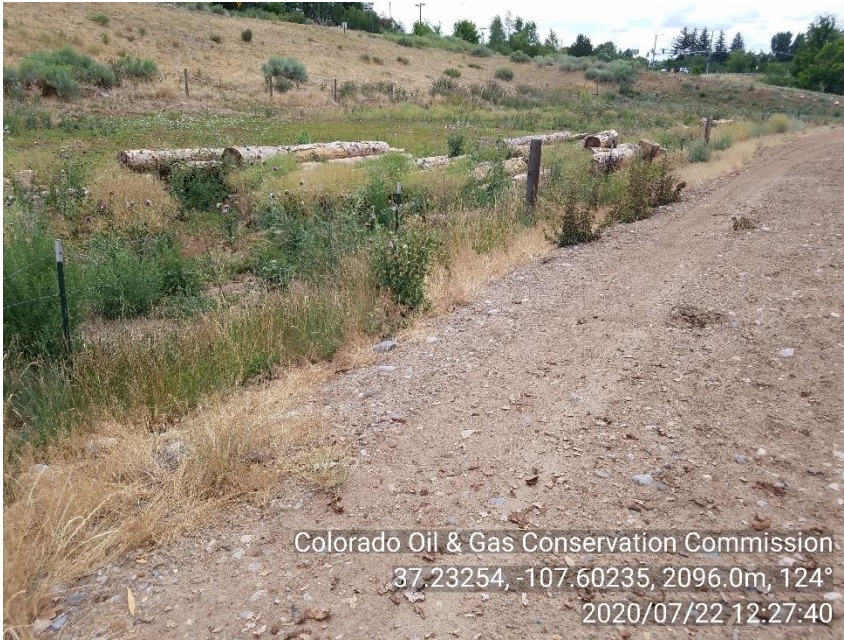
**PHOTO 5: NOZIOUS WEEDS ON NORTH EDGE OF LOCATION NEAR
GAS METER RUN FENCING. REMOVE NOXIOUS WEEDS COMPLY
WITH RULE 1003.f. CA DATE 7-29-20.**
