Inspection Photos
Location Name: STATE CD 1 & 3
API#: 05-067-07852
INSP. #: 695103007

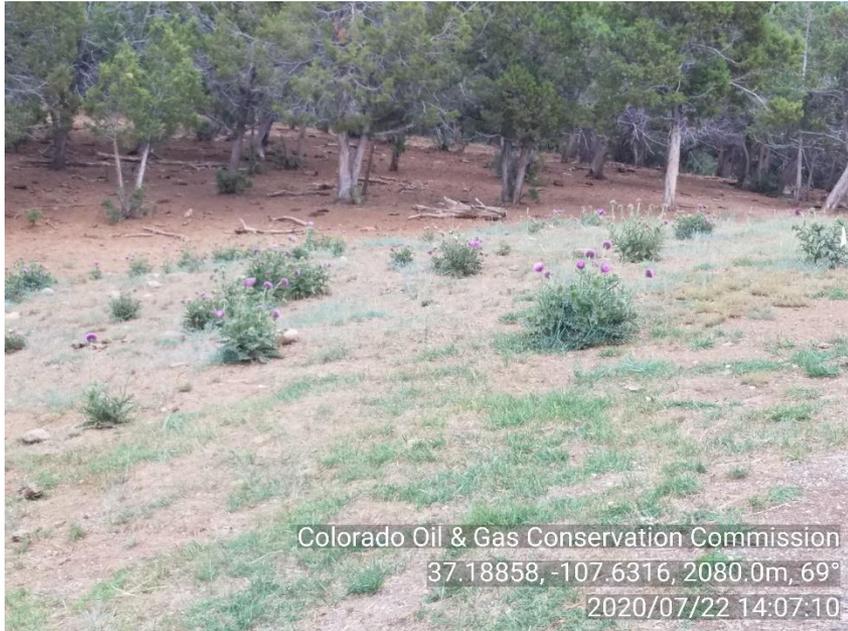
PHOTO 3: Canada Thistle growing at entrance to location and in perimeter of the interim reclamation area. Remove weeds and manage to prevent spread to comply with Rule 1003.f. CA DATE 7-29-20.

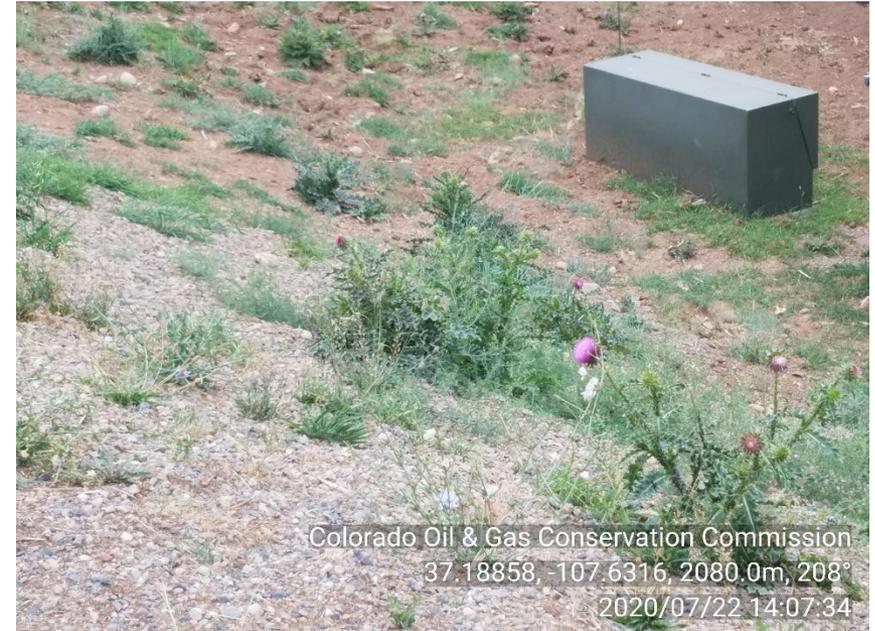
PHOTO 4: ANOTHER IMAGE OF CANADA THISTLE.

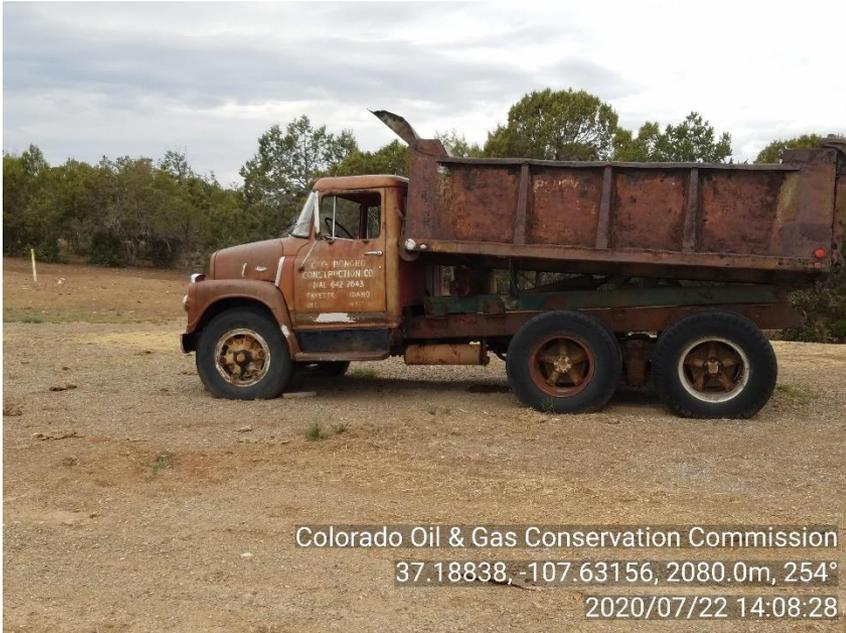
PHOTO 5: UNUSED EQUIPMENT STORED ON LOCATION APPEARS TO BE DUMPTRUCK NOT RELATED TO OPERATOR OR OIL & GAS OPERATION. REMOVE UNUSED EQUIPMENT PER RULE 603.f. CA DATE 10-22-20.

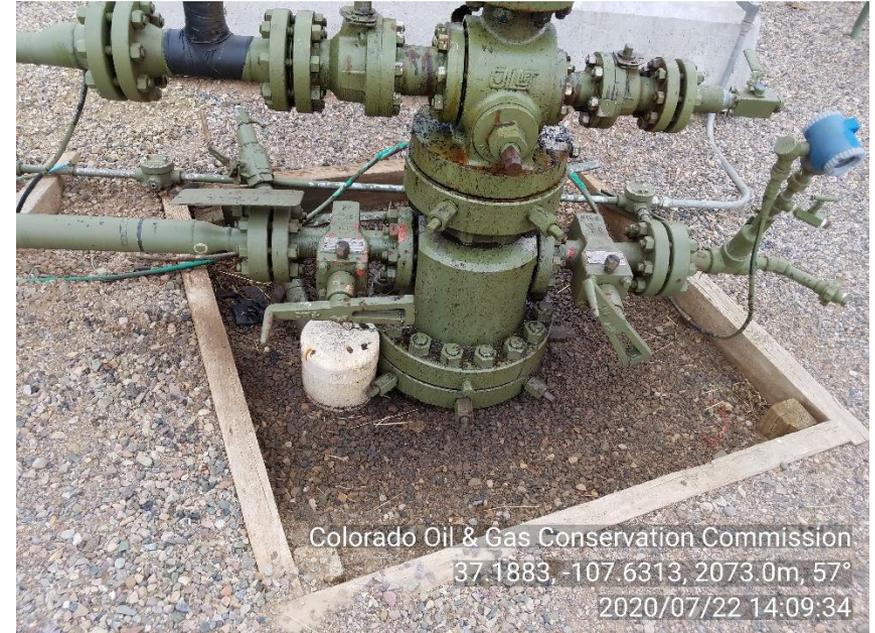
PHOTO 6: PHOTO 4: Approx 2' x 2' area of stained soil/gravel around base of STATE CD 1 wellhead. Clean-up and dispose of stained soil/gravel per Rule 1102.f.(2) and Rule 907.e. CA DATE 8-12-20.

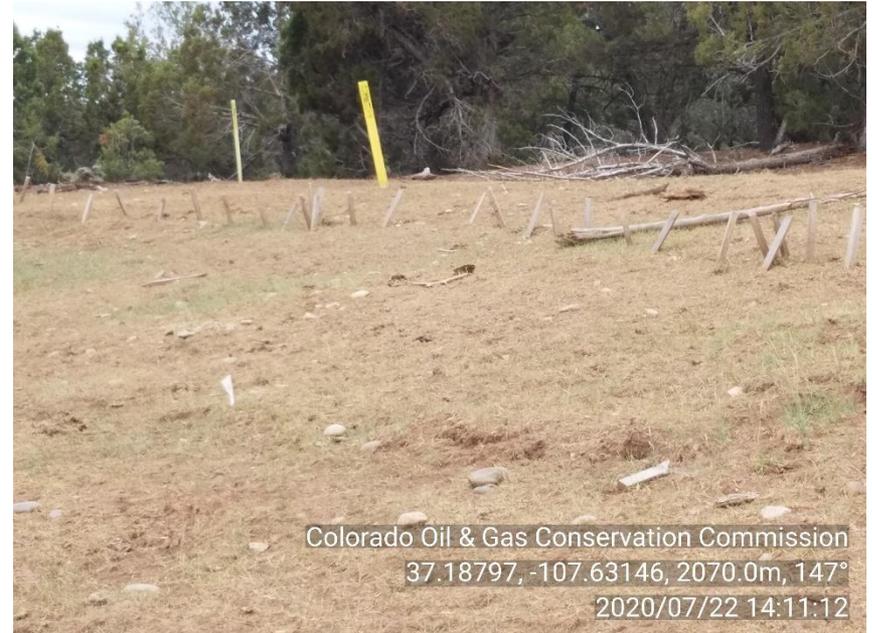
PHOTO 8: UNUSED EQUIPMENT (STAKES FOR WADDLES ARE LEFT ON INTERIM RECLAMATION AREA AROUND LOCATION). REMOVE UNUSED EQUIPMENT PER RULE 603.f. CA DATE 10-22-20.

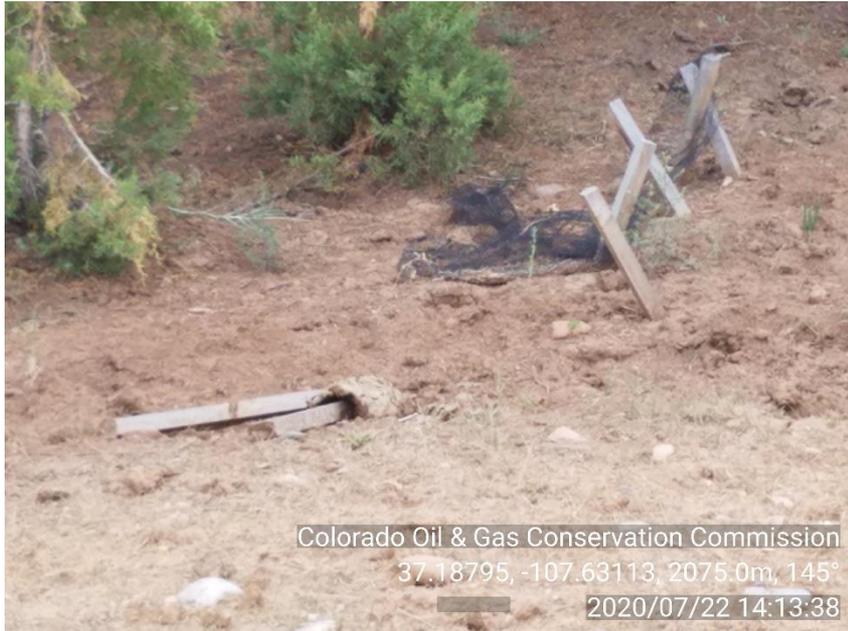
PHOTO 9: UNOTHER IMAGE OF CA FROM PHOTO 8.

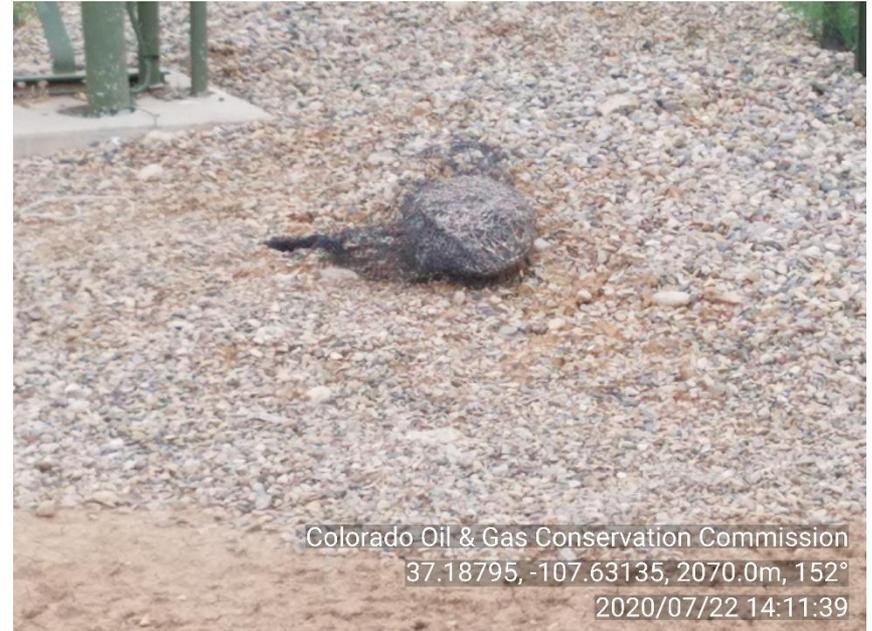
PHOTO 10: TRASH INSIDE TANK BATTERY FENCING AND AROUND SOUTH SIDE OF LOCATION APPEARS TO BE PIECES OF WADDLES MESH NOT DISCARDED WHEN WADDLES WERE REMOVED. PICK UP ALL TRASH ON AND AROUND LOCATION PER RULE 603.f. CA DATE 10-22-20

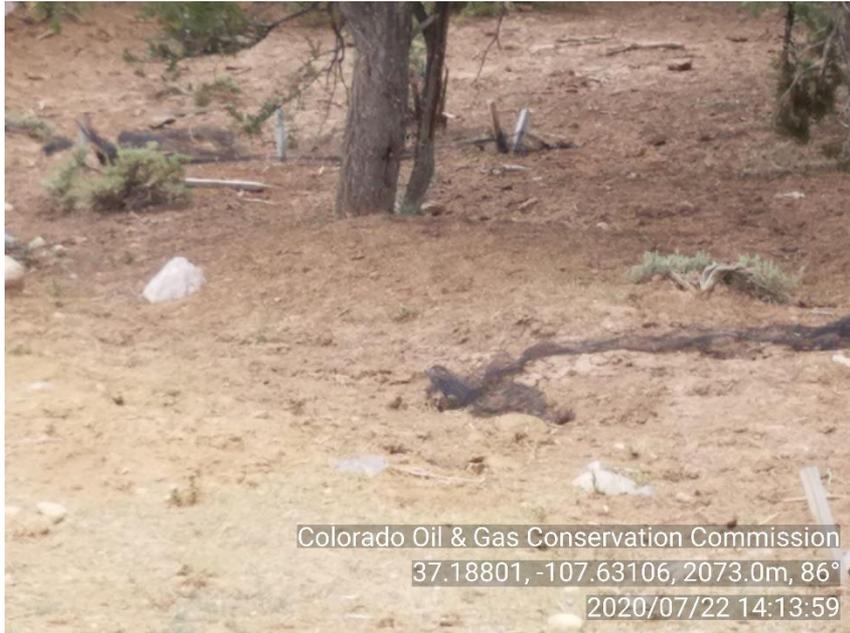
PHOTO 9: UNOTHER IMAGE OF CA FROM PHOTO 10.
