Inspection Photos  
Location Name: BUSH FEDERAL 2  
API#: 05-067-08663  
INSP. #: 695103018

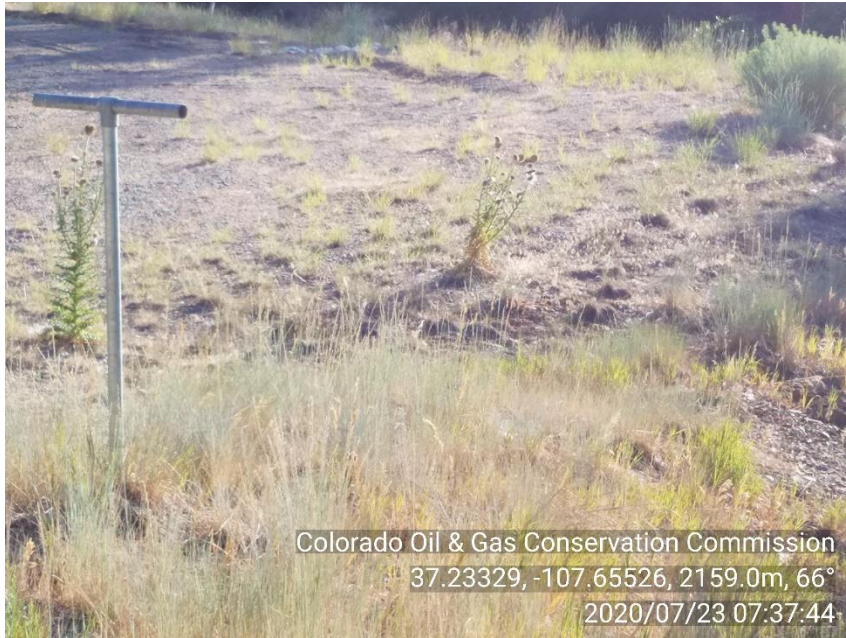
**PHOTO 3: MATURE FLOWERING NOXIOUS WEEDS ALL  
AROUND LOCATION AND ON INTERIM RECLAMATION AREA.  
CONTROL WEEDS CA DATE 7-27-20.**

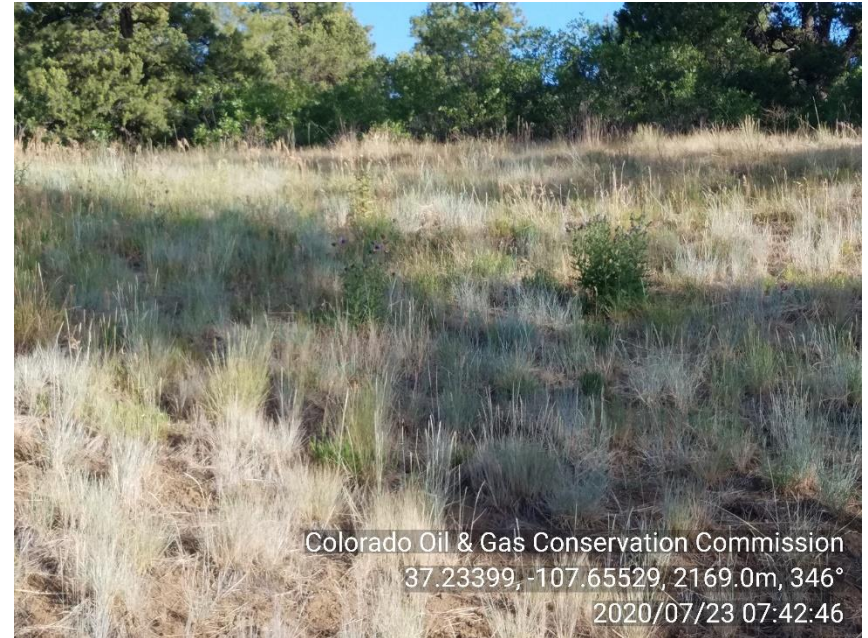
**PHOTO 4: ANOTHER PHOTO OF MATURE NOXIOUS WEEDS  
FROM PHOTO 3.**

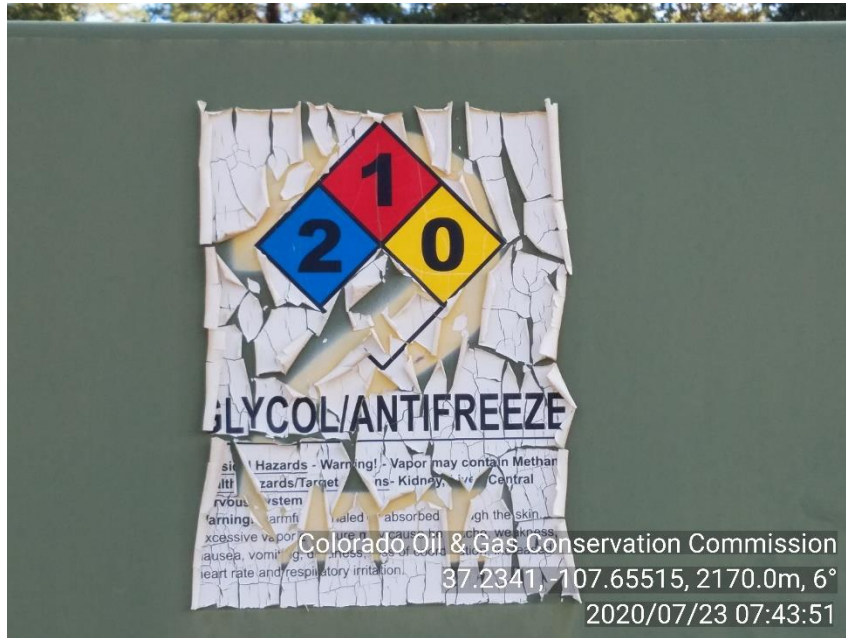
**PHOTO 5: PLACARD ON SEPARATOR IN CRACKING AND STARTING TO FALL OFF. PLACARD WITH NEED REPLACED SOON.**

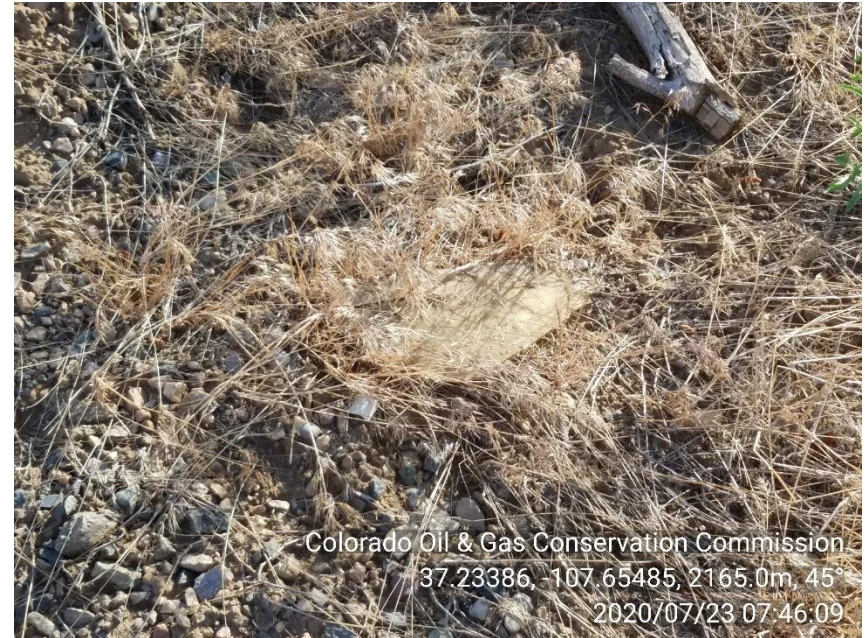
**PHOTO 6: THERE ARE SEVERAL PIECES OF TRASH AROUND LOCATION. **POLICE LOCATION AND SUROUNDING AREA FOR ALL TRASH, COMPLY WITH RULE 603.f. CA DATE 10-23-20****
