Inspection Photos
Location Name: HUBER HECHT 1-4
API#: 05-067-07554
INSP. #: 695103028

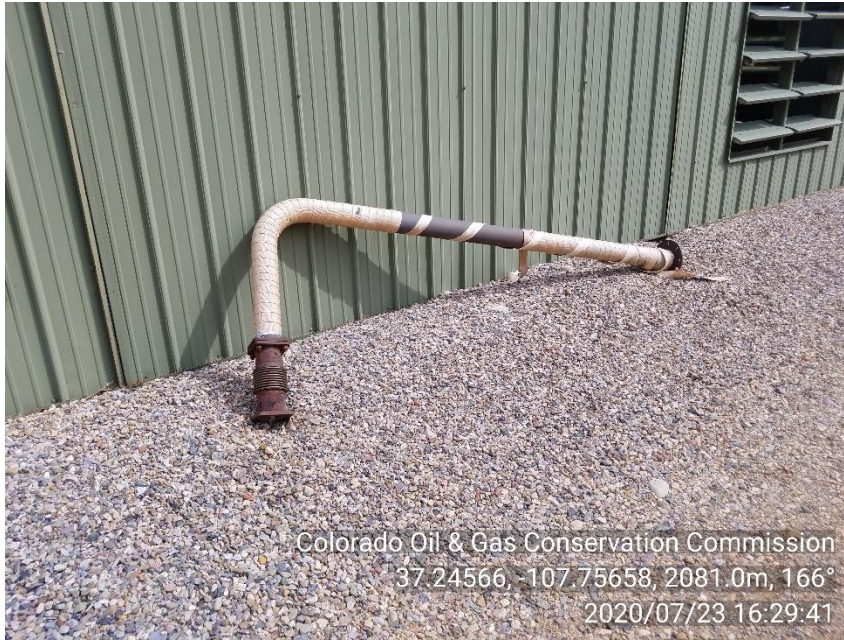
PHOTO 5: UNUSED EQUIPMENT (4" PIPE LEANING AGAINST SOUND WALLS). REMOVE UNUSED EQUIPMENT PER RULE 603.f. CA DATE 10-23-20.

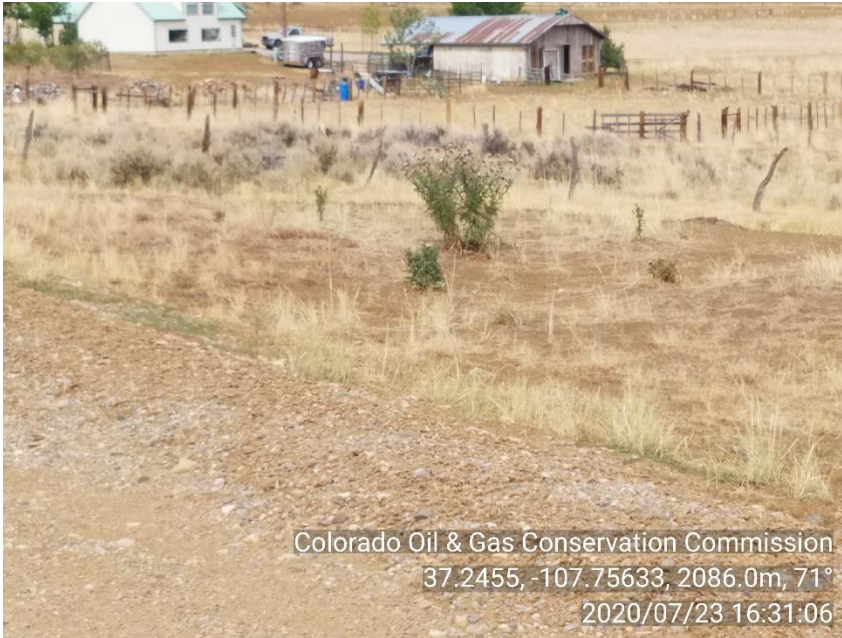
PHOTO 3: MATURE FLOWERING NOXIOUS WEEDS ALL AROUND LOCATION AND ON INTERIM RECLAMATION AREA.
CONTROL WEEDS CA DATE 7-27-20.

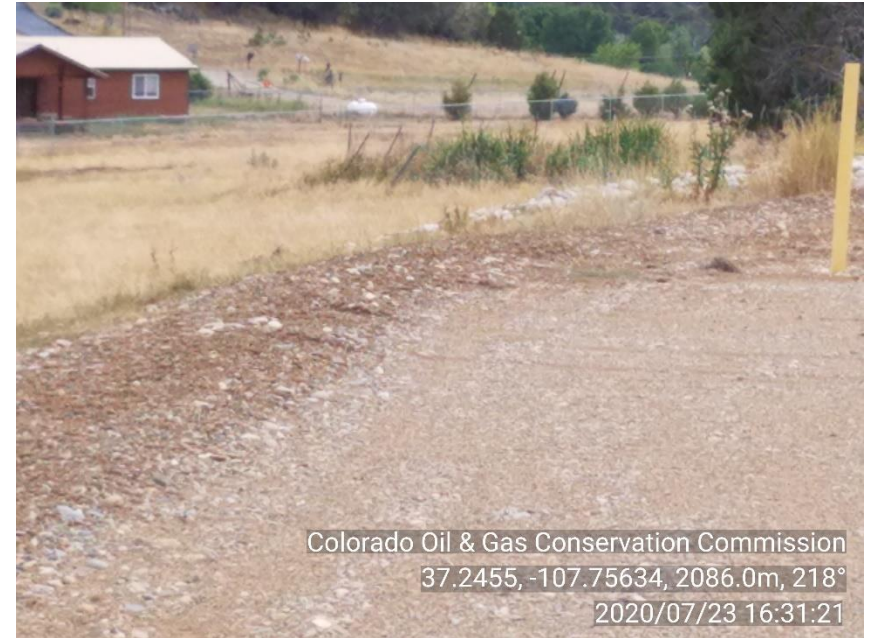
PHOTO 4: ANOTHER IMAGE OF NOXIOUS WEEDS. CANT SEE IN PHOTO BUT THISTLE HAVE MIGRATED ALL THE WAY OUT IN THE FIELD SOUTHEAST OF LOCATION.
