**RE: 2020 Quarter 2 Report  
Billings 1 Tank Battery  
NE ¼ NE ¼ SEC.34 T2N R68W 6PM  
40.099394, -104.983999  
Weld County, Colorado**

This report summarizes activities conducted in the second quarter of 2020 to address petroleum hydrocarbon impacts at the Billings Tank Battery (site). The Billings Well Pad and Tank Battery site is located within the Northeast Quarter of Section 34, Township 2 North, Range 68 West, of the 6th Prime Meridian (Figure 1). A site map is included (Figure 2) and analytical results (Table 2).

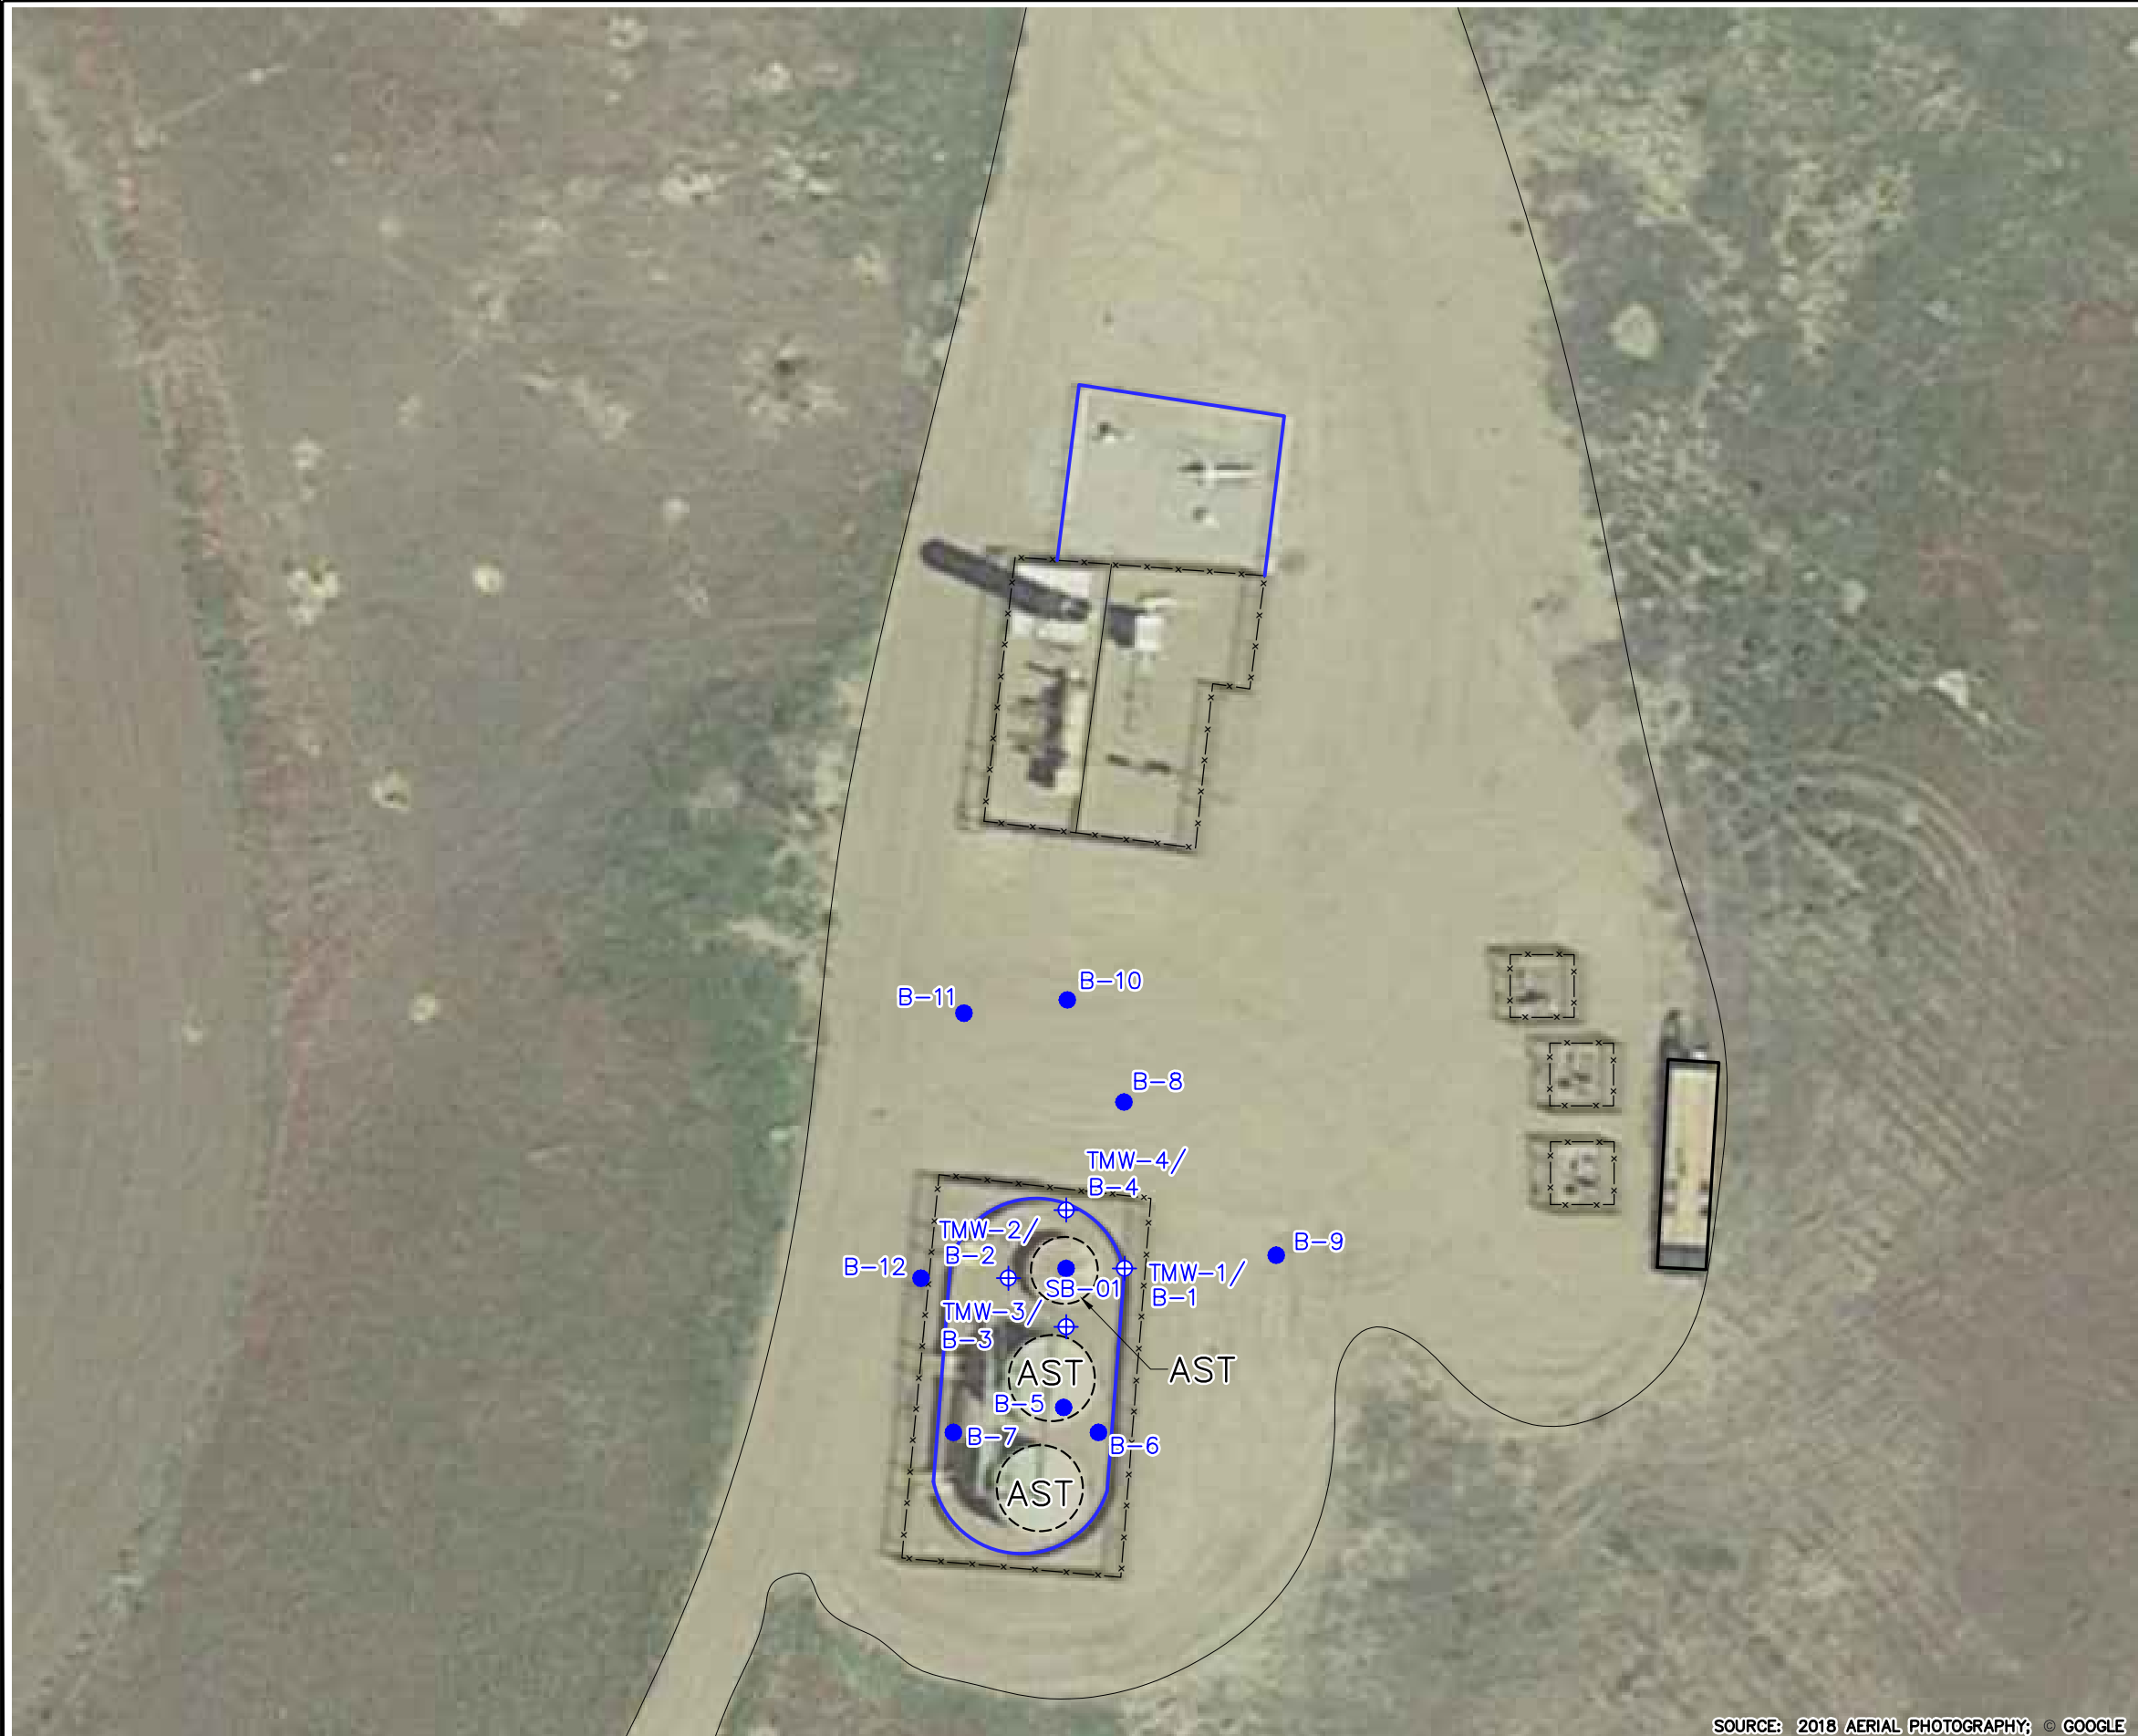
FIGURE 2  
SITE MAP

- TMW-1/⊕  
B-1 APPROXIMATE TEMPORARY  
MONITORING WELL LOCATION
- B-5 ● SOIL SAMPLE LOCATION
- BERM
- x-x-x-x- FENCE

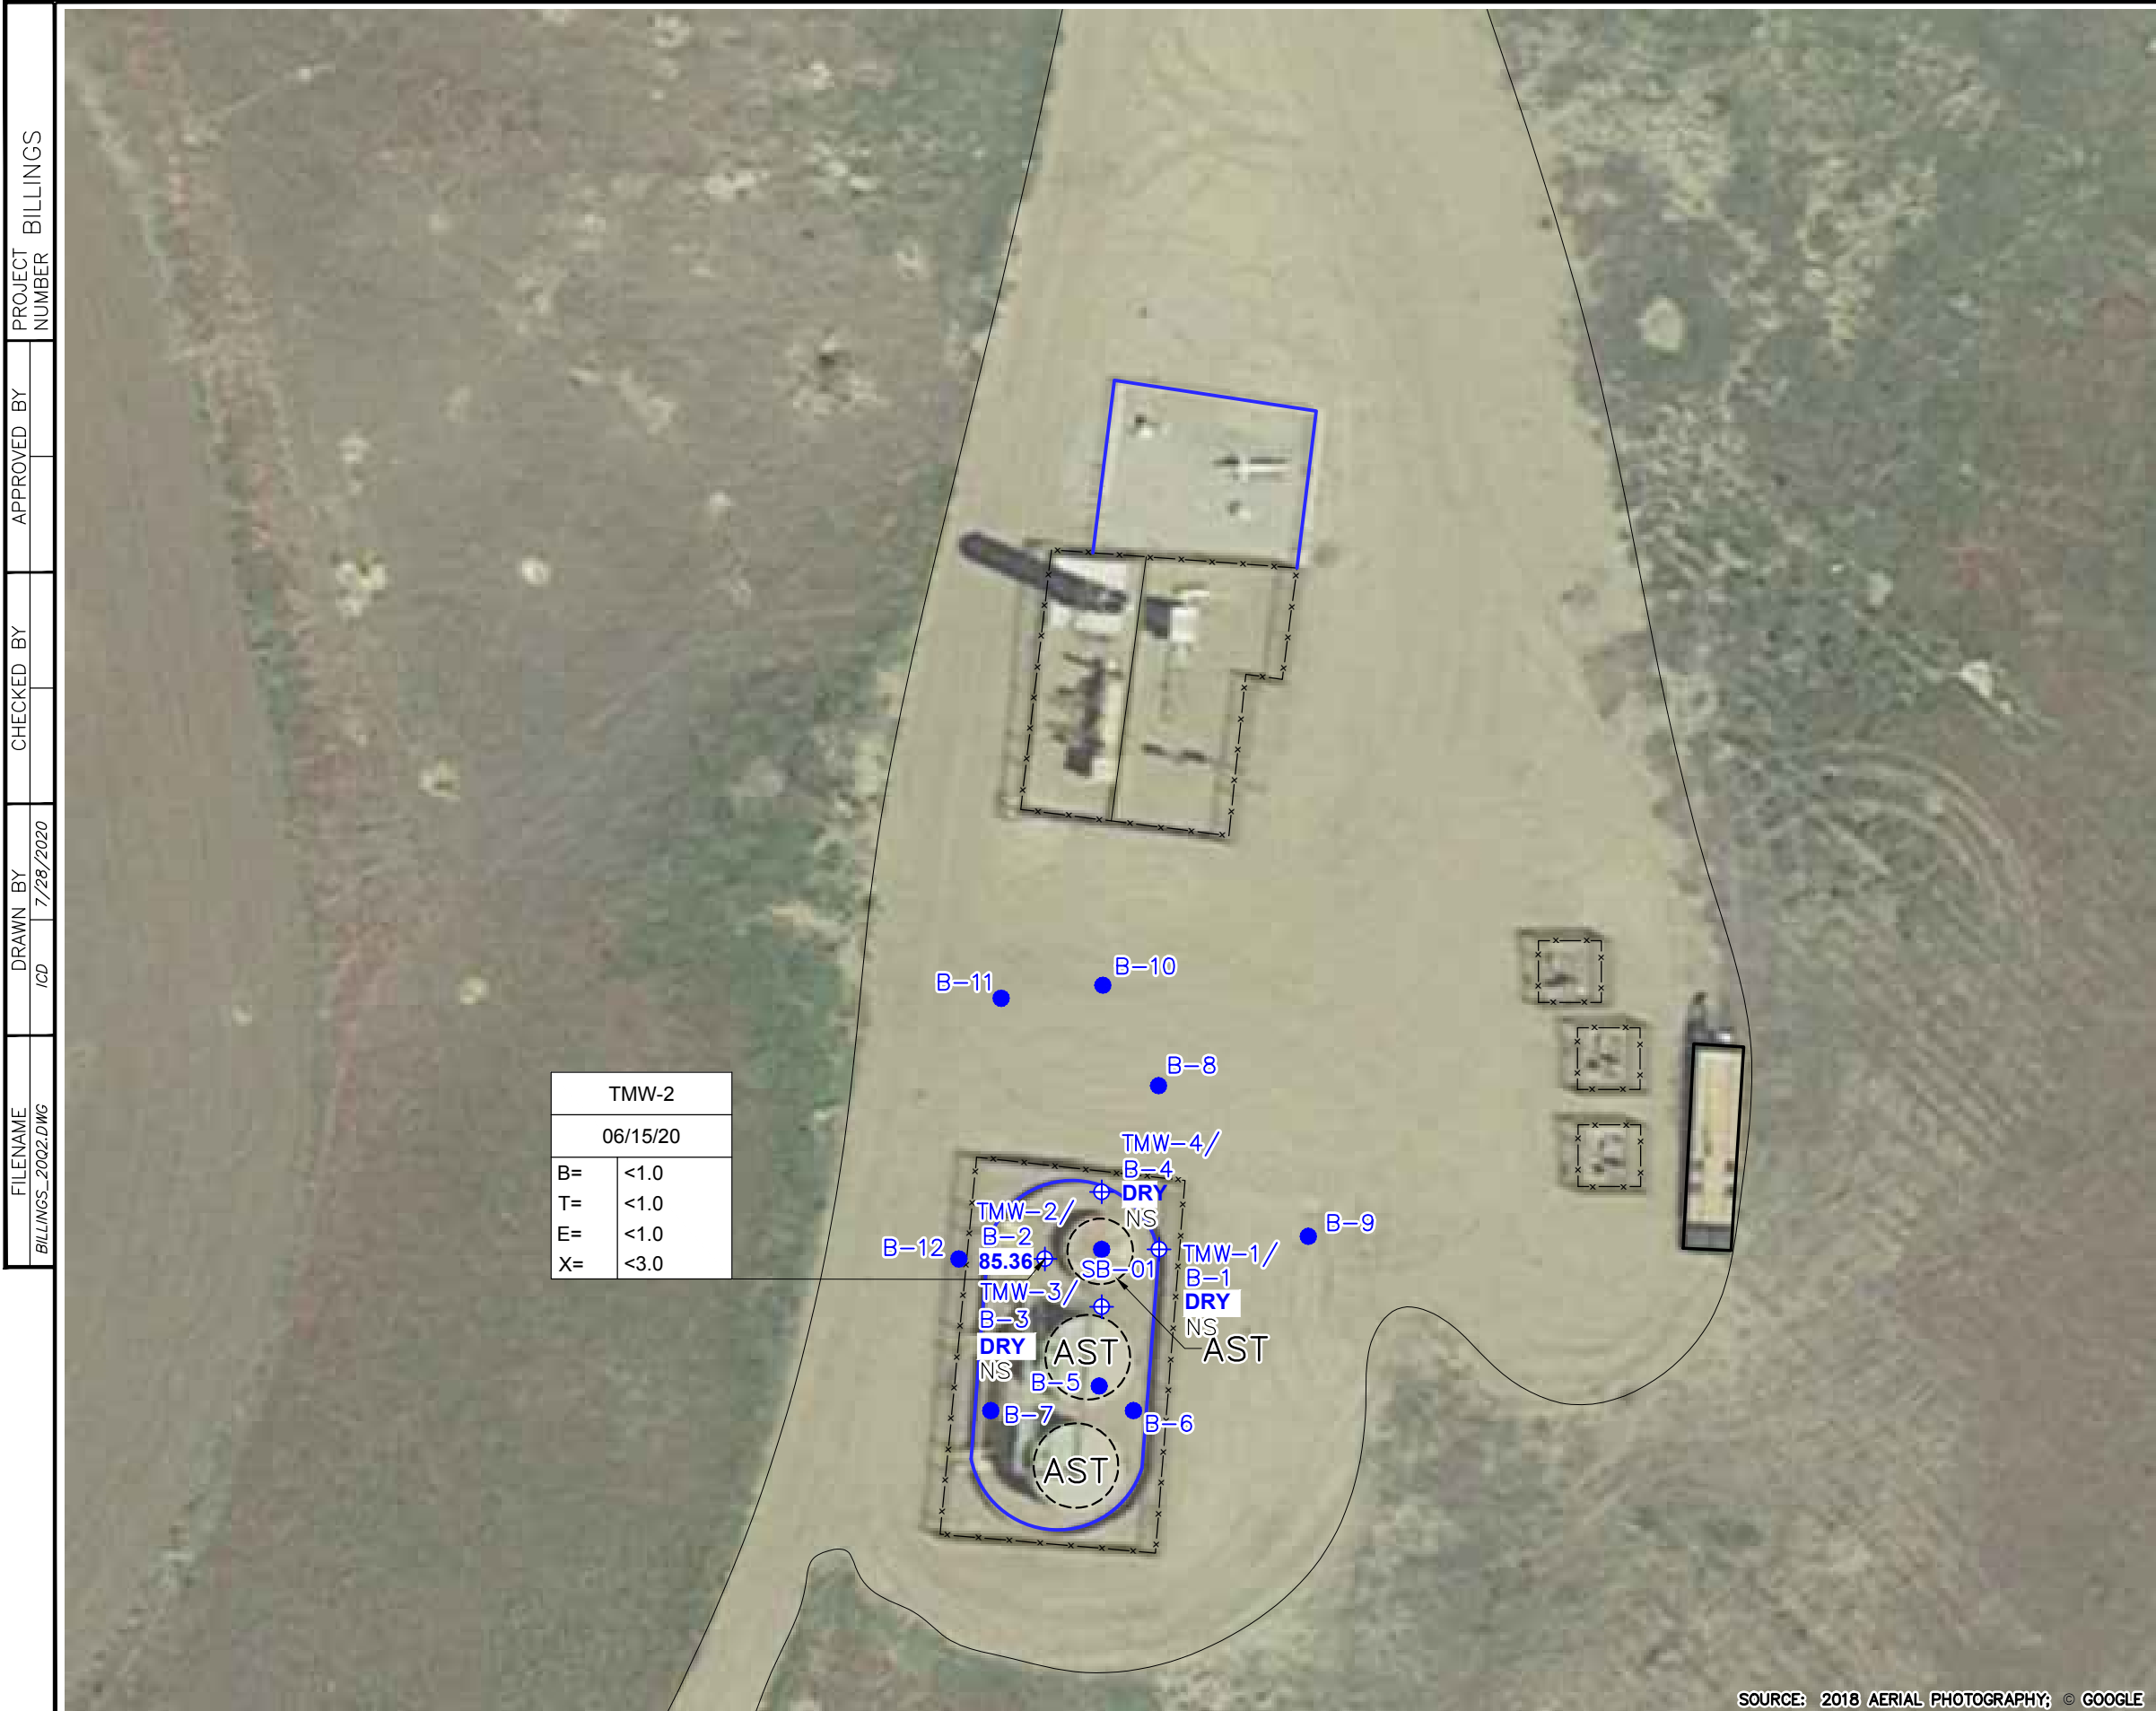
FIGURE 3

Monitoring well TMW-2 was reported below the COGCC Table 910-1 allowable limit.

Groundwater was not observed and unable to be sampled in monitoring wells TMW-1, TMW-2, and TMW-4.

TMW-2	
06/15/20	
B=	<1.0
T=	<1.0
E=	<1.0
X=	<3.0

GROUNDWATER MONITORING MAP  
06/15/2020

Quarterly groundwater monitoring will continue.
