# Inspection Photos

7/28/2020

Operator: BARGATH LLC - 10128  
Facility ID: 460855 - Spill/Release  
Garfield County, CO

Aaron Trujillo  
NW Reclamation Specialist  
COGCC

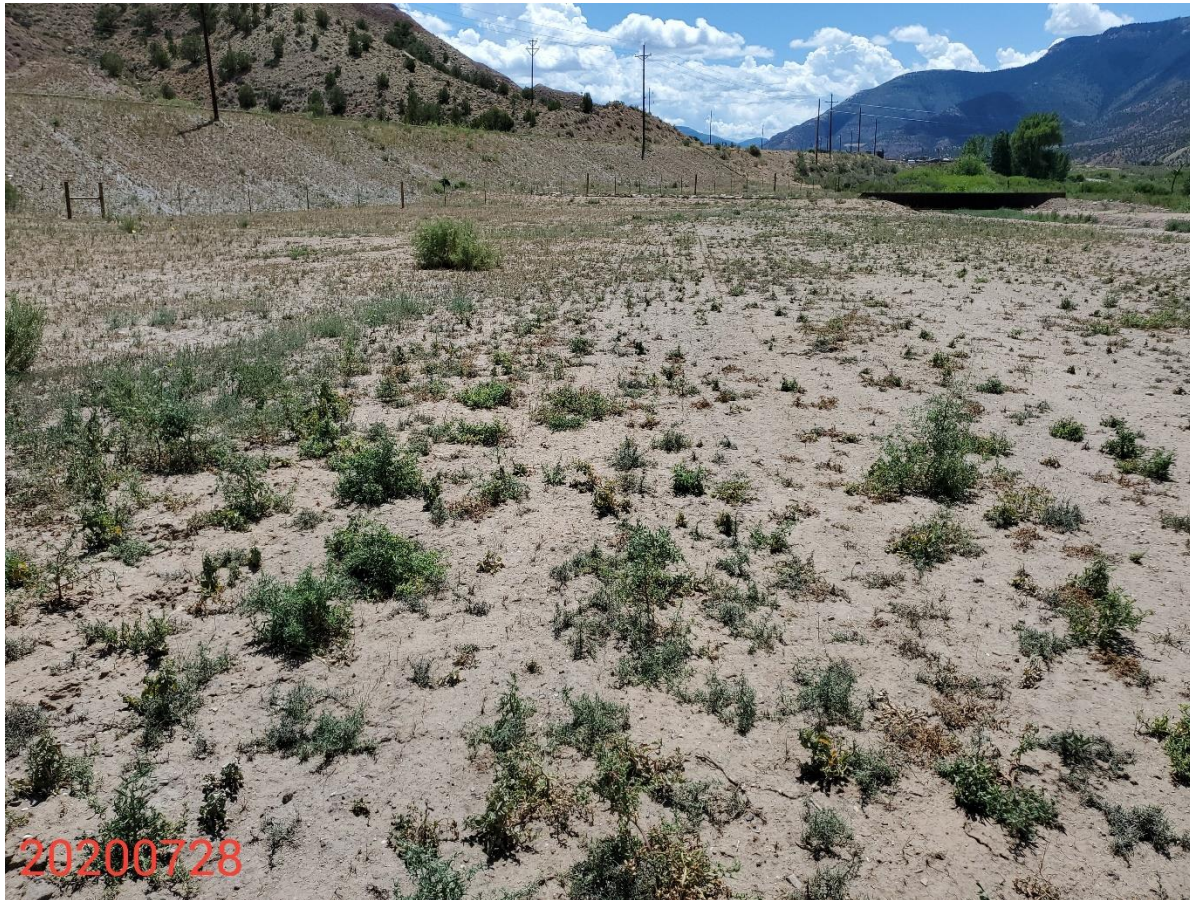
**Photo 1:** Photo taken from the eastern (upland) reclamation/remediation areas. Photo shows some germination evident, however Location is predominantly vegetated by undesirable weedy plant species, as well as noxious weeds such as Halogeton.

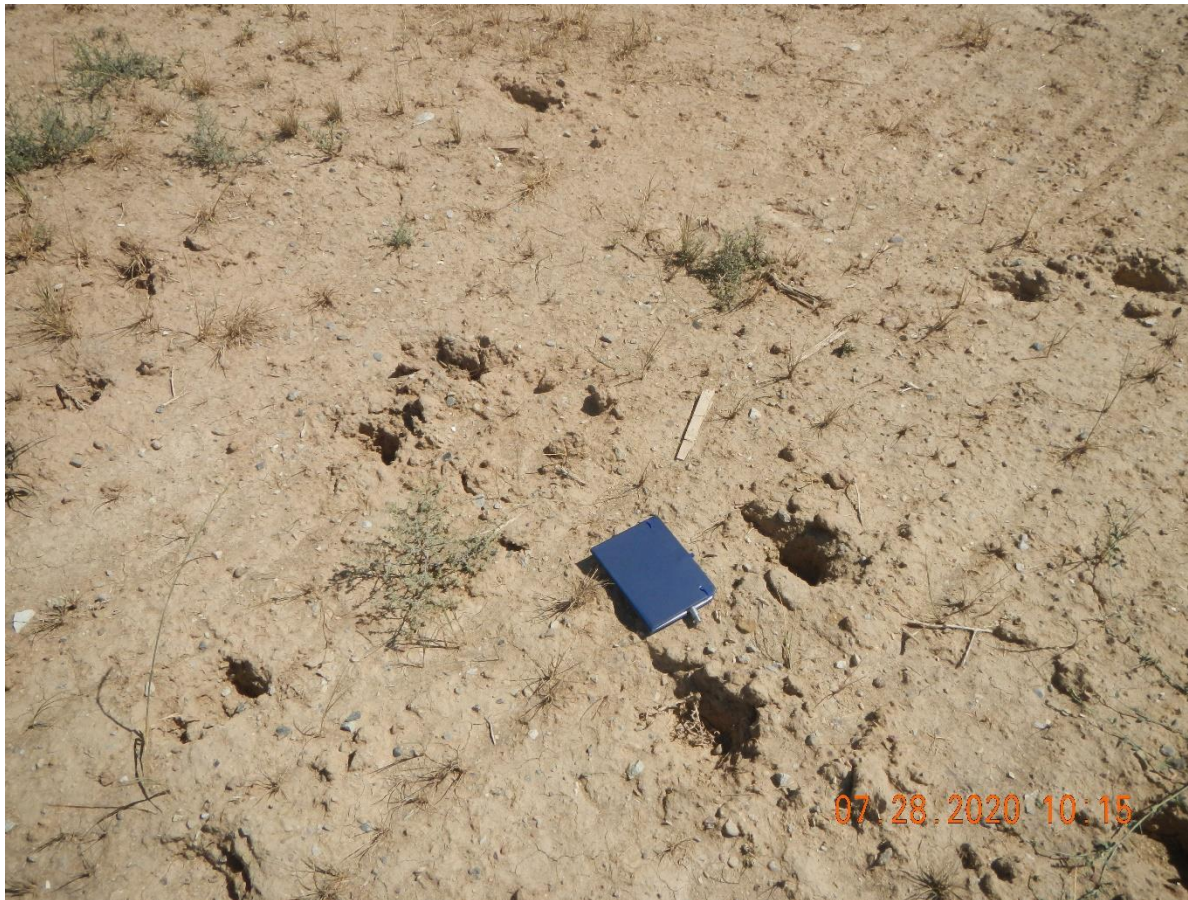
**Photo 2:** Photo shows soil surface on the remediation/reclamation area. Some germination evident, however it does not appear to be sufficient for reclamation to be considered “in process”.

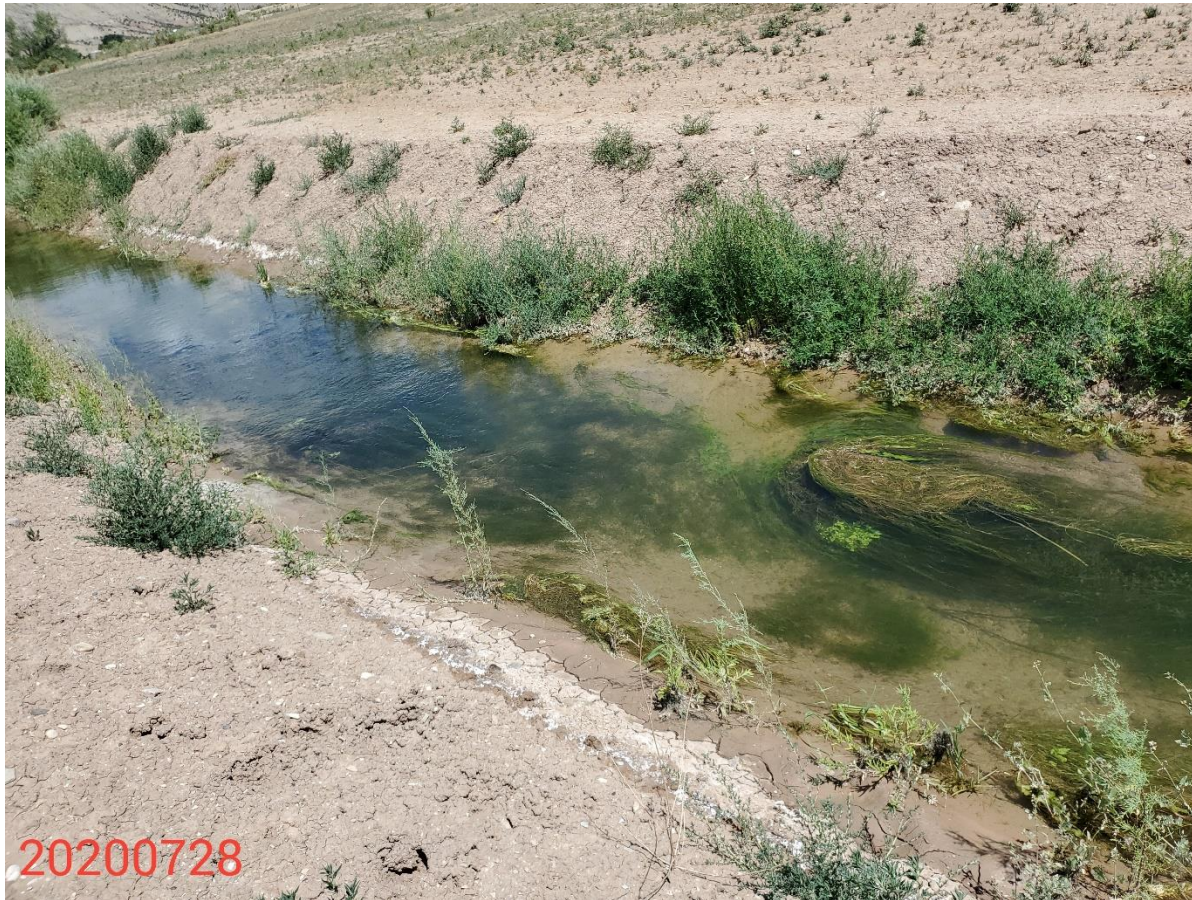
**Photo 3:** Photo taken from the irrigation ditch. Photo shows tamarisk establishing in ditch. This is a Colorado State listed noxious weed.

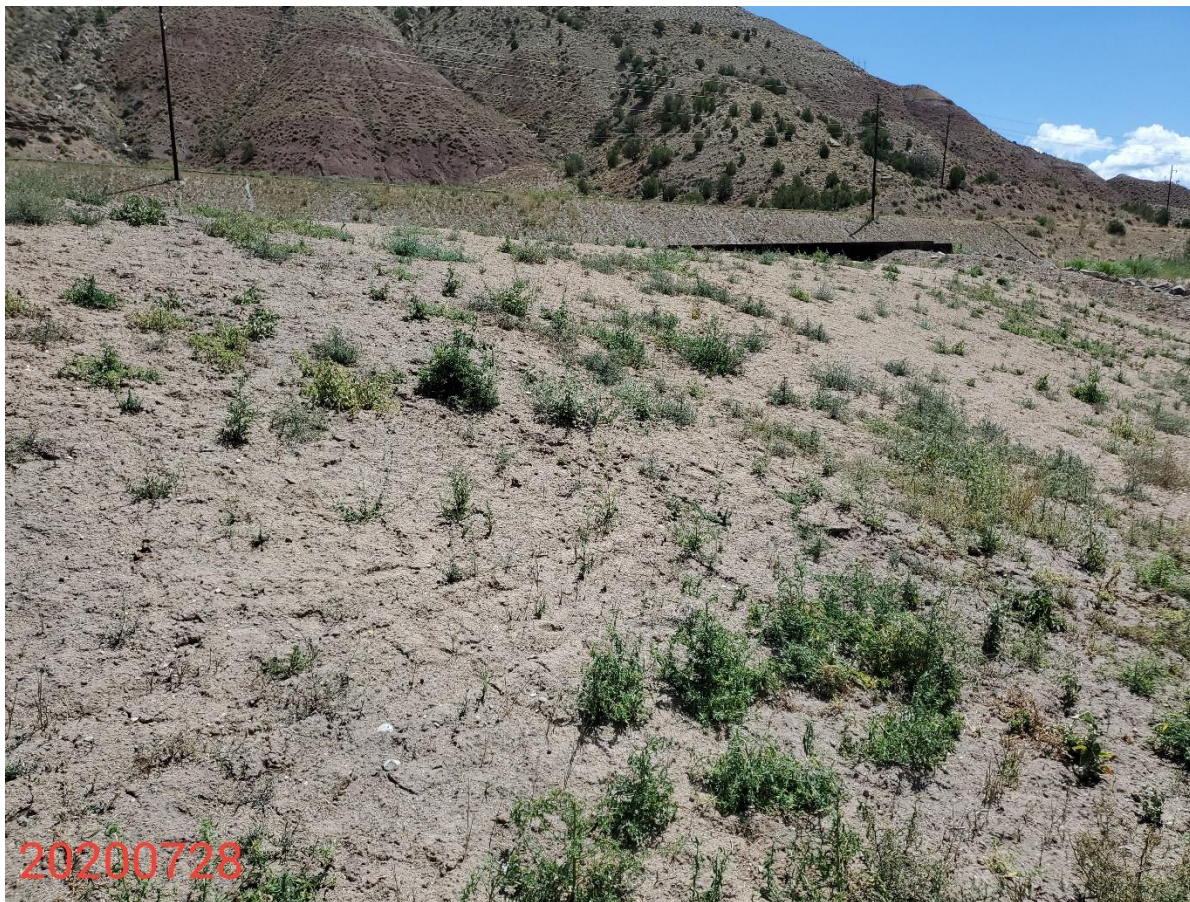
**Photo 4:** Photo taken from slope below ditch. Photo shows some germination, however vegetation is predominantly weedy plant species.

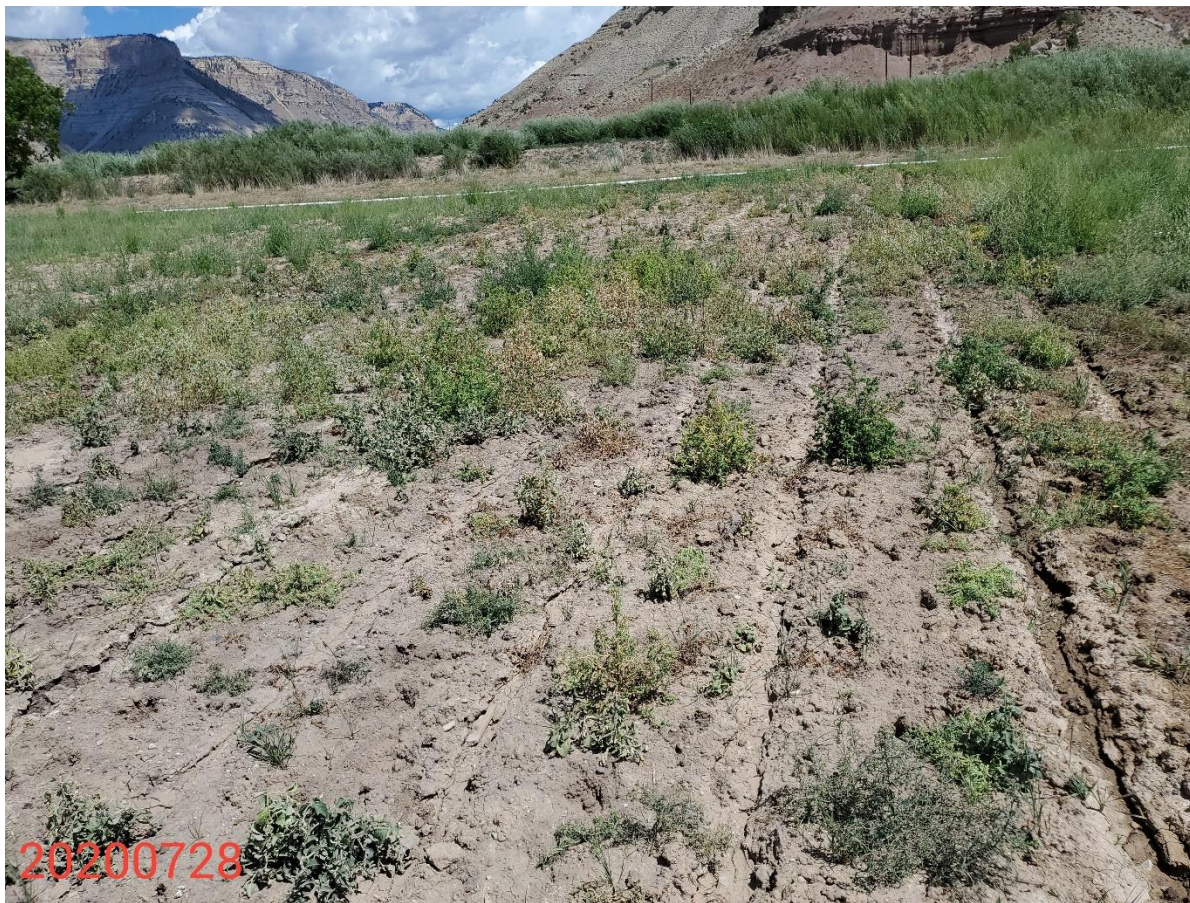
**Photo 5:** Photo taken from the areas of the reclamation where surface owner is irrigating; Vegetation observed is predominantly undesirable weedy plant species.

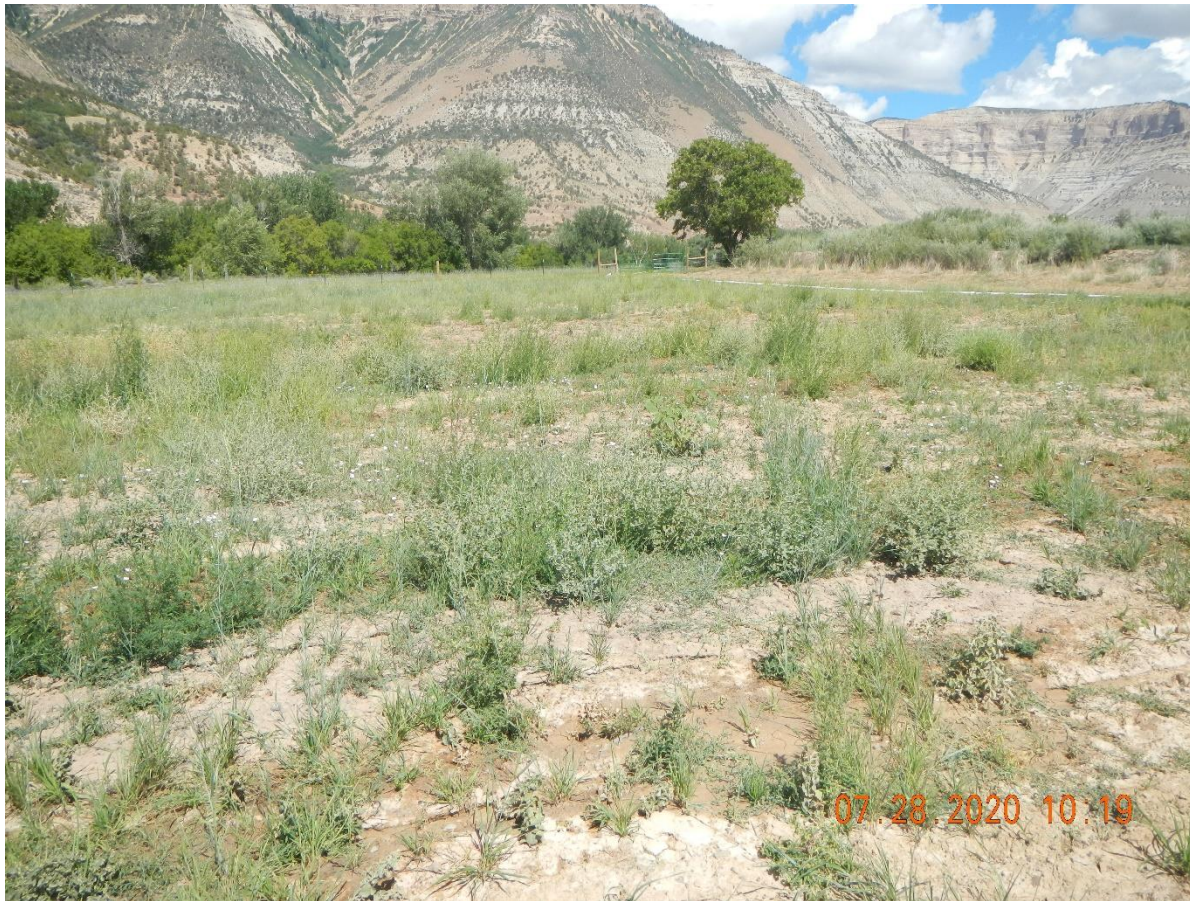
**Photo 6:** Continued from photo 5. Photo also shows reclamation area is predominantly undesirable weedy plant species. Photo also show Field Bindweed establishment on the reclamation area. This is a Colorado State listed noxious weed.

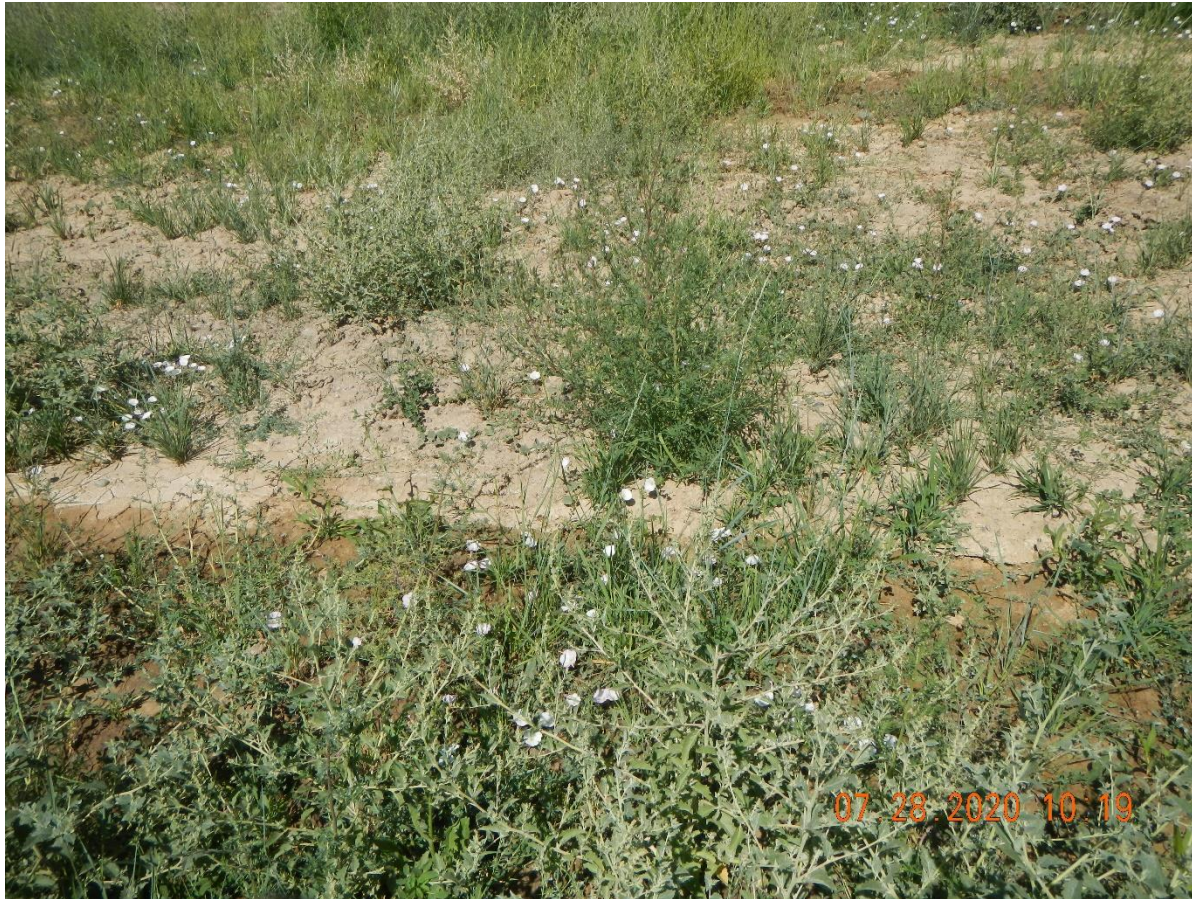
**Photo 7:** See comments under photo 6.

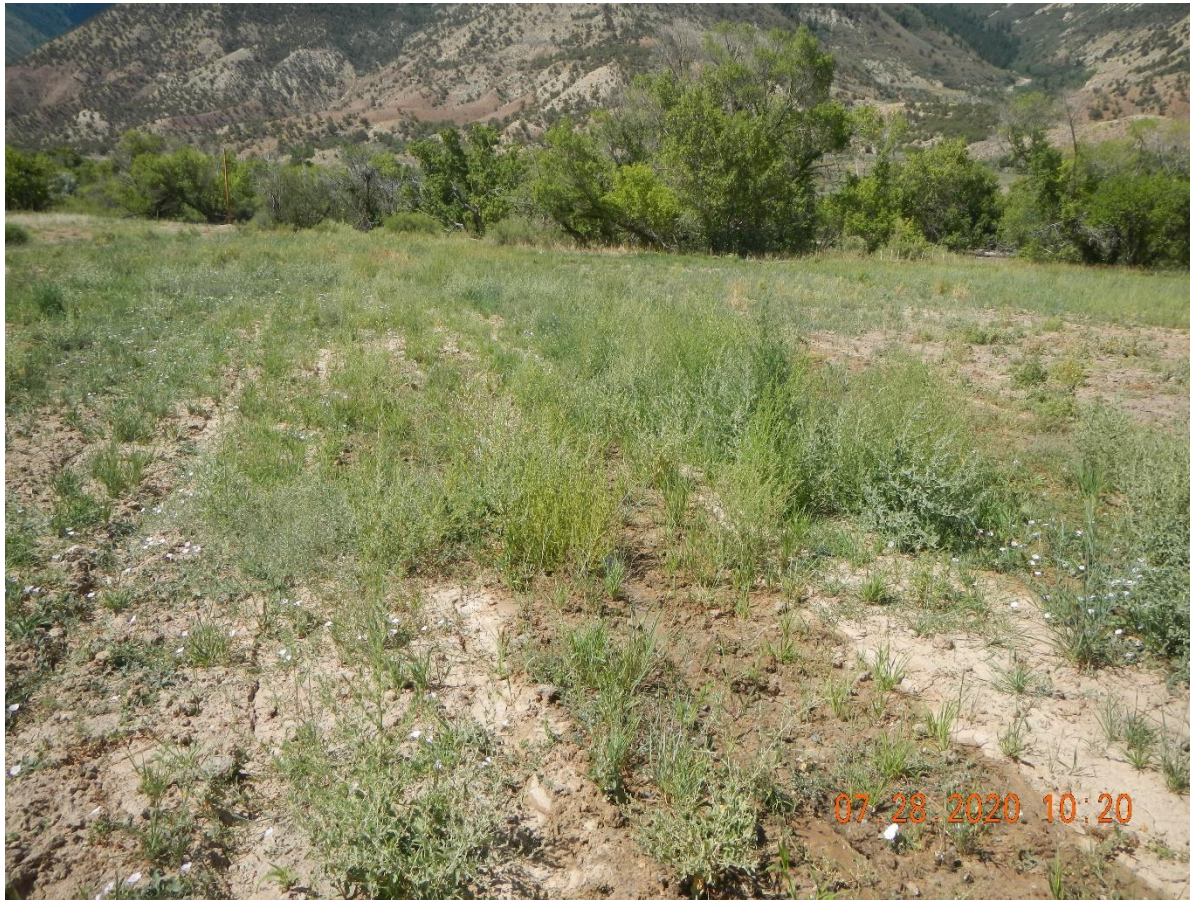
**Photo 8:** See comments under photo 6.

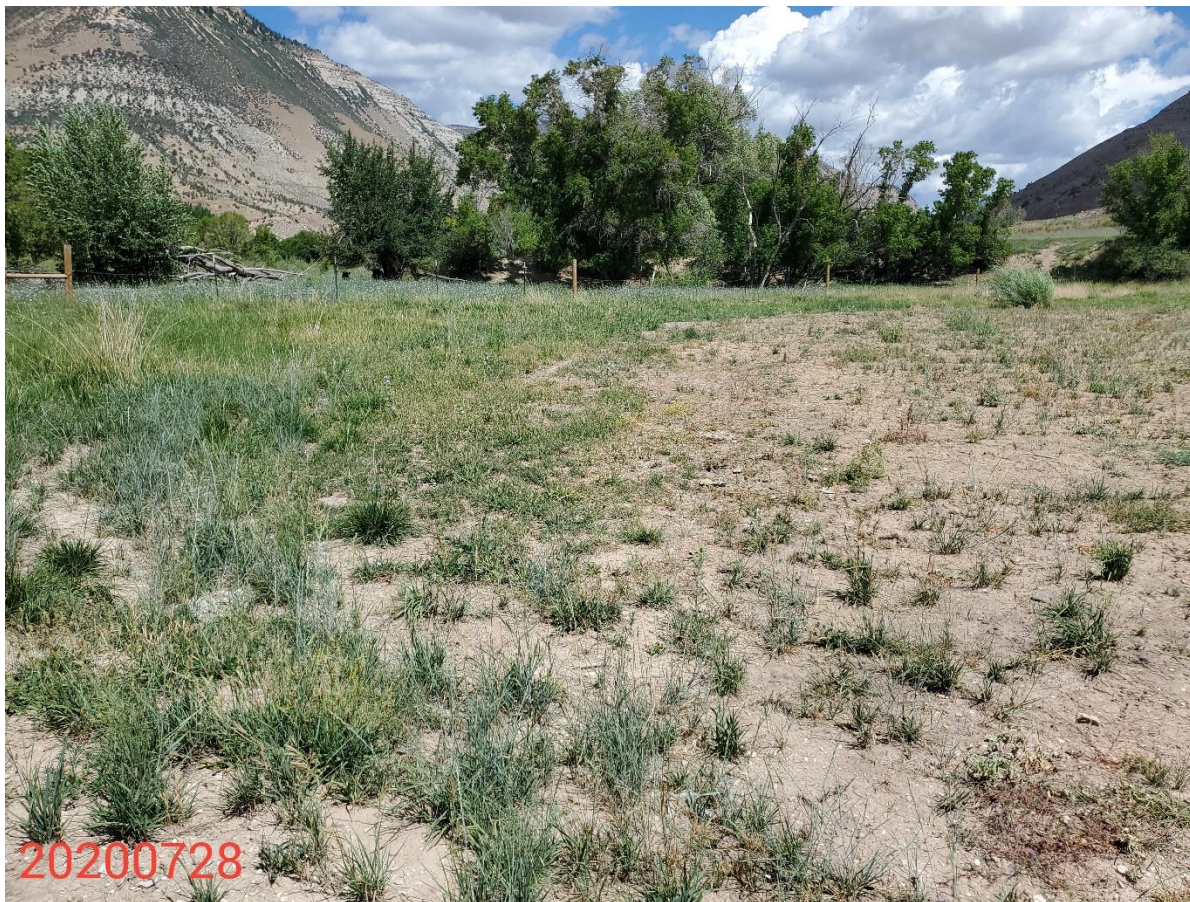
**Photo 9:** Photo taken from the lower/western reclamation areas, facing north. Though desirable perennial vegetative germination is more prevalent, areas remain predominantly weedy plant species.

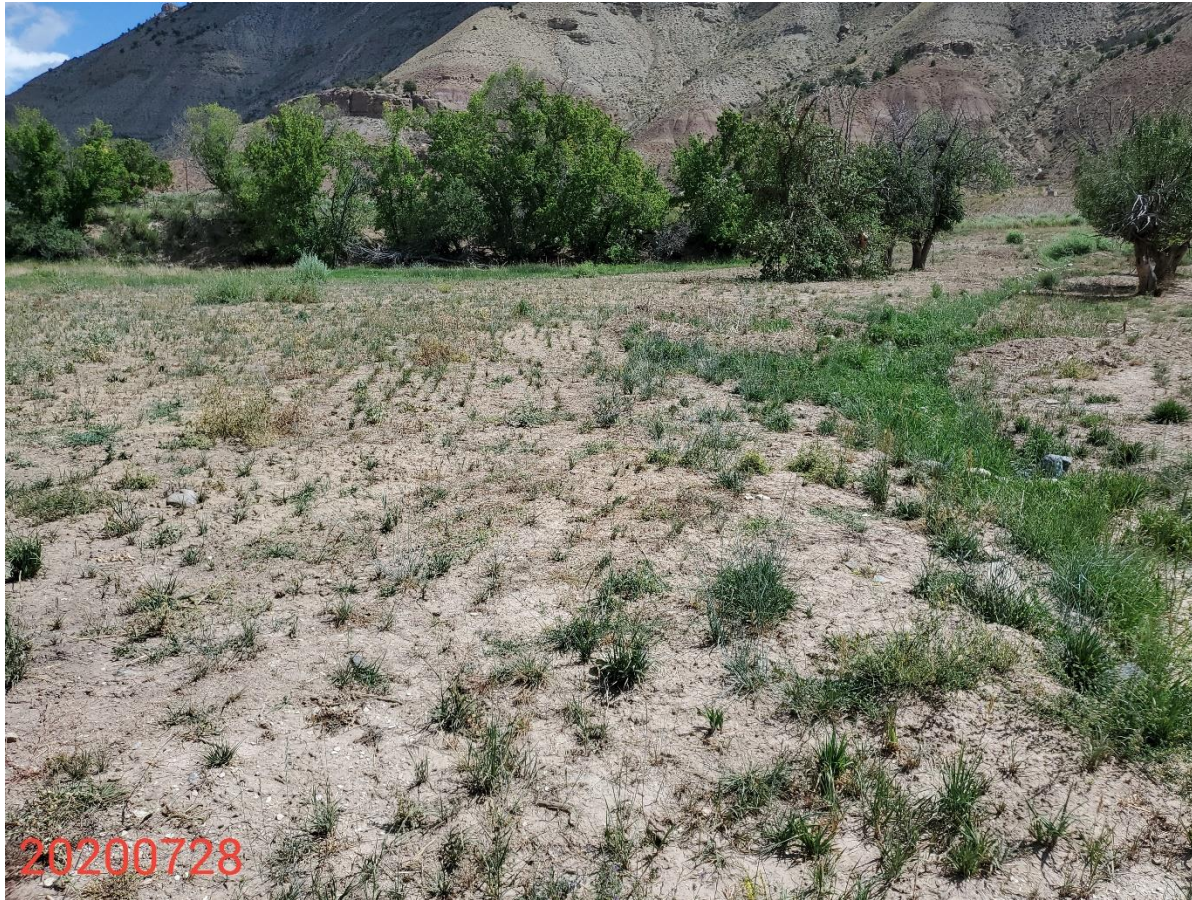
**Photo 10:** See comments under photo 9.

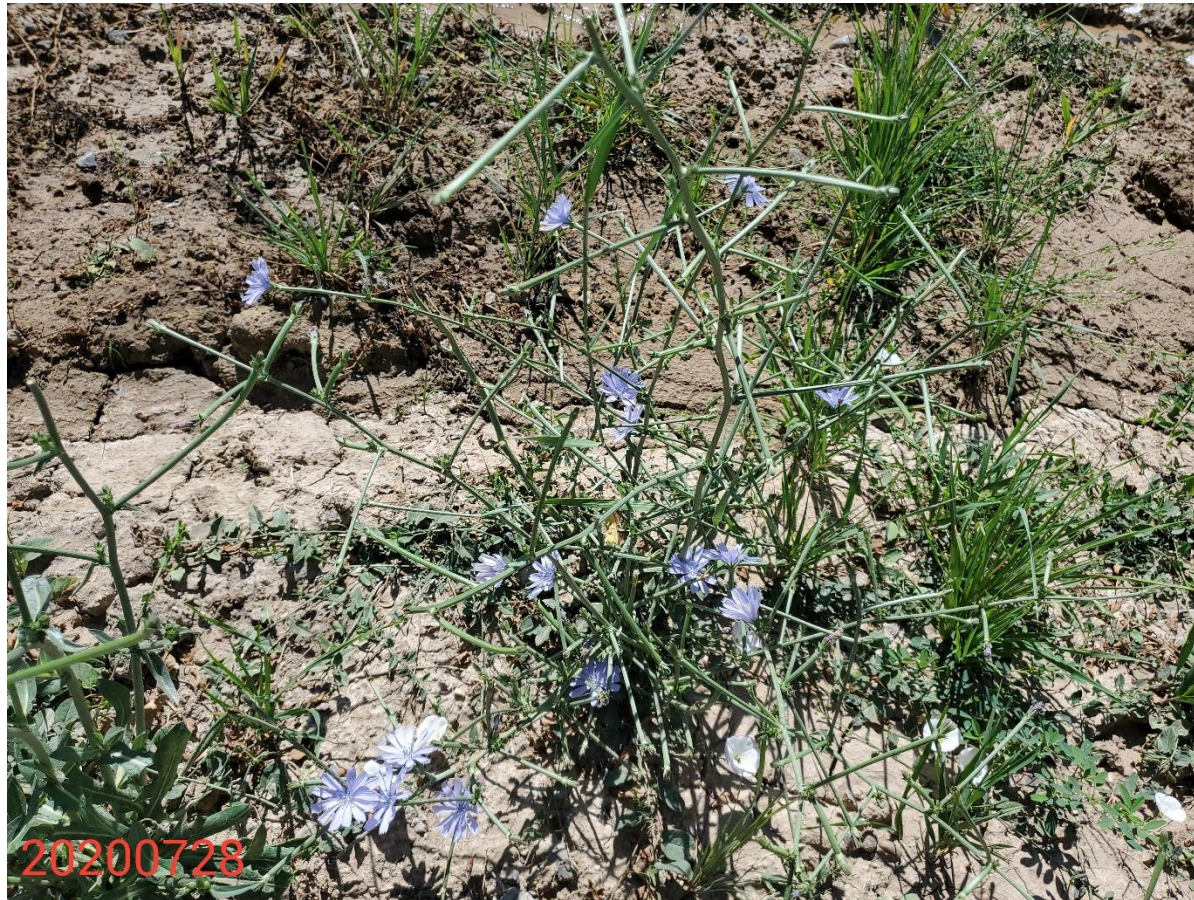
**Photo 11:** Photo of Chicory observed throughout the Location. This is a Colorado State listed noxious weed.

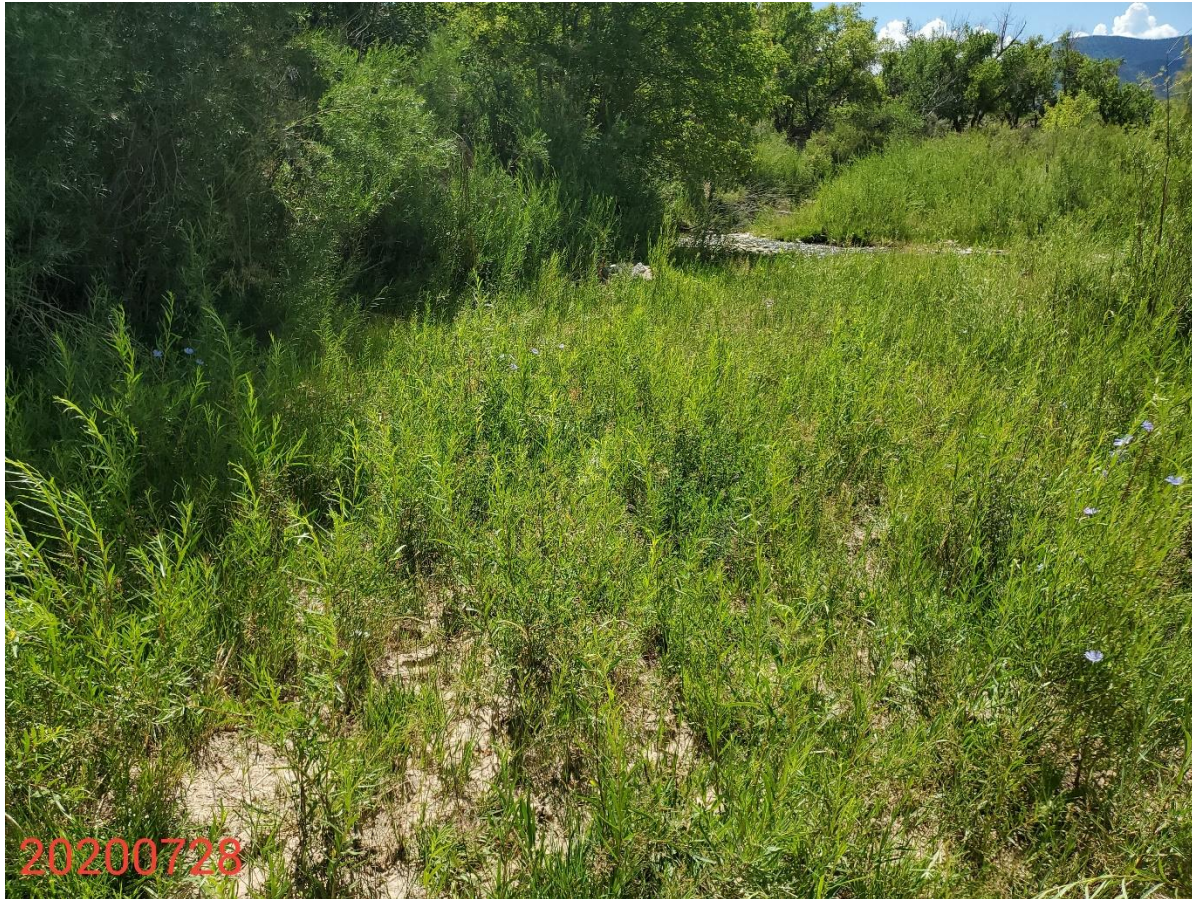
**Photo 12:** Photo taken from riparian areas on the western end of the reclamation area. Reclamation appears be progressing in these areas.

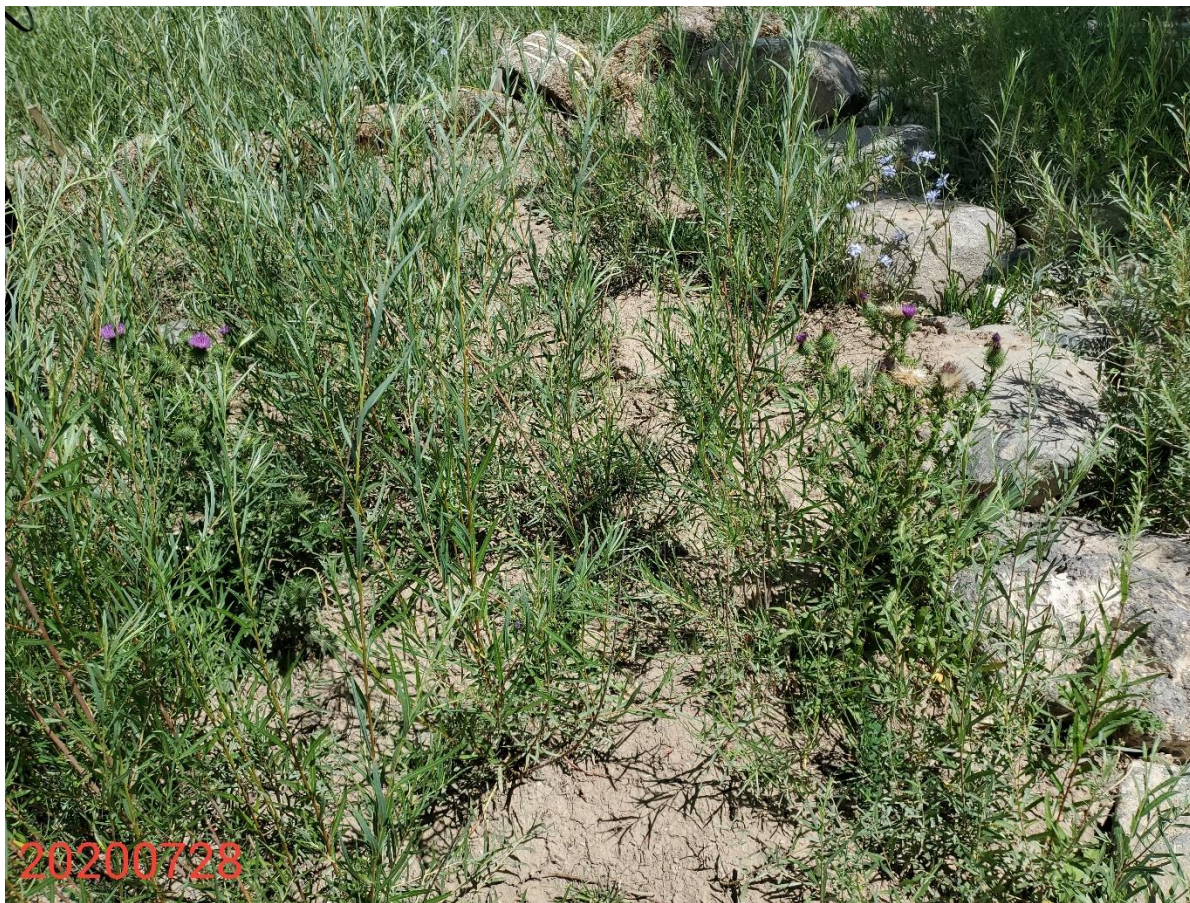
**Photo 13:** Photo taken from the riparian disturbance. Photo shows Bull thistle establishment. This is a Colorado State listed noxious weed.

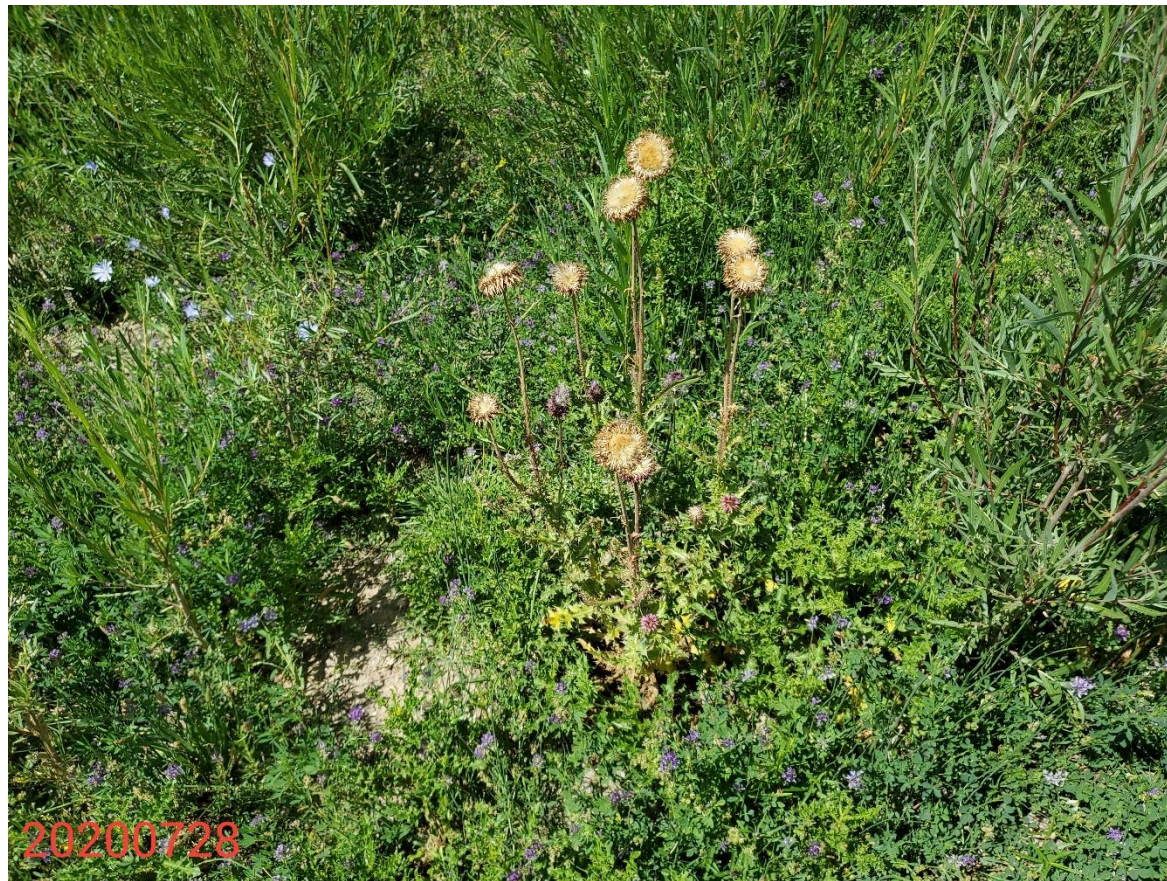
**Photo 14:** Photo taken from the riparian disturbance. Photo shows Musk thistle establishment. This is a Colorado State listed noxious weed.

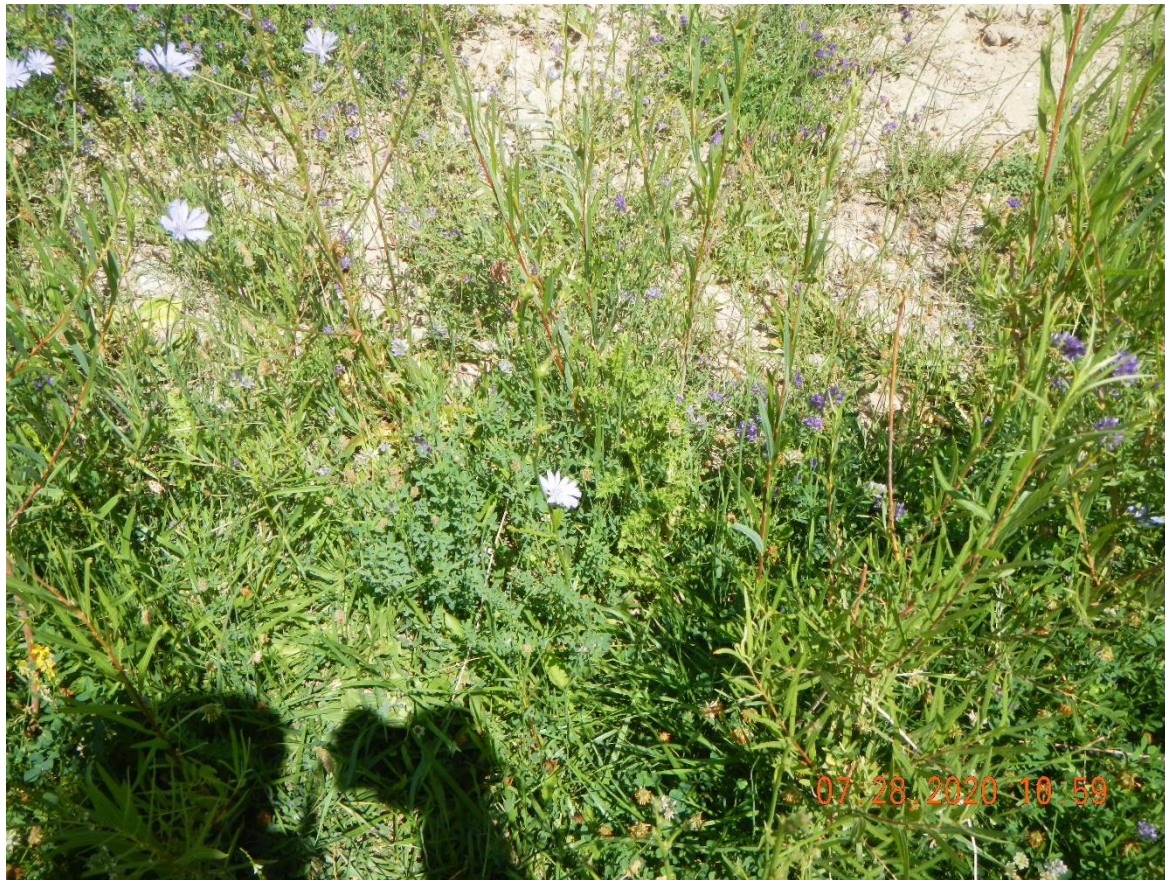
**Photo 15:** Photo taken from the riparian disturbance. Photo shows Canada thistle (rosettes) as well as Chicory establishment. This is a Colorado State listed noxious weed.

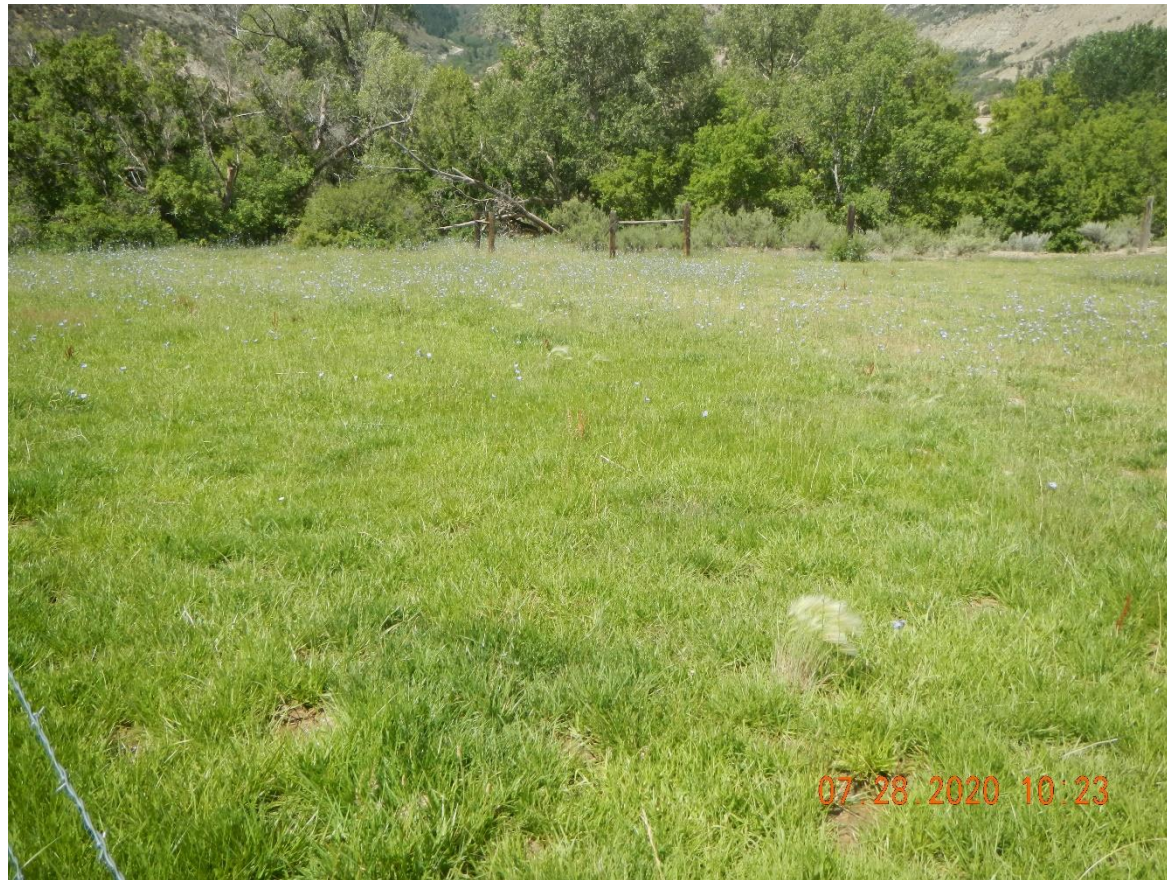
**Photo 16:** Photo of the adjacent reference area for comparison.
