Inspection Photos
Operator: Hilcorp Energy
API: 067-09383
Date: 7/28/2020

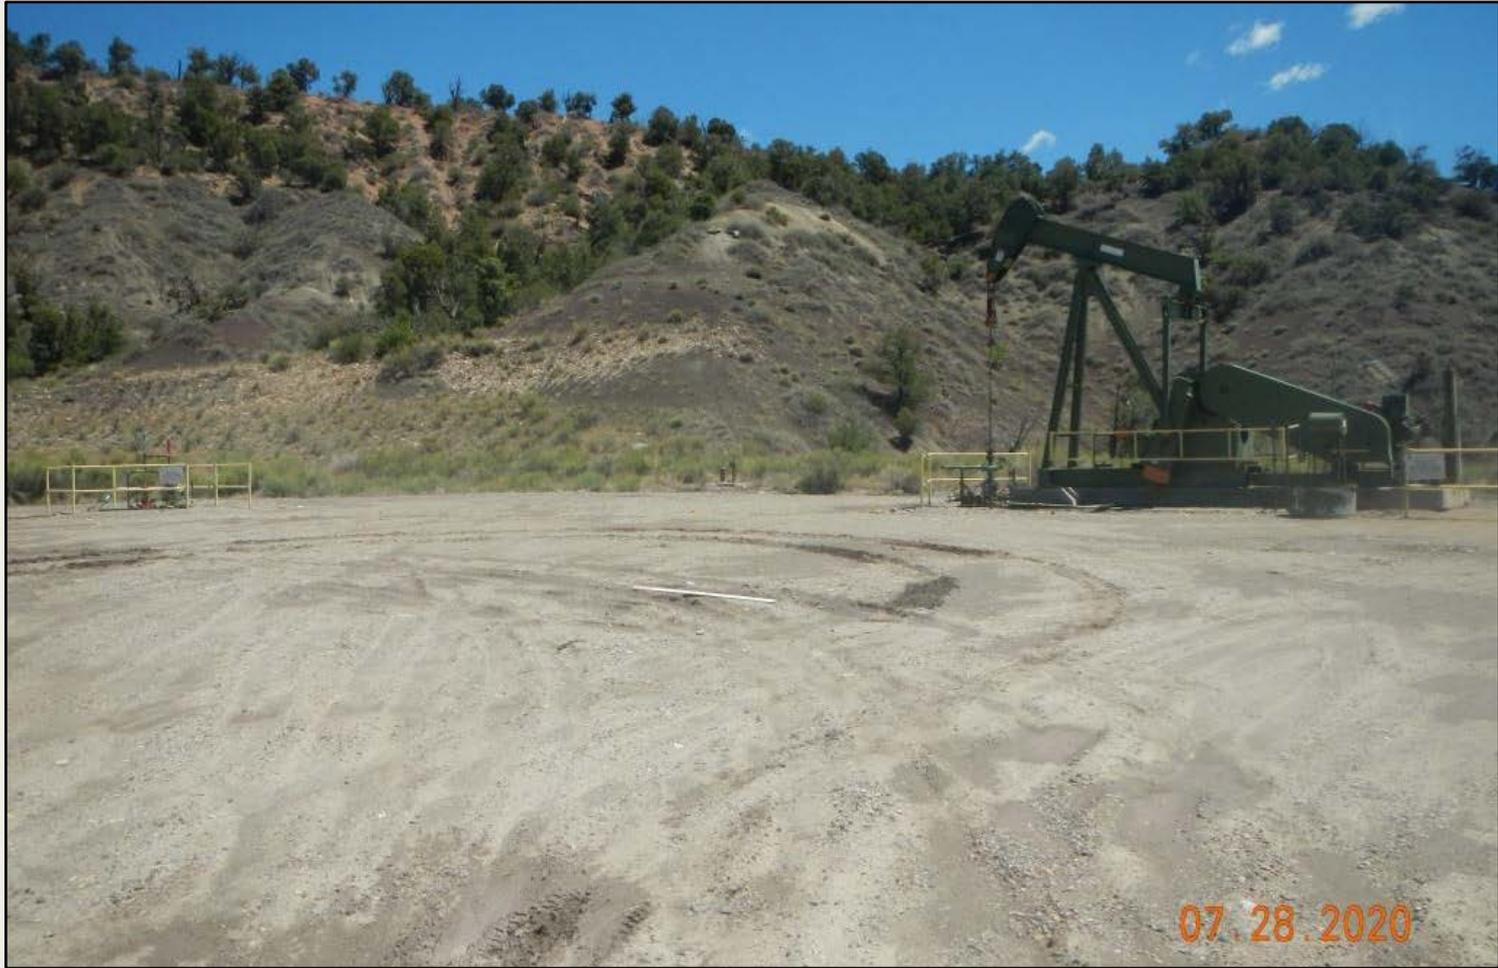
Photo 1. View of the project area from the well pad entrance facing center.

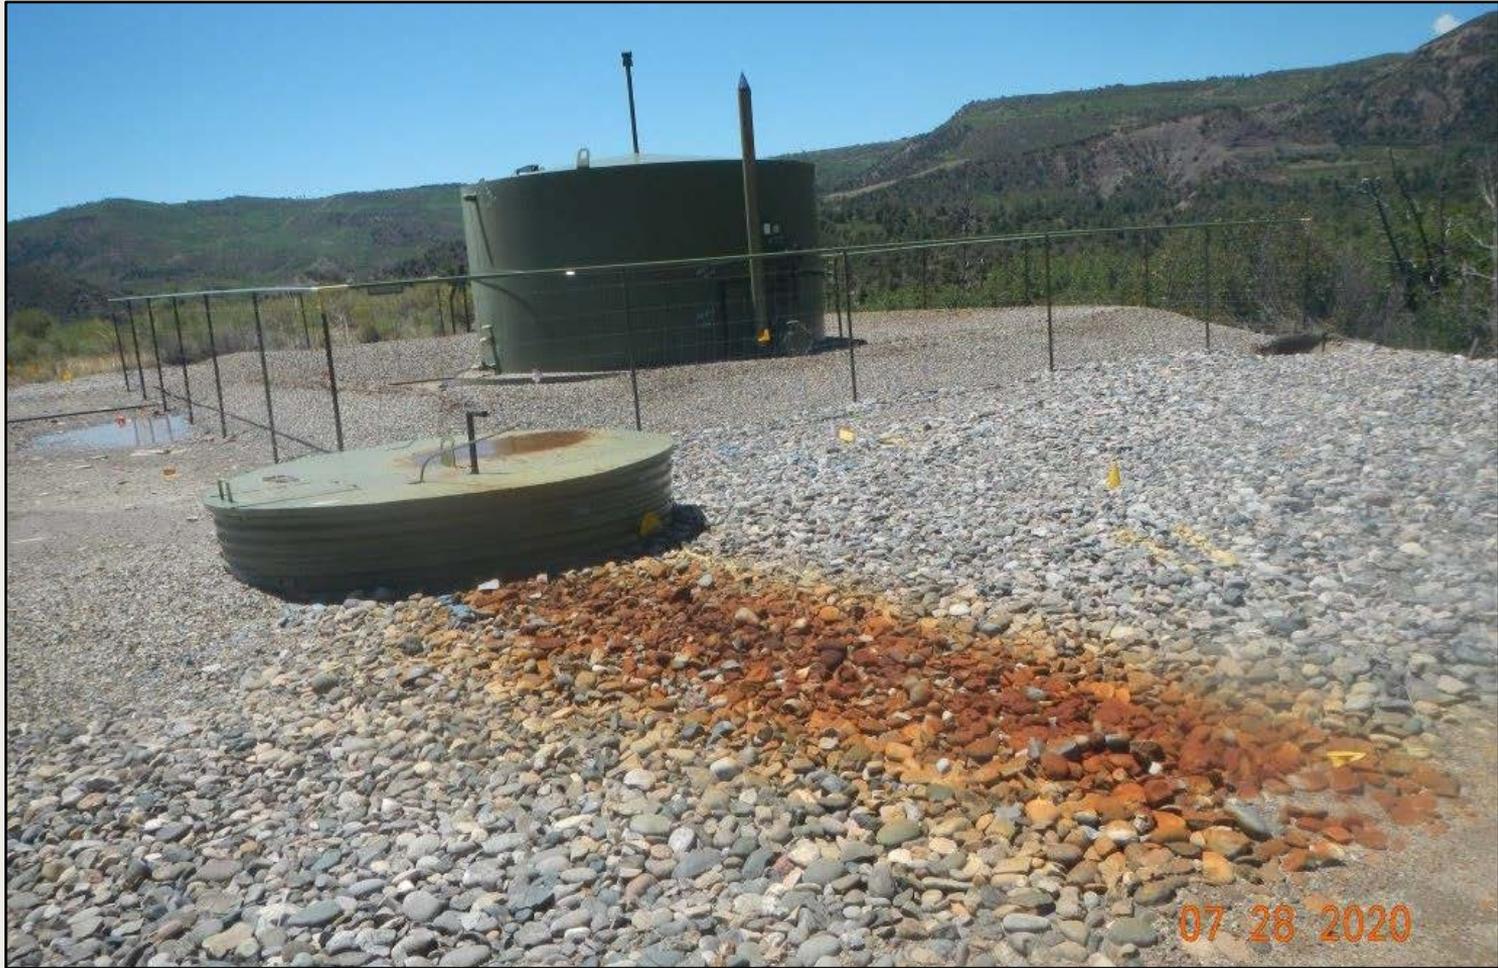
Photo 2. View of unknown material approximately 5 feet wide and 15 feet long on the well pad.

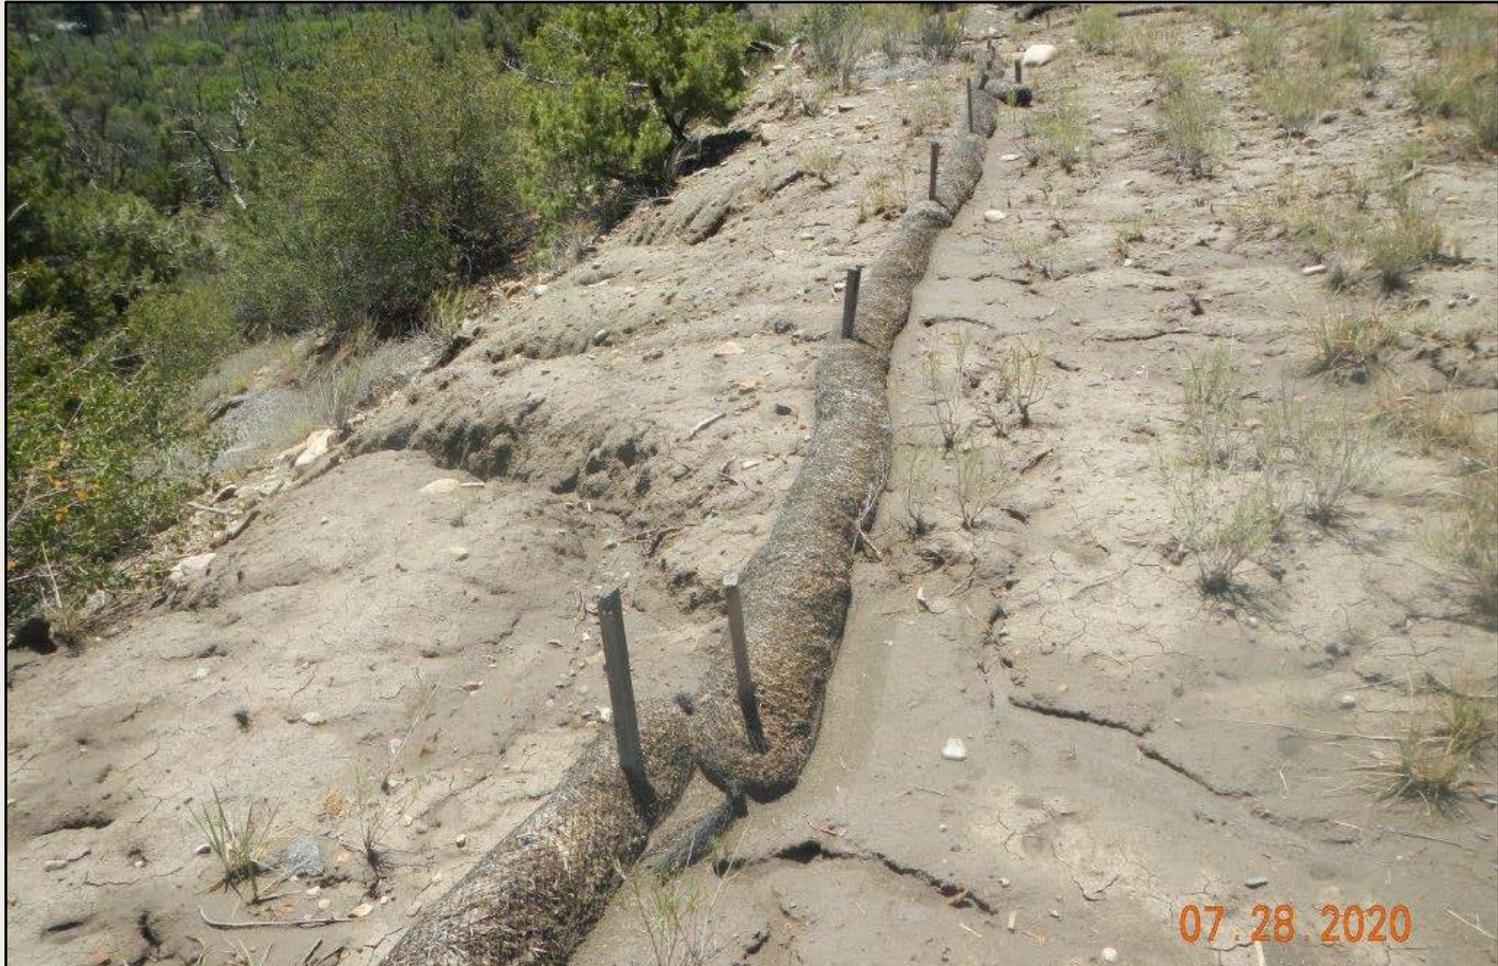
Photo 3. View of wattles along the eastern edge of the project area that are no longer functioning and are not adequate BMPs in this area.

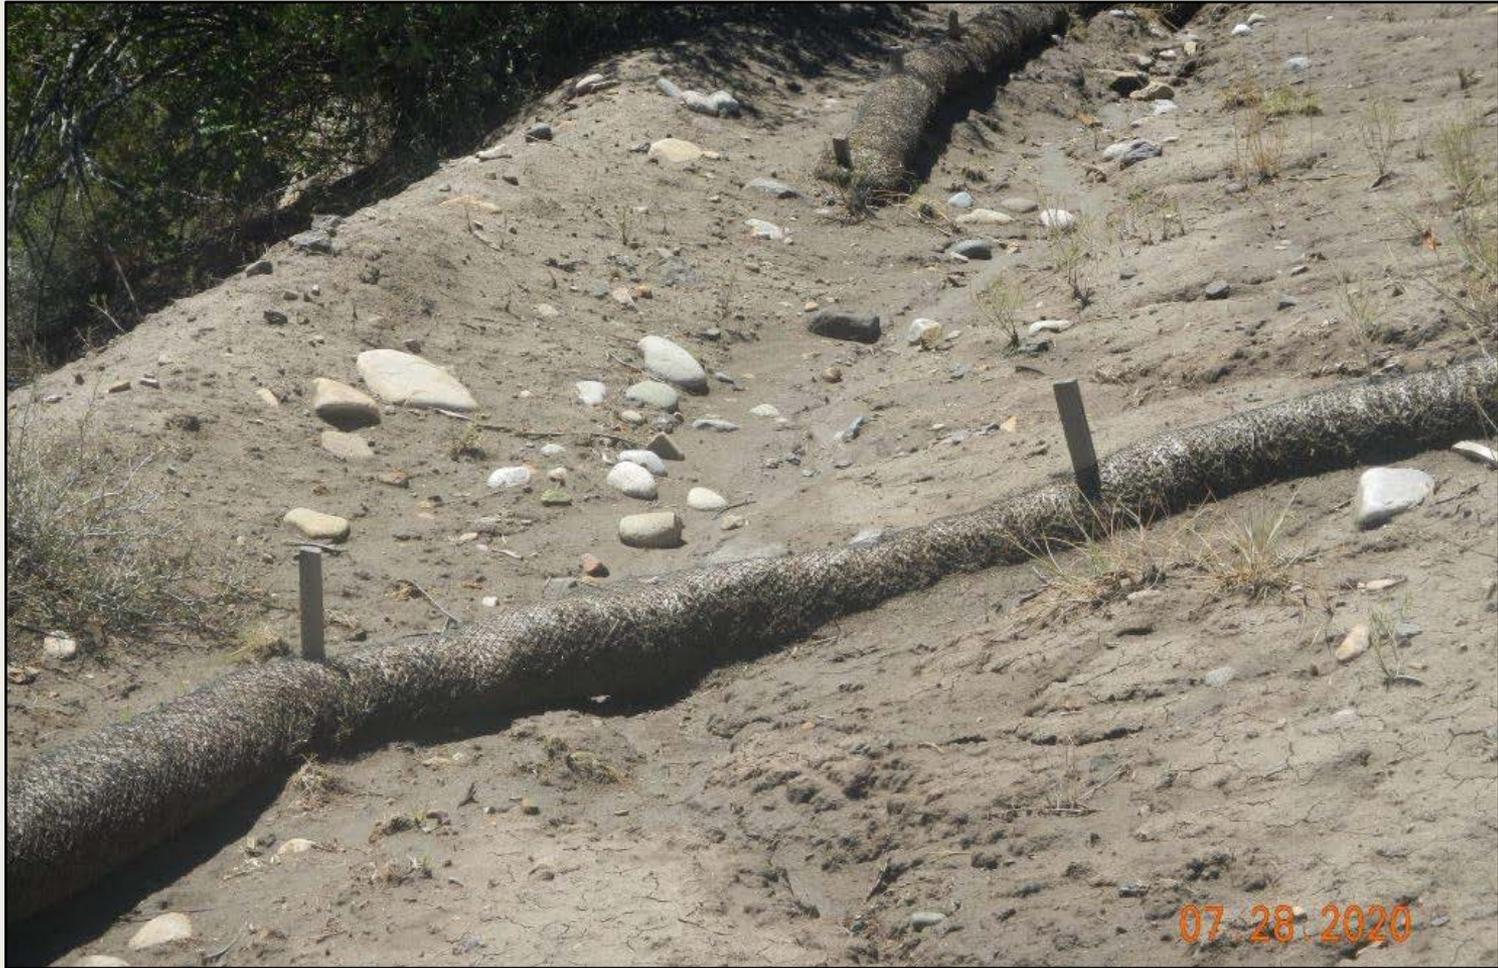
Photo 4. View of wattles in the southeastern project area that are no longer functioning and are not adequate BMPs in this area.

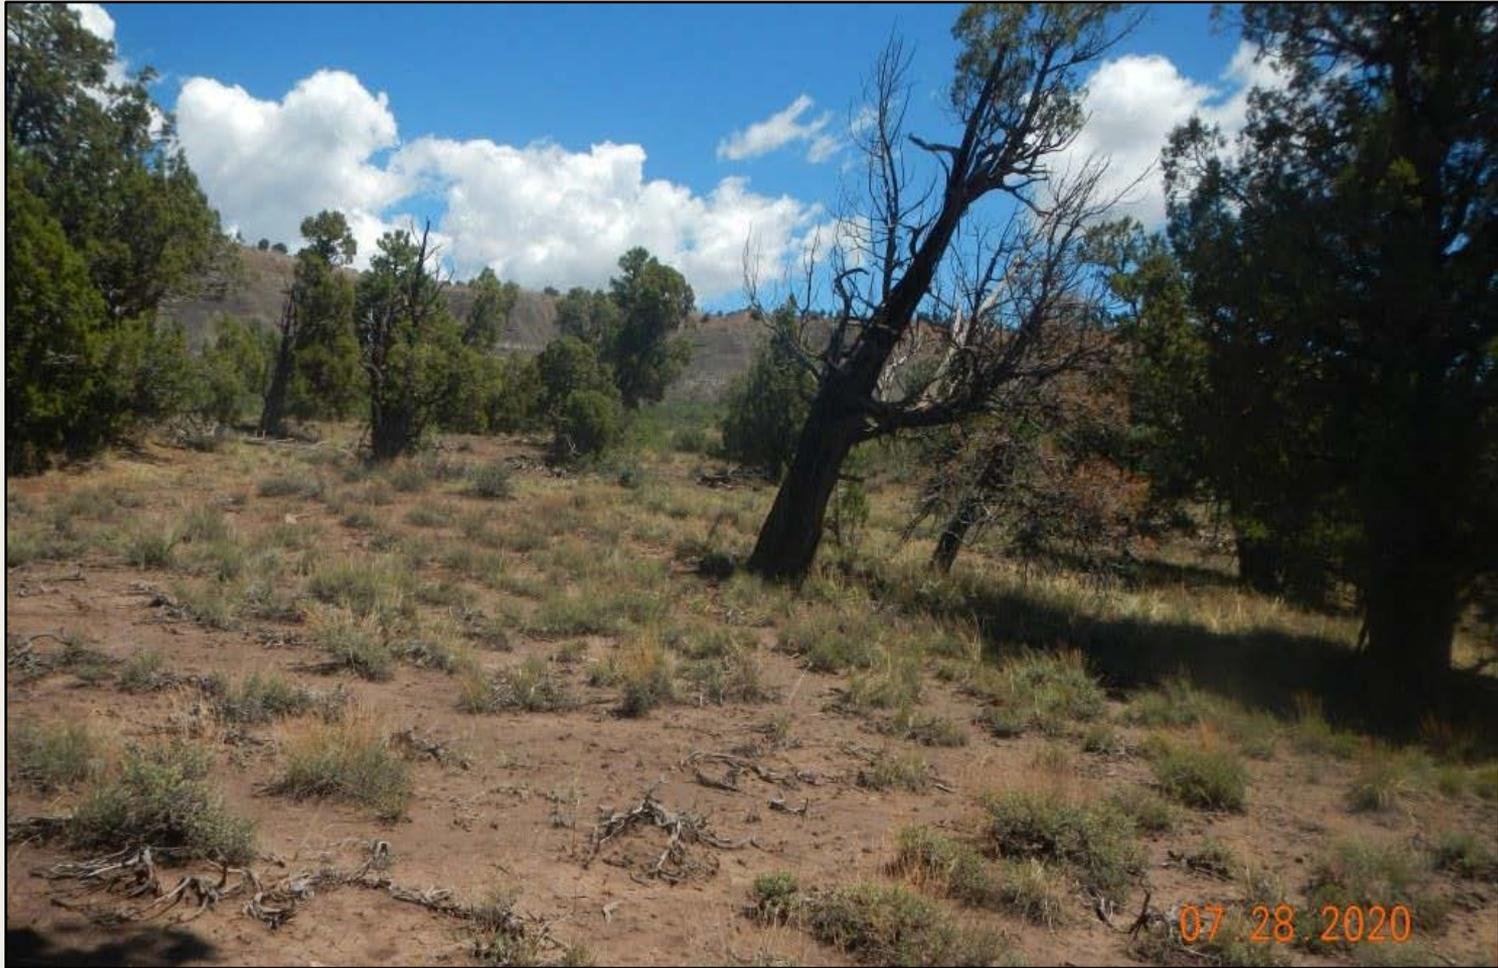
Photo 5. View of reference area vegetation comprised of pinyon and juniper woodland, with black sage, blue grama, and *Tetaneuris* sp.
